# Key Property Inspection Group

## Property Inspection Report

985 El Paso Dr, Los Angeles, CA 90042

Date of Inspection: 6/6/2019 Time: 12:30 PM

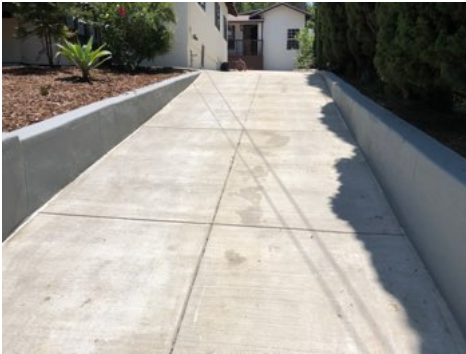
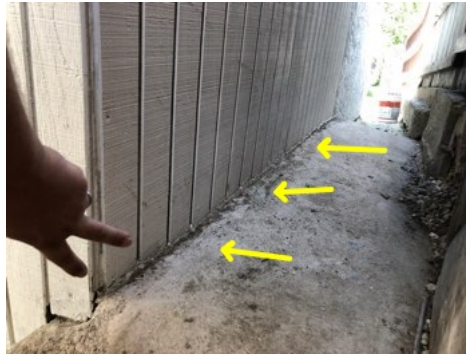
1.1. Cracks present at driveway/sidewalk surfaces.

1.2. Evidence of Poor Drainage present at driveway/sidewalk surfaces- seepage Noted at interior wall at front unit at left rear, recommend further evaluation by qualified drainage contractor.

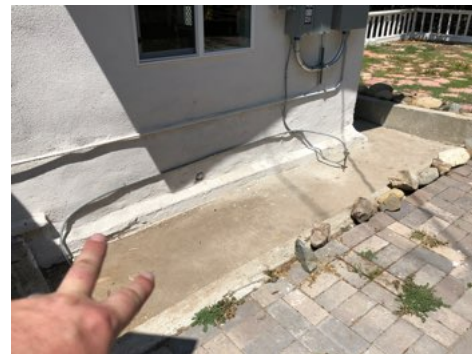
2.4. Patio slab and/or grading/walkways built high at foundation, covers stucco **drip edge** - Improper, poor workmanship noted. Possible seepage can occur. Have it checked by a qualified contractor.

2.5. House built on hillside grade - In these cases further evaluation by a qualified Structural Engineer and/or Geological evaluation is recommended by this Property Inspection Company. Hillside is not part of this inspection, property lines are not checked - FYI

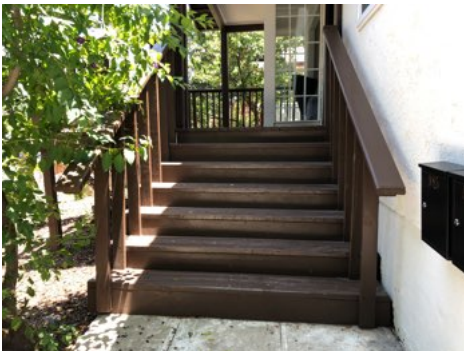
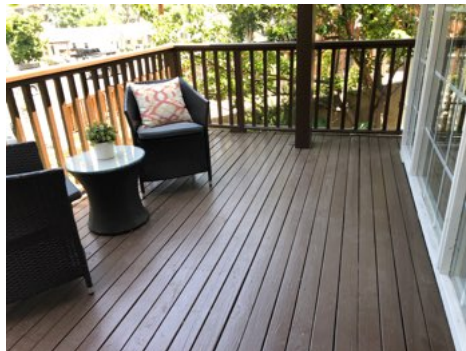
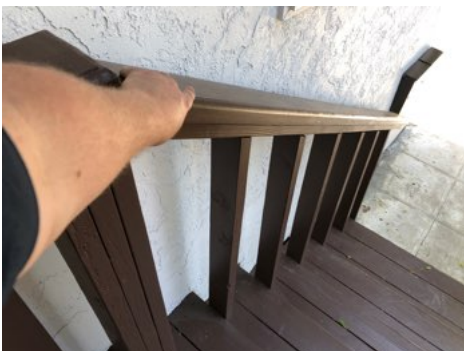
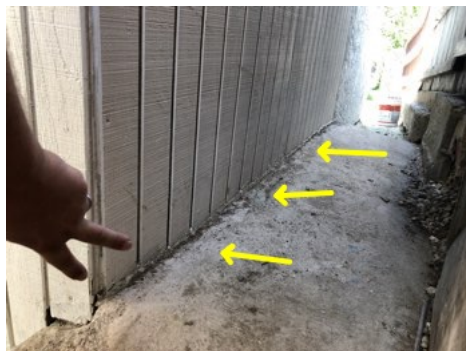
- 3.10. Patio slab and/or grading/walkways built high at foundation, covers stucco drip edge - Improper, poor workmanship noted. Possible seepage can occur- seepage Noted at interior wall at front unit at left rear. Have it checked by a qualified contractor.

- 3.11. Wall to deck flashing not visible, covered, and/or missing - Improper. Possible seepage can occur. Have it checked by a qualified specialist.
- 3.12. Recommend further complete evaluation of decks/patio cover, necessary corrections made by a qualified specialist, contractor.

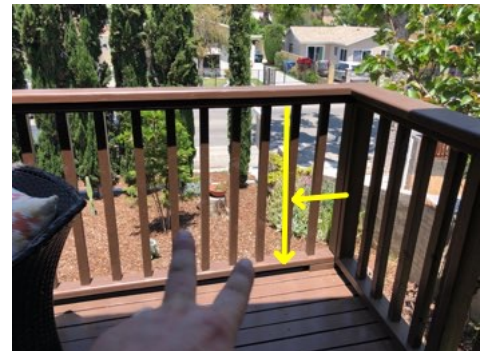
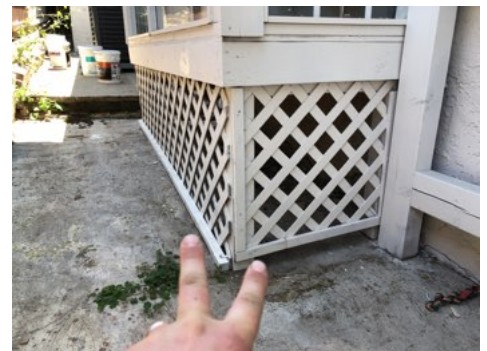
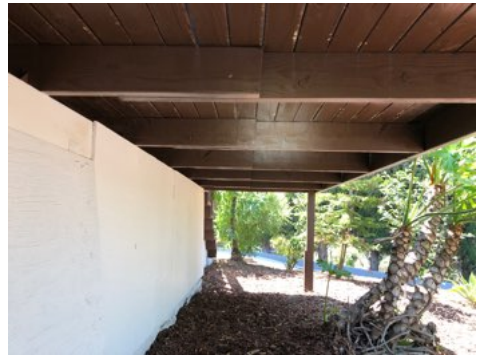
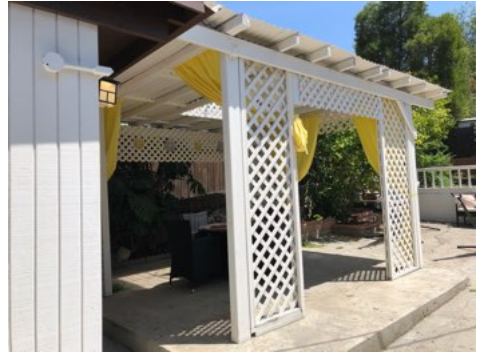
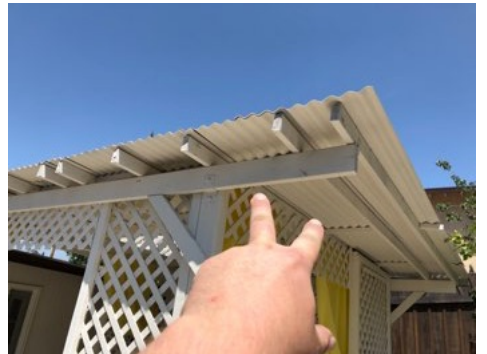
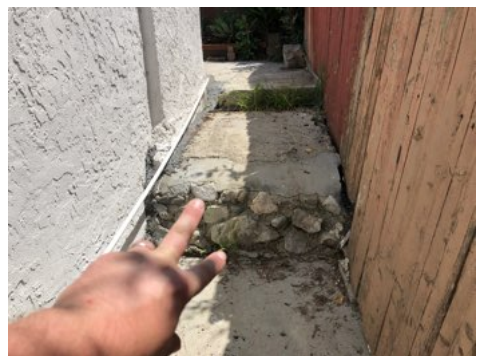
- 3.1. Cracks, settlement, uneven present at rear patio area(s)/walkways. Have it checked, any necessary corrections made by a qualified contractor.
- 3.2. Uneven rise was noted at exterior steps- this condition present trip hazards. Recommend to have checked, any necessary corrections made by a qualified contractor.

- 3.4. Earth To Wood Contact at support post(s) at many areas at patio cover/decks. Have it checked, corrected by a structural pest specialist.
- 3.5. Post base(s) missing, Recommend to be connected to concrete footings by a post base with a 1" standoff. Have checked, necessary corrections made by qualified specialist.

- 3.7. Metal and/or plastic patio covers Noted. These type of covers prone to leaks, regular periodic maintenance required- holes, gaps/damage noted at patio cover. Have checked, corrections/repairs made by qualified specialist.

Loose railing/not grippable.

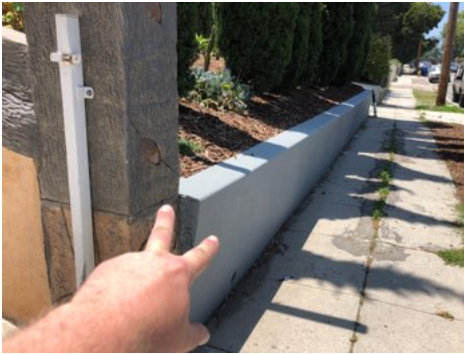
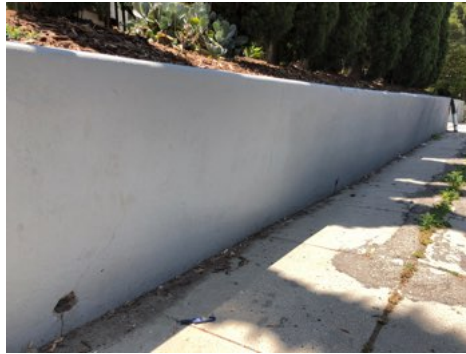
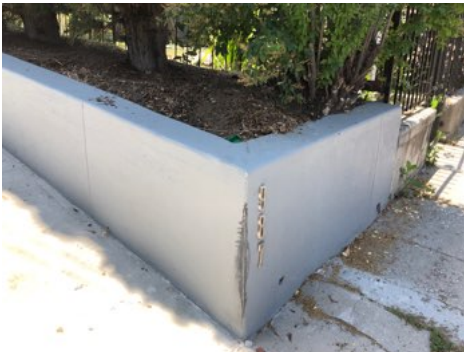
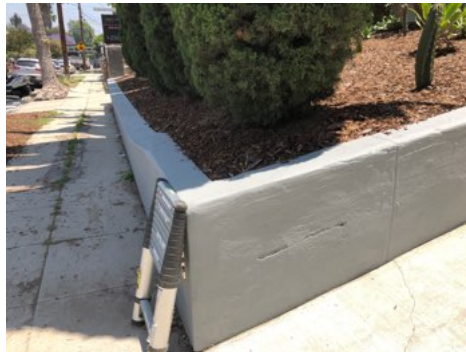
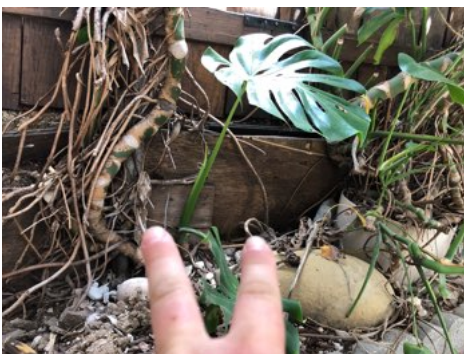
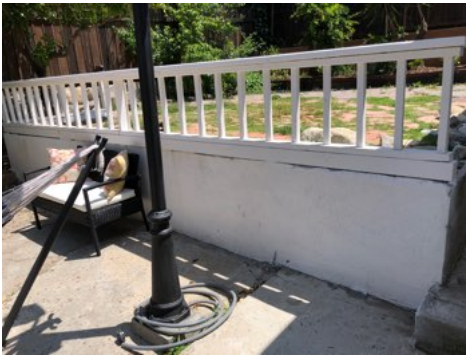
4.3. Timber/Wood boards noted at exterior at left side at rear, damage/deterioration/age defects/leaning noted. Recommend to have checked, necessary corrections/repair made by qualified contractor or geotechnical specialist.

4.4. Cracks, leaning noted at garden/retaining walls. Have it checked by a qualified specialist, contractor.

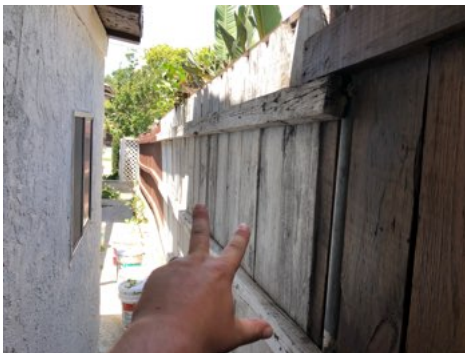
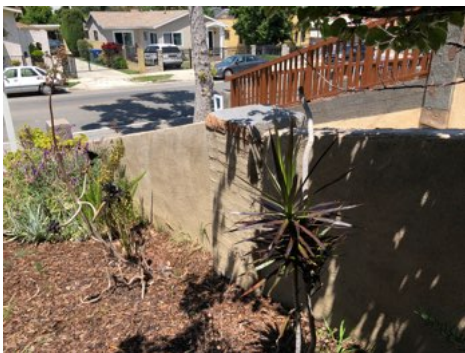
**5.5. Fencing was loose/leaning at areas. Recommend Further Evaluation, repairs by qualified specialist.**

**5.6. Loose Wood boards in use as fencing noted at some area(s), missing proper fence. Have checked by qualified specialist for correction.**

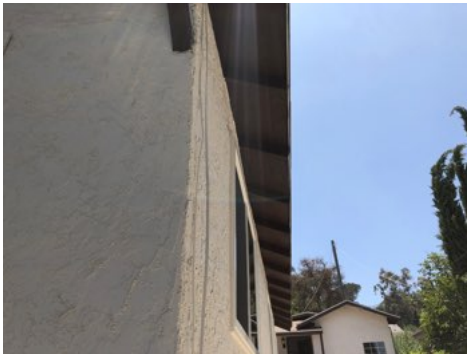
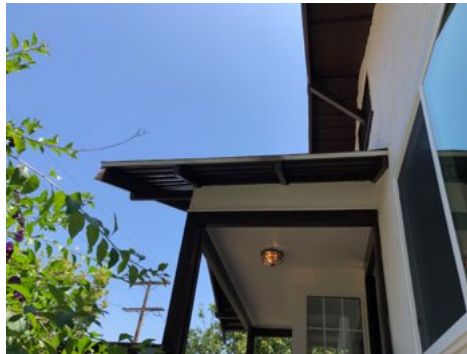
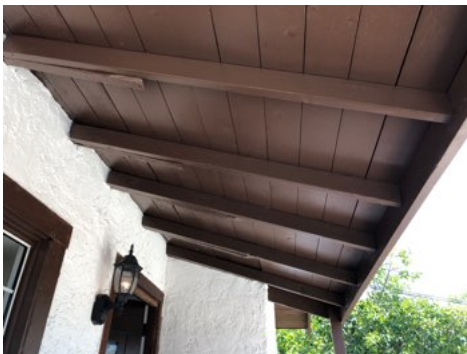
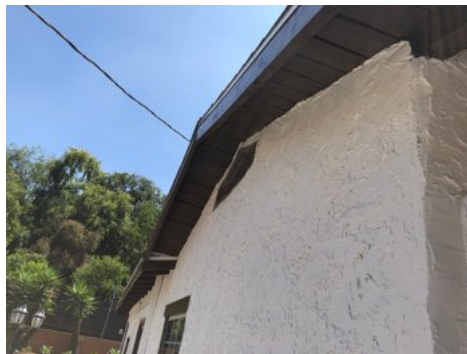
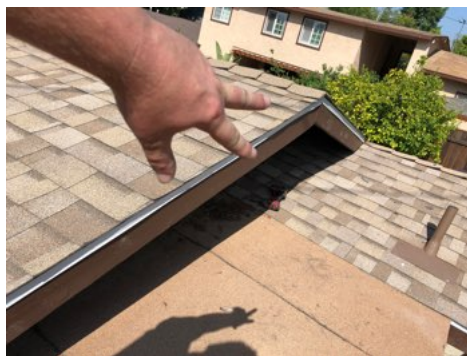
6.2. Wasp Nest(s) noted at eaves. Recommend to have it checked, removed/cleaned by a qualified Pest specialist.

Wasp nest/activity Noted

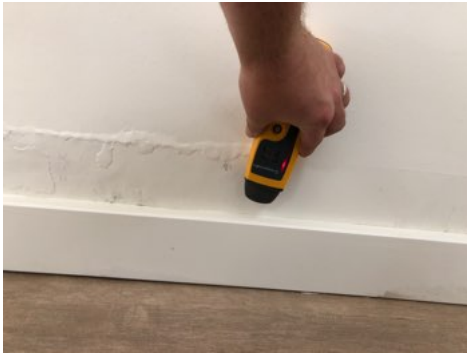
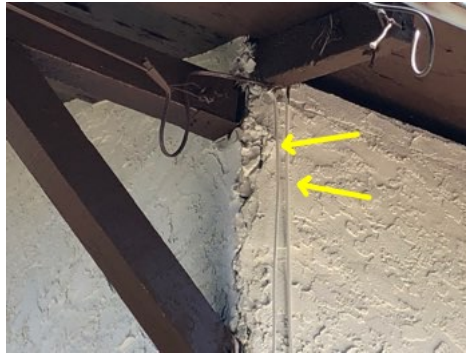
7.5. Water stains, damage, bubbling at interior wall, moisture detected with meter present at the interior wall(s) at rear living area by laundry, seepage Noted from exterior at siding, caulking noted where walkway/wall meet, missing wall/deck flashing. Recommend further evaluation, repairs by qualified specialist(s).

7.6. Cavity/opening at exterior wall at left rear- recommend to correct/seal to prevent water seepage and future damage. Have checked by qualified contractor.

Front by porch steps

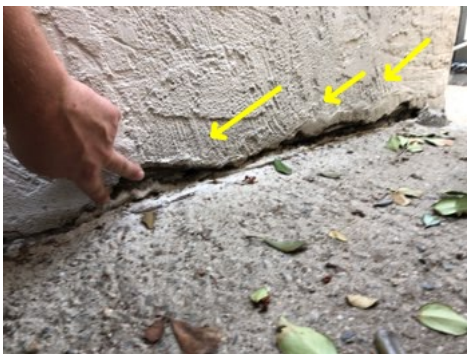
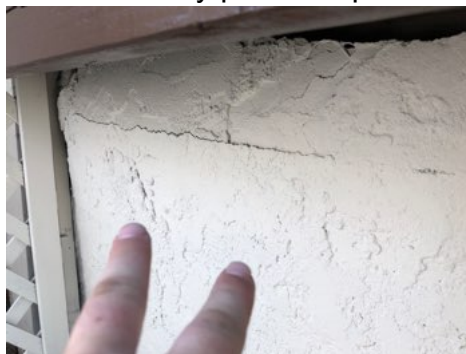
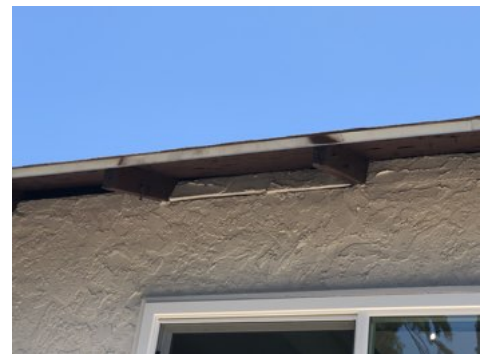
Under front porch area have checked

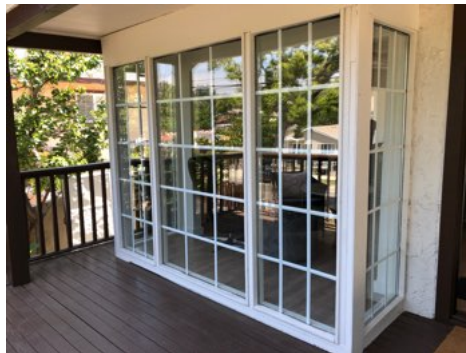
**8.4. House with some old aluminum (single pane) windows type. Recommend to upgrade.**

Single pane- laundry

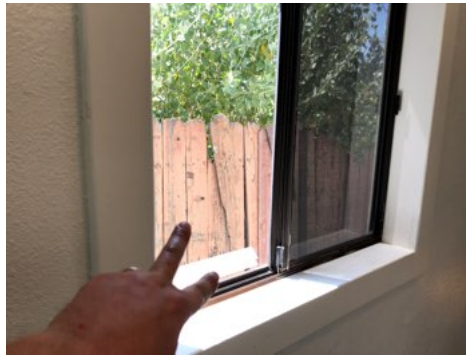
Single pane- master bath rear unit

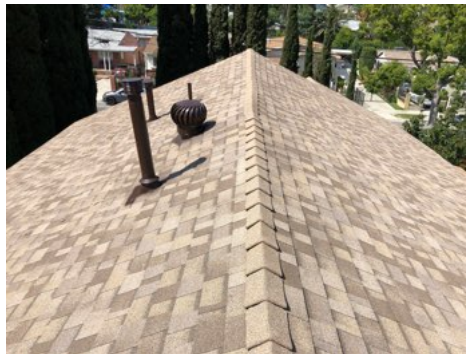
**2.3. Exposed fastener(s), nail(s) noted at area(s) of the roofing which may allow moisture/water penetration. Recommend to seal, have checked, corrections made by qualified specialist.**

Nails

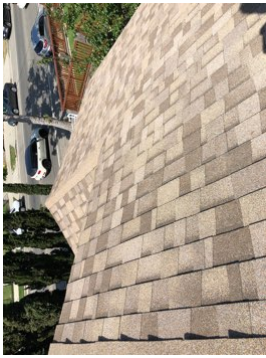
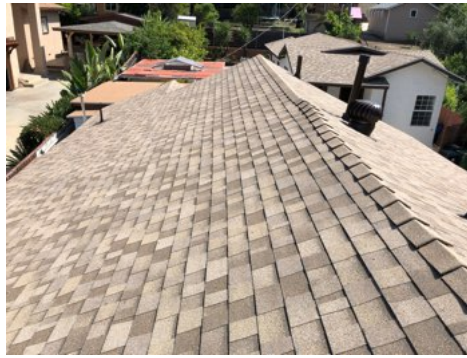
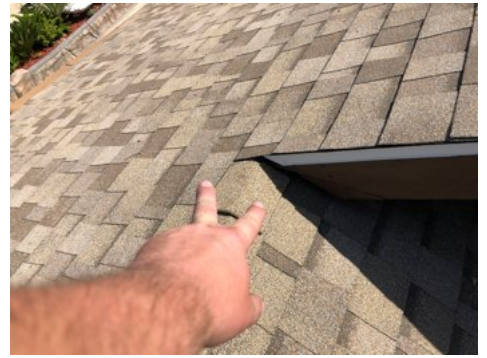
Nails

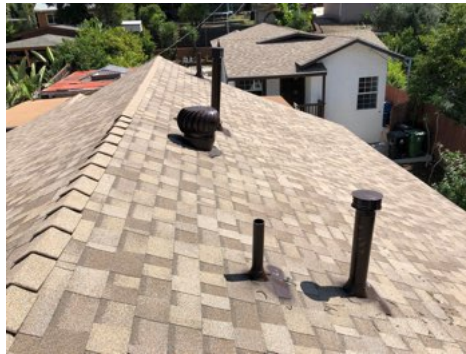
Missing collar

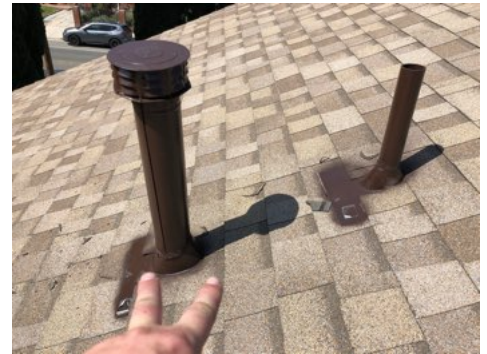
Missing lockout flashing

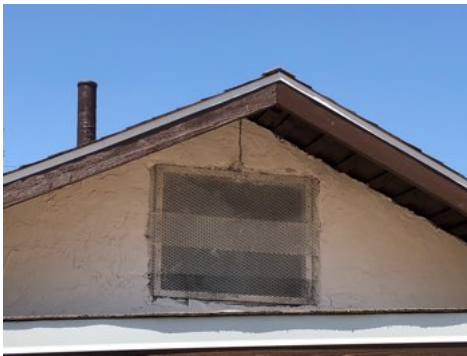
5.2. Bee Hive and/or nesting noted at gable and/or soffit vent(s) at rear unit at rear noted. Recommend to have it checked, removed and necessary corrections made by a qualified Pest specialist.

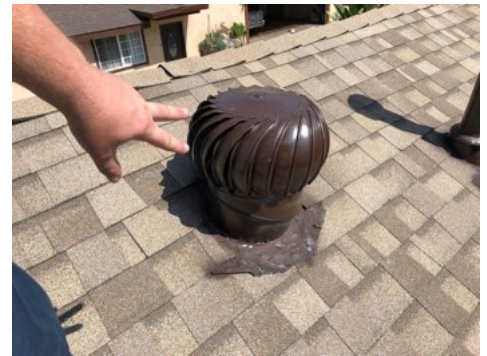
5.1. Turbine type attic vents were noted - This vent type is prone to leaks.

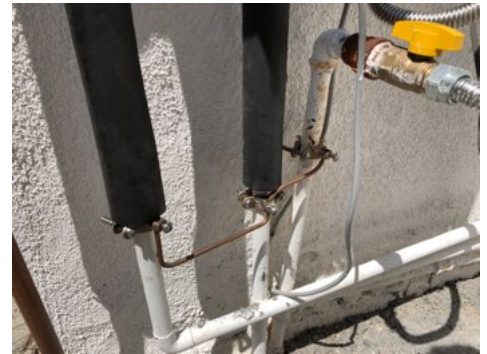
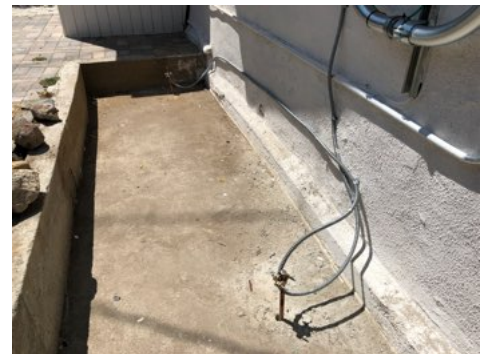
**2.1. Ground clamp not visible at the Main water pipe. Recommend to install. Have checked by qualified specialist.**

**2.2. Newer installation or upgraded panel noted. Recommend to check the records, permits.**

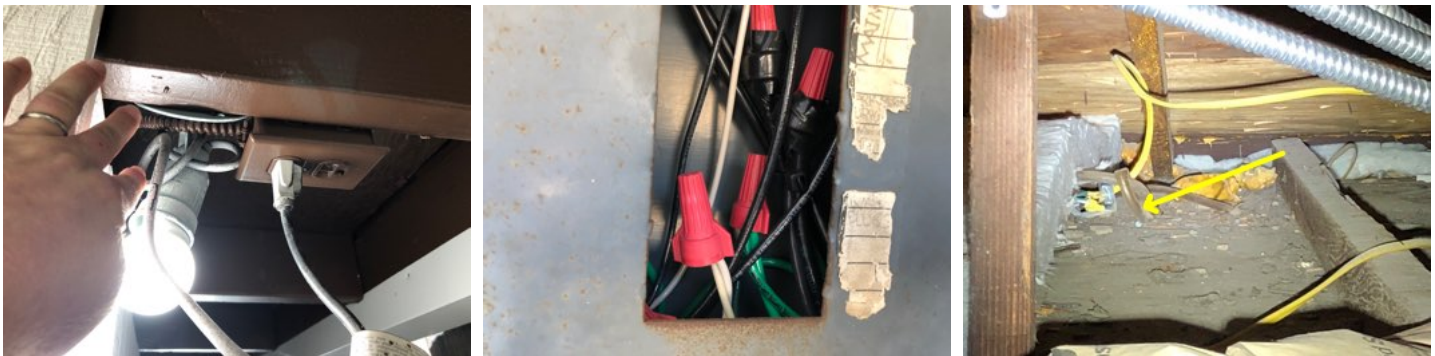
**4.2. Interior grade Flex tubes are used at exterior outlet- Improper. Recommend to have it checked, fixed by a qualified electrician.**

Flex/missing cover

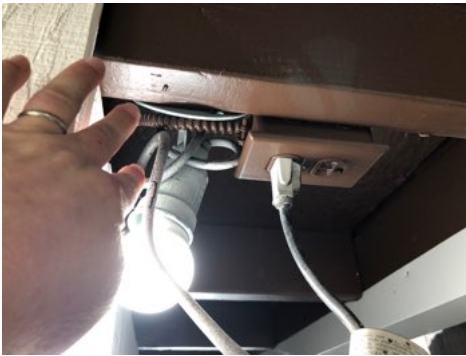
**5.2. Number of outlets with missing, damaged covers noted. Recommend to install new.**

**5.3. Interior grade Flex tubes are used at exterior outlet- Improper. Recommend to have it checked, fixed by a qualified electrician.**

Flex/missing cover

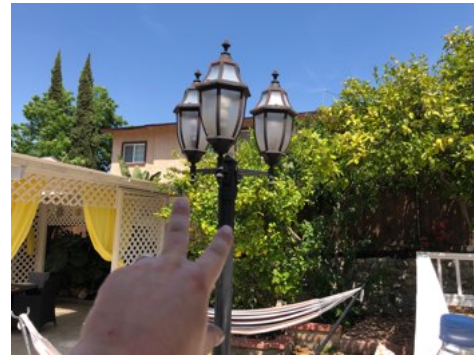
Not working

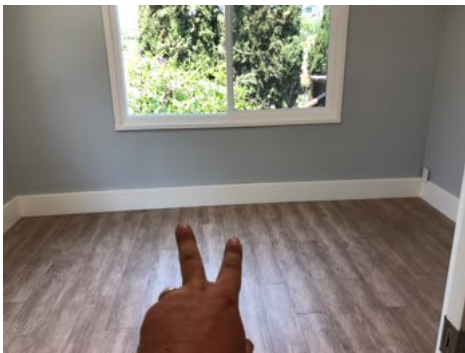
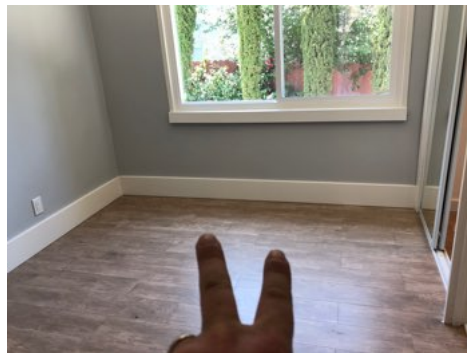
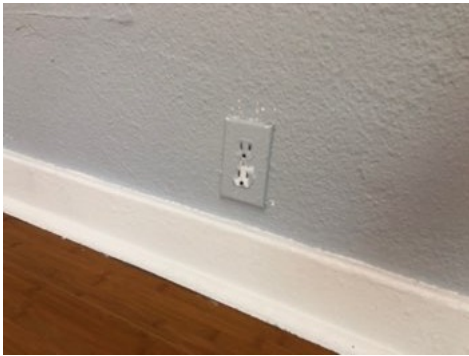
7.5. Painted outlets, switches noted. Recommend to replace for fire safety.

7.6. Newer fixtures noted. Recommend to check the records, permits.

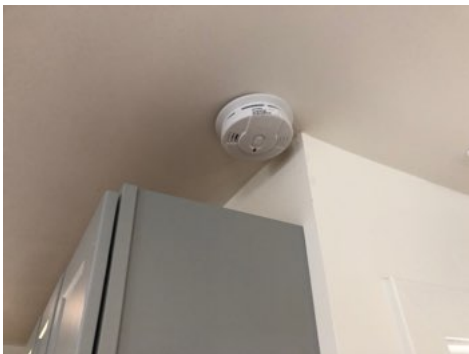
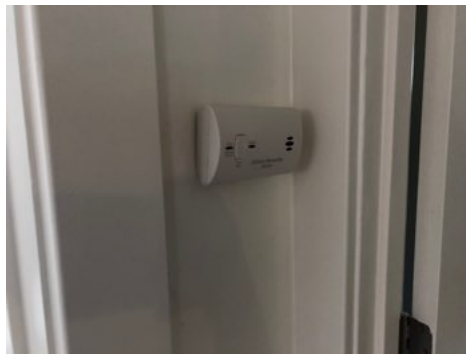
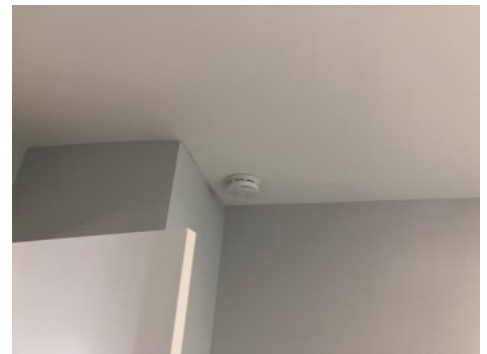
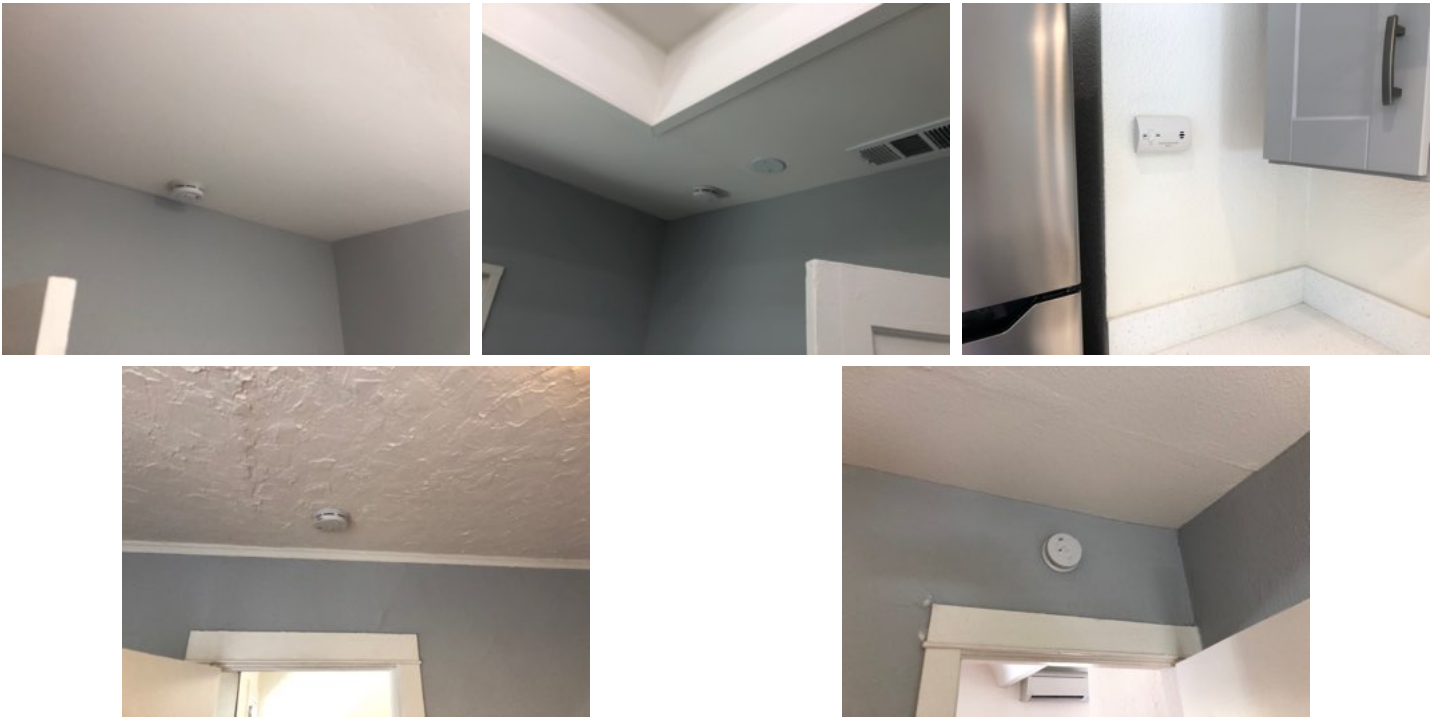
8.1. Smoke detectors in bedrooms and/or hallway noted - Recommend to test them periodically

8.2. Carbon monoxide detector noted - Recommend to test it periodically.

**8.3. Smoke and Carbon Monoxide detectors, fire alarms/systems not inspected. Beyond the scope of this inspection. Recommend to install smoke and carbon monoxide detectors per City/Manufacturers requirements and test them periodically - Recommend to have checked by a qualified retrofitter. THIS IS A HEALTH/SAFETY CONCERN.**

**8.4. Recommend to install carbon monoxide detectors per City/Manufacturers requirements and test them periodically- should be within 10 feet from each bedroom. Information regarding placement can be found on the State Fire Marshall website at <http://osfm.fire.ca.gov>**

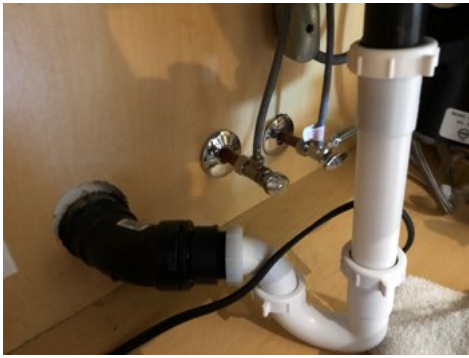
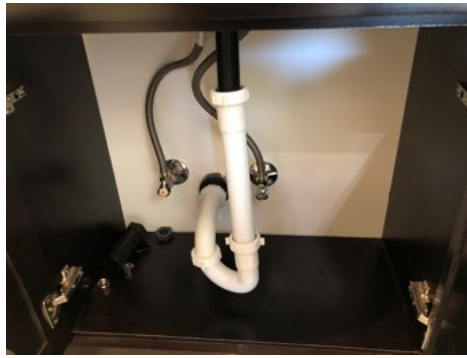
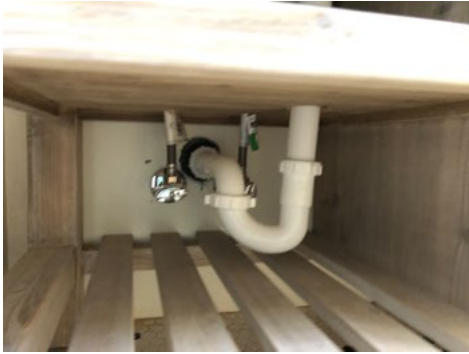
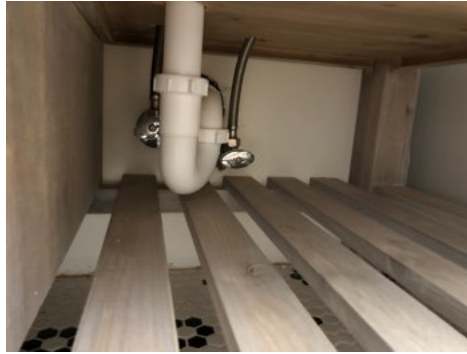
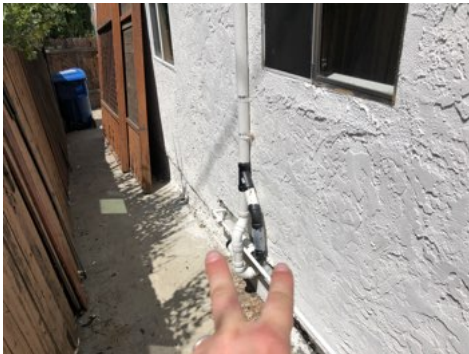
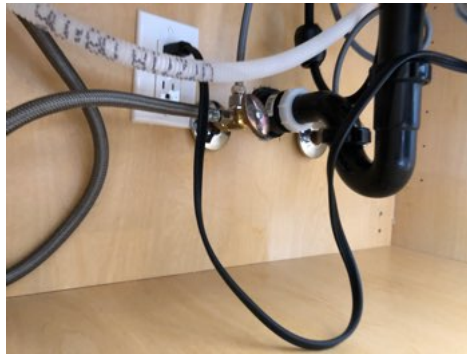
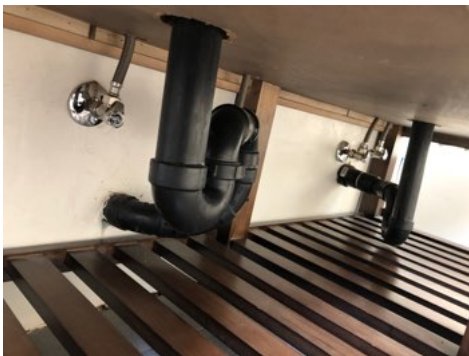
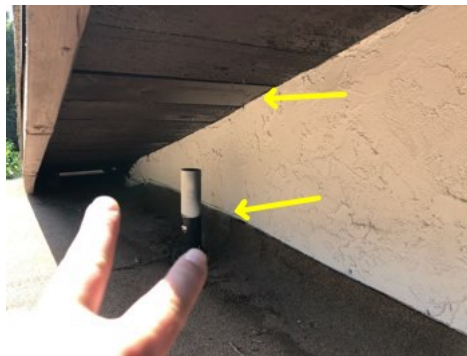
1.3. Sewer clean out at driveway noted - Recommend to check service records.

1.4. House with some old/rusted cast iron sewer waste pipes type - In need of repair/replacement. **LIMITED LIFE EXPECTANCY** - In most cases cast iron sewer pipes should last 50-75 years in a residential application Recommend to hire a qualified plumber for further evaluation for any necessary repair, replacement.

1.5. Newer ABS type waste pipes noted - Recommend to check the records, permits.

1.6. Support method of the ABS waste pipes in the crawl space are considered to be inadequate - Lacks rigid support. Have checked, properly secured and any necessary corrections made by a qualified specialist.

1.7. Combination of newer ABS pipes and old cast iron pipes noted at sewer line under house. Check records and permits for plumbing work previously completed. This indicates original pipes were failing due to age and further upgrades and replacement may be required. Periodic inspection and complete evaluation recommended by qualified plumber.

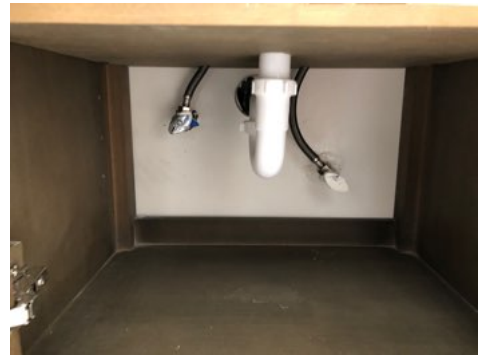
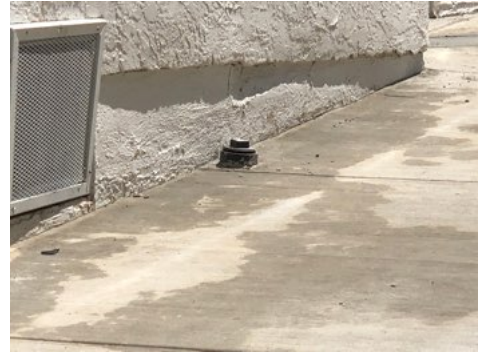
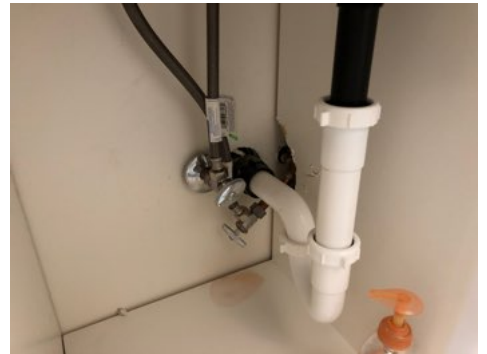
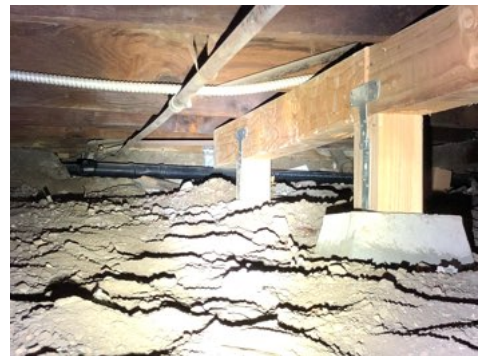
1.9. Sewer vent pipe(s) terminates terminates under eaves and below roof line - Improper, should vent above roof and be painted/sealed. In need of further evaluation, necessary corrections/repair made by a qualified plumber.

terminates under roof

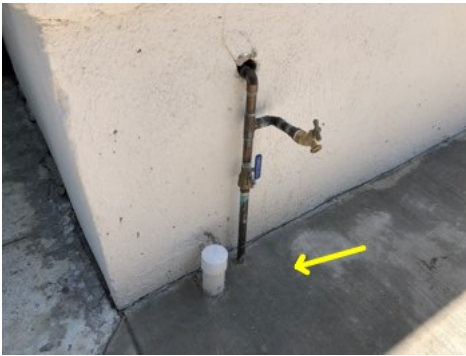
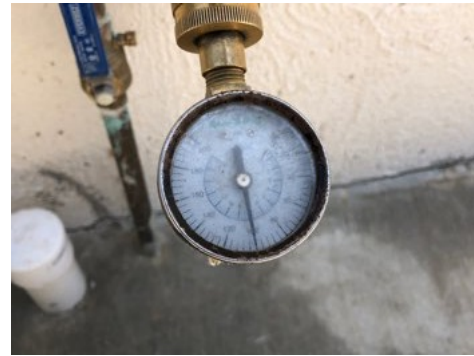
100 psi

**2.4. Water pressure** is too high, measured at - 100 PSI - Recommend installation of the regulator and adjust pressure to below 80 PSI.

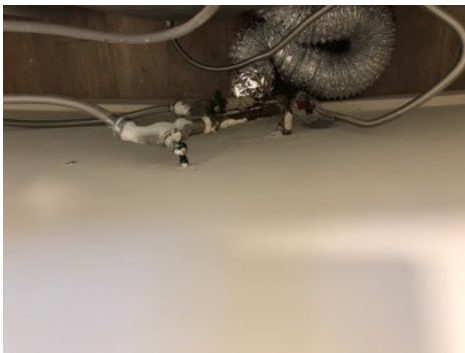
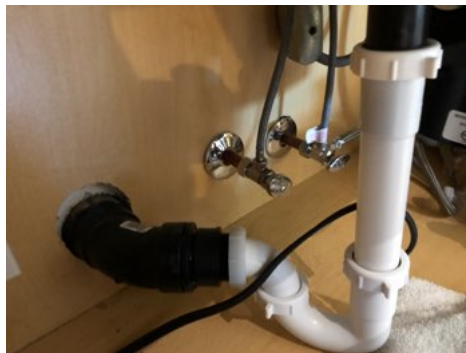
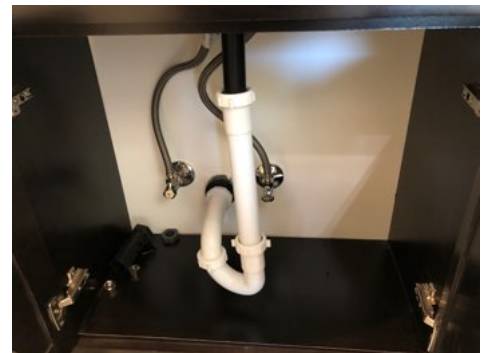
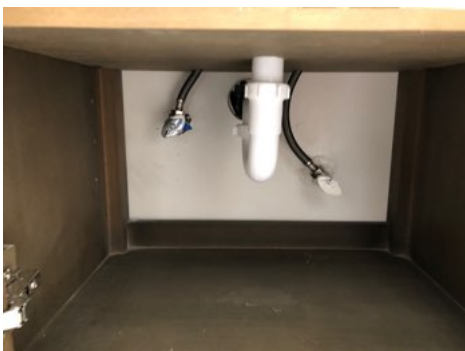
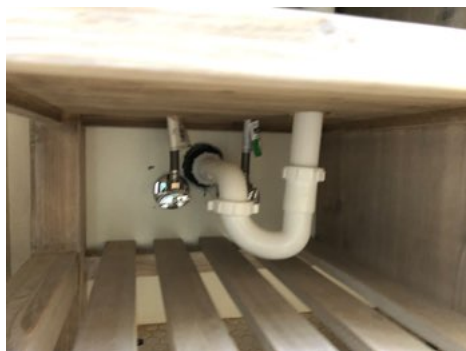
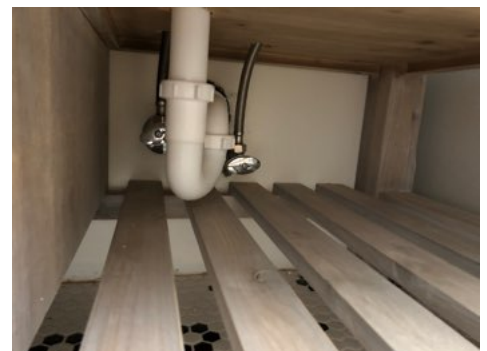
3.3. Recommend to check the records, permits on copper/PEX re-piping and scope of re-piping.

3.4. Most of the plumbing pipes were not visible at this inspection. Check the records for any known defects, repairs.

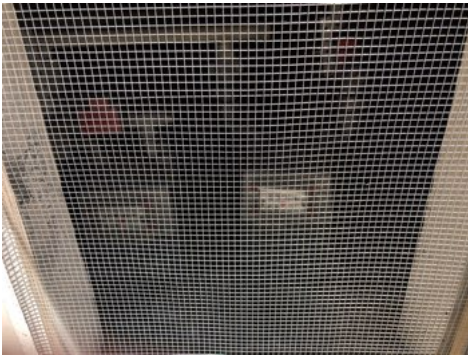
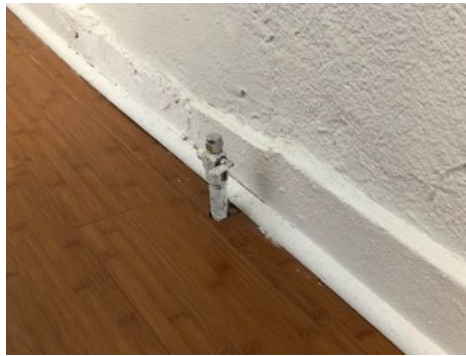
4.1. Gas meter(s) - seismic shut off was present at the time of inspection. (FYI) Not tested at this inspection check the records. Most of the plumbing pipes not visible at this inspection. Check the records for any known defects, repairs.

4.3. Underground gas pipe noted (type unknown). Have it checked for possible gas leak. Gas leaks or pipe testing not part of this inspection. Recommend to check the building records, permits for any known issues or repairs regarding gas pipes, fuel systems and/or have it tested by the Gas Co. and/or a qualified plumber.

4.4. Gas meter is located in crawl space, poor location - Recommend to relocate to exterior. Check with The Gas Co.

4.5. Old gas valve(s) noted at interior - Recommend to remove and cap the pipe(s)

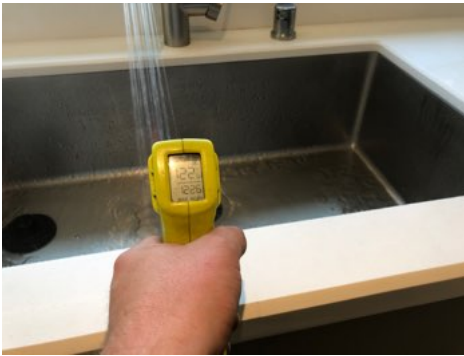
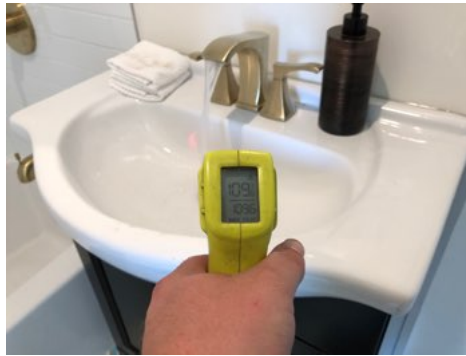
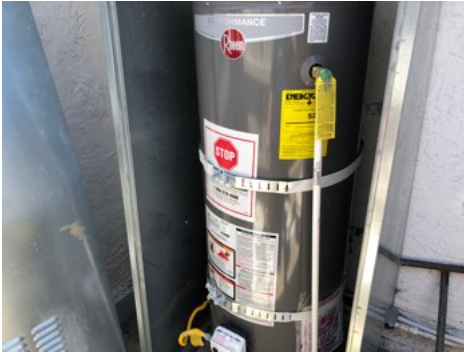
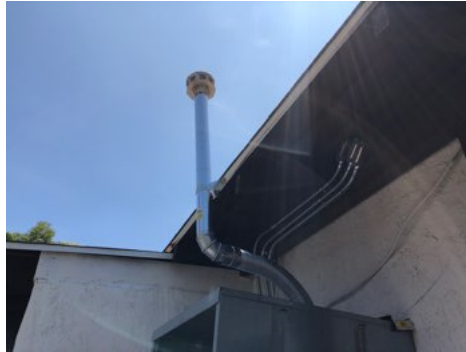
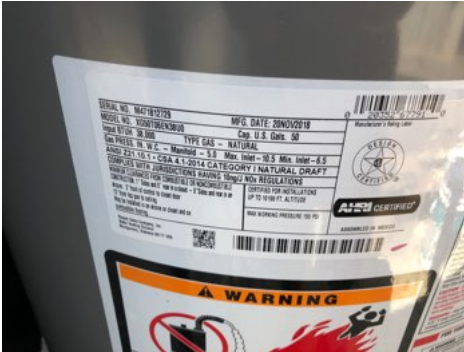
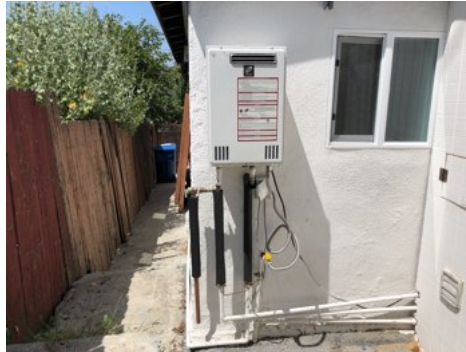
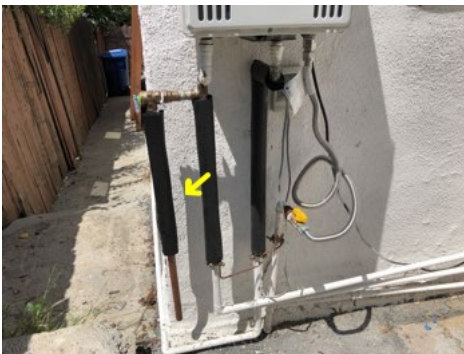
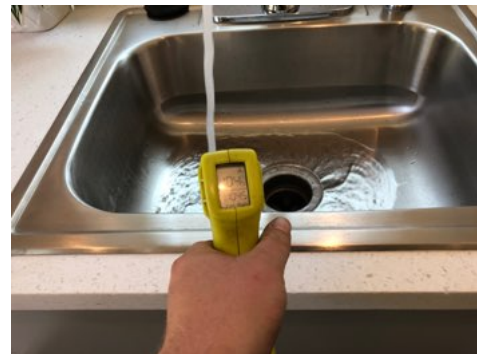
**5.11.** Copper tube was used on condensate pipe without Condensate Neutralizer at tankless water heater. Recommend to replace with **PVC** type drain pipe and install a Condensate Neutralizer. Have it checked and repaired by a qualified plumber.

**5.12.** Water heater lacks a catch pan with exterior routed line. Recommend to install.

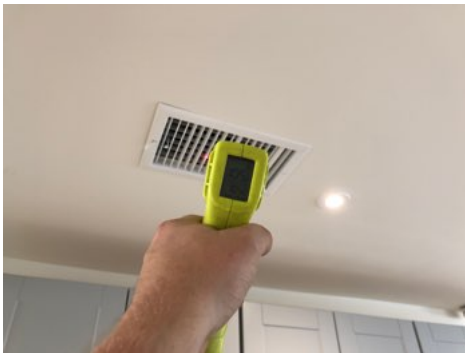
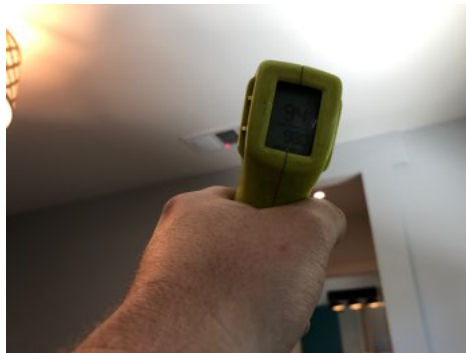
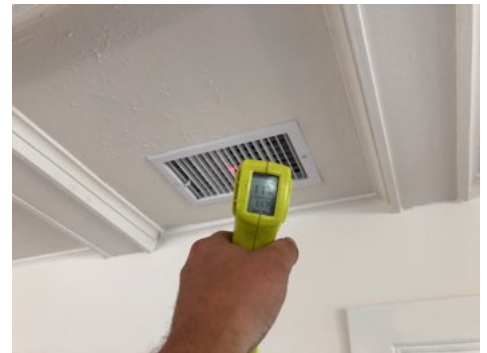
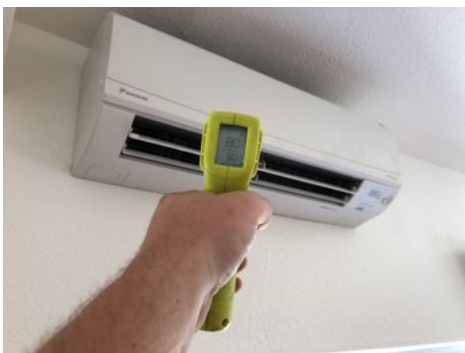
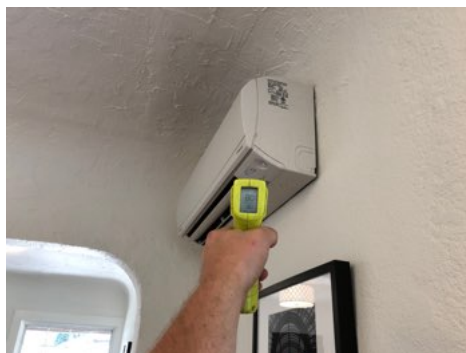
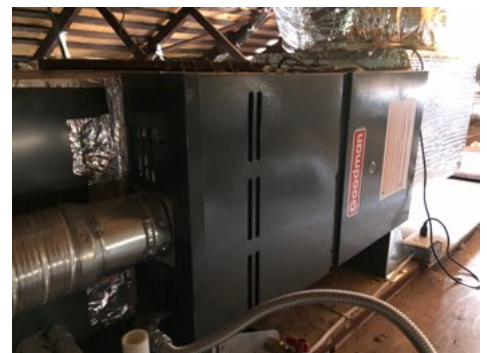
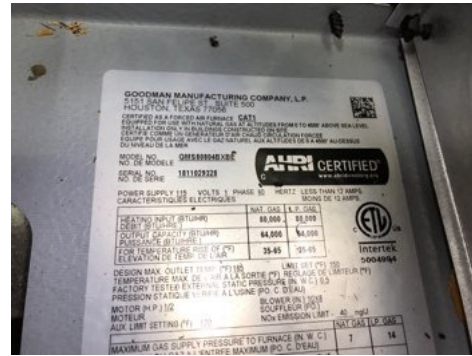
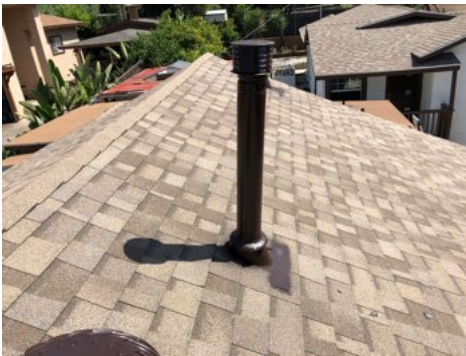
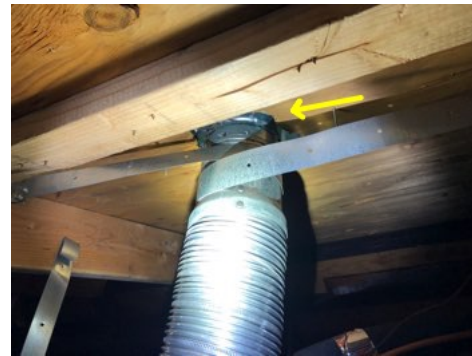
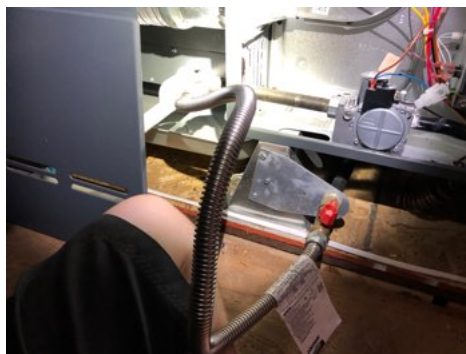
1.4. Unit(s) are newer/upgraded installation - Recommend to check the records, permits, warranties.

1.2. Recommend to check the service history with the Seller and to have the unit(s) serviced by a qualified HVAC Contractor if not performed in the past year. Air flow is not a part of this inspection. Recommend to check the disclosures regarding day to day functionality. No service tags noted. This is a limited Visual Inspection - Recommend to have the unit(s) evaluated by a qualified HVAC Contractor. Annual service, evaluation and maintenance is recommended with gas fired furnaces.

1.3. Typical Lifespan of heat unit(s) are 15 to 20 years. Recommend to have a qualified HVAC specialist to inspect and/or evaluate the entire system to have a better understanding and expected life span of the HVAC system.

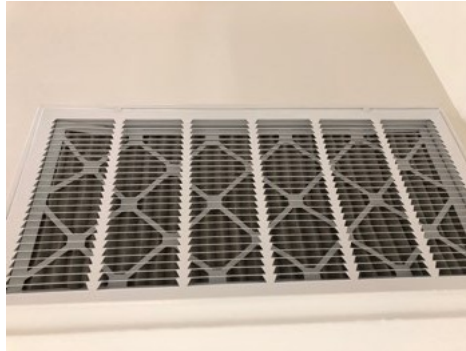
14x30x1

**4.2. The Filter(s) are dirty and in need of replacement. Have checked, service/maintenance performed by qualified HVAC specialist.**

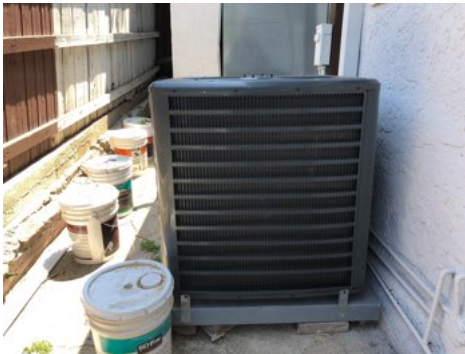
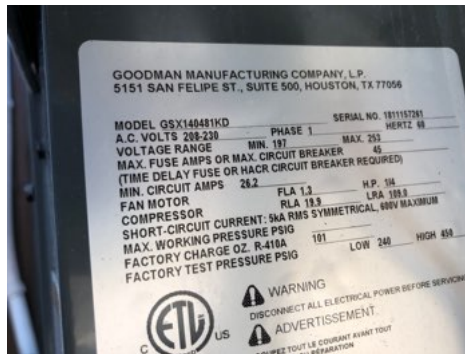
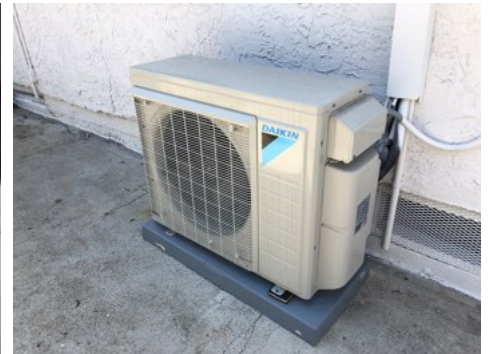
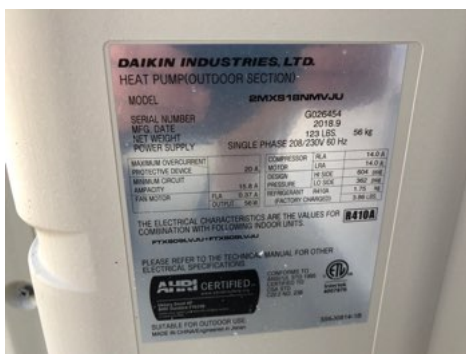
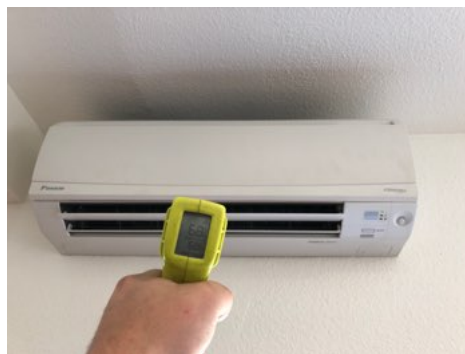
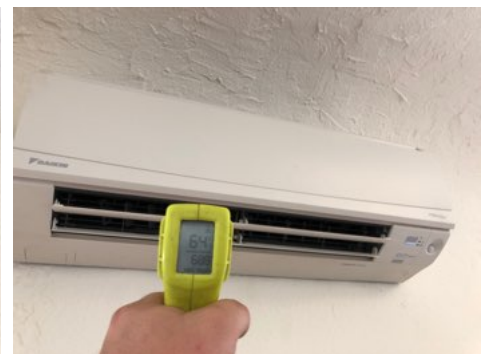
7.3. Ambient air test was performed by using thermometers on air handler of Air conditioner to determine if the difference in temperatures of the supply and return air are between 14 degrees and 22 degrees which indicates unit is cooling as intended. The range in Temperature drop was normal at the time of the inspection (FYI).

7.4. Unit(s) appear to be a newer installation- Recommend to check the records/permits/warranties.

7.2. Recommend to check the service history with the Seller and to have the unit serviced by qualified HVAC Contractor if not performed in the past year. No service tags noted at the unit. Air flow/balance is not a part of this inspection. Recommend to check the disclosures regarding day to day functionality.

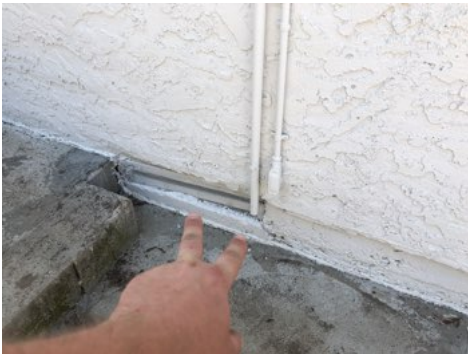
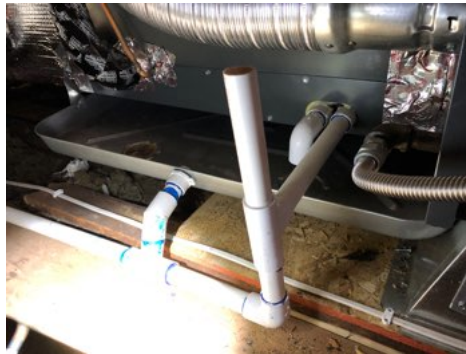
10.1. Primary and Secondary condensation pipe(s) connected together, missing safe T switch- Improper. Recommend to separate. Have checked by a qualified HVAC specialist for any necessary corrections.

10.2. **A/C** condensation lines drain and terminate at sewer vent(s) at attic space- Poor location - Improper (It is possible to get sewer gases inside the house). Recommend to correct. Have checked, corrections made by qualified HVAC specialist.

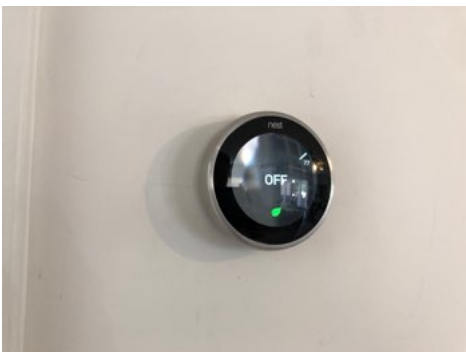
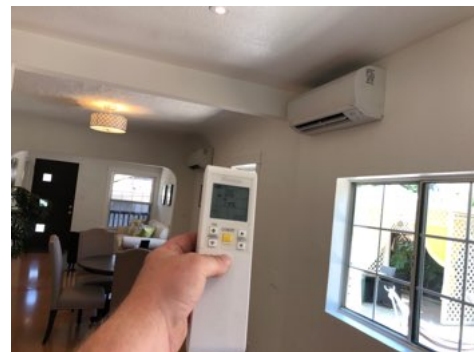
11.1. Thermostat(s) operational at the time of inspection. (FYI)

11.2. No thermostat is present for the unit(s) - On-board controls/remote only noted. Only one remote for both wall Units Noted- FYI

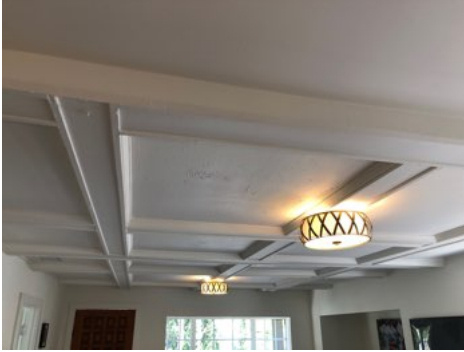
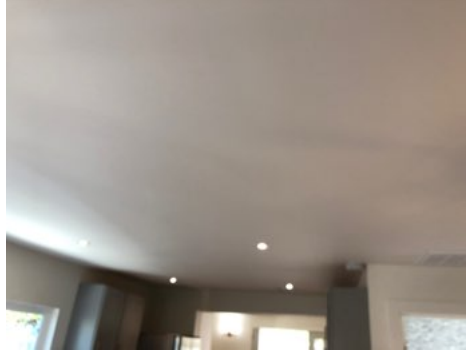
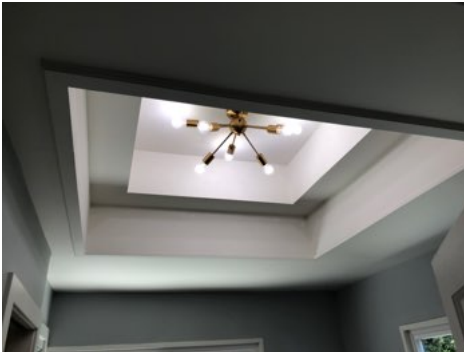
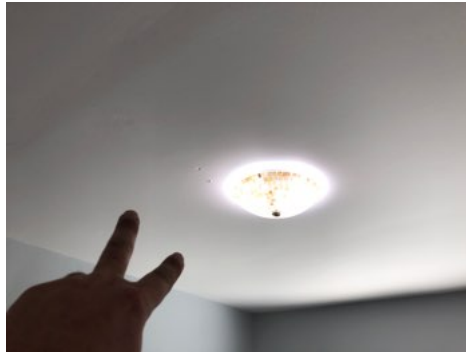
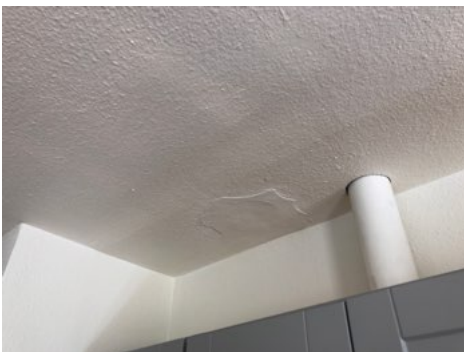
**1.1. Common cracks were noted at the ceilings.**

**1.2. Newer paint job noted - Check the records for any known defects and/or repairs.**

**1.3. Previous Patches, repairs noted at ceiling- Check the records, with seller of any known defects or repairs.**
