# Key Property Inspection Group

## Property Inspection Report

985 El Paso Dr, Los Angeles, CA 90042

Date of Inspection: 6/6/2019 Time: 12:30 PM

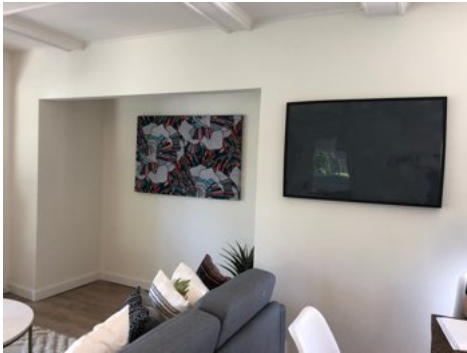
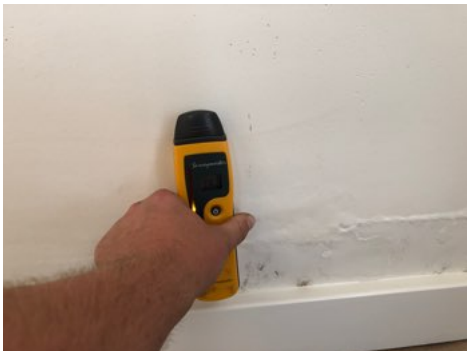
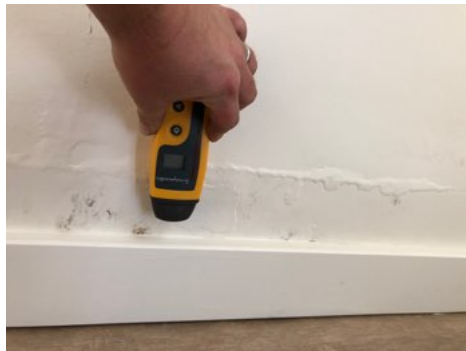
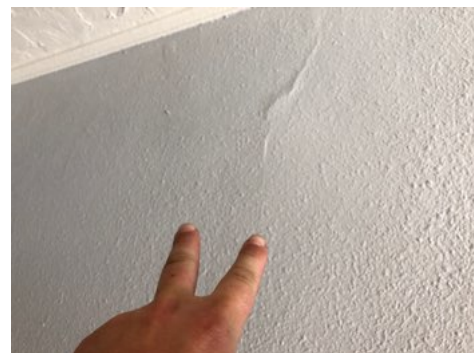
- 2.1. cracks and/or anchor holes were noted at the interior walls. Have checked by qualified paint contractor any necessary correction.
- 2.2. House was furnished but vacant at the time of the inspection (walls were not fully visible)- Recommend to check the records for any known defects and/or repairs.

- 2.3. Newer Paint noted - Check the records for any known defects and/or repairs.
- 2.4. Water stains, damage, bubbling at wall, moisture detected with meter present at the interior wall(s) at rear living area by laundry, seepage Noted from exterior. Recommend further evaluation, repairs by qualified specialist(s).

- 2.5. Signs of Mold like substance present on walls at wall by laundry where bubbling, damage at wall is, seepage Noted from exterior. We did not inspect, test or determine if this is Mold or if this Mold like substance is or is not a health hazard. Recommend you contact a qualified Mold inspector or expert for investigation and/or correction if needed.

- 2.6. Prior patchwork noted at interior wall(s). Check the records, permits and/or with seller of known defects/repairs.

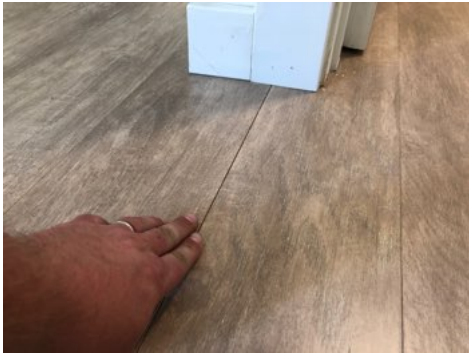
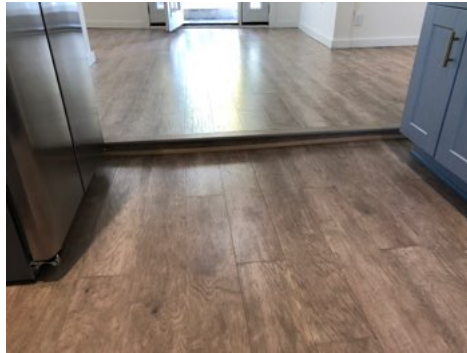
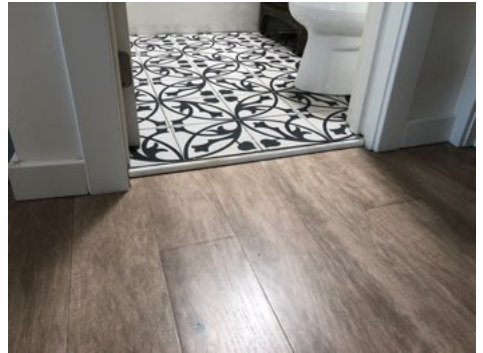
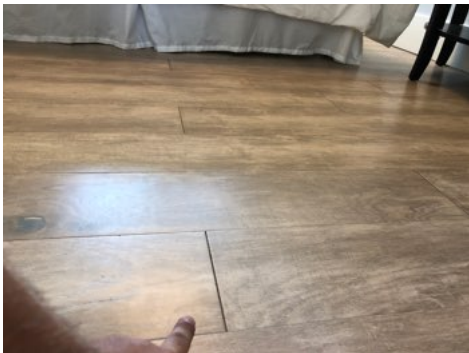
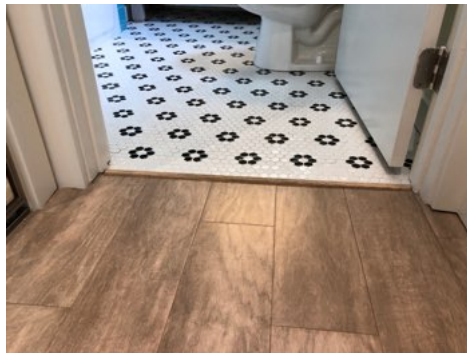
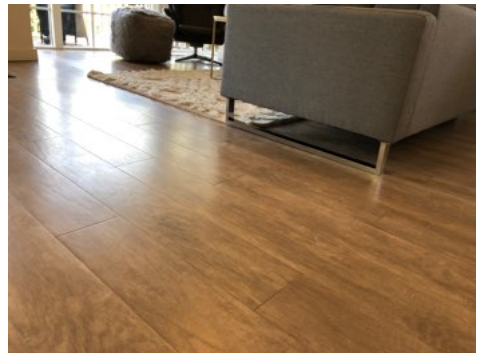
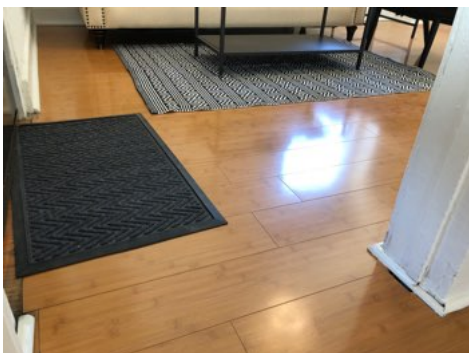
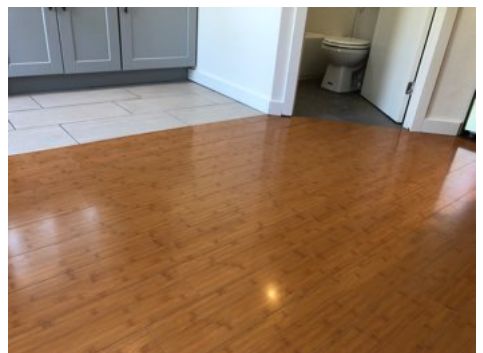
- 3.2. Floor squeaks are present at the interior of the home (common for this type structures). Have it checked by a qualified flooring contractor.
- 3.3. Area rug(s) noted at inspected property. Rug(s) are not removed or moved at time of inspection, may mask or hide hidden defects. Check with seller for any known defects. Recommend to have checked prior to close of escrow.

- 3.4. Uneven areas, sloping was noted at various areas of the flooring. Check the records for any known defects, repairs and/or have it checked by a qualified specialist(s).

- 3.5. Trip hazards noted due to differing flooring material heights. FYI
- 3.6. Some expanded gaps noted at flooring material joints. In need of further evaluation, corrections by a qualified floor specialist.

- 3.7. Cracked grout, Chipped Engineered wood floor noted at interior at kitchen of rear unit. Recommend further evaluation, corrections made by qualified specialist(s).

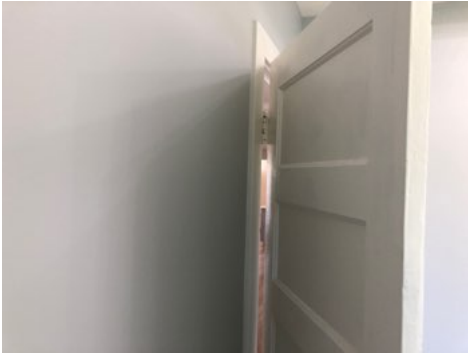
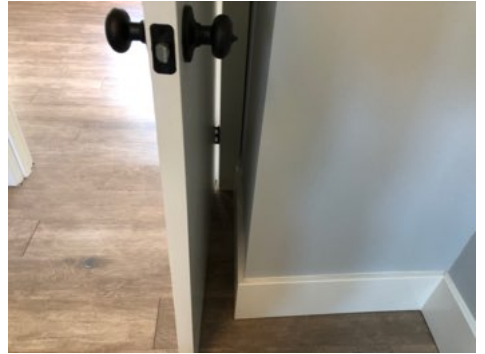
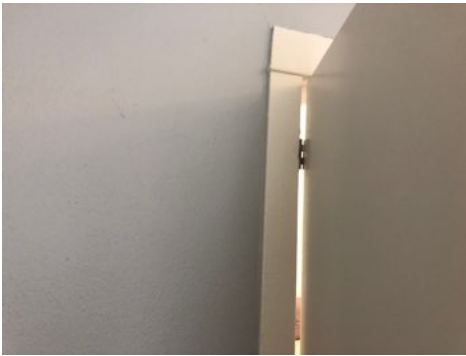
**4.1. Recommend to install door stops to prevent wall damage.**

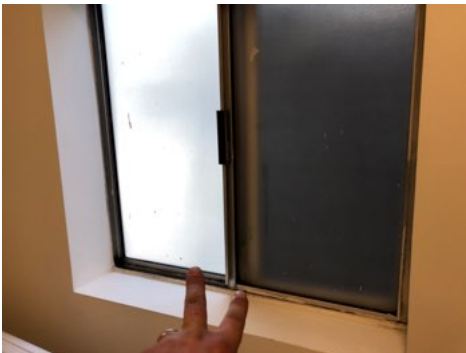
Single pane- laundry

5.4. House with some old aluminum (single pane) windows type at Add on Noted. Recommend to upgrade.

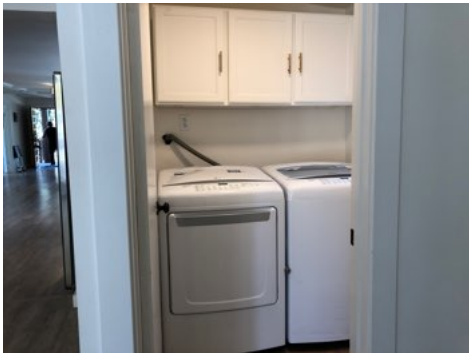
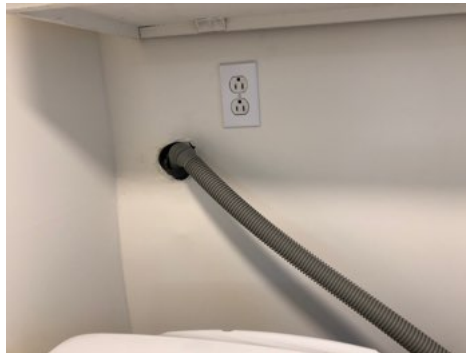
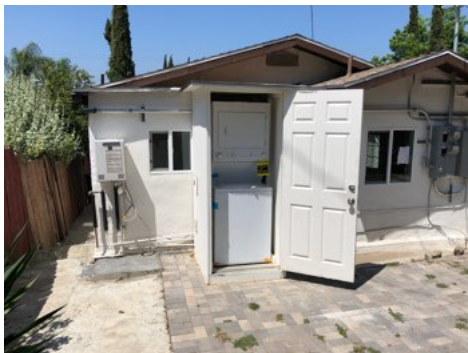
**7.4. Washing machine, laundry area without catch pan and/or drainage pipes. Recommend to install if possible to prevent damage when machines leak.**

**7.5. 20 GFCI Amp outlet is recommended at laundry as a safety upgrade. Have checked by a qualified specialist for correction.**

**7.6. Recommend to check the records/permits for rear laundry area/laundry enclosure. Have checked by qualified contractor any necessary corrections.**

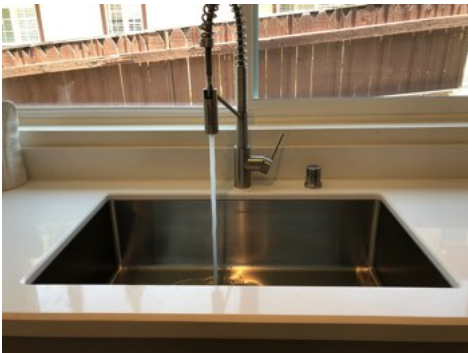
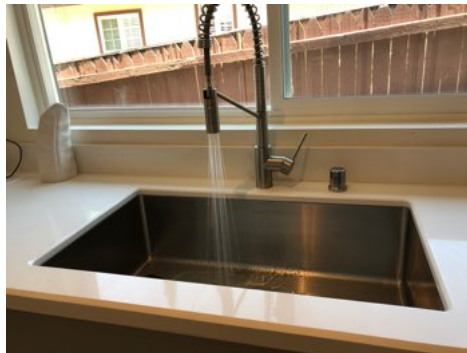
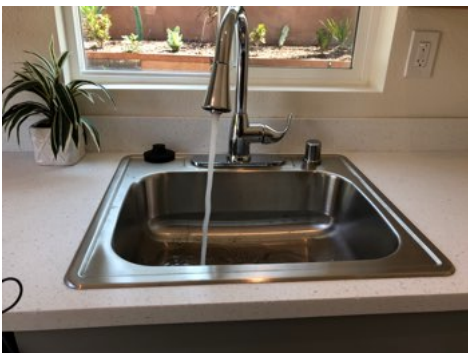
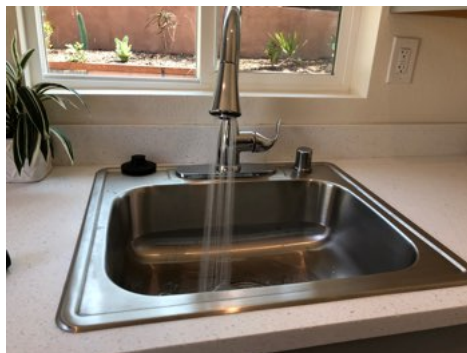
3.2. Old supply valves/tubes(angle stops) noted- these type of valves are prone to leaks. Recommend to upgrade, have checked by a qualified specialist, plumber.

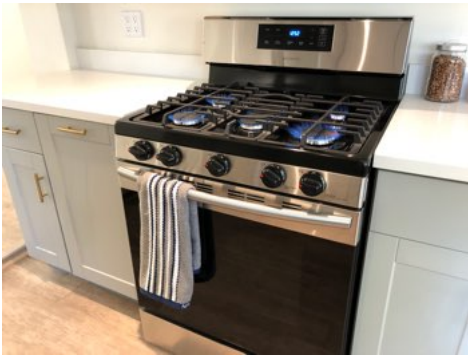
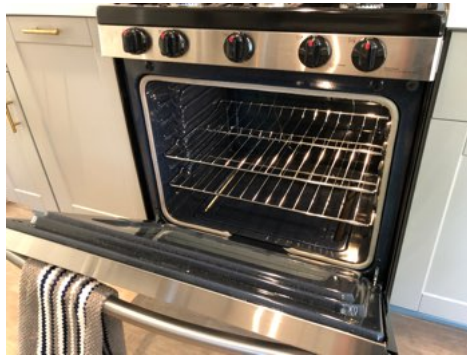
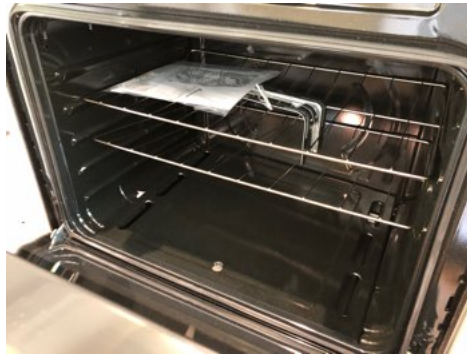
**6.2. Missing Anti-Tip Device at the freestanding range - Recommend to add for safety concerns. Consult a licensed specialist for proper installation.**

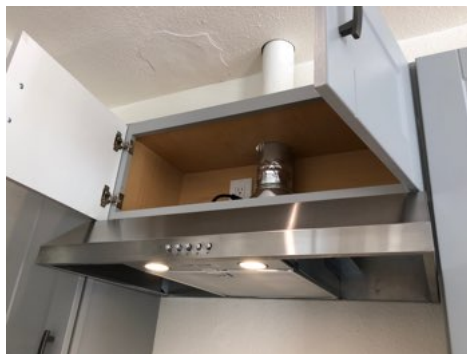
7.2. Recirculate type vent noted at kitchen- recommend to upgrade to vented type system to exterior for upgrade. Have checked by qualified specialist/contractor.

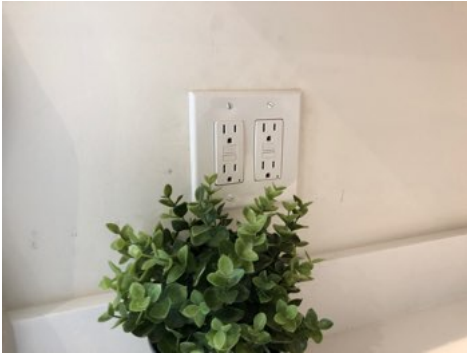
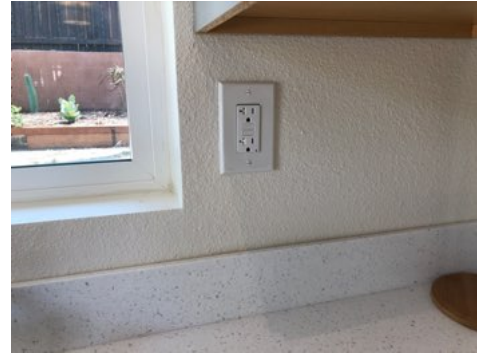
**10.2. This is not a Mold or Fungus inspection, it is advised to have a Mold specialist examine the property and structure and do a complete inspection to determine the presence or absence of any Mold that may affect the health or safety of the occupants. It is typical when a building is remodeled or repairs are undertaken that additional problems surface that were not noted on the inspection report.**

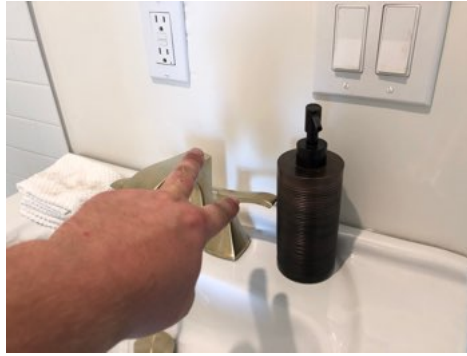
2.2. Missing proper backsplash at sink noted. Recommend to install to prevent water damage.

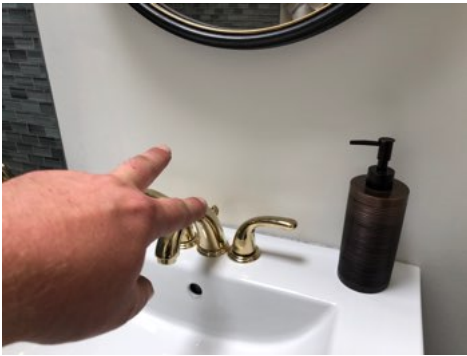
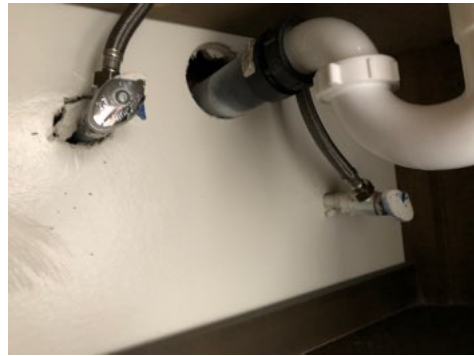
2.2. Missing proper backsplash at sink noted. Recommend to install to prevent water damage.

2.3. Old supply valves/tubes(angle stops) noted- these type of valves are prone to leaks. Recommend to replace/upgrade by a qualified specialist, plumber.

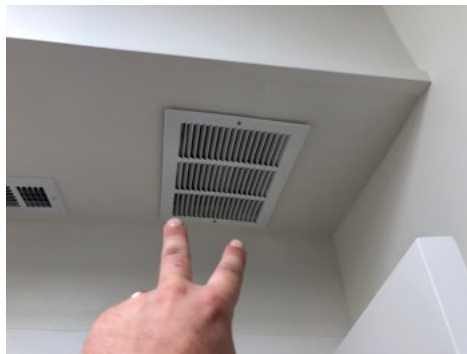
5.1. Dirty exhaust fan(s) noted. Recommend to clean, service.

5.2. Improper cover at vent fan noted- have checked- not removable  
To clean, service.

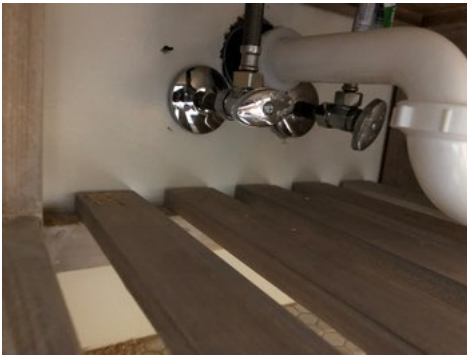
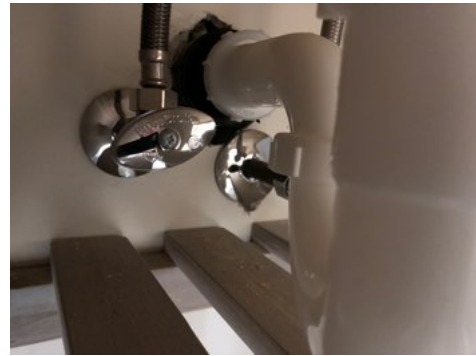
2.2. Old supply valves/tubes(angle stops) noted- these type of valves are prone to leaks. Recommend to replace/upgrade by a qualified specialist, plumber.

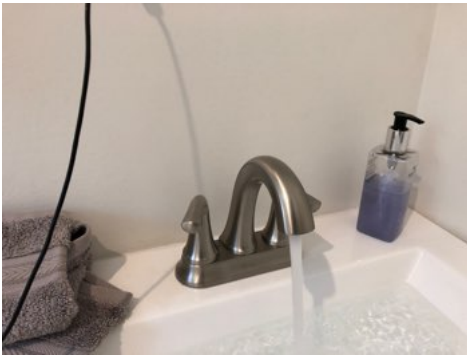
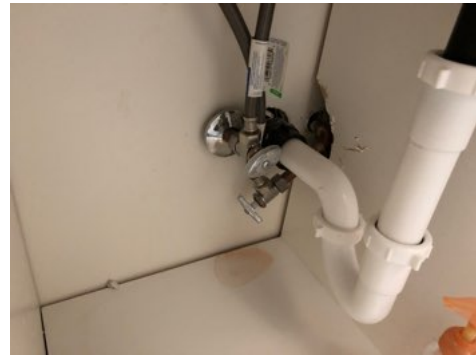
- 2.1. Sink faucet(s) functional at time of inspection.
- 2.2. Missing proper backsplash at sink noted. Recommend to install to prevent water damage.
- 2.3. Old water stains noted under sink cabinet. No active leak noted at the time.
- 2.4. Old supply valves/tubes(angle stops) noted- these type of valves are prone to leaks. Recommend to replace/upgrade by a qualified specialist, plumber.

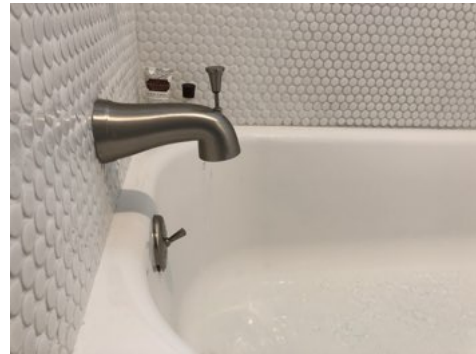
3.1. Leaking at downspout noted at shower mode due to defective diverter. Have it checked, repaired, replaced.

3.2. Window was set too low at tub/shower head. Recommend to install curtain to prevent water seepage, damage.

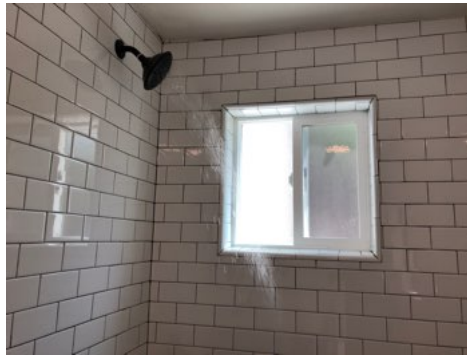
- 3.1. Window was set too low at tub/shower head. Recommend to install curtain to prevent water seepage, damage.

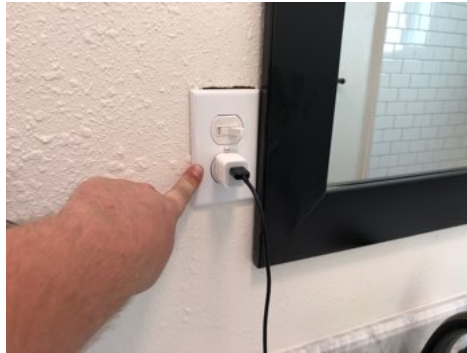
4.1. Recommend to install GFCI type outlet at Bathroom(s) and to test periodically. This is a safety upgrade. Missing GFCI outlet at bathroom. Recommend to install GFCI type outlet by qualified electrician

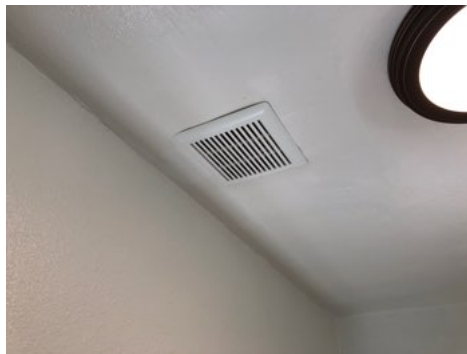
5.1. Noisy exhaust fan noted - Recommend to upgrade.

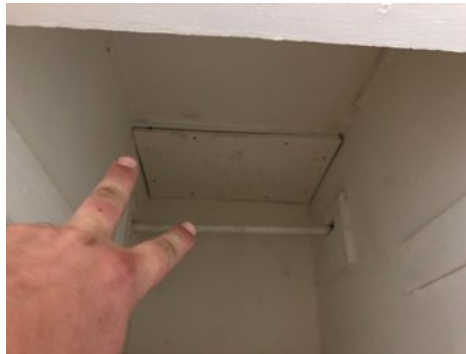
**1.1. Attic access is missing and/or not installed at front unit, scuttle hole screwed shut/sealed at rear unit- gable Vents used to access attic space . Recommend to correct.**

Sealed shut- bedroom closet- rear unit

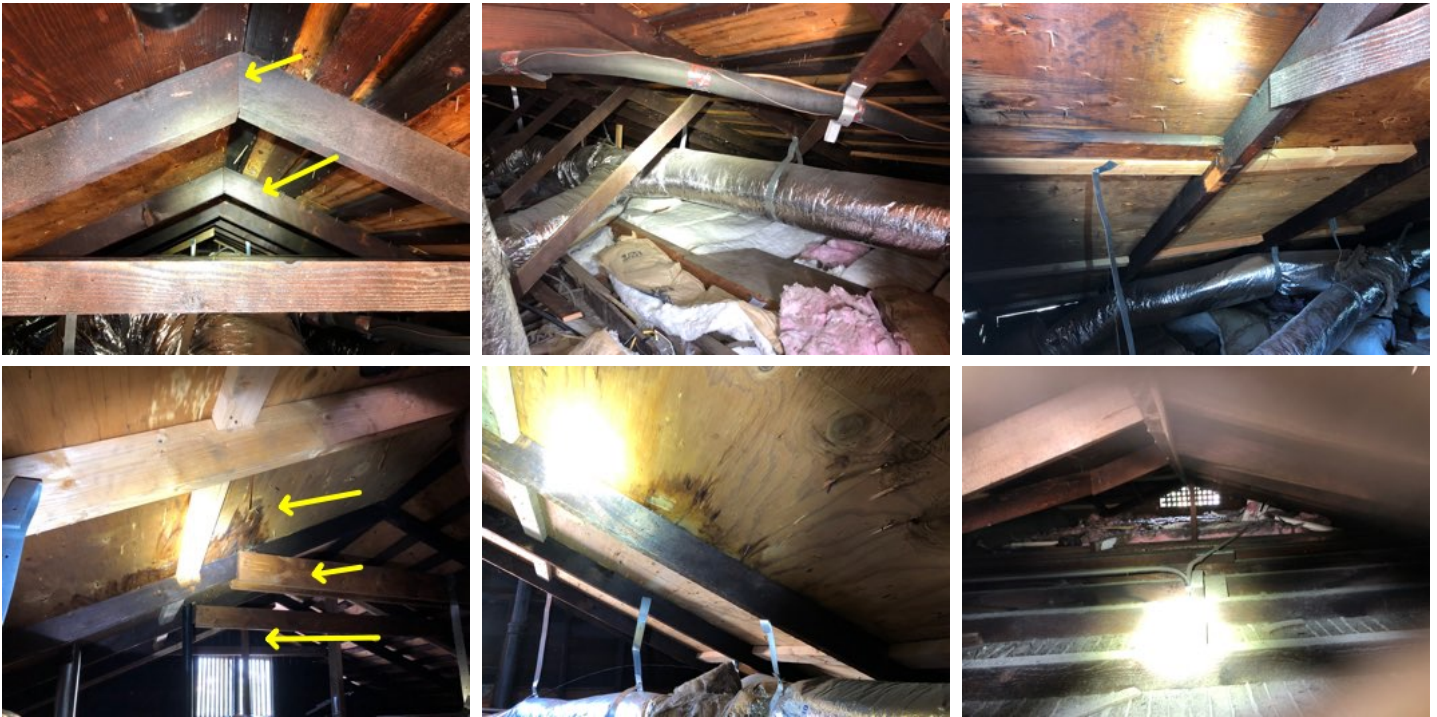
**2.8. Moisture stains/damage at some areas noted at front unit attic. Have checked, necessary corrections/repairs made by qualified framing contractor or roofer.**

Damage at framing- soft spots noted when walking roof- in need of repair

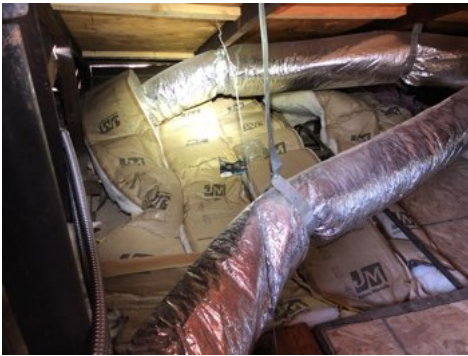
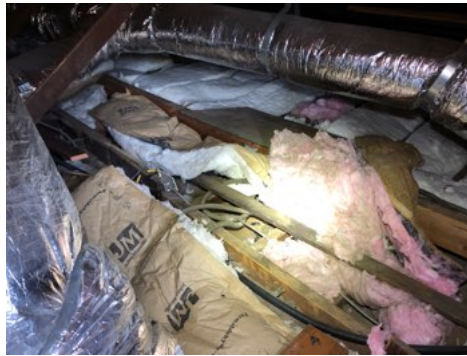
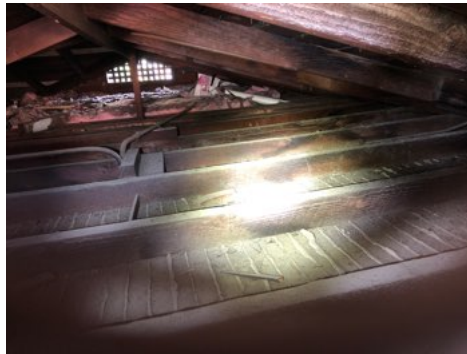
- 3.1. No insulation at some areas present in the attic of the inspected property at rear unit. Recommend to install approved insulation material in the attic.
- 3.2. Inadequate insulation, poor coverage of insulation was noted - Correction recommended.
- 3.3. Some loose and/or missing insulation noted at attic space. Have it checked, fixed.
- 3.4. Insulation in attic covers or is too close to recessed light fixtures. This is a fire hazard, correction is recommended.
- 3.5. Insulation in attic is installed wrong side up (upside down). Have it checked, fixed by a qualified specialist.

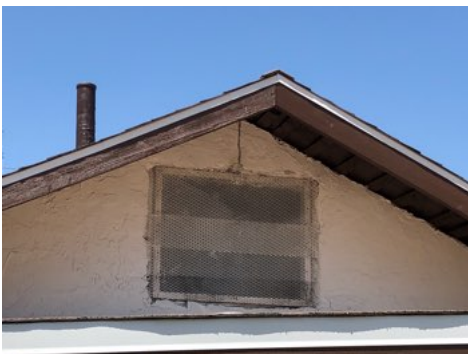
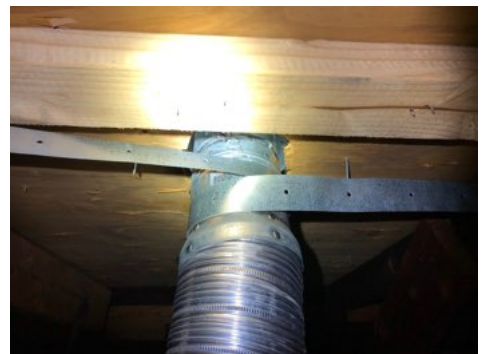
4.4. Bee Hive and/or nesting noted at gable and/or soffit vent(s) at rear unit at rear.

Recommend to have it checked, removed and necessary corrections made by a qualified Pest specialist.

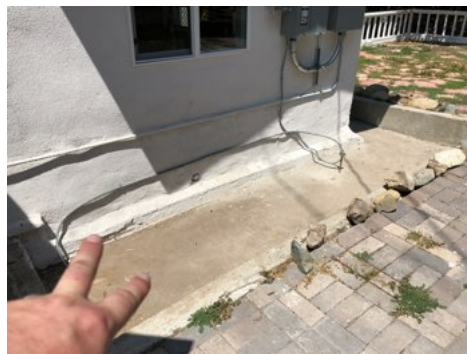
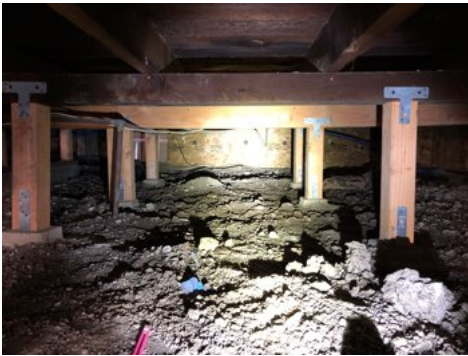
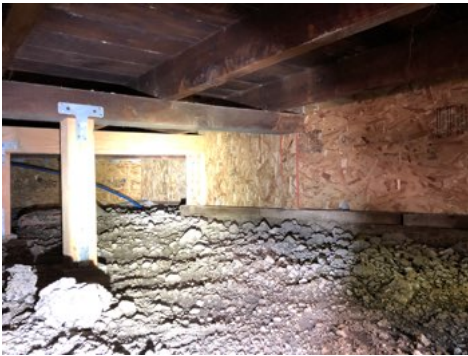
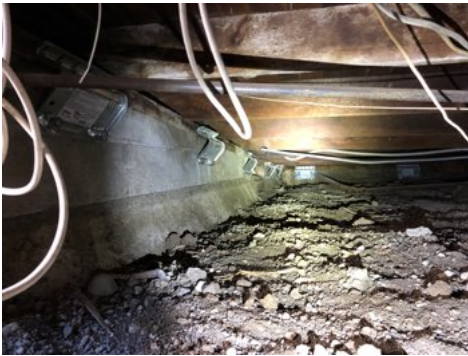
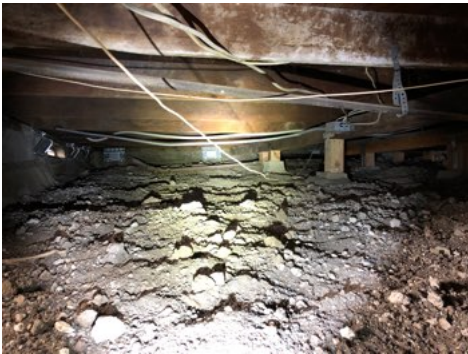
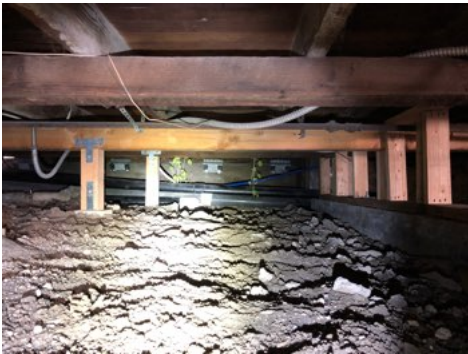
**1.5. Efflorescence was noted present on the foundation walls. Recommend to keep moisture around the inspected property to a minimum.**

**1.6. Foundation vents were set low at exterior soil, water seepage into the crawl space noted. Recommend to built a curb to prevent water intrusion.**

**1.7. Moisture stains, dampness noted at grading and/or scaling stains noted at grading at crawlspace at both units - check with seller of known defects, repairs. Recommend complete evaluation and to have checked, necessary corrections made by qualified foundation and/or drainage specialist.**

**1.8. Recommend further complete evaluation, necessary corrections made by qualified foundation specialist.**

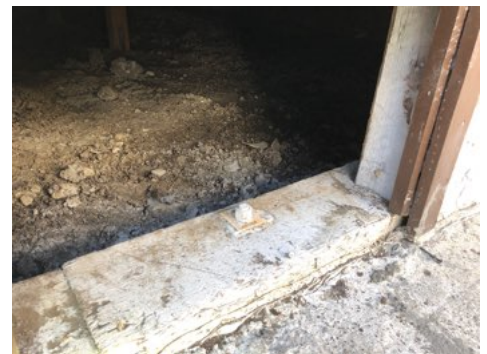
Dampness/scaling

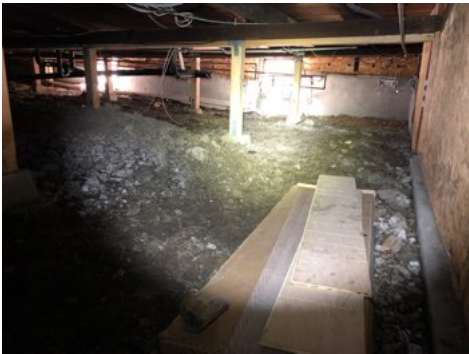
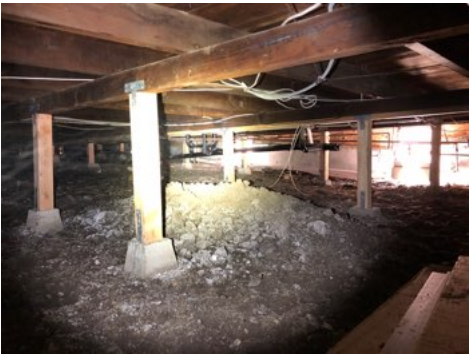
Dampness/scaling

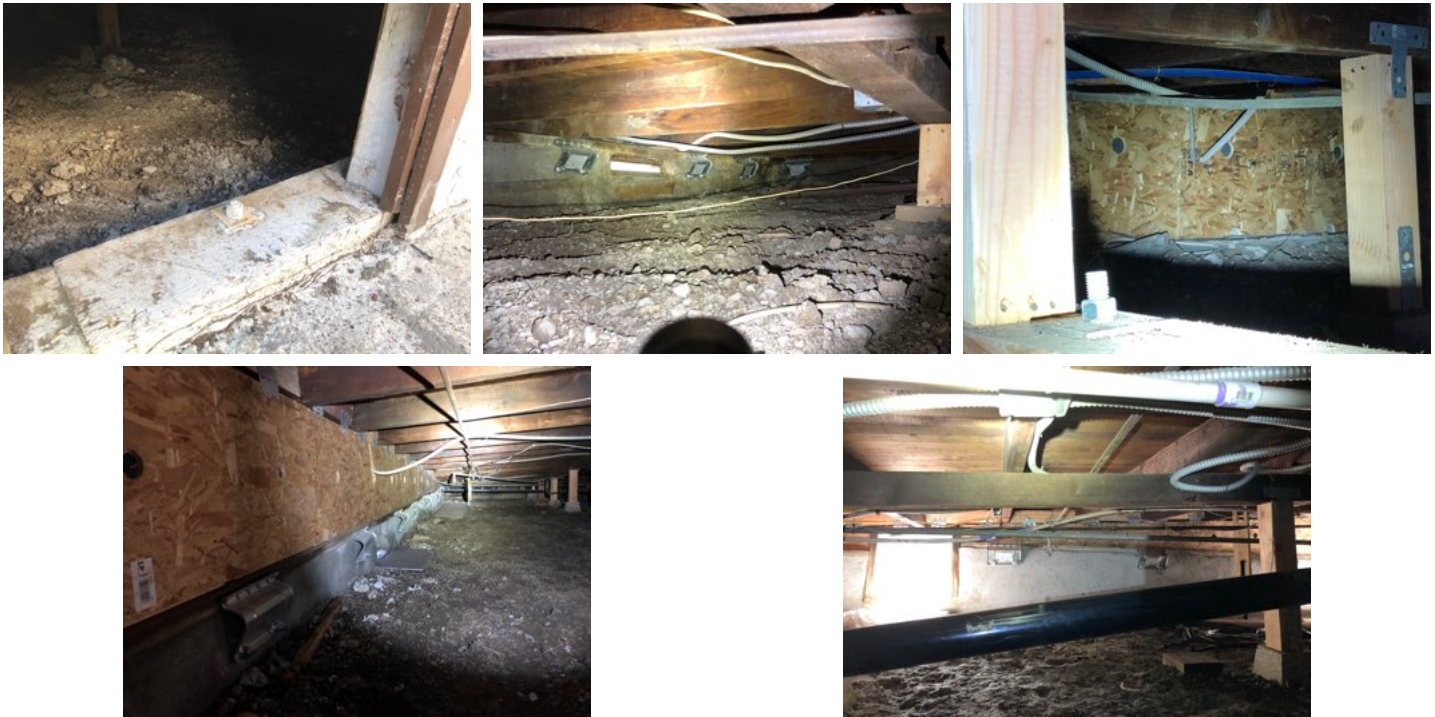
- 2.1. Efflorescence was noted present on the foundation wall. Recommend to keep moisture around the inspected property to a minimum.**
- 2.2. Newer foundation bolts, anchors, straps noted. Check the records, permits.**
- 2.3. Newer work, alterations noted. Recommend to check the records, permits.**
- 2.4. Moisture stains, dampness noted at grading and/or scaling stains noted at grading at crawlspace at both units - check with seller of known defects, repairs. Recommend complete evaluation and to have checked, necessary corrections made by qualified foundation and/or drainage specialist.**
- 2.5. Recommend further, complete evaluation by a qualified foundation specialist.**

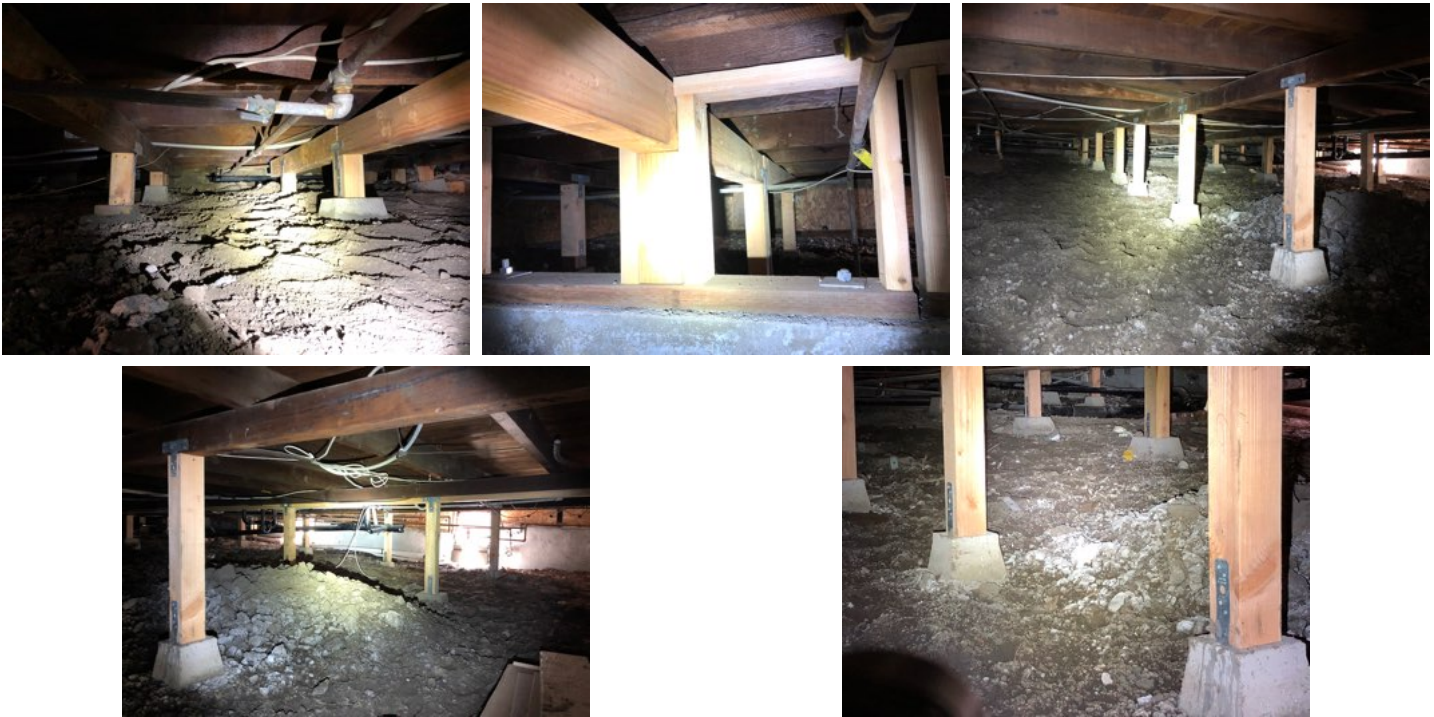
- 3.1. This is an Old raised Foundation type structure. Further evaluation of foundation walls and framing by a qualified foundation contractor, inspector is recommended by This Inspection Co.**
- 3.2. Wood support posts are have newer T strap connectors. Recommend to have checked records, permits.**
- 3.3. Newer work, alterations noted. Recommend to check the records, permits.**

Damp/scaling

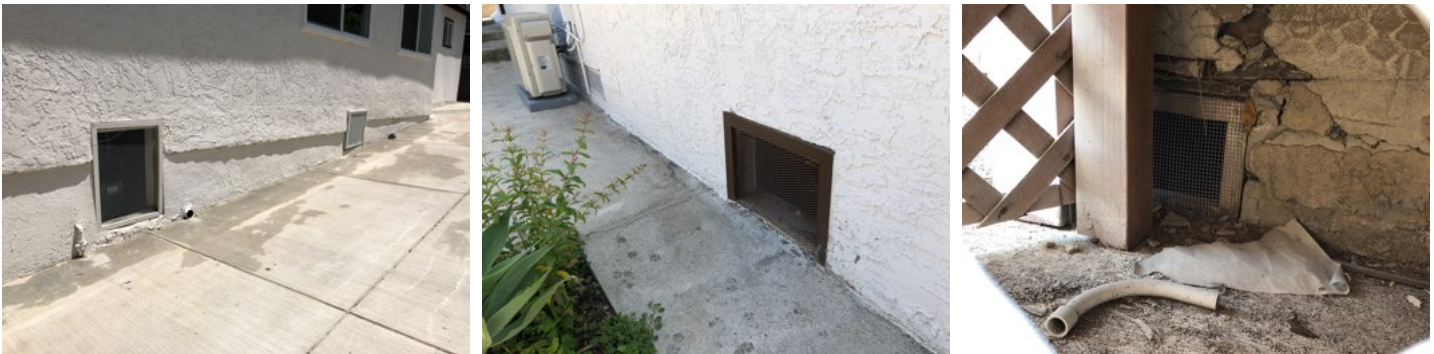
**5.1. Foundation vent(s) are below ground level at exterior soil/slab, which appears to be allowing water to enter crawlspace. Recommend to re-grade and/or install proper flashing, curb to prevent water seepage.**
