Key Property Inspection Group

Property Inspection Report

1717 S Berendo St, Los Angeles , CA
Inspection prepared for:
Real Estate Agent: -

Date of Inspection: 6/7/2019 Time: 9:30 AM
Age of Home: 1906 Size: 1774 sq. Feet
Weather: Clear
Order ID: 9914

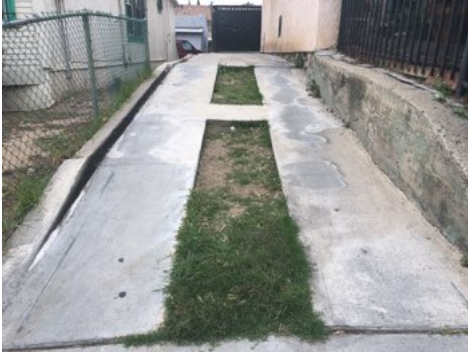
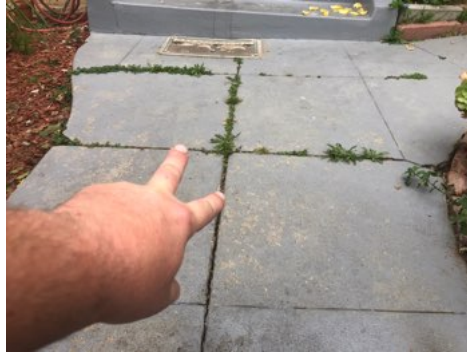
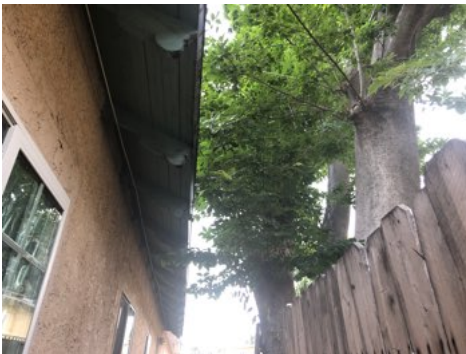
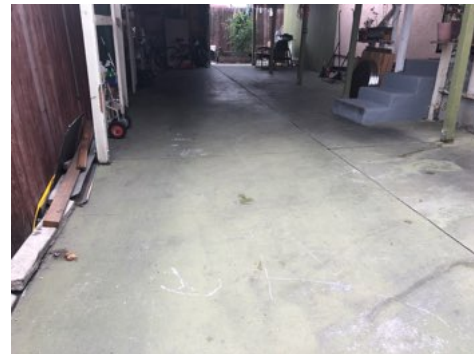
- 1.1. Cracks, settlement present at driveway/sidewalk surfaces. Have checked, necessary repairs made by qualified specialist.
- 1.2. Tree Roots appear to be uplifting the driveway/sidewalk surface causing a trip hazard. Tree removal may be necessary. Have it checked by a qualified specialist.
- 1.3. Evidence of Poor Drainage present at driveway/sidewalk surfaces, recommend further evaluation by qualified contractor.

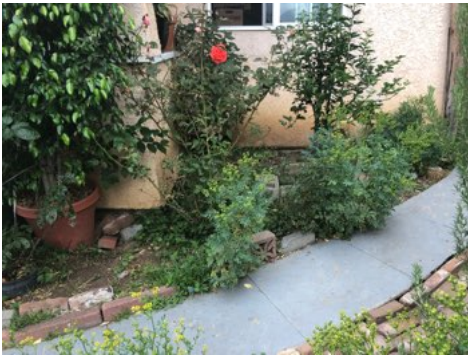
- 2.5. House without drainage pipes. Possible water ponding at rear/side elevations noted. Check with the seller for any known defects, repairs. Have it checked by a qualified contractor.

- 2.6. Planter(s) built at the foundation - not recommended. Recommend to remove to prevent water seepage into crawl space/foundation.
- 2.7. Added curb wall at exterior of the foundation at some areas is indication of attempt to address poor drainage/moisture seepage issue. (FYI)

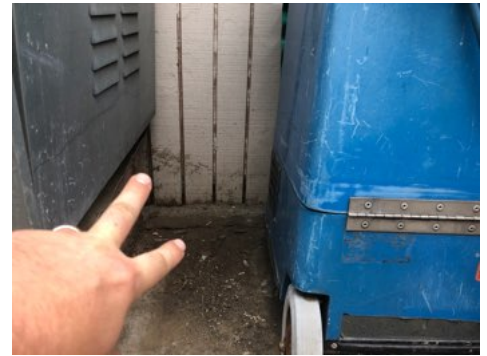
- 2.1. Plants/shrubs touch structure. Recommend to move sprinklers and vegetation minimum 2' away from house/foundation.
- 2.2. Trees noted planted too close to the structure which may require removal in order to prevent damage to the foundation.

- 2.3. Tree limbs that are in contact with roof or hanging near roof should be trimmed away. Recommend to trim away and inspect the roof.
- 2.4. Ab/walkways is high at the foundation (at sill plate and/or weep screed). Water seepage can occur. Recommend to re-grade. Keep water and vegetation away from structure. Have it checked and necessary corrections made by a qualified drainage contractor. Note: possible hidden damage could be inside the walls. Have it checked by a qualified Mold Inspector.

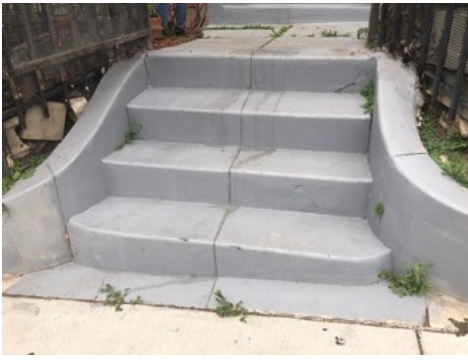
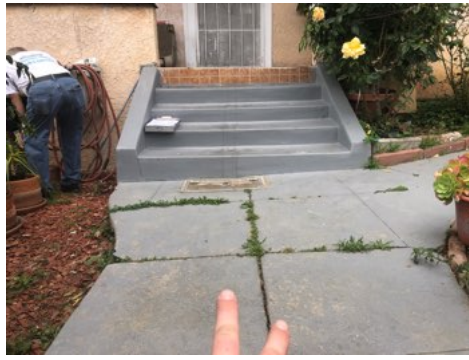
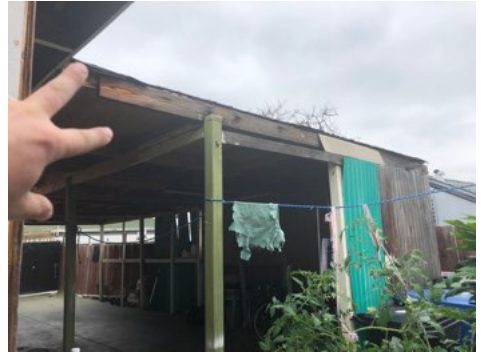
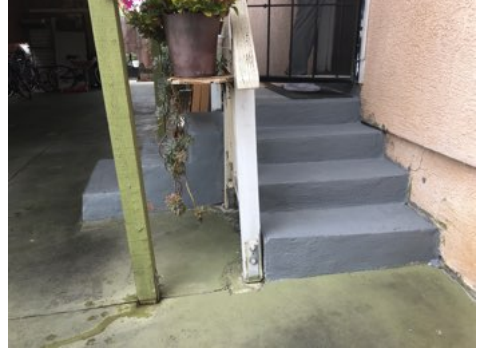
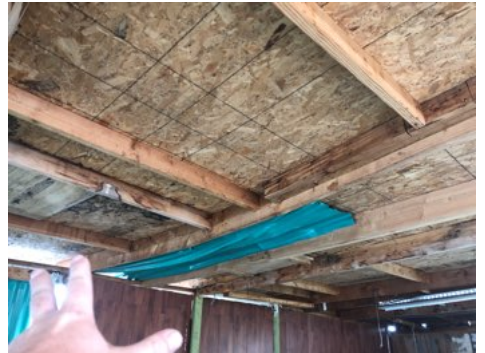
- 3.1. Recommend to install proper railing at all exterior steps (safety upgrade). Recommend to install.
- 3.2. Recommend to install non slip strips at steps for safety.

- 3.3. Cracked tiles, settlement noted at porch area and/or walkway(s) at front. Have checked, necessary corrections made by qualified specialist.
- 3.4. Enclosed patio area Noted at a undry area, Recommend to check records/permits-moisture stains/damage at siding, damaged posts noted, missing post base. Recommend further evaluation, repairs/correction made by a qualified specialist, contractor.

- 3.5. Patio cover is improperly attached to the structure: Attached to the eaves, fascia and missing the ledger board with staggered lag bolts. Have it checked, corrected by a qualified contractor.

- 3.6. Due to patio cover construction we recommend you check all applicable permits, records and to have further evaluation by a qualified contractor.

- 3.7. Moisture stains/damage noted at wood posts at laundry area enclosure. Have it checked and fixed by a qualified structural pest specialist.
- 3.8. Moisture stains, damage and signs of seepage, Damaged Wood Present at Patio Cover-roof covering improperly/poorly installed at carport/patio cover. Have it checked, repaired by a qualified structural pest specialist, contractor.

- 3.9. Patio cover shows signs of wear and may be near end of lifespan. Have it checked by a qualified structural pest specialist.
- 3.10. Uneven rise was noted at the exterior steps - This condition can present trip hazards. Recommend to have it corrected by a qualified specialist.

- 3.11. Railing at exterior is not to current safety standards - Openings too wide (this is a safety upgrade).
- 3.12. Loose Handrail(s) Present at Decking, Have it Checked, Repairs/Corrections made by a qualified specialist - This is a Safety hazard

- 3.13. Recommend further complete evaluation, necessary corrections or repairs made by a qualified specialist, contractor.

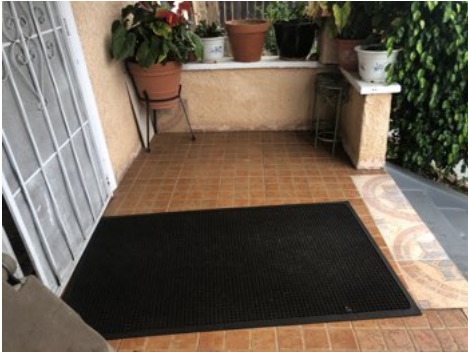
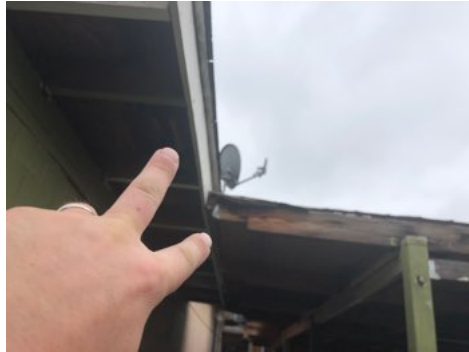
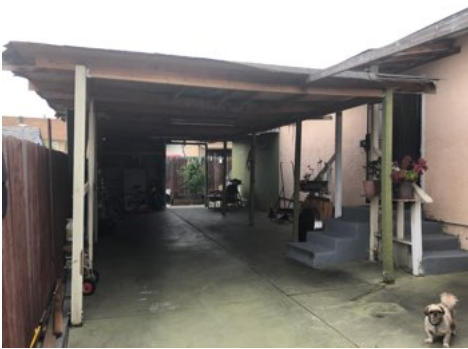
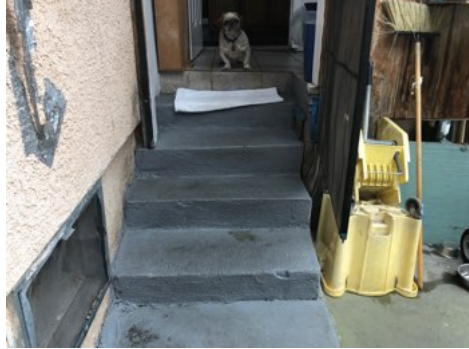
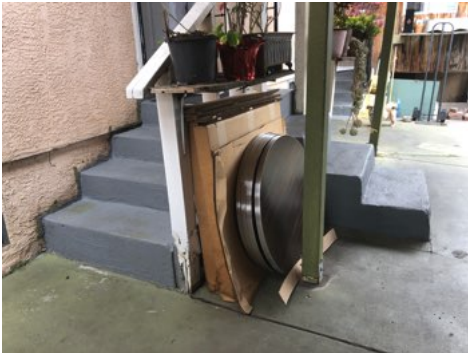
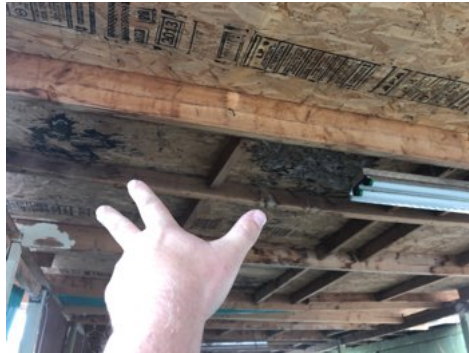
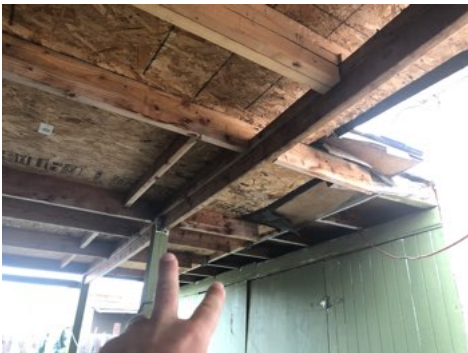
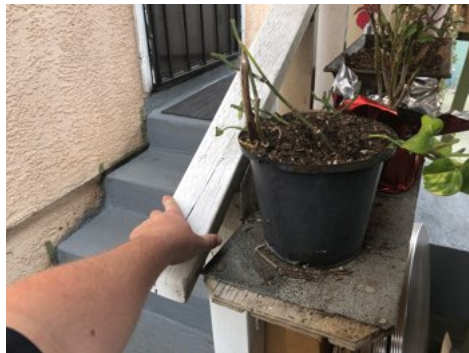
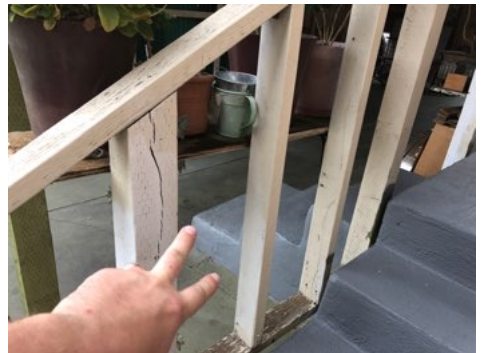
Loose

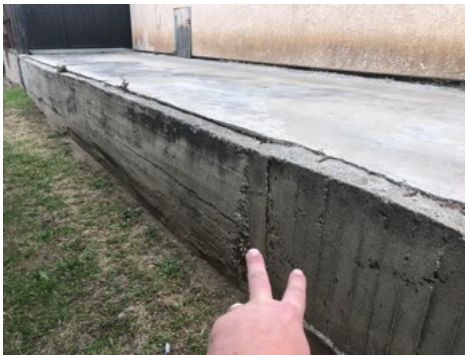
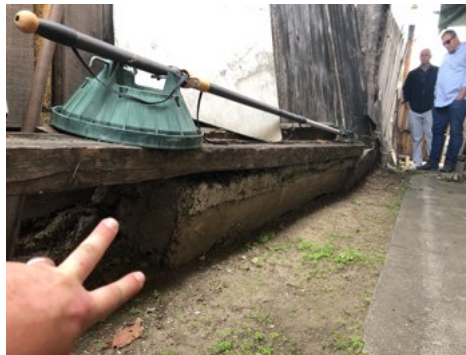
- 4.1. Cracks, settlement present at Retaining/Garden Wall(s) at left side exterior at driveway. Recommend to monitor and/or have it checked by a qualified contractor.
- 4.2. Large Cracks, settlement/bowing Present at Retaining Wall(s) at right side. Have it Checked, necessary correction/repairs made by qualified Contractor or geotechnical contractor.
- 4.3. Cracks, leaning noted at garden/retaining walls. Have it checked by a qualified specialist, contractor.

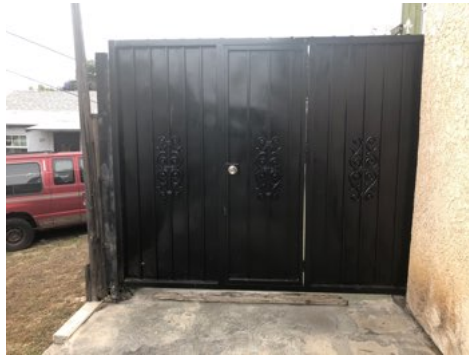
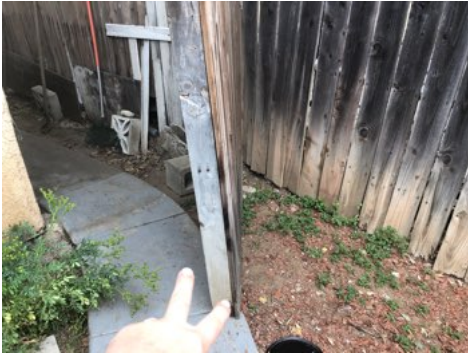
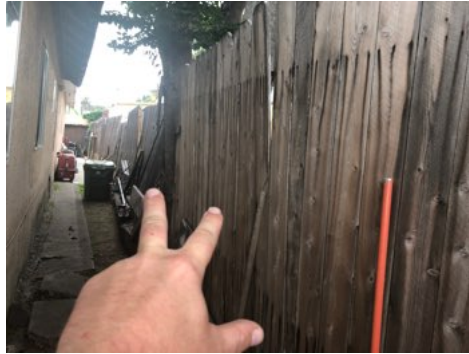
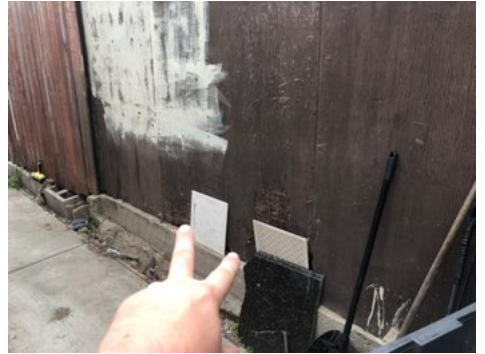
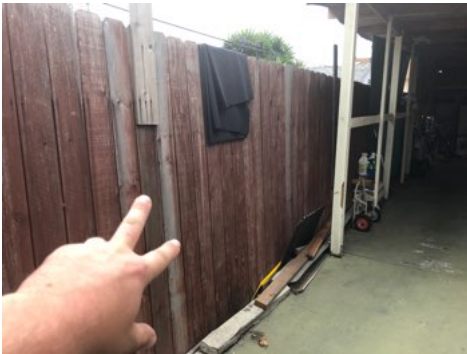
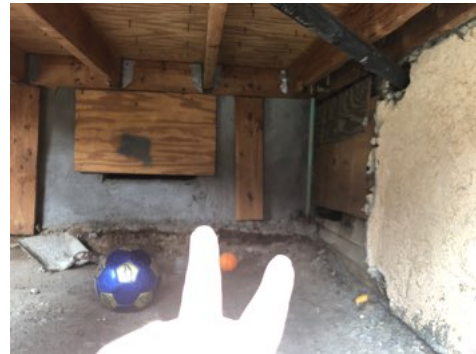
Rubs at ground

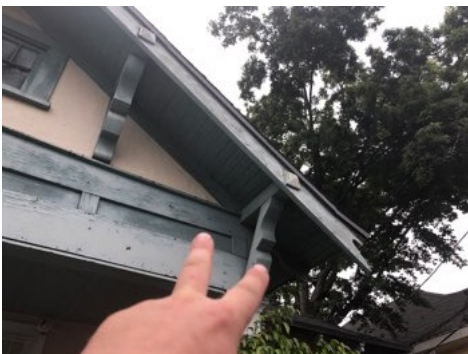
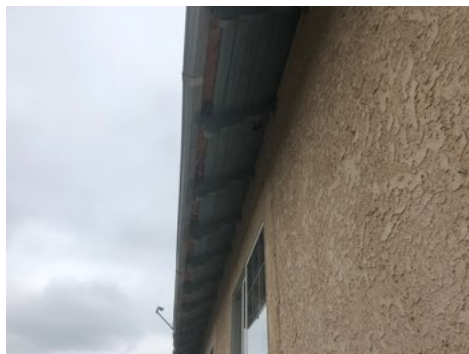
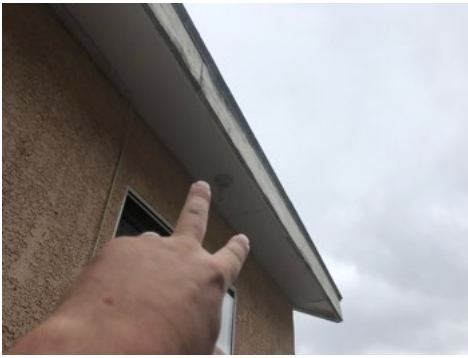
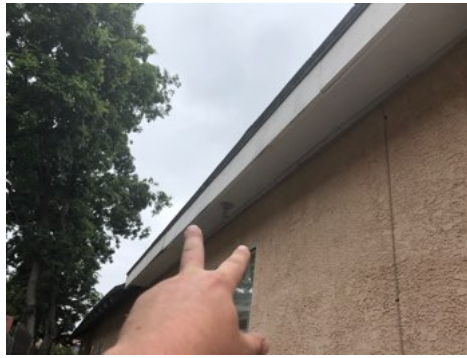
6.1. Age defects, peeling paint and/or moisture stains, damage were noted at the eaves and fascia. Recommend further evaluation, repairs by a qualified structural pest inspector and contractor.

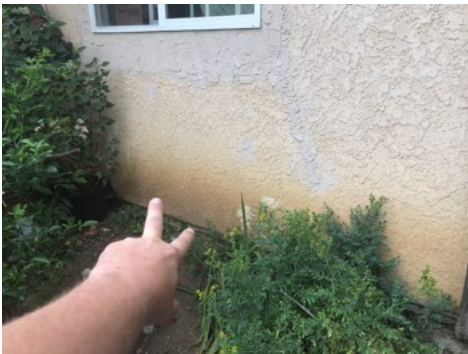
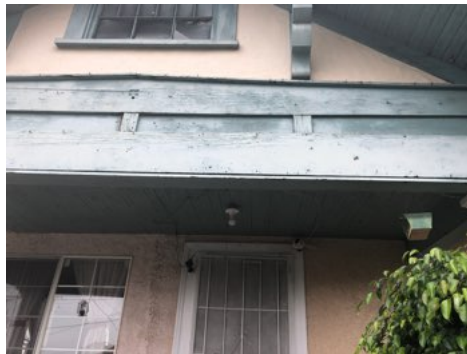
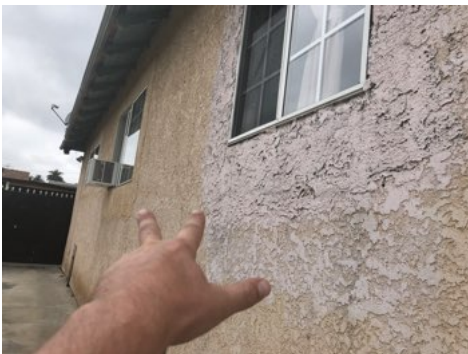
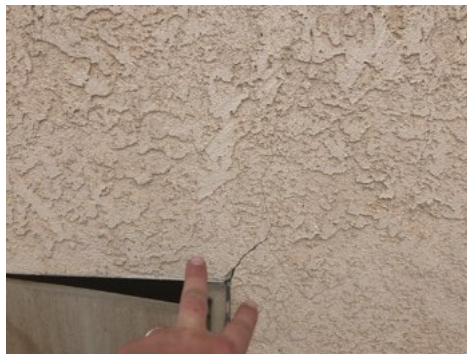
7.6. Missing flashing at the base of the wood siding, siding is embedded in concrete curb- poor workmanship- wood will rot. Have it checked by a qualified specialist for correction.

7.7. Rusted and/or damaged weep screed noted at exterior siding. Recommend to have checked, any necessary correction/repair made by qualified specialist(s).

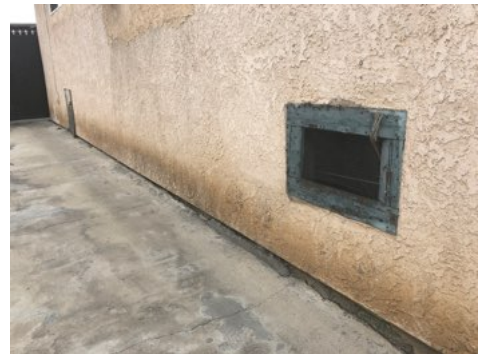
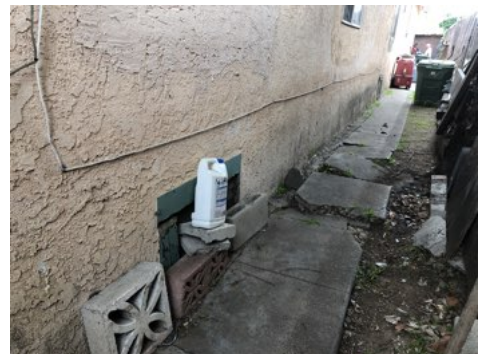
7.1. cracks were noted in the exterior stucco walls. Have checked by paint contractor.

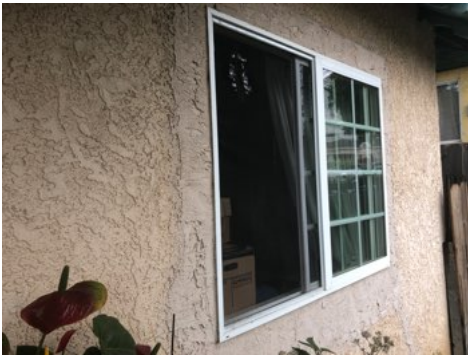
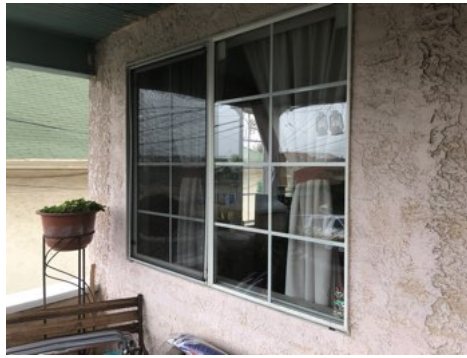
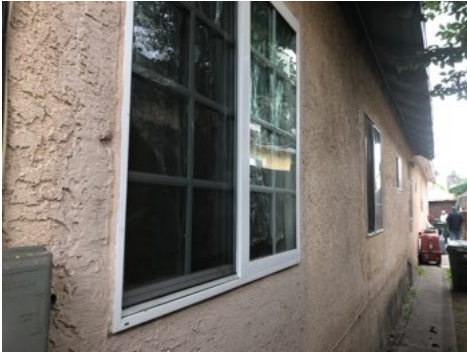
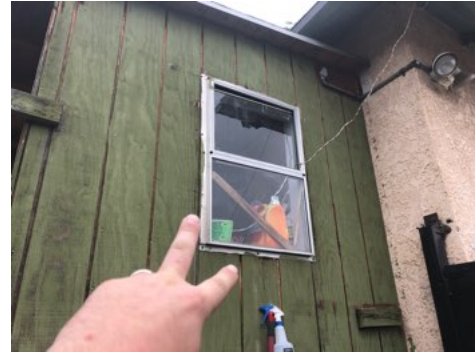
8.3. House with some old aluminum (single pane) windows type. Recommend to upgrade.

8.4. Damaged/poorly installed window at laundry noted. Have checked/fixed/corrections made by qualified contractor.

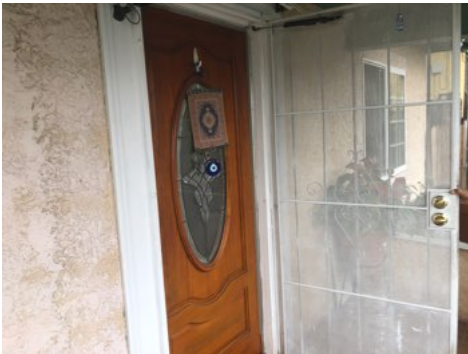
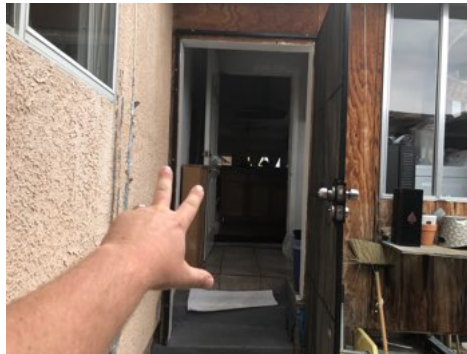
9.1. Missing exterior rated door, metal security door only at laundry exterior. Have checked, corrections made by qualified specialist.

Missing exterior rated door, metal security door only at laundry exterior

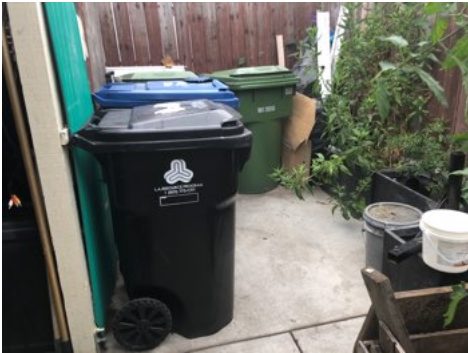
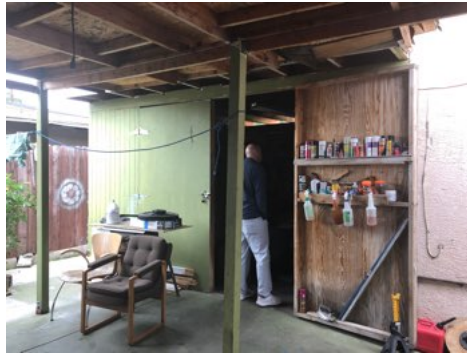
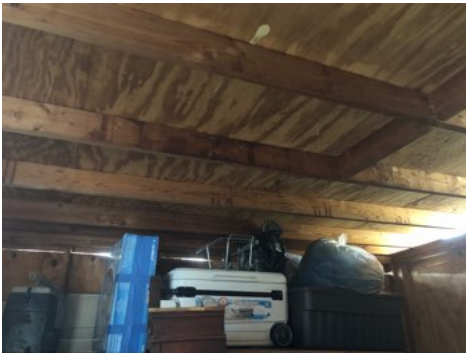
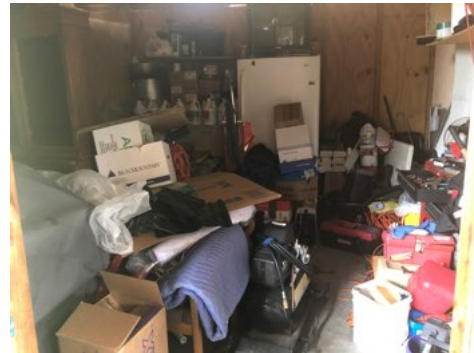
10.5. Recommend to check records/permits of storage shed. Moisture stains, Moisture stains/Damage Noted at interior ceiling, deterioration at exterior siding, poor/improperly installed roof covering noted. In need of complete system evaluation for repair/replacement or removal.

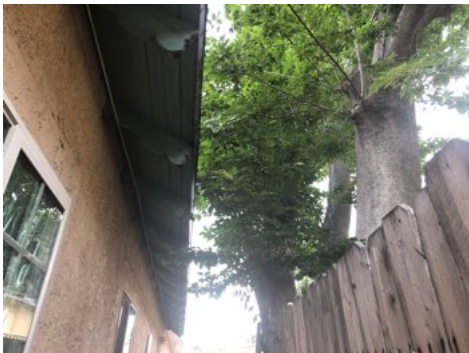
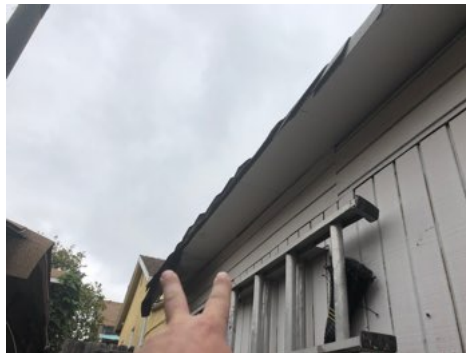
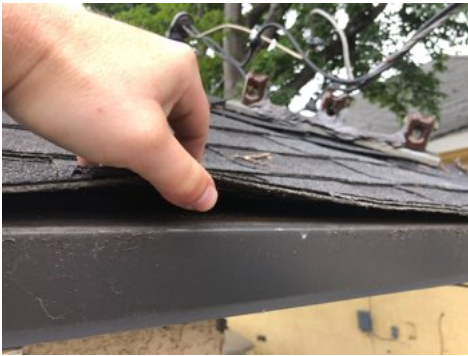
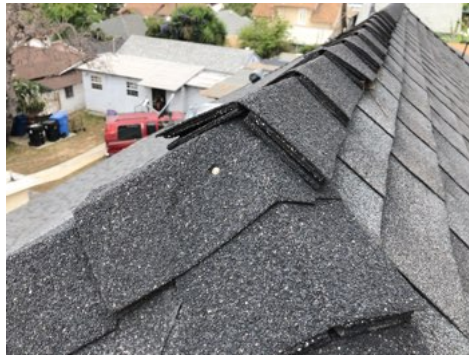
- 2.1. Ridge of the roofing is weathered, damaged, and aging - Replacement of the ridge material is recommended. Have checked by qualified roofer for necessary corrections.

- 2.4. Patching and previous repairs noted to various locations/areas of the flat roof areas. Check the records, warranties. in need of complete evaluation, corrections by qualified roofer.

- 2.9. Flat Roof covering shows puckering, blistering and alligating/damage at some areas- These areas will eventually crack, leak and lead to roof being in need replacing. Have it checked by a qualified roofer.

- 2.10. Aged flat roof cover noted. Recommend to apply roof coating to prolong life of the roof. Have it checked by a qualified roofer.
- 2.11. Water ponding at sections at flat roof area noted- Recommend to have it checked, any necessary corrections made by a qualified Roofer.

- 2.14. Recommend further complete evaluation of roof system, necessary maintenance and/or corrections performed by a qualified roofer.

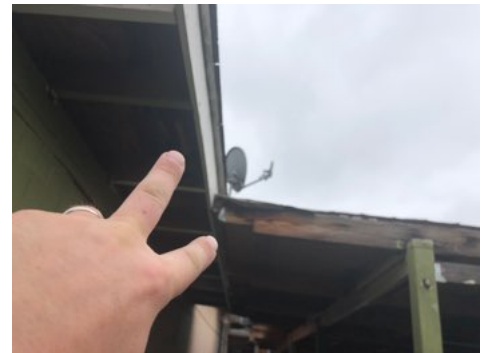
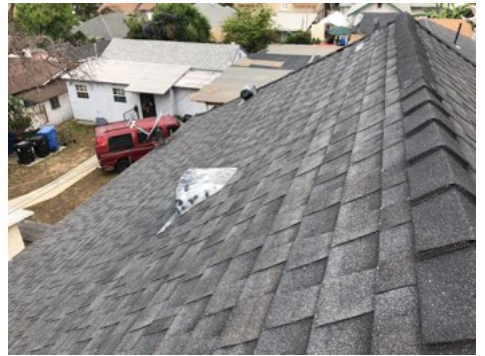
- 2.12. Leaking at interior noted at flat roof at patio cover/shed. Have checked, correction/repair made by qualified specialist.
- 2.13. Yearly roof service contract with a qualified Roofing Company is recommended.

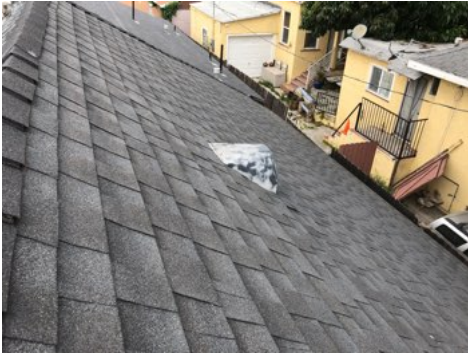
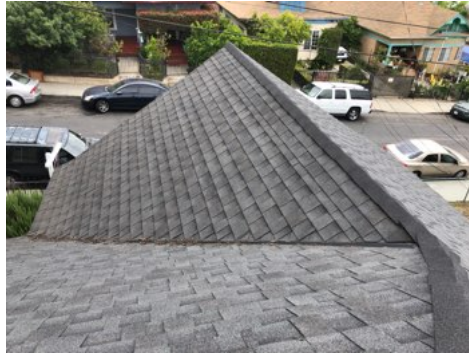
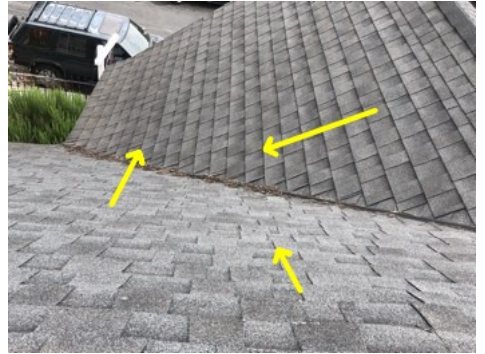
- 2.2. Exposed fastener(s), nail(s) noted at area(s) of the roofing which may allow moisture/water penetration. Recommend to seal, have checked, corrections made by qualified specialist.

Nail

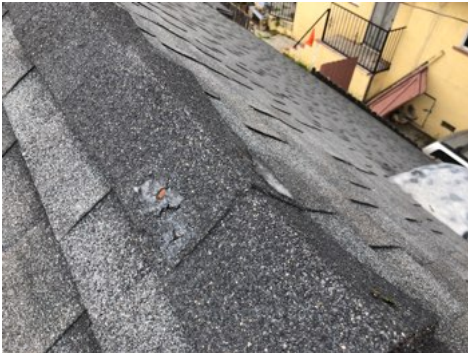
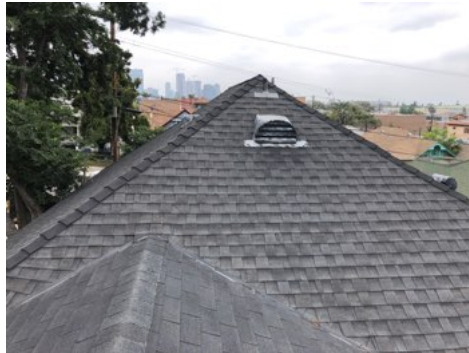
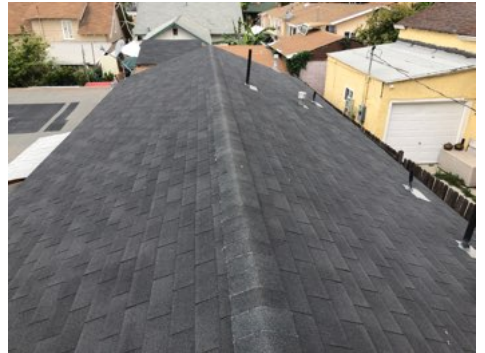
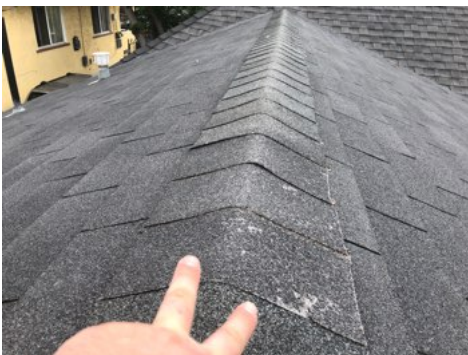
- 2.7. Debris noted at the Roof. May cause future leaks and/or damage. Recommend to clean/remove.
- 2.8. Flat roof (Less than 3/12 slope) noted - Has improper style roof covering (three-tab shingles). It should have either salvage, roll roofing, rubber membrane or an approved covering for a flat roof. The roof may leak in heavy rain. Have checked by qualified roofer.

Debris build up

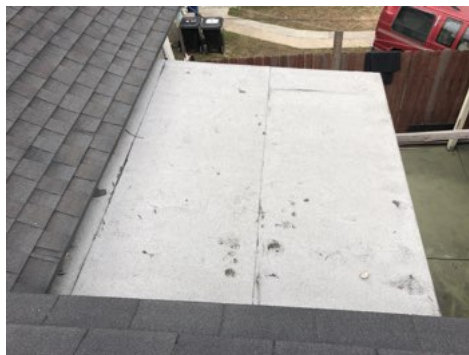
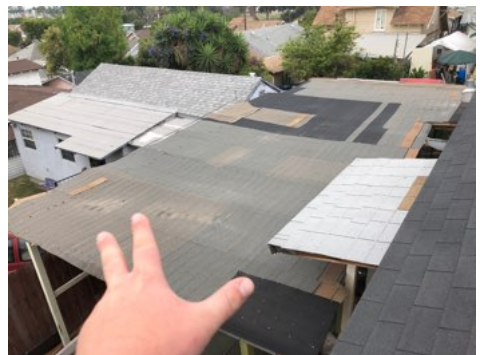
- 2.3. Granular loss, age defects noted at shingle(s) at roof at ridge at rear. In need of further evaluation, necessary correction/repair performed by a qualified roofer.

word ridge shingles

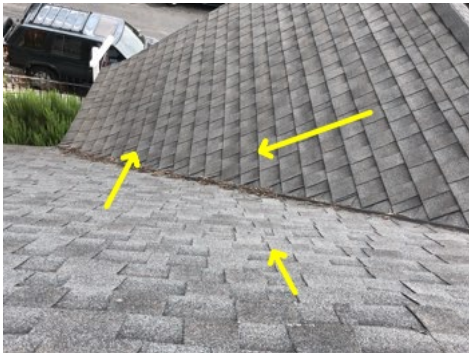
- 3.1. Exposed fasteners/nails noted at the roof flashing(s). Recommend to seal to prevent leaks. Have checked, corrections/maintenance performed by qualified roofer
- 3.2. **ABS** type sewer vent pipes noted at the roof- Pipes were not painted to protect from UV rays. Recommend to paint.
- 3.3. Roof to wall flashing is not visible and/or covered with mastic (Hidden damage may exist). Periodic maintenance is required to prevent leaks. Recommend further evaluation, any necessary corrections by a qualified roofer.
- 3.4. All roof flashings in need of further complete evaluation, corrections made by a qualified roofer.
- 3.5. Debris noted at the Roof. May cause future leaks and/or damage. Recommend to clean/remove.

Debris build up

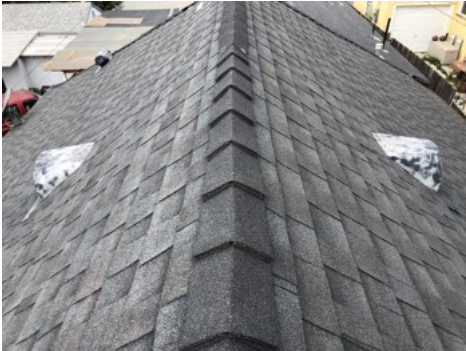
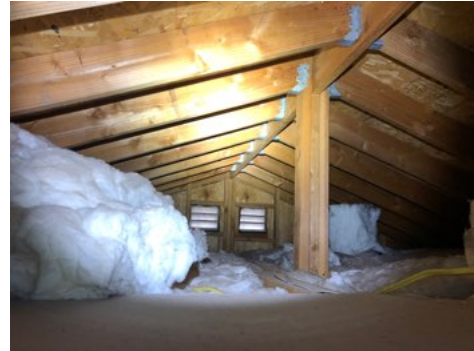
5.1. Lack of proper cross ventilation noted in the attic- missing roof vents at rear add on roof area. Recommend to add. Have checked, fully evaluated by qualified contractor

5.2. Recommend complete evaluation/corrections made by qualified roofer or framing contractor.

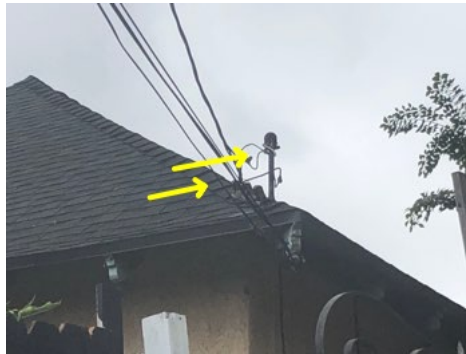
1.1. Service wires too close to the roof - Not with today's standards for safety. Recommend to upgrade. Have checked by qualified Electrician.

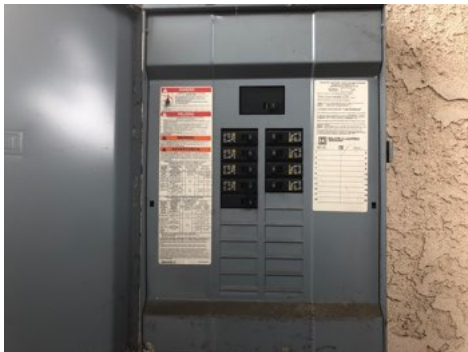
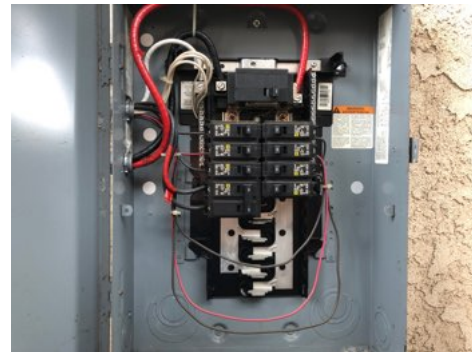
2.1. Ground rod and clamp not visible at the meter base. Recommend to install. Have it checked by a qualified electrician.

2.2. Gas pipes are not grounded/bonded. Recommend to install. Have it checked, corrections made by a qualified electrician.

2.3. Ground clamp not visible at the Main water pipe. Recommend to install. Have checked by qualified specialist.

2.5. Newer installation or upgraded panel noted. Recommend to check the records, permits.

2.6. Recommend complete system evaluation, necessary corrections made by a qualified electrician.

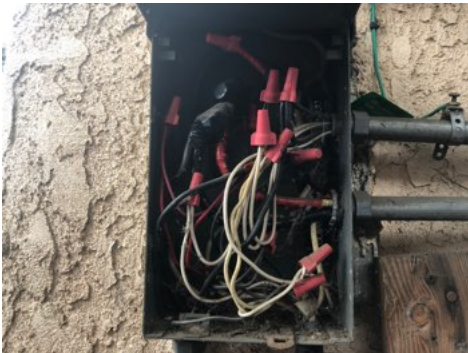
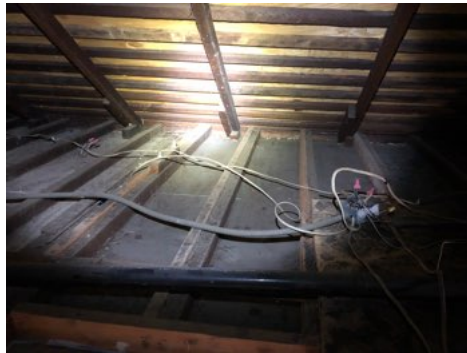
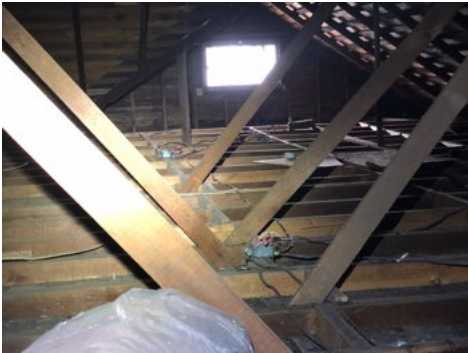
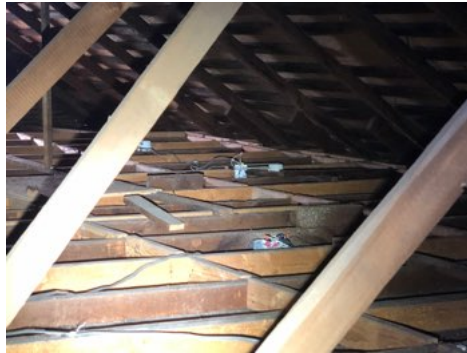
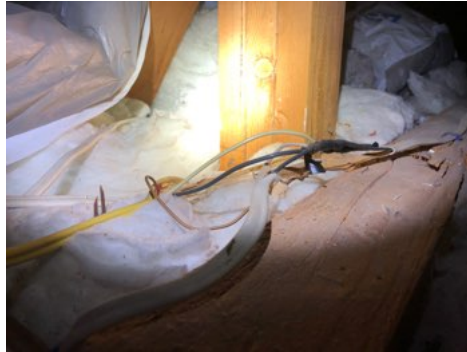
3.2. Exposed splices, missing box covers... Noted in the attic - A fire hazard/Safety concern. Have it checked, fixed by a qualified Electrician.

3.3. Recommend complete system evaluation to determine the cost and scope of work before expiration of your Contingency Period and before the Close of Escrow by a qualified electrician.

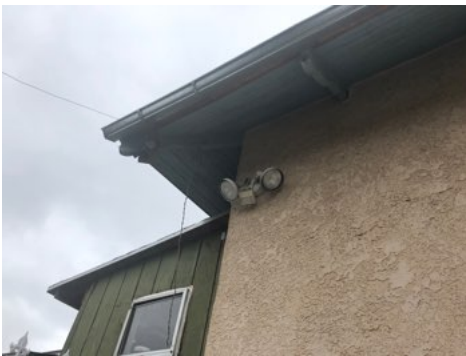
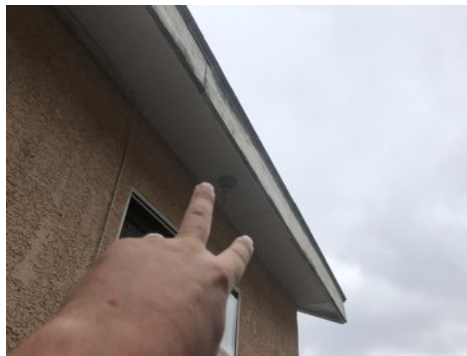
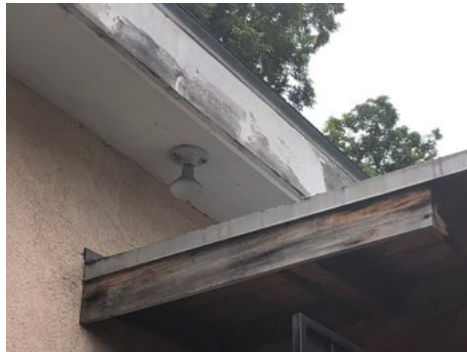
- 4.1. Light(s) not working at the exterior. Have checked, fixed by a qualified electrician.
- 4.2. Some of the lights are not water proofed type and exposed to the rain, may not work. Have it checked by a qualified electrician.
- 4.3. Light Cover is damaged and/or missing at the exterior. Have it replaced.
- 4.4. Building without timer, sensor operated exterior lights. Recommend to install - Safety, Liability concern.
- 4.5. Several material, installation defects, and/or safety considerations were noted with regard to the Electrical System - Further evaluation of the system for repairs, corrections, safety upgrades by qualified Electrical Contractor is recommended.
- 4.6. Recommend complete system evaluation to determine the cost and scope of work before expiration of your Contingency Period and before the Close of Escrow by a qualified electrician.

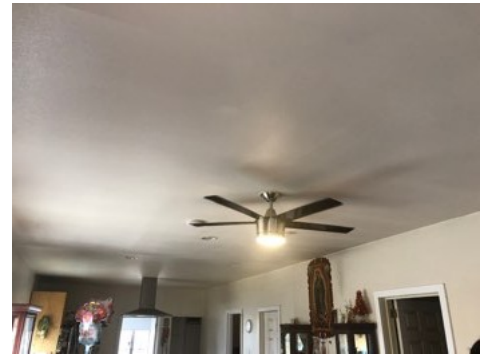
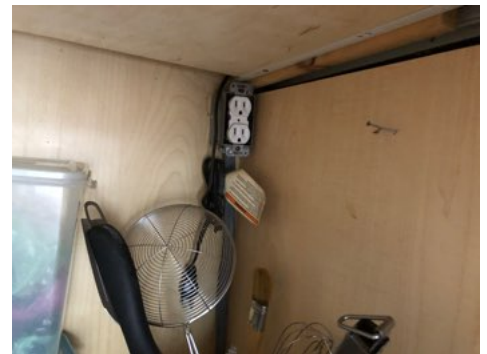
Not working- bedroom

- 6.8. Non grounded outlets noted. Recommend to replace for fire safety. Have checked by qualified electrician.
- 6.9. Coverplates cracked at some areas. Have checked.

- 6.10. Kitchen- Switch at counter at kitchen doesn't control anything, unable to determine operation, Missing cover plate at outlet under stove top. Have fixed.

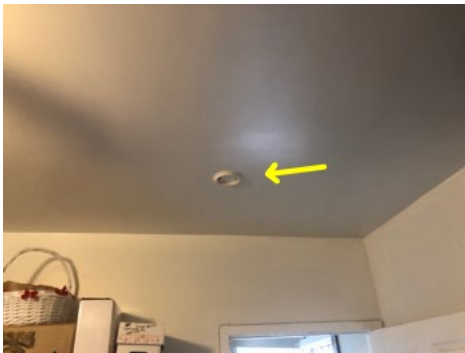
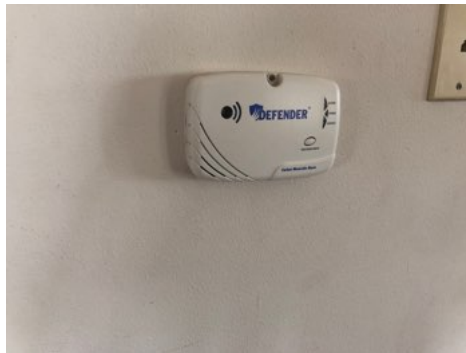
7.3. Missing smoke detectors at bedrooms and/or hallway. Recommend to Install and test periodically for fire safety. Have checked by qualified retrofitter.

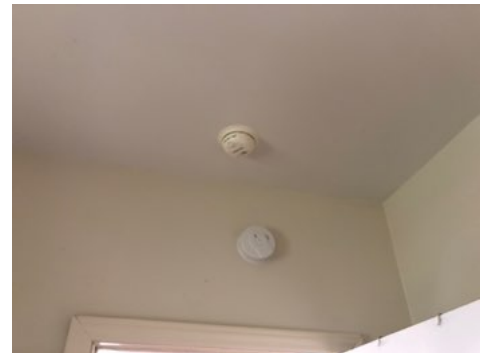
7.2. Recommend to install carbon monoxide detectors per City/Manufacturers requirements and test them periodically. Information regarding placement can be found on the State Fire Marshall website at <http://osfm.fire.ca.gov>

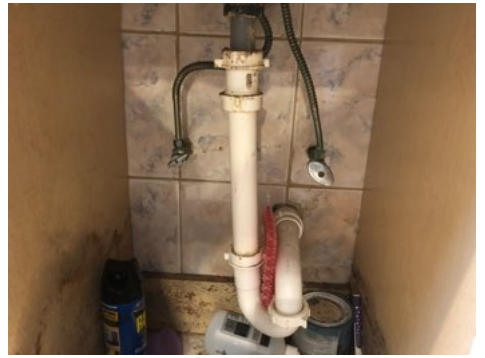
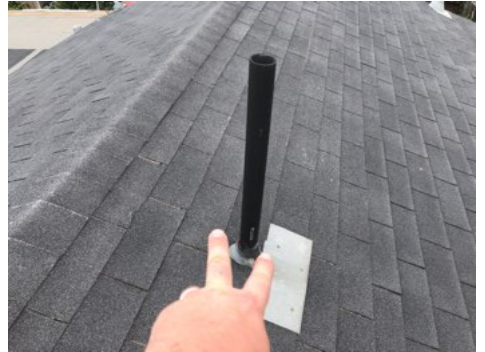
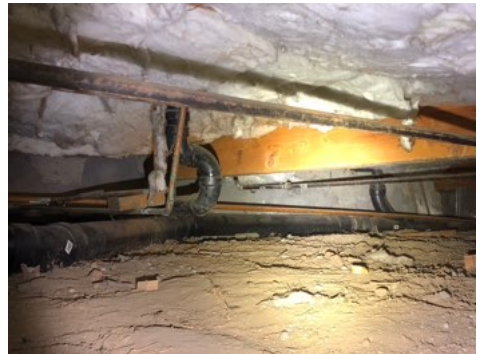
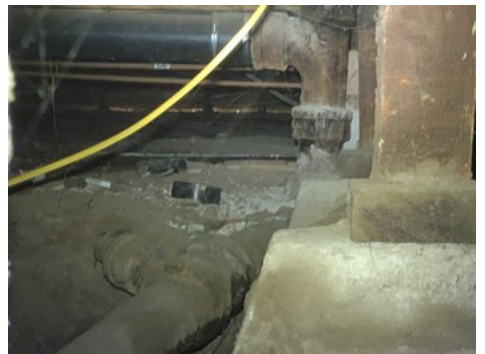
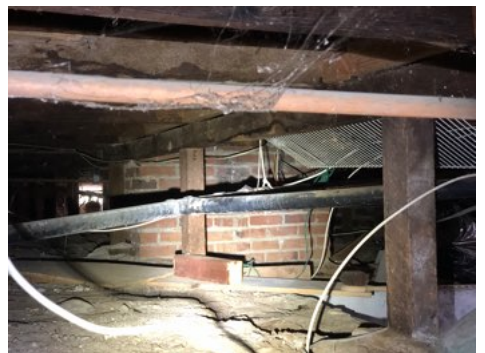
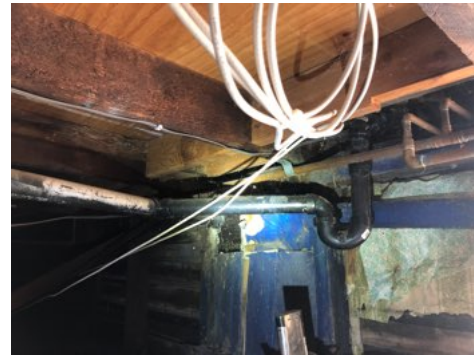
1.10. ABS type sewer vent pipes noted at the roof and/or exterior - Pipes were not painted to protect from sun damage (UV rays). Recommend to seal/paint to prevent damage. Have checked by qualified specialist.

1.11. Most of the Sewer, Waste pipes are located underground not fully visible/accessible and not part of this inspection. A sewer video inspection must be completed prior to close of escrow by a qualified plumber in order to determine the true condition of the Sewer, Waste line.

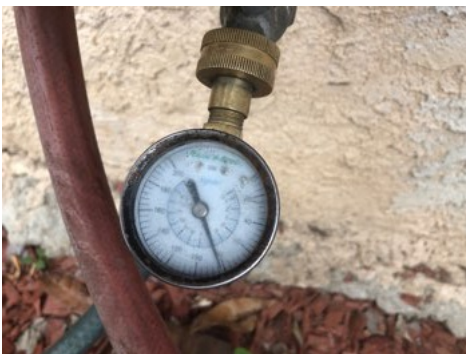
80 psi

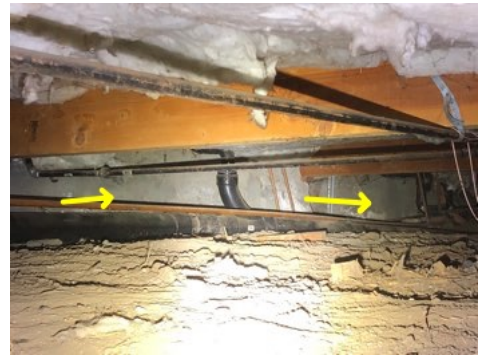
Lacks support

3.7. Old supply shut off valve(s)/angle stops noted at/under sinks- These type of valves are prone to leaks. Recommend to upgrade/replace by qualified specialist, plumber.

Leaking

3.8. Recommend further, complete evaluation, repairs by a qualified plumber.

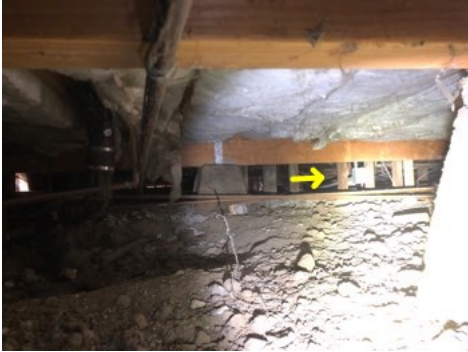
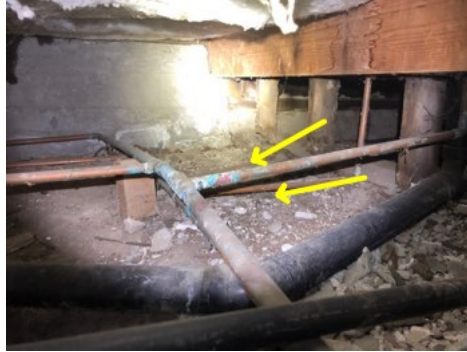
3.4. Leaking Noted at some lines at crawlspace. Oxidation at copper pipe solder joints noted in crawl space, this can result in future leaks - recommend to fix. Have it checked, cleaned, fixed by a qualified plumber.

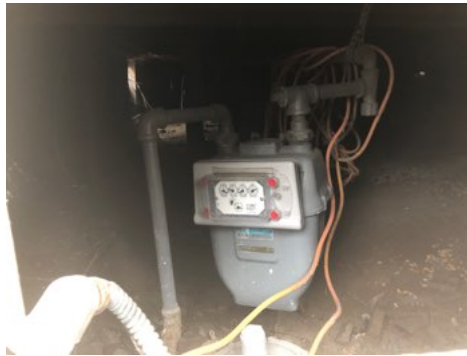
4.2. Gas meter(s) - Seismic shut off was not present at the time of inspection. Recommend to install. Have it checked by a qualified plumber.

4.3. Gas meter is located in crawlspace, poor location - Recommend to relocate to exterior. Check with The Gas Co.

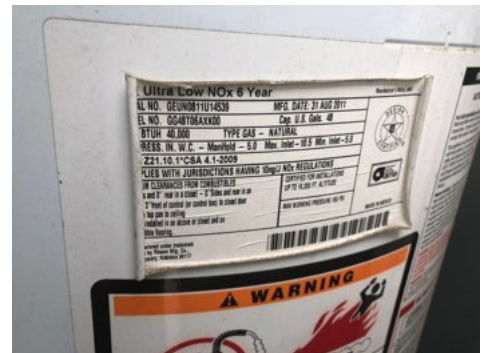
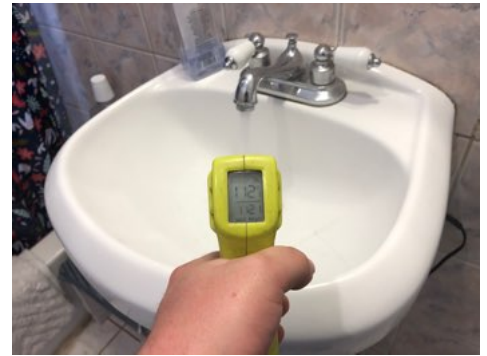
5.7. **TPR valve** line terminates unsafely. Recommend to extend outside into a safe location.

5.8. Water heater lacks a catch pan with exterior routed line. Recommend to install.

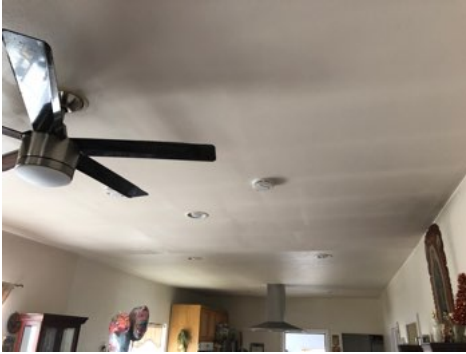
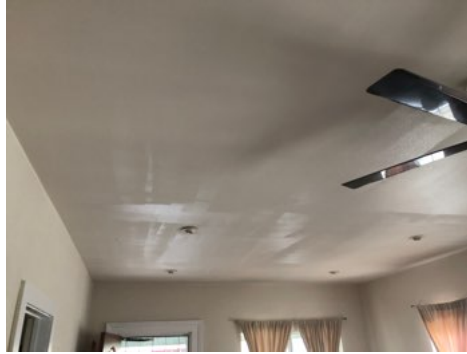
1.1. Common cracks were noted at the ceilings.

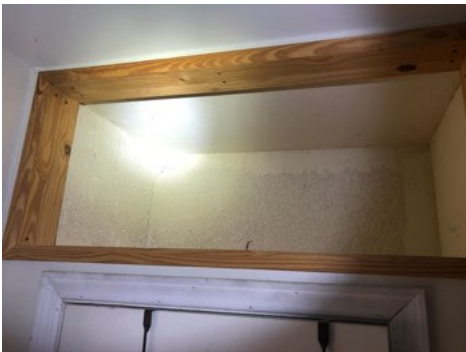
Bedroom

2.4. Damage at interior wall above closet at front bedroom. Have checked, patched/repainted by qualified specialist

2.5. Possible Acoustic spray at bedroom wall above closet noted. Acoustic spray may be asbestos containing type - Recommend further testing for possible abatement as a safety upgrade.

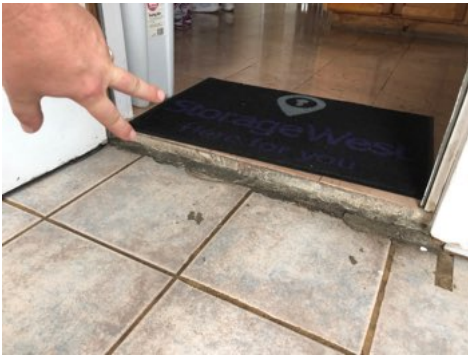
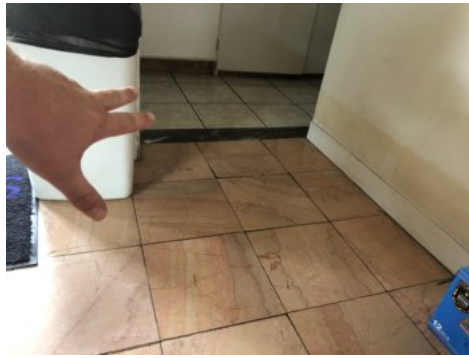
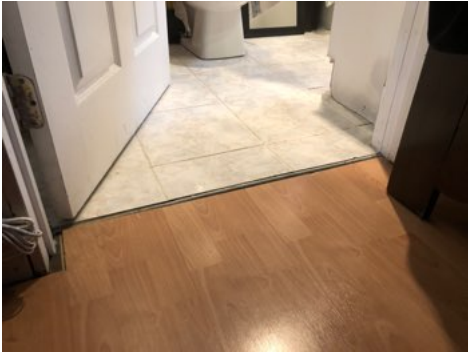
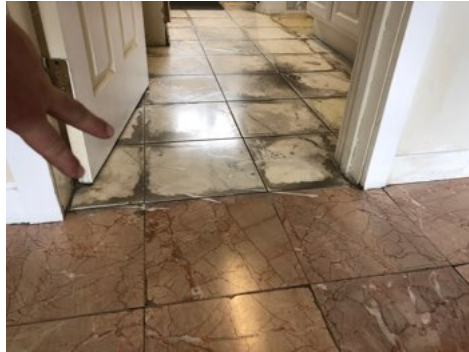
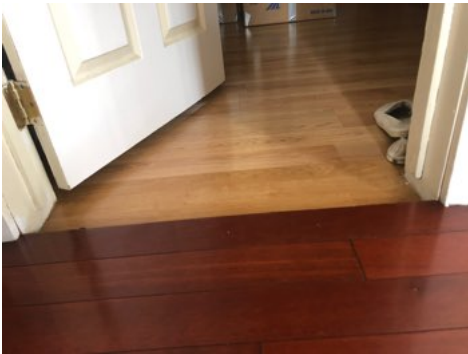
3.9. Cracked, Damaged Tile(s) noted. Recommend further evaluation, repairs made by qualified specialist(s).

Cracked/loose tiles

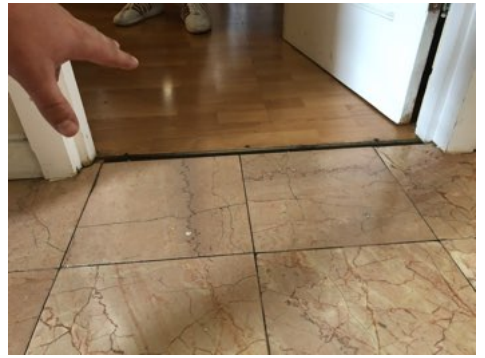
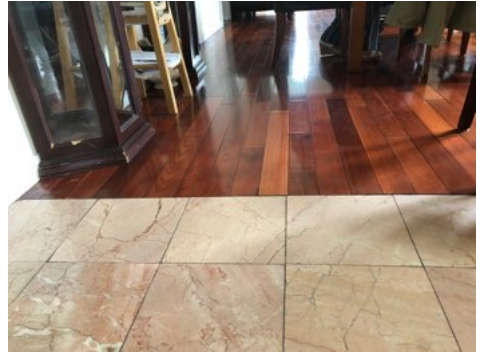
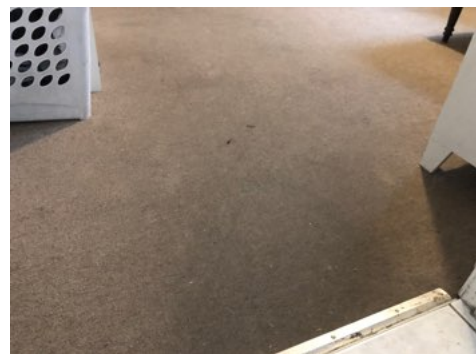
3.8. Some expanded gaps noted at flooring material joints. In need of further evaluation, corrections by a qualified floor specialist.

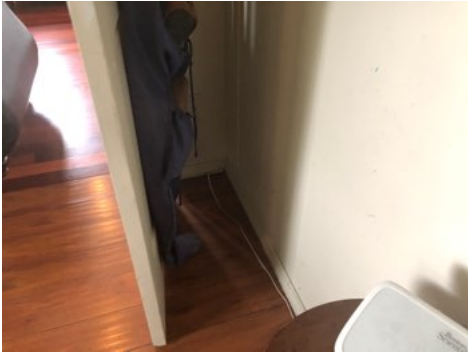
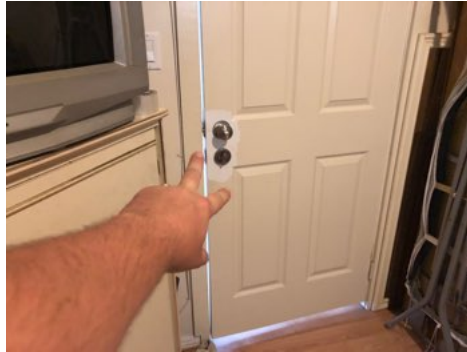
- 4.1. Recommend to install door stops to prevent wall damage.
- 4.2. Door frames are not square, some rub at frames and/or not closing, latching properly - An indication of settlement or movement. Further evaluation and corrections by a qualified Contractor is recommended.
- 4.3. Exposed framing noted at bedroom window. Have checked, fixed by qualified contractor.

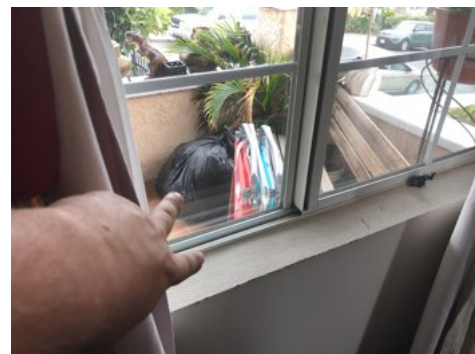
- 5.4. Worn window roller(s) noted - Have it checked, necessary corrections made by a qualified specialist.
- 5.5. House with some old aluminum (single pane) windows type at Add on Noted. Recommend to upgrade.

- 5.6. Common age defects were noted to windows at the time of inspection.
- 5.7. Damaged/poorly installed window at laundry noted. Have checked/fixed/corrections made by qualified contractor.

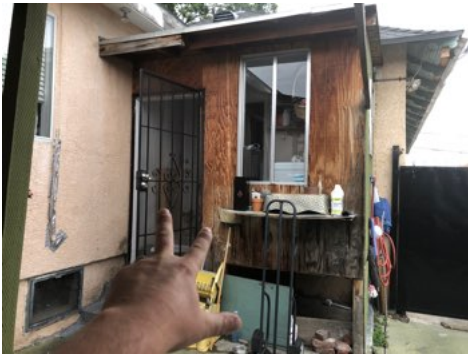
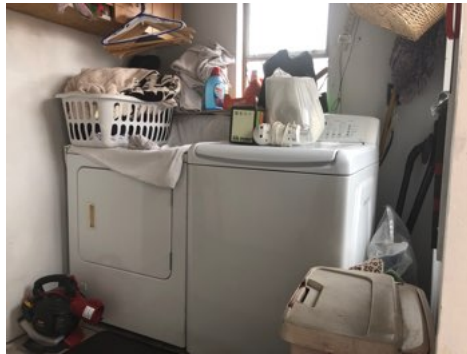
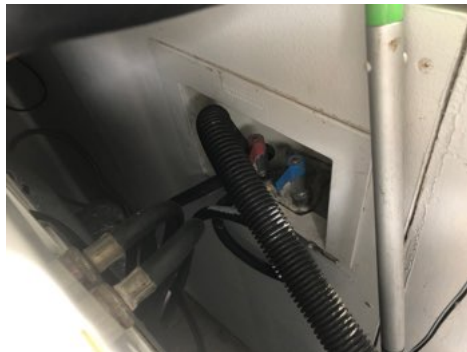
7.4. Washing machine, laundry area without catch pan and/or drainage pipes. Recommend to install if possible to prevent damage when machines leak.

7.5. 20 GFCI Amp outlet is recommended at laundry as a safety upgrade. Have checked by a qualified specialist for correction.

7.7. Improper/damaged dryer vent noted- recommend to upgrade.
