Key Property Inspection Group

Property Inspection Report

1717 S Berendo St, Los Angeles , CA
Inspection prepared for:
Real Estate Agent: -

Date of Inspection: 6/7/2019 Time: 9:30 AM
Age of Home: 1906 Size: 1774 sq. Feet
Weather: Clear
Order ID: 9914

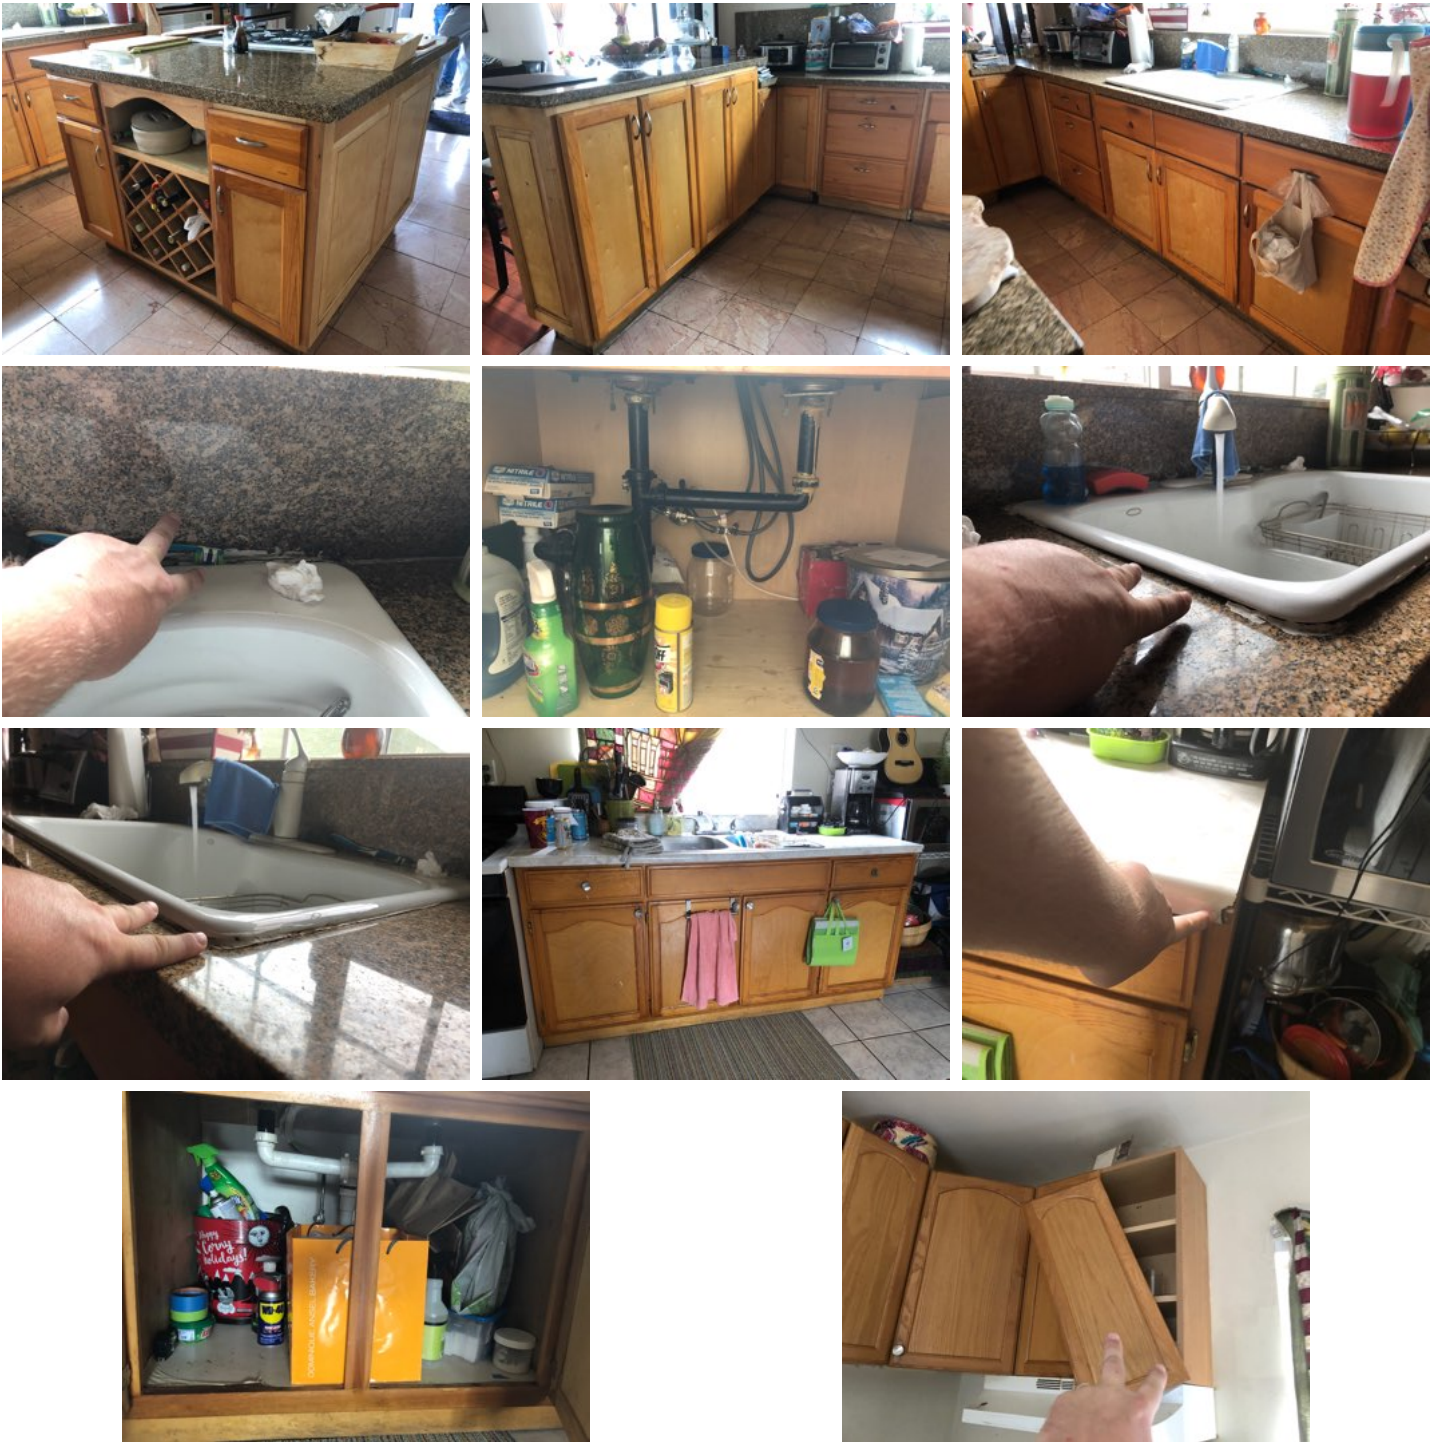
2.3. **Wear and general age defects were noted to counter, cabinets at the time of inspection.**

2.4. **Cracked grout noted at counter//sink/splash. Recommend to have it sealed by a qualified specialist.**

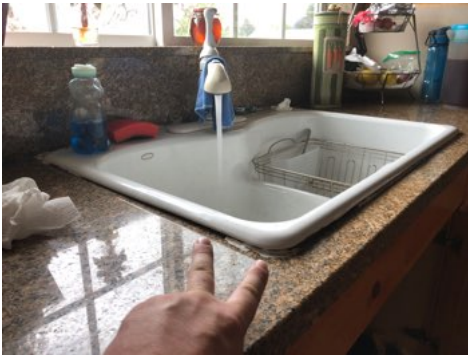
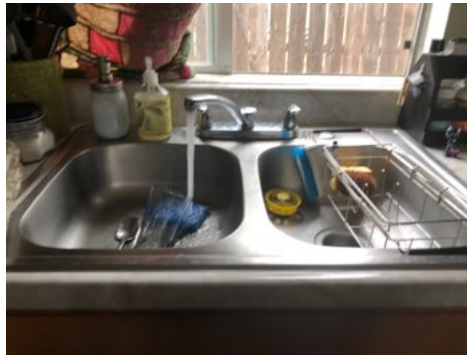
- 3.1. Sink faucet(s) functional at time of inspection.
- 3.2. View under sink cabinets was restricted due to belongings.
- 3.3. **Old supply valves/tubes(angle stops) noted- these type of valves are prone to leaks. Recommend to upgrade, have checked by a qualified specialist, plumber.**
- 3.4. **Cracked and/or dirty caulking noted at sink/counter connection. Recommend to clean, re seal and correct by specialist to prevent seepage.**

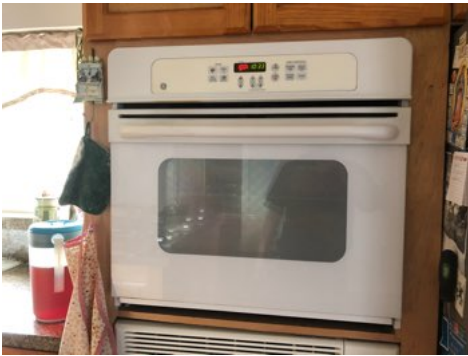
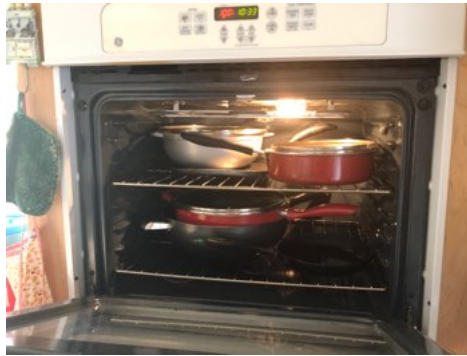
6.3. Igniter(s) did not work at all burner(s) at front kitchen and front right at rear unit kitchenette. Have them all checked, fixed or replaced by a qualified specialist.

Igniters not working

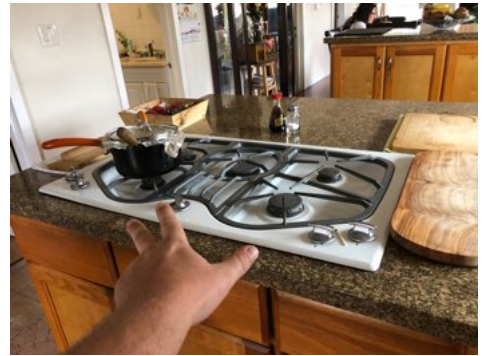
6.2. Older model noted - Was operational at the time of inspection but does show wear and age defects.

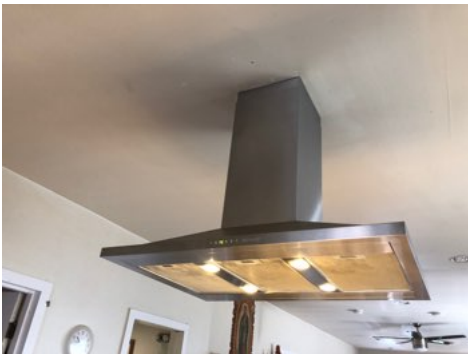
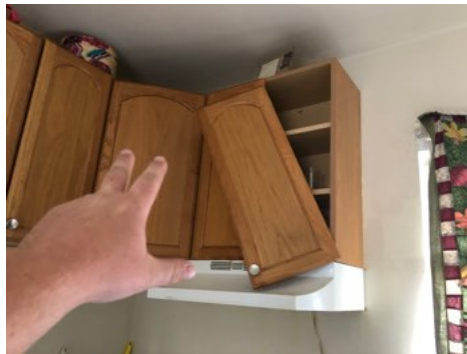
7.2. Dirty filter(s) noted at the time of inspection. Recommend to replace.

7.3. Recirculate type vent noted at rear unit- recommend to upgrade to vented type system to exterior. Have checked by specialist for upgrade

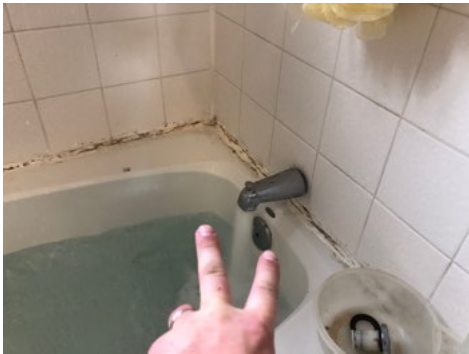
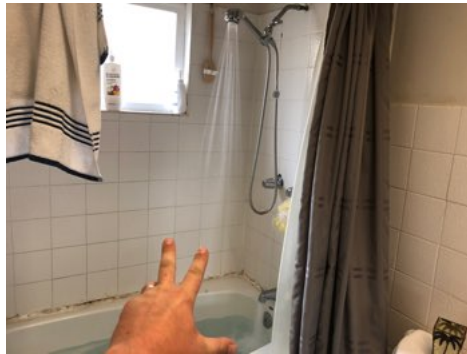
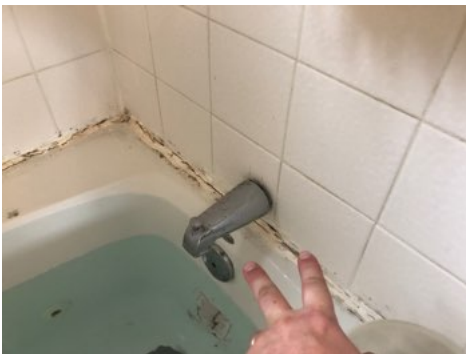
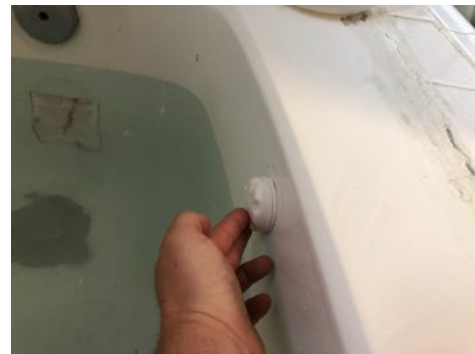
- 4.1. Defective tub stopper noted. Have it checked, fixed by a qualified specialist.
- 4.2. Defective diverter valve noted- shower and tub run at same time- improper. In need of repair, replacement.

- 4.3. Cracked, dirty caulking noted at tub enclosure. Recommend to re-caulk at tub tiles and enclosure.
- 4.4. The flexible sealants (caulking) is missing, failing and/or gaps noted at the fixtures valve(s) or along the base of the walls and should be re sealed, caulked to prevent water seepage, damage. Have checked, fixed by qualified specialist.

- 4.5. Leaking at downspout noted at shower mode due to defective diverter. Have it checked, repaired, replaced.
- 4.6. Window was set too low at tub/shower head. Recommend to install curtain to prevent water seepage, damage.

- 4.7. Wall tiles are installed at tub ledge. Unable to determine if proper flashing was used at tub to wall to prevent water seepage, damage. These type of tubs are not designed to be used as shower. No access was installed to check under the tub area. Inspection was limited. Have corrections made by qualified specialist.

- 4.8. Jet tub pump access not found and/or installed - Unable to check the installation. Recommend to install and check equipment for proper installation, grounding.

- 4.9. Debris noted when running jets- **air gap**/adjustment knob hard to rotate. Have checked by qualified specialist for any necessary correction.

Difficult to turn

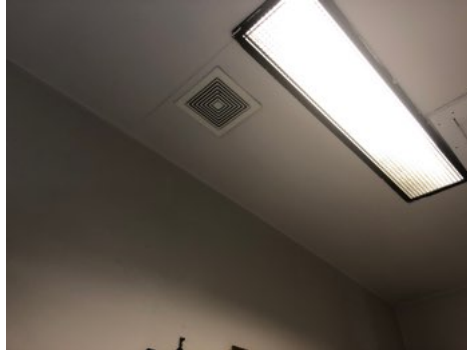
- 6.1. Dirty exhaust fan(s) noted. Recommend to clean, service.
- 6.2. Noisy exhaust fan noted - Recommend to upgrade.

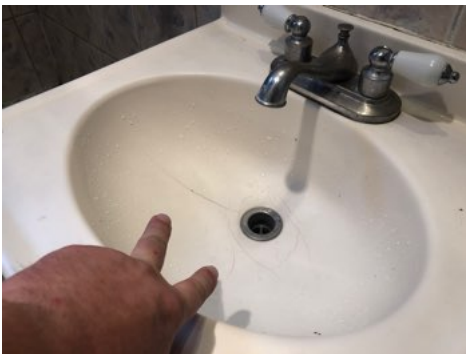
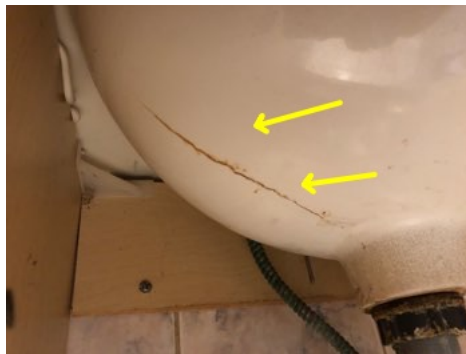
- 2.1. Sink faucet(s) functional at time of inspection.
- 2.2. Defective sink stopper noted. Have it checked, fixed by a qualified plumber.
- 2.3. Moisture stains, damage under sink cabinet noted. Recommend to have it checked, repairs made by a qualified specialist.
- 2.4. Signs of Mold like substance present under sink(s): at cabinets and/or walls. We did not inspect, test or determine if this is Mold or if this Mold like substance is or is not a health hazard. Recommend you contact a Mold inspector or expert for investigation or correction if needed.
- 2.5. Old supply valves/tubes(angle stops) noted- these type of valves are prone to leaks. Recommend to replace/upgrade by a qualified specialist, plumber.
- 2.6. Cracks noted at sink finish and under sink. Have it checked, fixed, replaced, by a qualified specialist.

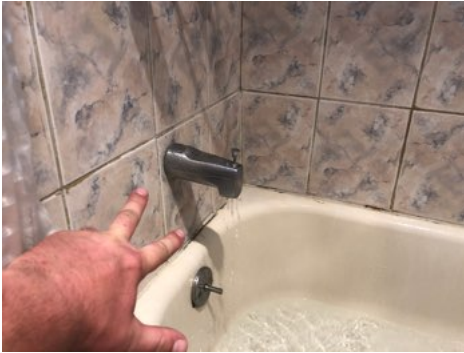
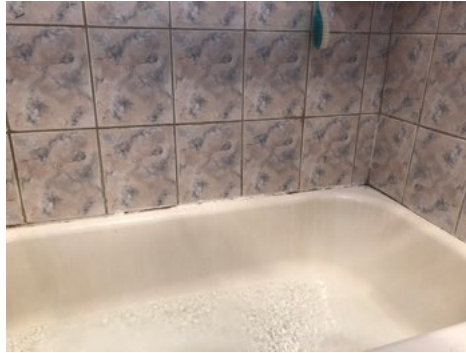
- 5.1. Cracked, dirty caulking noted at tub enclosure. Recommend to re-caulk at tub tiles and enclosure.
- 5.2. The flexible sealants (caulking) is missing, failing and/or gaps noted at the fixtures valve(s) or along the base of the walls and should be re sealed, caulked to prevent water seepage, damage.
- 5.3. Leaking at downspout noted at shower mode due to defective diverter. Have it checked, repaired, replaced.
- 5.4. Window was set too low at tub/shower head. Recommend to install curtain to prevent water seepage, damage.

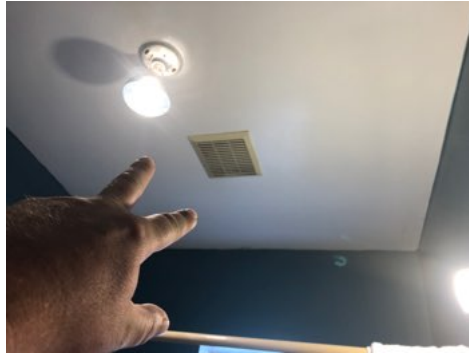
- 7.1. Dirty exhaust fan(s) noted. Recommend to clean, service.
- 7.2. Noisy exhaust fan noted - Recommend to upgrade.

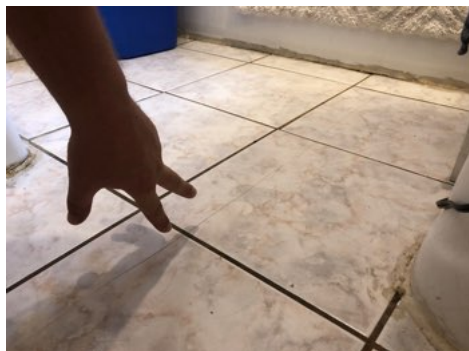
3.1. Cracked tiles noted at flooring. Have it checked, fixed, replaced by a qualified specialist.

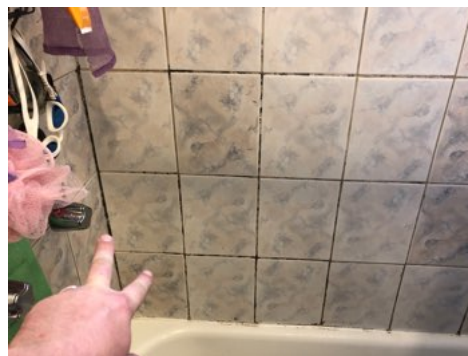
4.1. Cracked, dirty grout noted at tub enclosure. Recommend to re-grout at tub tiles and enclosure.

4.2. The flexible sealants (caulking) is missing, failing and/or gaps noted at the fixtures valve(s) or along the base of the walls and should be re sealed, caulked to prevent water seepage, damage.

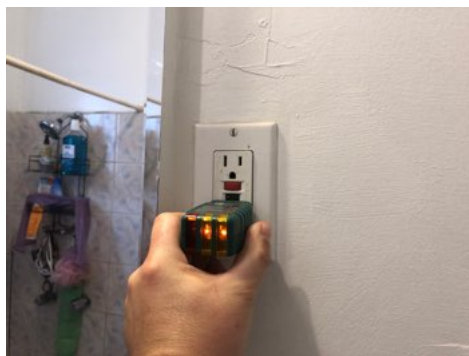
5.1. GFCI type outlet(s) noted. Recommend to test periodically.

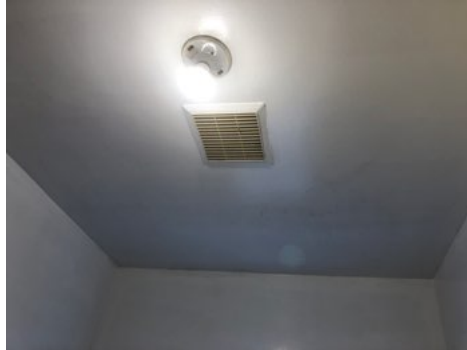
- 6.1. Dirty exhaust fan(s) noted. Recommend to clean, service.
- 6.2. Noisy exhaust fan noted - Recommend to upgrade.

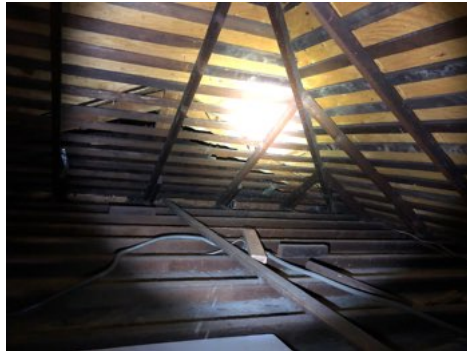
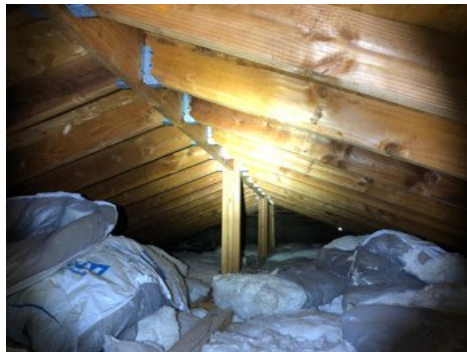
2.1. Water staining was noted to the structure at the time of inspection. Unable to determine if leak is present and/or has been previously fixed. Check with the seller for any known roof leaks or repairs and/or have it checked by a qualified roofer to make sure roof is free of leaks.

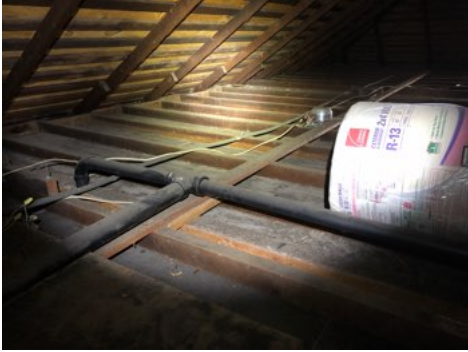
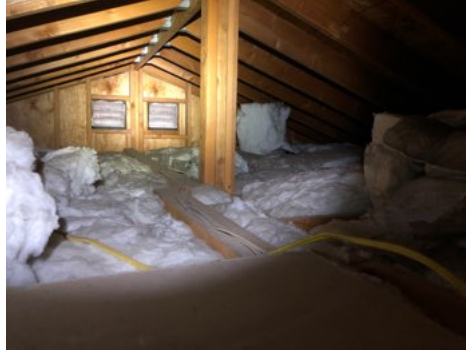
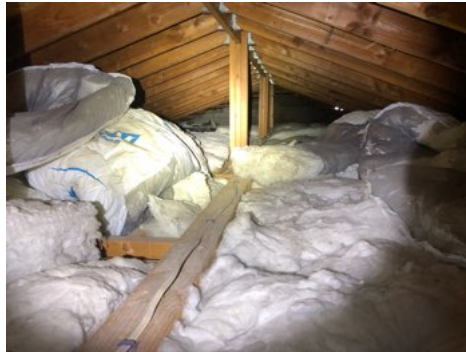
Recommend to install approved insulation material in the attic.

3.2. Some loose and/or missing insulation noted at attic space. Have it checked, fixed.

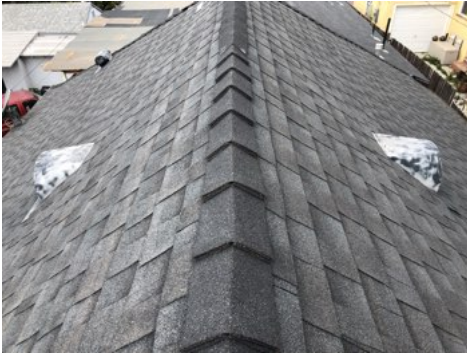
4.2. Lack of proper cross ventilation noted in the attic- missing roof vents at rear add on roof area. Recommend to add. Have checked, fully evaluated by qualified roofing or framing contractor for correction.

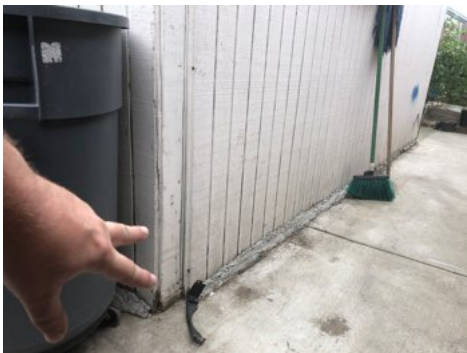
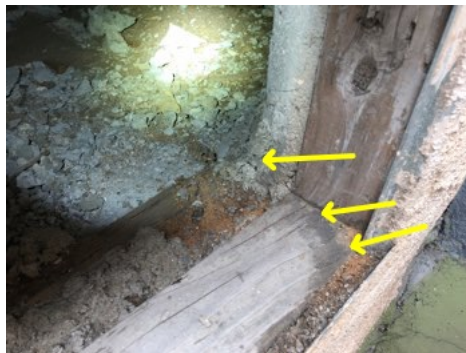
1.4. Newer work, alterations noted at crawlspace. Recommend to check the records, permits.

1.5. Efflorescence was noted present on the foundation walls. Recommend to keep moisture around the inspected property to a minimum.

1.6. Foundation vents were set low at exterior soil, water seepage into the crawl space noted. Recommend to built a curb to prevent water intrusion.

1.7. Added curb wall at exterior of the foundation is indication of attempt to address poor drainage, moisture seepage issue. Have it checked by a qualified specialist.

1.8. Construction debris/belongings noted in the crawl space which should be removed.

1.9. Recommend further complete evaluation, necessary corrections made by qualified foundation specialist.

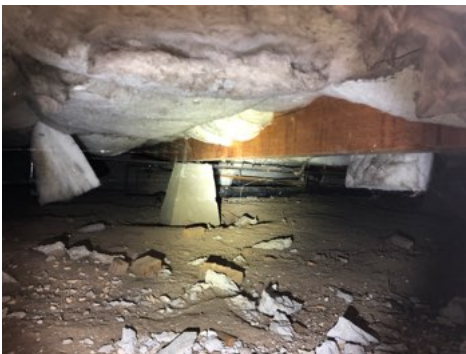
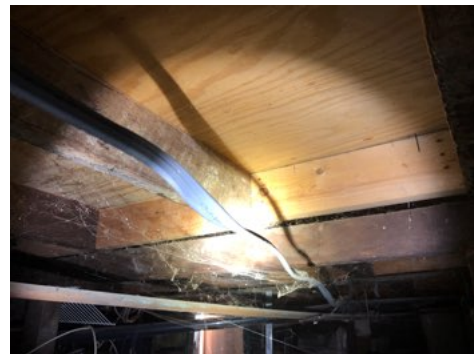
- 4.1. moisture staining was present at the floor structure in the crawl space. Recommend further evaluation, necessary corrections by a qualified structural pest inspector.**
- 4.2. Most of Floor system is not insulated. Heat loss can occur more on this home than one that is properly insulated.**
- 4.3. Newer work, alterations noted. Recommend to check the records, permits.**
- 4.4. Floor joists were not fully visible due to insulation at add on. Inspection was limited. Check the records for any known defects, repairs.**
- 4.5. Recommend further complete evaluation, necessary corrections made by qualified foundation specialist.**

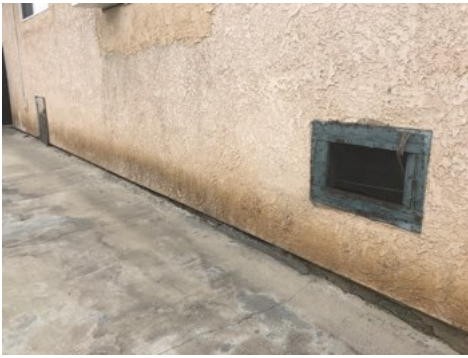
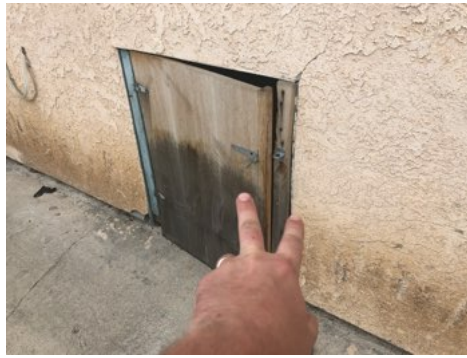
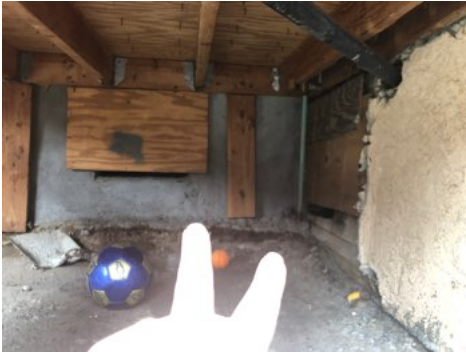
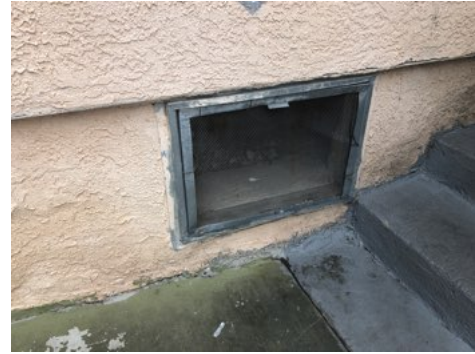
5. Foundation Ventilation

- 5.1. Some vent screens noted damaged/loose. Repairs, replacement of damaged screens is recommended.**
- 5.2. Foundation vent(s) are below ground level at exterior soil/slab, which can allow water to enter crawlspace. Recommend to re-grade and/or install proper flashing, curb to prevent water seepage.**
