## Property Inspection Report

43802 Kirkland Ave, Lancaster, CA 93535  
Inspection prepared for: Maria Rodriguez  
Real Estate Agent: Francisco Lopez - Titan Realty & Investments

Date of Inspection: 3/16/2019 Time: 3:30 PM  
Age of Home: 1957 Size: 1225 sq. Feet  
Weather: Clear  
Order ID: 9204

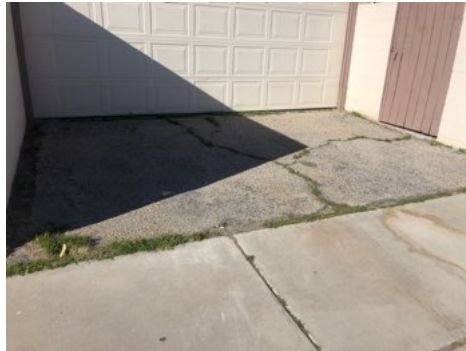
- 1.1. Large Cracks, settlement present at driveway/sidewalk surfaces. Have checked, necessary repairs made by qualified specialist.
- 1.2. Evidence of Poor Drainage present at driveway/sidewalk surfaces, recommend further evaluation by qualified contractor.
- 1.3. Worn, cracked, damaged asphalt noted. Have it checked by a qualified paving contractor.

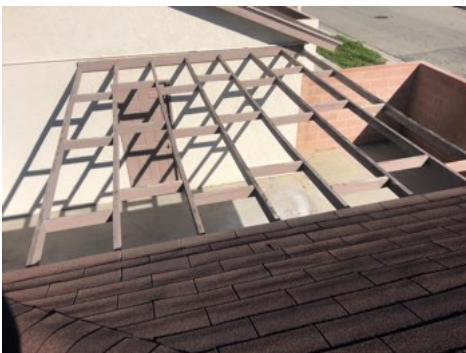
- 3.1. Common Cracks present at porch/patio area.
- 3.2. Earth To Wood Contact at support post(s). Have it checked, corrected by a structural pest specialist.
- 3.3. Post base(s) missing, Recommend to be connected to concrete footings by a post base with a 1" standoff. Have checked, necessary corrections made by qualified specialist.
- 3.4. Peeling paint/wear at patio cover. Recommend to have checked by qualified structural pest specialist for any necessary corrections.

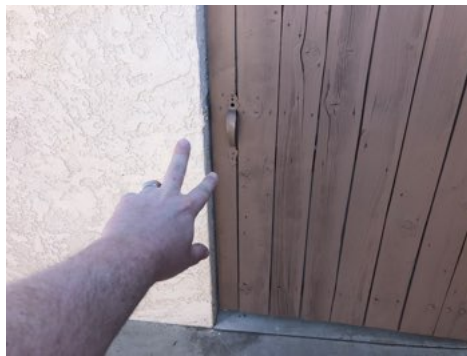
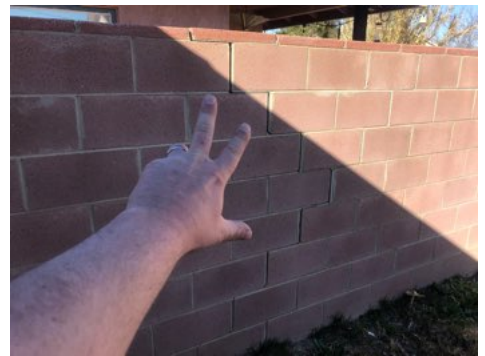
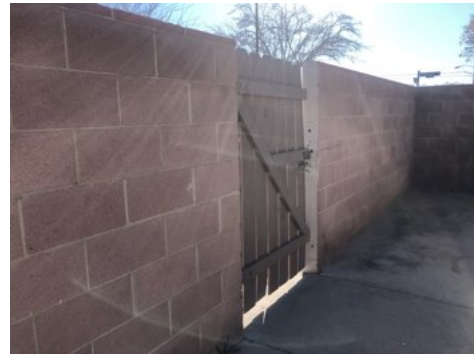
- 4.1. Common age defects noted to fencing. Recommend to monitor the condition.
- 4.2. Fencing in need of repairs at some areas. Have it checked by a qualified contractor
- 4.3. Gate(s) in need adjustment or repairs noted- tub at wall/ground noted. Have checked, fixed by qualified specialist.
- 4.4. Cracks were noted, some movement noted to the masonry fencing- Have it checked, fixed by a qualified contractor.

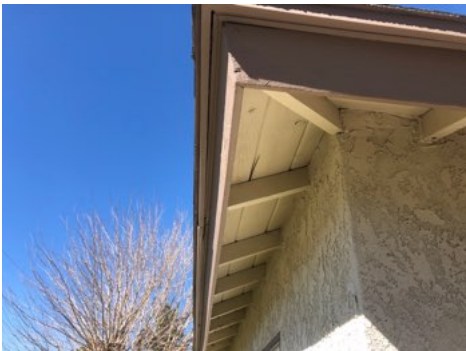
- 5.1. Age defects, peeling paint and/or moisture stains, damage were noted at the eaves and fascia. Recommend further evaluation, repairs by a qualified structural pest inspector and contractor.

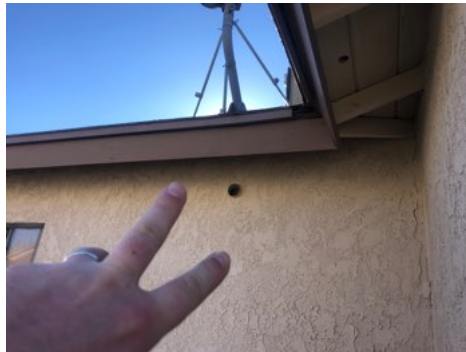
6.1. Newer paint noted which may mask older defects. Have it checked by a qualified structural pest inspector.

6.2. Missing exterior cover at exhaust vent. Recommend to install.

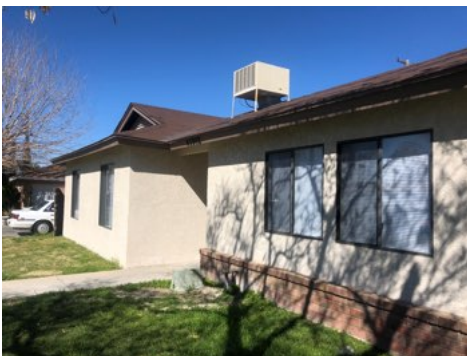
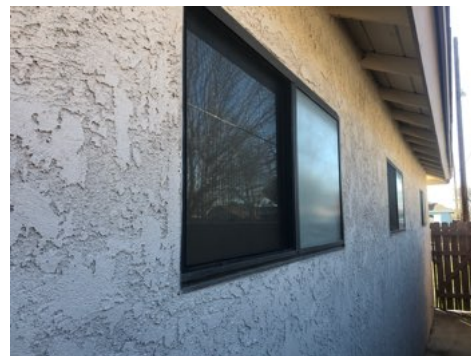
7.1. Dual pane windows noted. It is not always possible to determine fogging of this type of window due to temperature changes, etc. Check with the seller or records for any known defects, repairs.

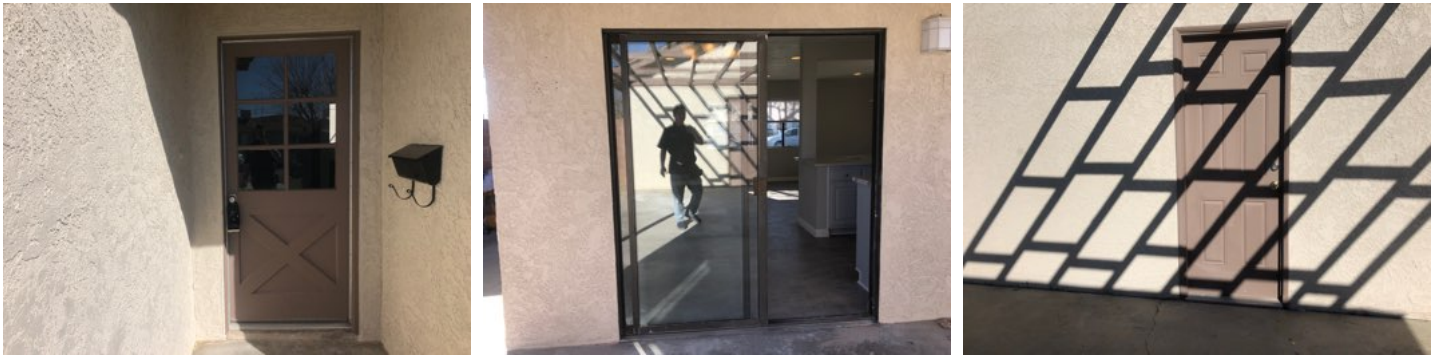
8.1. Old, worn, weathered finish at exterior doors noted. Peeling paint at frames. Have checked, any necessary corrections made by qualified specialist.

8.2. Slider doors noted installed backward - It is possible to remove the doors from the tracks from exterior even if locked - A security concern.

8.3. Missing screen door(s) at exterior sliding door(s). Have checked, fixed by qualified specialist.

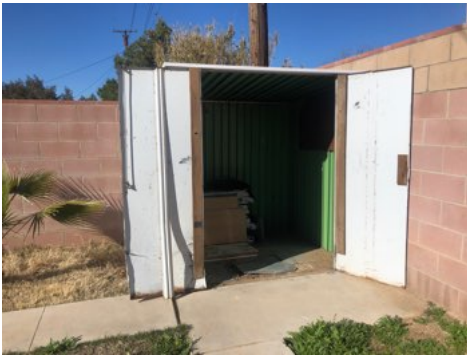
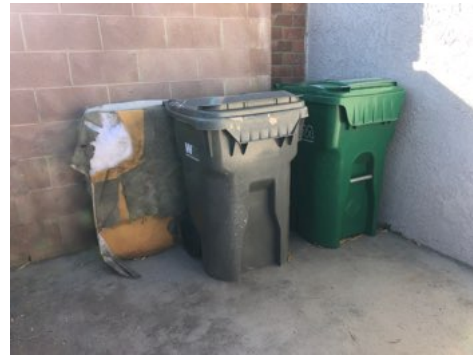
- 9.1. Trash bins noted. Check the records, contracts.
- 9.2. **Recommend to check the building records, permits.**
- 9.3. **Recommend to check the building records, permits on: additions, alterations, remodel.**
- 9.4. **Storage shed(s) noted. Not part of this inspection. Damaged doors noted.**

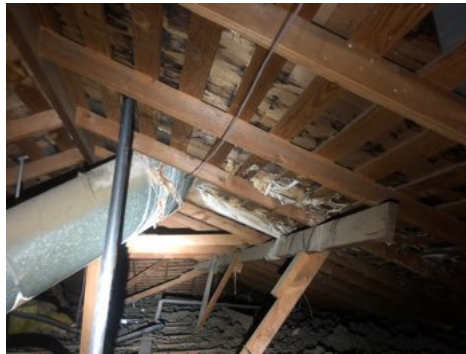
**1.1. We recommend an annual inspection, service, maintenance of the roofing material and its components to prevent leaks and/or damage. This is a visual inspection - The home inspector cannot warranty the roof to be free from leaks in the past or the future. Check the service records, with seller regarding any known defects or repairs relating to the roof.**

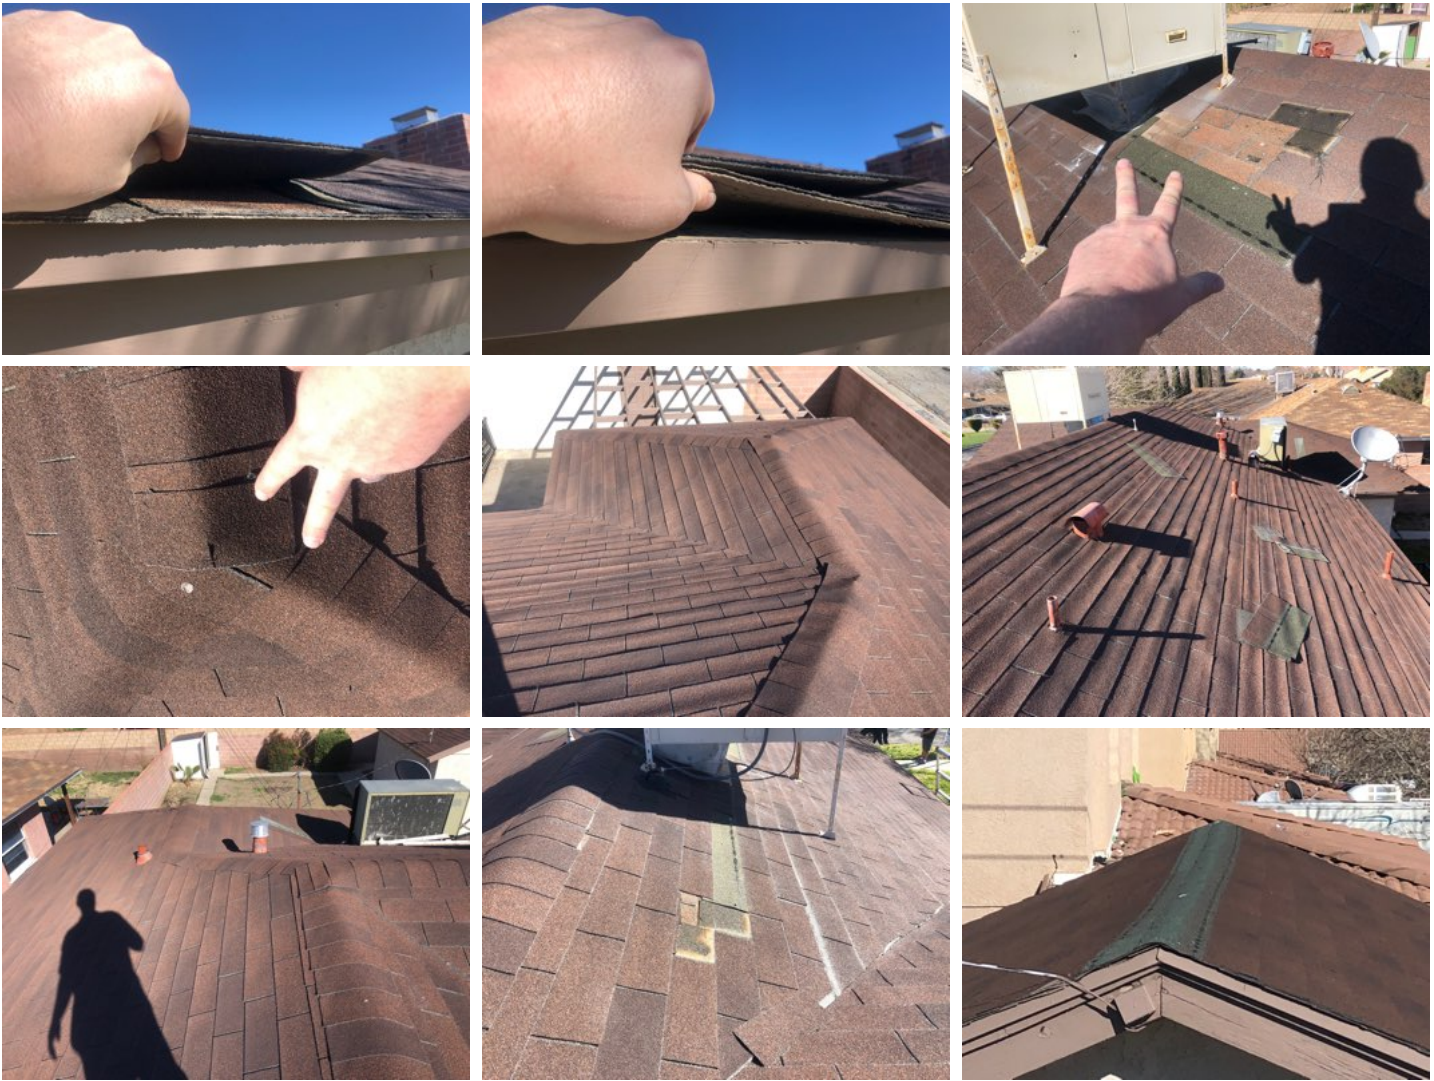
**2.1. Some damaged, torn shingles noted. Recommend further evaluation, repairs by qualified Roofer.**

**2.2. Felt paper is installed under the edge metal at down pitch edges of the roofing (common installation defect)- Improper method which can lead to moisture trapping and damage to eaves.**

**2.4. Exposed fastener(s), nail(s) noted at area(s) of the roofing which may allow moisture/water penetration. Recommend to seal, have checked, corrections made by qualified specialist.**

**2.5. Exposed Staples noted as fasteners at the roof. Considered substandard method of shingle attachment. Have checked, any necessary corrections performed by qualified roofer**

**2.6. Weathering, aging and cracks were noted to the roofing material. Roofing material appears to be nearing end of its useful life. Have it checked by a qualified roofer.**

**2.7. Old wood shake roofing noted still in place as 1st layer of two identifiable layers. Three layers of roofing is the maximum allowable number of layers- After which, roof replacement will require total tear off and sheathing. Recommend further evaluation by qualified roofer**

**2.8. Multiple layers of roofing noted - Three layers is the maximum allowable number of layers - Next roof replacement may require total tear off and possible sheathing. Have it checked by a qualified roofer.**

**2.9. Recommend further complete evaluation, necessary maintenance and/or corrections performed by a qualified roofer.**

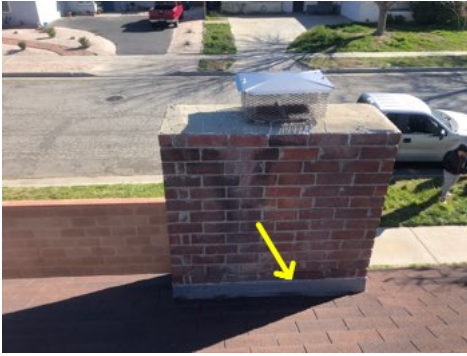
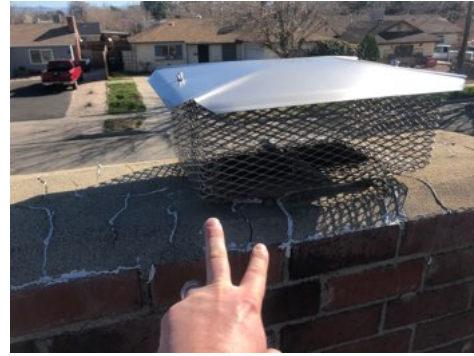
**6.3. Missing proper flashing/cricket at chimney. A cricket is a ridge structure designed to divert water on a roof. Have it checked, installed by a qualified roofer.**

**6.4. Recommend complete evaluation, any necessary corrections made by a qualified chimney inspector.**

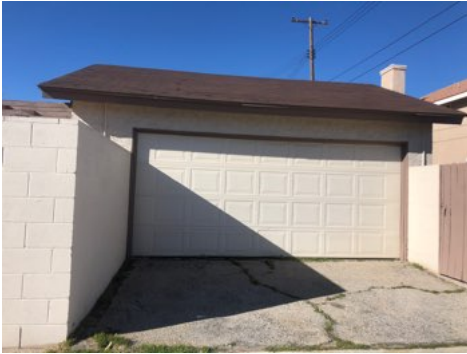
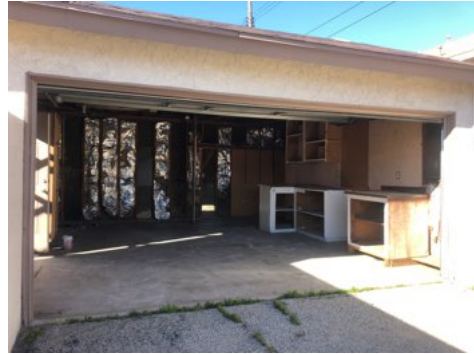
- 2.1. No automatic opener present - Manual vehicle door type. (FYI)

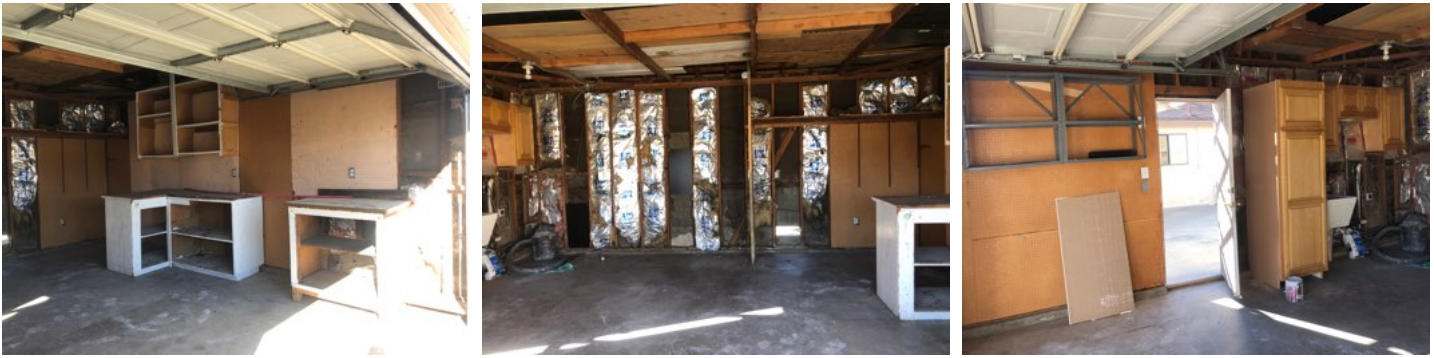
- 4.1. Not fully visible due to belongings. Recommend further evaluation by a qualified structural pest specialist.

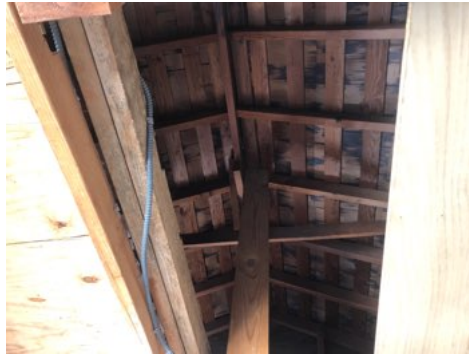
5.1. Dry Water stains at garage ceiling noted - Check the records and/or have it checked by a qualified specialist.

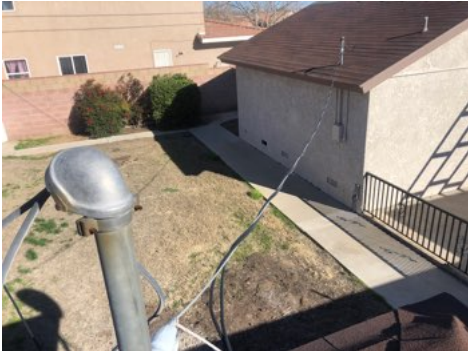
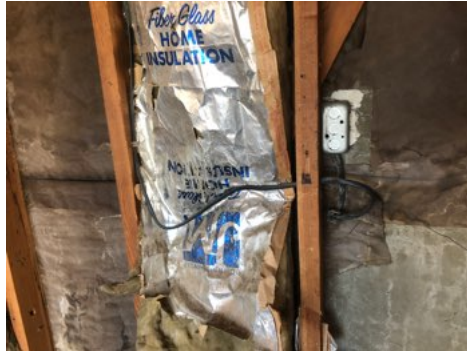
- 7.1. Recommend **GFCI** protected electrical outlets as a safety upgrade.
- 7.2. Exposed "Romex" type wires noted in the garage - Improper, subject to damage. Recommend to have checked, fixed by a qualified electrician.
- 7.3. Electrical Service drop from the main structure to the garage is too low and connections appear improper - Corrections by qualified Electrical Contractor are recommended for safety.
- 7.4. Service wire connections do not appear to have been done by a service provider, exposed wires at life Noted- improper. Recommend to check the records, permits and have it checked by a qualified electrician.

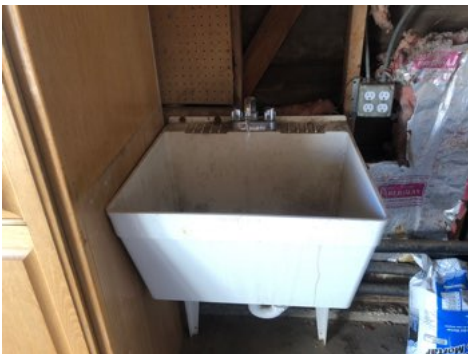
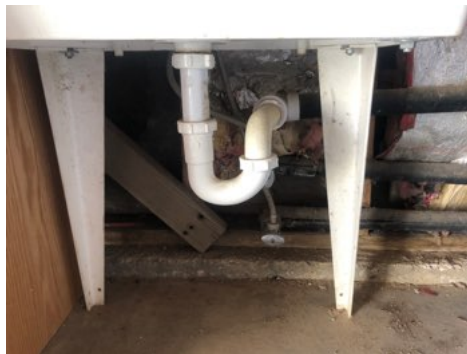
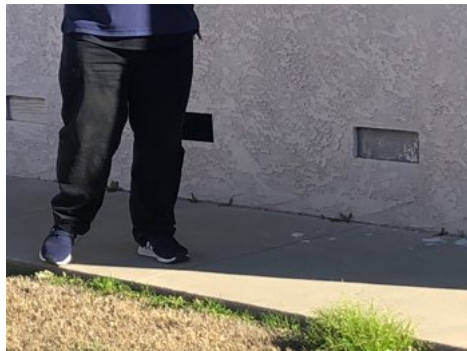
- 8.1. Garage sink was functional at the time. FYI
- 8.2. Poor slope/taping Noted at drain pipe at garage/laundry sink- improper. Have checked, fixed by qualified specialist.
- 8.3. Missing screen at vent at exterior wall. Have fixed

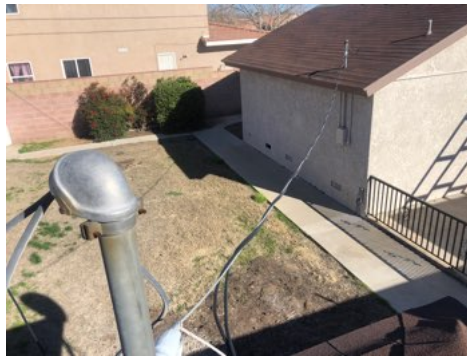
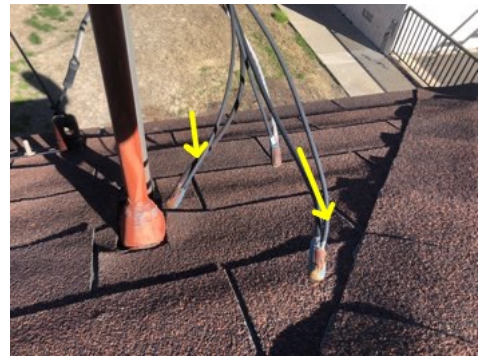
**1.2. Garage service wires running low at ground. Recommend to upgrade for safety. Have checked by qualified electrician.**

**1.3. Service wire connections do not appear to have been done by a service provider, exposed wires at life Noted- improper. Recommend to check the records, permits and have it checked by a qualified electrician.**

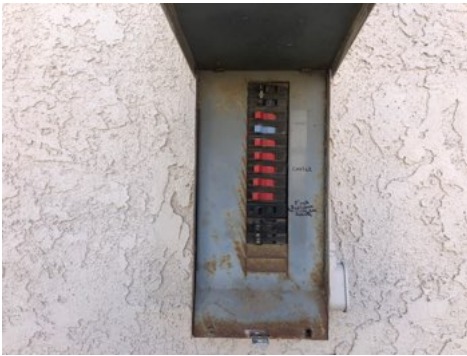
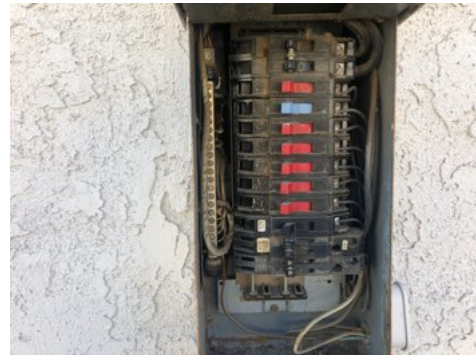
**2.6. Older model electric panel(s) noted - life span of electric panels are 40 to 50 years. Recommend to hire a qualified electrician for complete system evaluation and possible replacement of the panel(s).**

**2.7. Recommend complete system evaluation, necessary corrections made by a qualified electrician.**

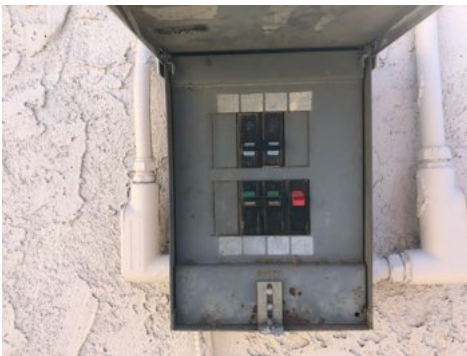
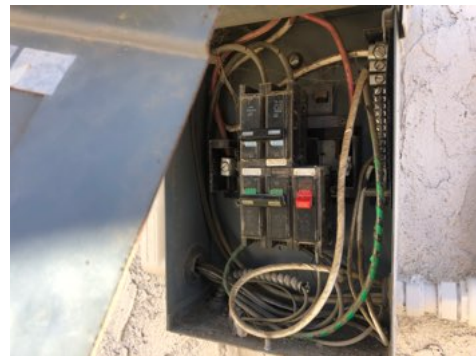
**3.1. Breakers are not properly labeled for emergency identification.**

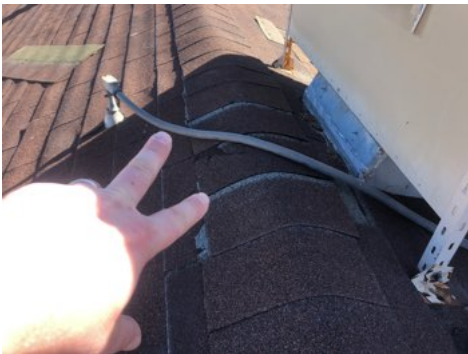
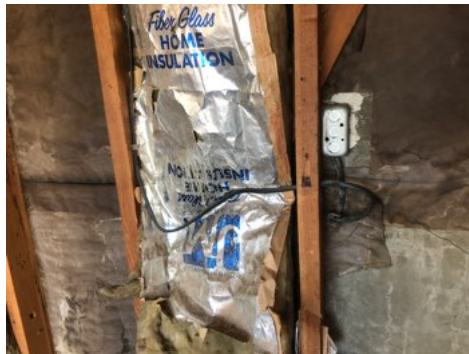
**4.2. Exposed Romex type wiring noted in the Garage. Require protection of conduit. Have the condition corrected for safety by a qualified Electrician.**

**4.3. Newer wiring, fixtures noted - Check the records, permits.**

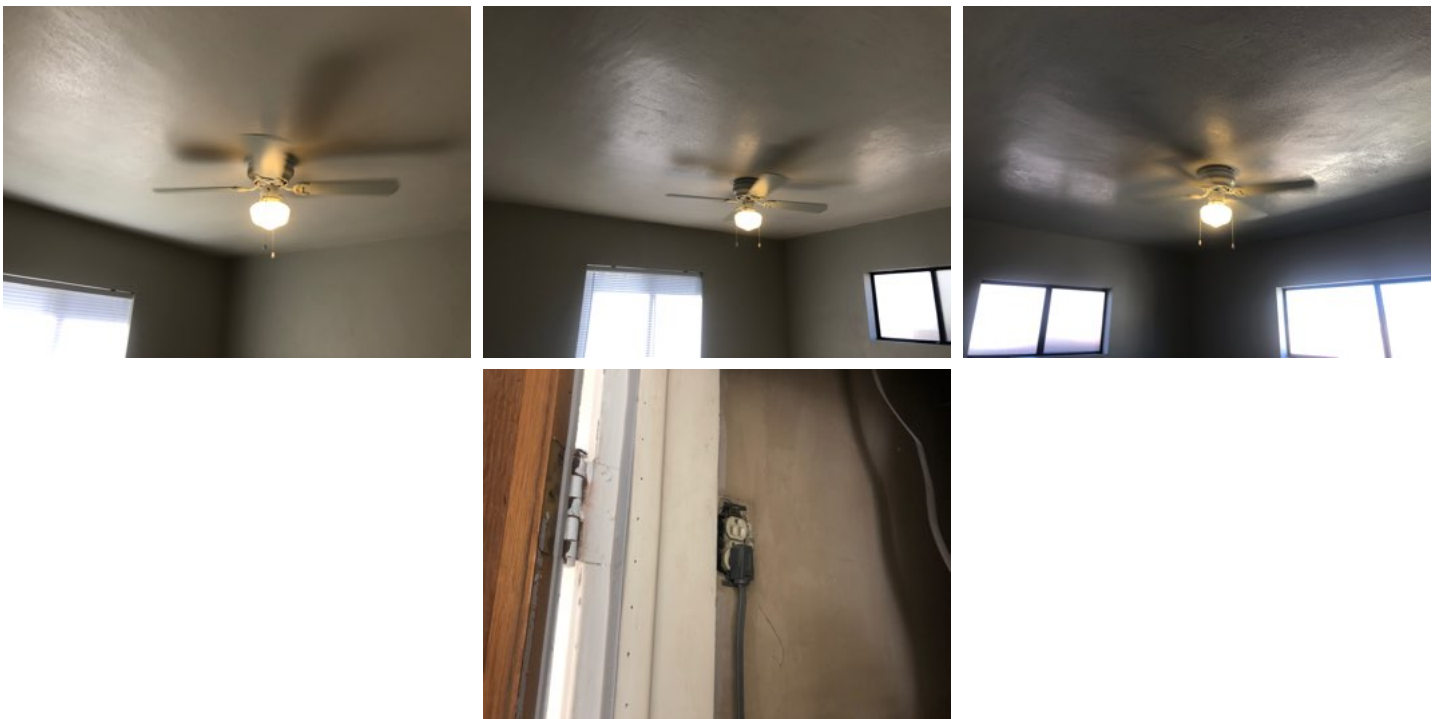
HVAC closet

6.4. Missing cover plate at HVAC closet. Recommend to install.

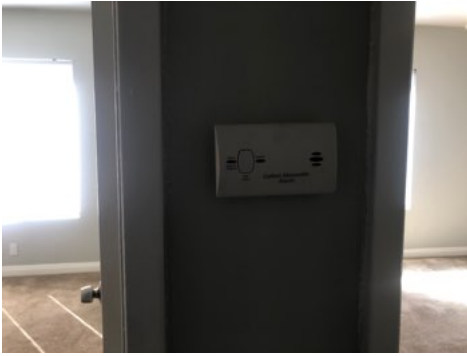
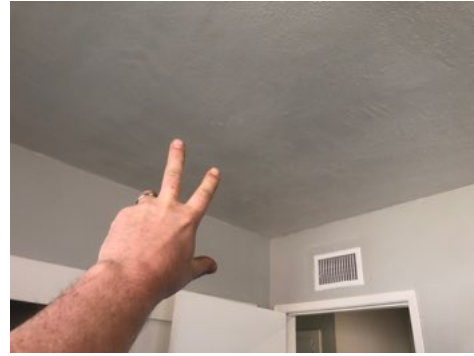
7.4. Missing smoke detectors at bedrooms and/or hallway. Recommend to Install and test periodically for fire safety. Have checked by qualified retrofitter.

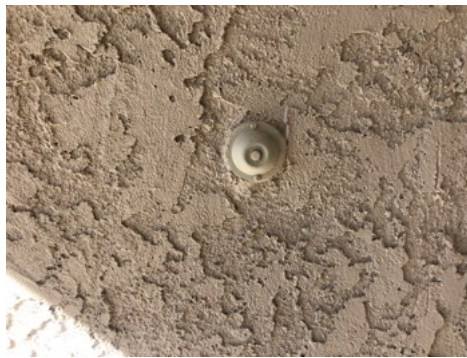
8.1. Door bell(s) functional at the time. (FYI)

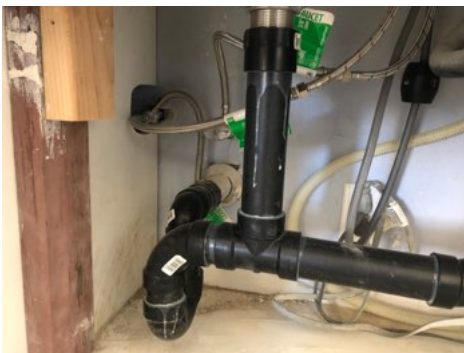
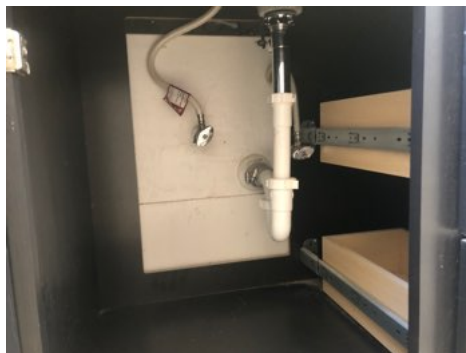
1.4. **Active galvanized water drain pipe(s) were noted servicing property - Type is considered to be at and/or near end of life, of limited remaining life. Recommend to upgrade, re-pipe. Have checked and evaluated by a qualified plumber.**

1.5. **Most of the Sewer, Waste pipes are located underground not fully visible/accessible and not part of this inspection. A sewer video inspection must be completed prior to close of escrow by a qualified plumber in order to determine the true condition of the Sewer, Waste line.**

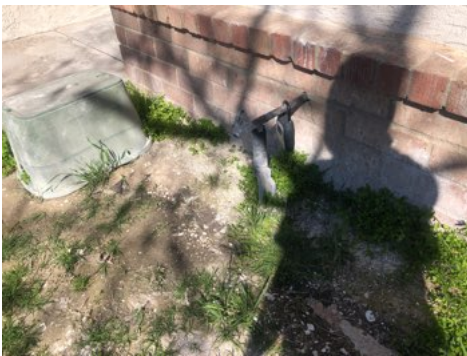
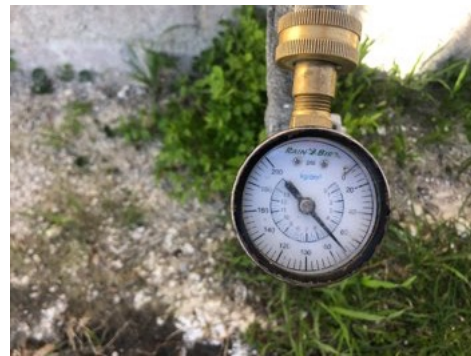
70 psi

**2.2. Hose Bibs: Missing anti-siphon valve at hose bibs (A anti-siphon valve is a device that prevents liquid from returning to the line from which it came if a siphon action occurs). Recommend to have checked and installed by a qualified specialist.**

**2.3. Missing pressure relief valve at Main water line noted. Recommend to install.**

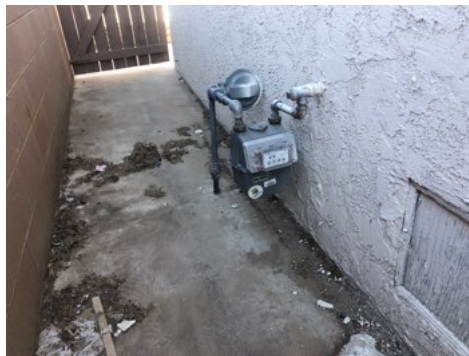
4.2. Gas meter - Seismic shut off was not present at the time of inspection, recommend to install - May not be required in the City of Location - Recommend to check the local regulations.

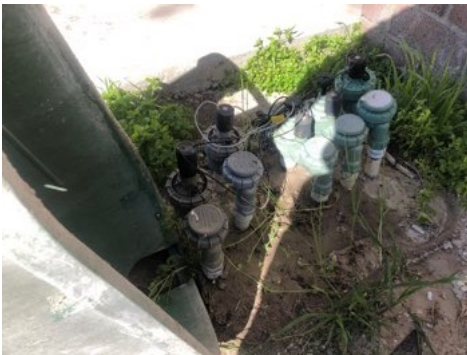
6.2. Sprinklers are set too close to the building/structure. Recommend moving minimum 2' away from structure - Recommended to keep water/vegetation away from structure/foundation. Have checked by qualified specialist for any necessary correction.

6.3. Water ponding near valves at rear. Have checked, any necessary repairs made by qualified specialist.

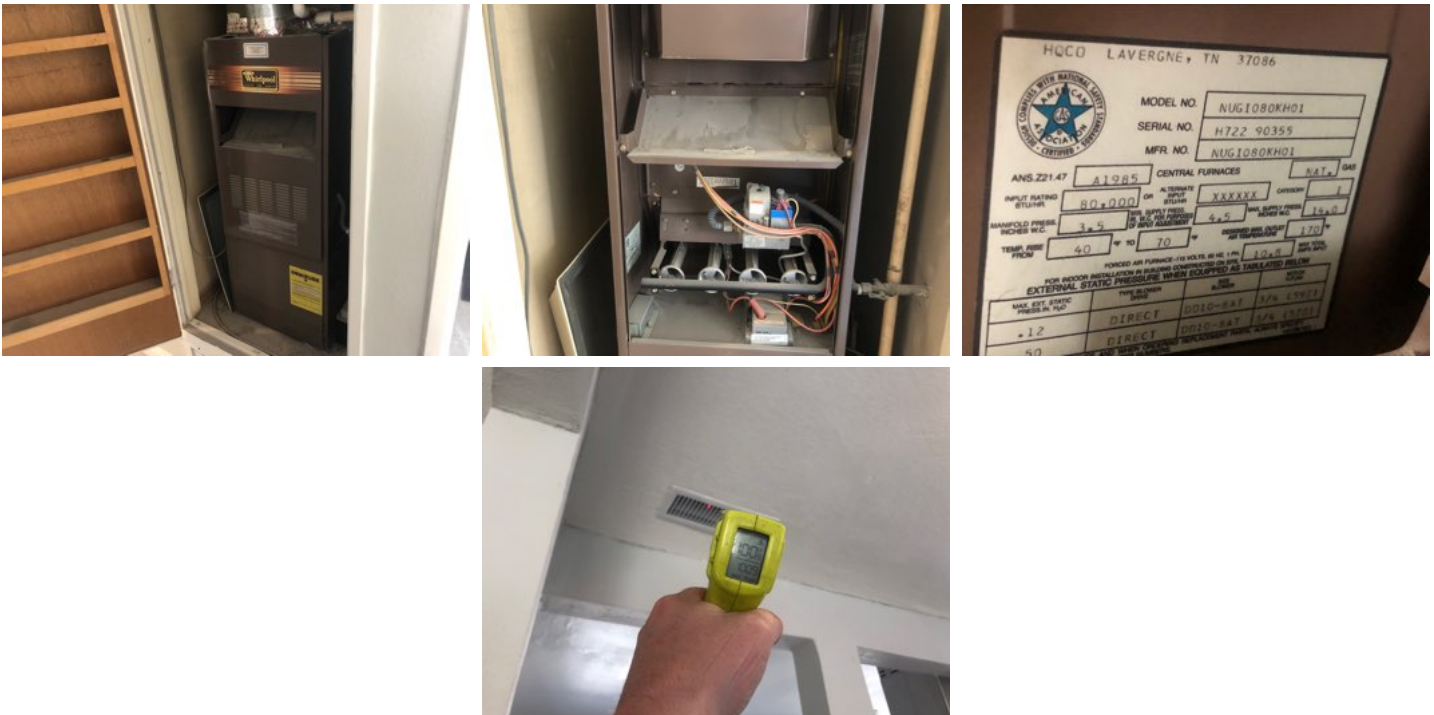
1.2. Recommend to check the service history with the Seller and to have the unit(s) serviced by a qualified HVAC Contractor if not performed in the past year. Air flow is not a part of this inspection. Recommend to check the disclosures regarding day to day functionality. No service tags noted. This is a limited Visual Inspection - Recommend to have the unit(s) evaluated by a qualified HVAC Contractor. Annual service, evaluation and maintenance is recommended with gas fired furnaces.

1.3. Typical Lifespan of heat unit(s) are 15 to 20 years. Recommend to have a qualified HVAC specialist to inspect and/or evaluate the entire system to have a better understanding and expected life span of the HVAC system.

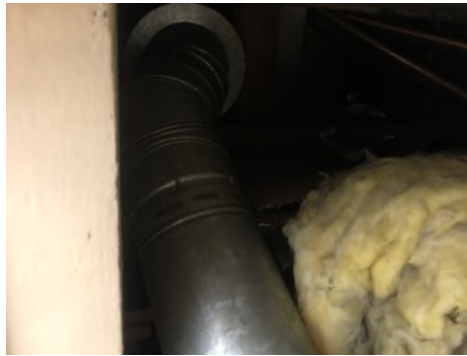
2.1. Vent pipe is not fully visible at this inspection to comment. Check the records for any known defects, repairs.

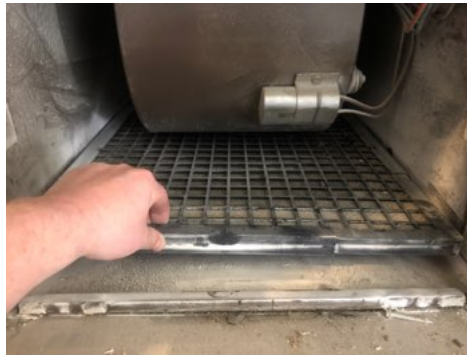
- 4.1. Air filters should be changed or cleaned regularly according to Manufacturer's instructions (seasonally and/or every 3-4 months recommended). Air flow, balance is not a part of this inspection. Recommend to check with the seller about air comfort and distribution.
- 4.2. The Filter(s) are dirty and in need of replacement. Have checked, service/maintenance performed by qualified HVAC specialist.
- 4.3. Air filter is not properly installed, lacks filter hold down in unit, recommend to correct - Unit is not properly filtering return air. I do not know how long unit in present condition - Recommend to have coils to be checked, cleaned and serviced if necessary by HVAC specialist.

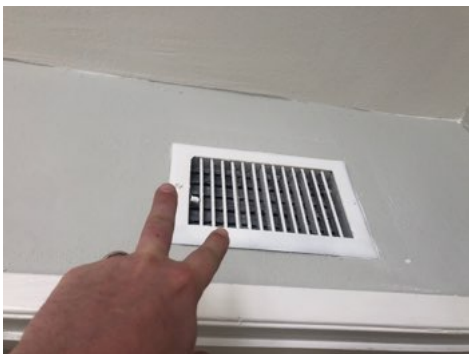
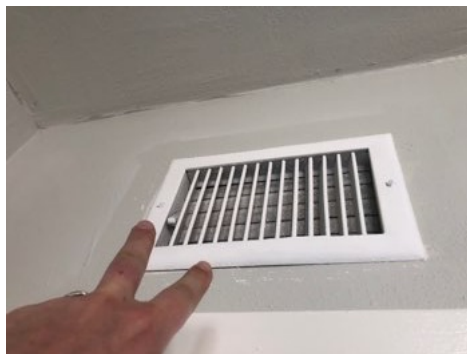
**5.7. Old ducting system noted, recommend to upgrade. Have checked, necessary corrections made by qualified HVAC contractor.**

**5.8. Leak noted at swamp cooler vent/roof. Have fixed by qualified specialist.**

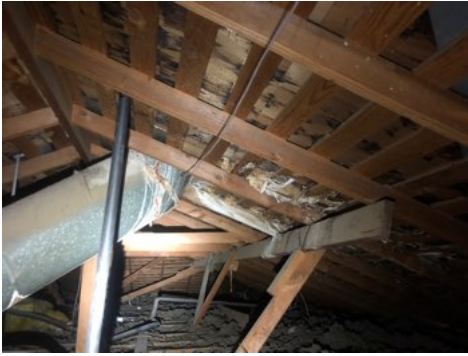
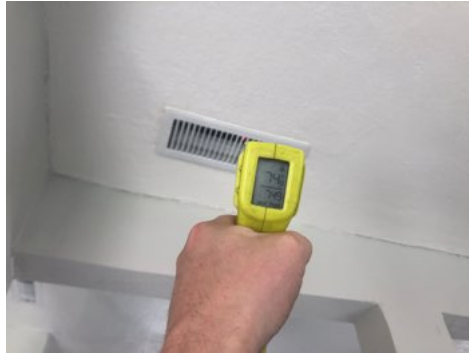
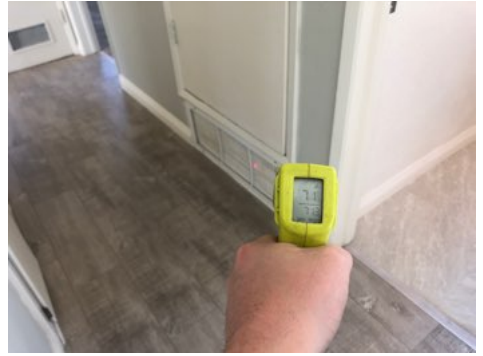
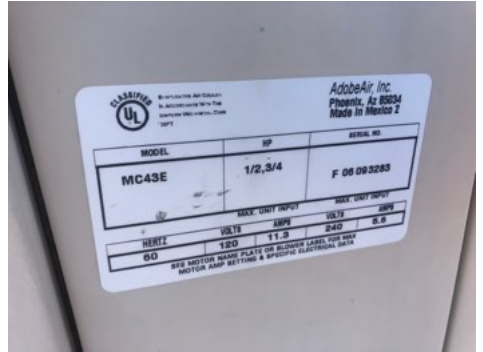
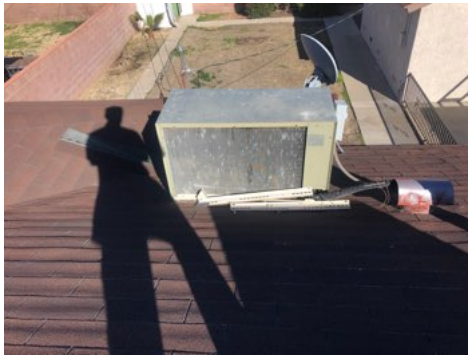
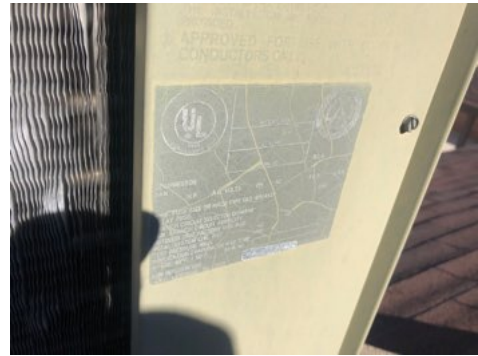
**7.6. Old Evaporative Coil (Swamp cooler noted, not tested at this inspection, signs of leaking at swamp cooler duct at attic/roof. Recommend further evaluation, necessary corrections made by a qualified HVAC specialist.**

**7.7. Recommend complete System evaluation, any necessary corrections, repair/replacement made by a qualified HVAC Contractor.**

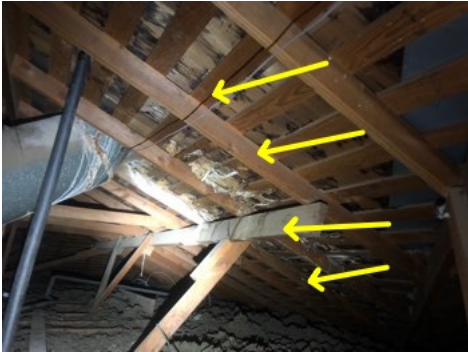
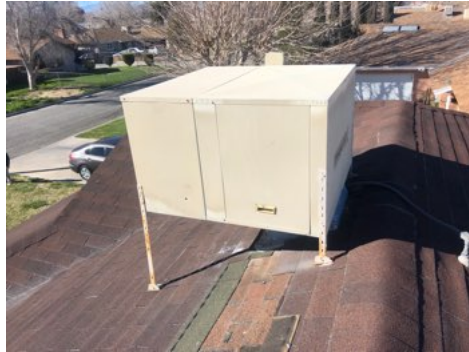
**7.3. AC unit is using R - 22 refrigerant. After 2020 contractors may not be able to purchase R - 22 refrigerant for servicing this type AC units. Recommend to consult with a qualified HVAC contractor for possible upgrade/replacement of the HVAC system.**

**7.4. AC Unit did not operate at the time of the inspection. Recommend to have it checked, necessary corrections made by a qualified specialist (HVAC contractor).**

**7.5. Compressor(s) outside (AC unit) old and may last a few years more, but maybe not-limited life expectancy. Possible unit(s) could fail after a home inspection during seasonal change from mild to hot weather. I cannot determine how long your AC will last before a replacement is necessary and life expectancy is not determined at this inspection. Check service records or have tested by a qualified HVAC specialist, Contractor.**

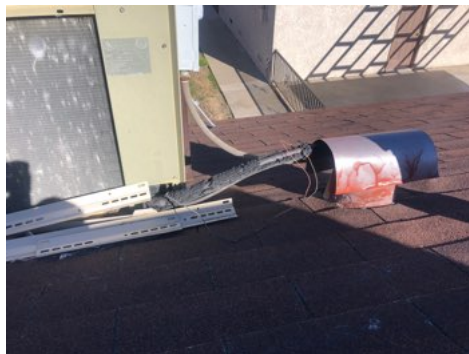
8.1. Damaged insulation at refrigerant line at exterior noted at AC unit. Recommend to upgrade, correct. Have checked by a qualified HVAC specialist.

8.2. Exposed refrigerant line noted- Subject to damage. Recommend to install proper insulation, protection/cover.

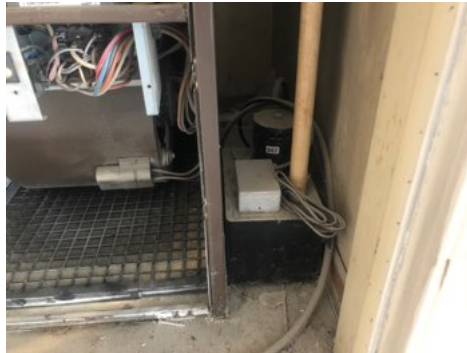
10.1. AC condensation pump noted in use- Pump and drainage not tested at this inspection. Check the service records, periodic care and maintenance required.

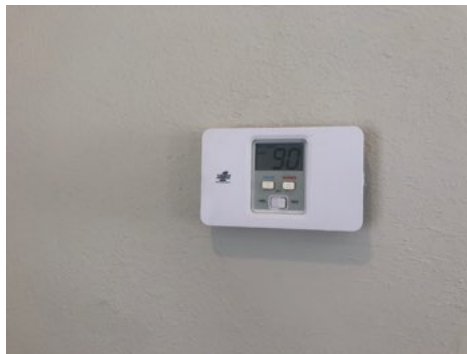
11.1. Thermostat(s) operational at the time of inspection. (FYI)

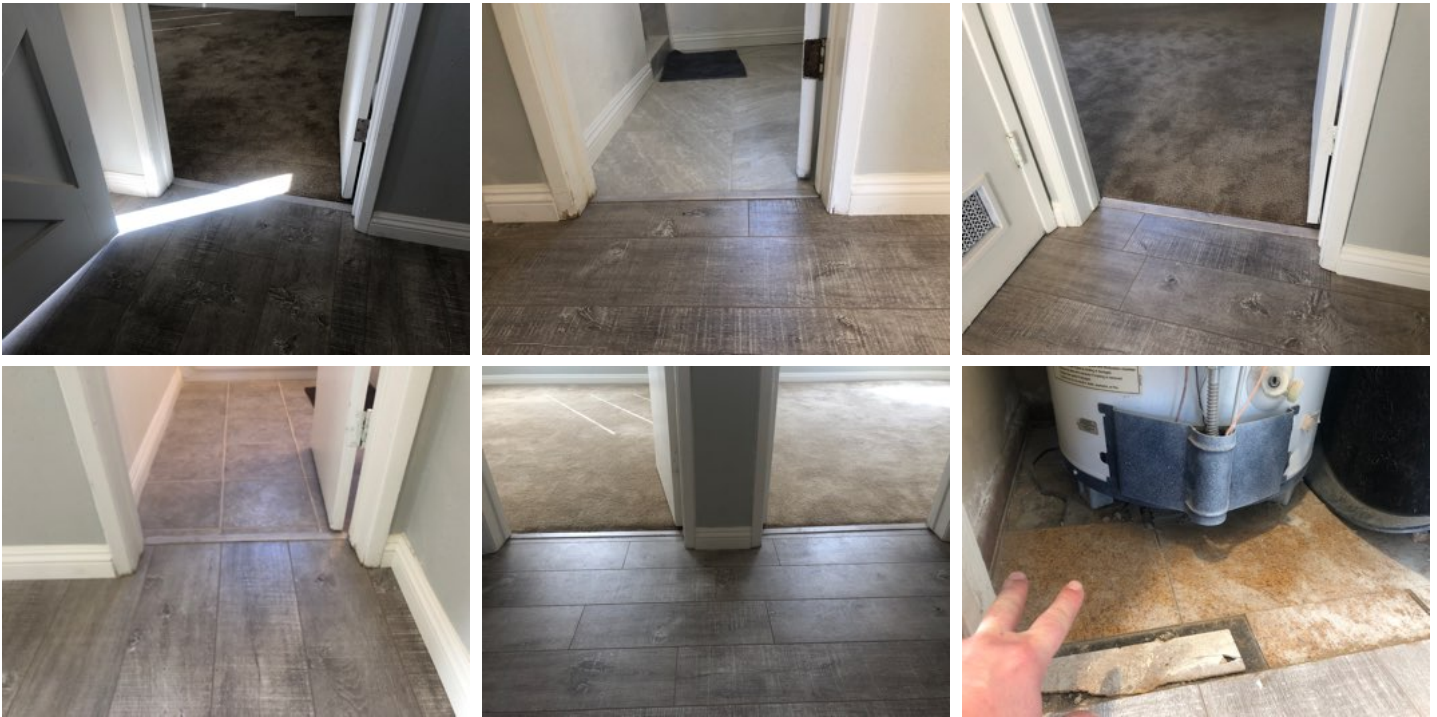
**3.1. Trip hazards noted due to differing flooring material heights. FYI**

**3.2. Old 9" square vinyl floor tile(s) noted- May contain asbestos- Noted at water heater closet. Have it checked by a qualified specialist.**

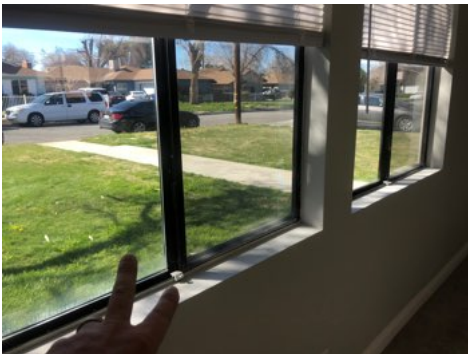
**5.2. Worn window roller(s) noted - Have it checked, necessary corrections made by a qualified specialist.**

Won't open- kitchen

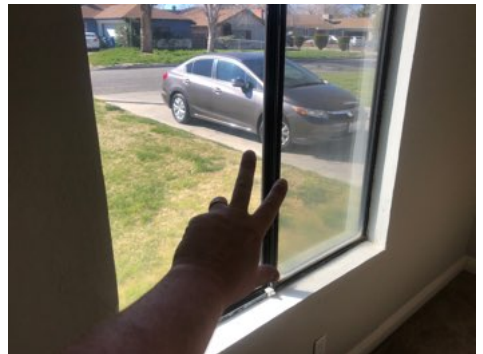
Missing lock- bedroom

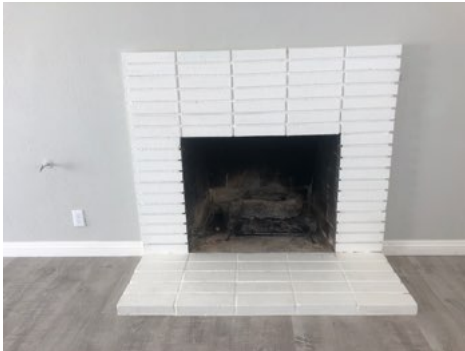
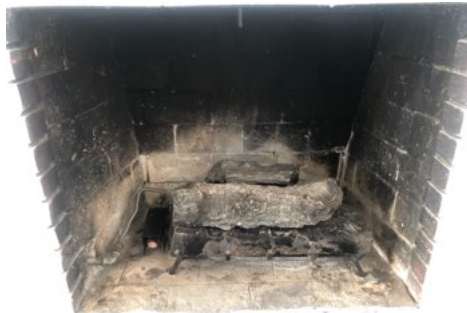
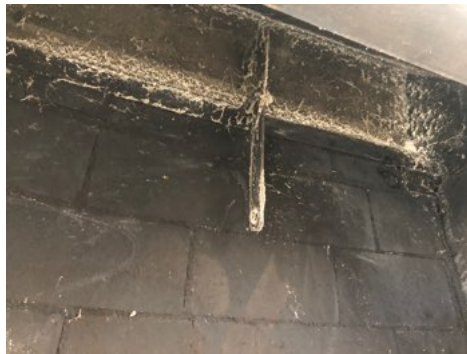
**6.2. Missing high heat caulk at the gas pipe penetration point. Recommend to have it sealed - Fire hazard, Safety concern. Have checked by qualified chimney specialist.**

**6.3. There is no damper clamp/stop to keep damper in open position. This is an important safety feature that prevents harmful gases from being discharged into the living space - recommend to install Damper Clamp. Have checked by chimney specialist for necessary correction.**

**6.6. Gas valve was noted inside the firebox. Recommend to relocate, upgrade for safety. Have checked by a qualified chimney specialist.**

**6.7. Gas yellow flex pipe was noted inside the firebox - Recommend to upgrade to rigid type pipe for safety.**

**6.8. Missing door and/or screen at fireplace. Recommend to correct by qualified specialist.**

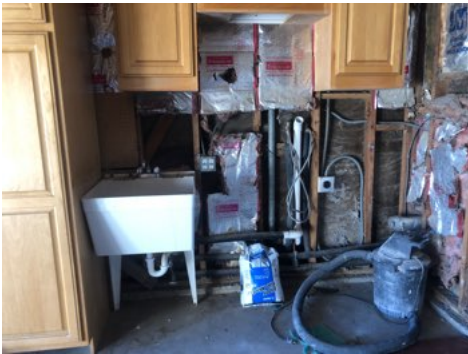
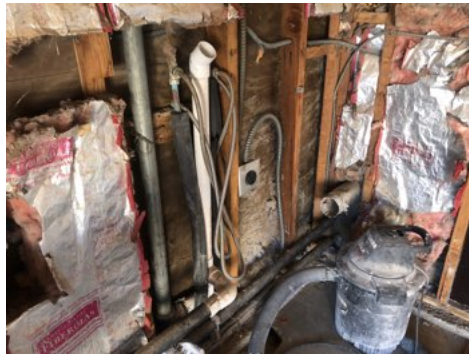
7.2. 20 GFCI Amp outlet is recommended at laundry as a safety upgrade. Have checked by a qualified specialist for correction.

7.3. Laundry area located in the garage. Laundry area was not elevated minimum 18" from garage floor- missing platform. This is a fire safety concern. Have it checked, fixed by a qualified specialist.

7.4. Poor slope/taping Noted at drain pipe at garage/laundry sink- improper. Have checked, fixed by qualified specialist.

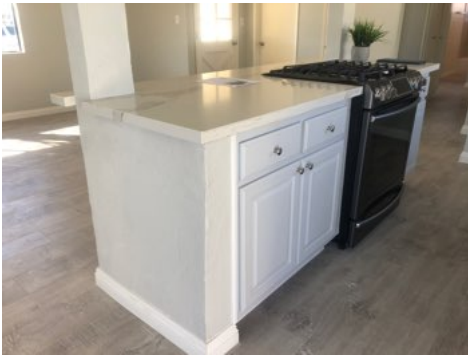
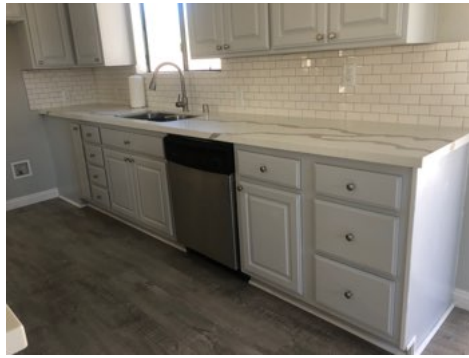
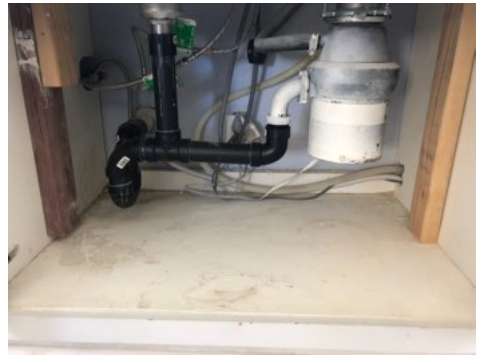
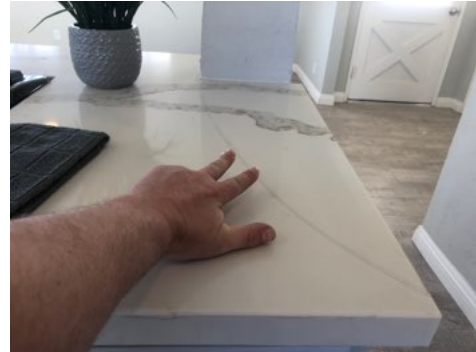
2.3. Cracked and/or damaged counter top noted. Have it checked, repaired by qualified specialist.

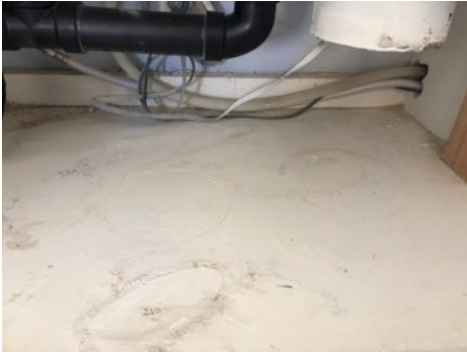
2.1. Wear and general age defects were noted to counter, cabinets at the time of inspection.

2.2. Old water stains noted under sink cabinet. Have it checked by a qualified structural pest specialist.

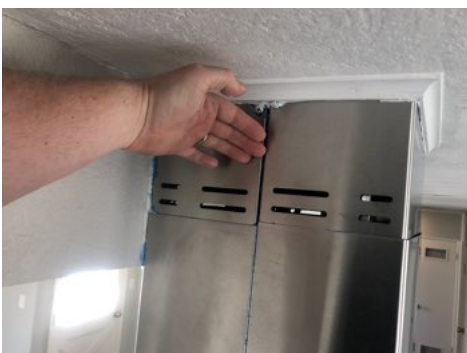
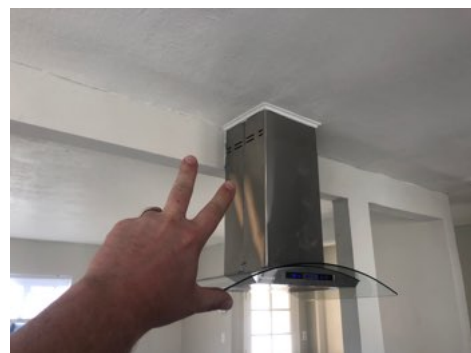
7.2. **Missing vent to exterior at exhaust fan noted- improper. Recommend to install and correct by qualified specialist.**

7.3. **Loose screen cover. Have fixed**

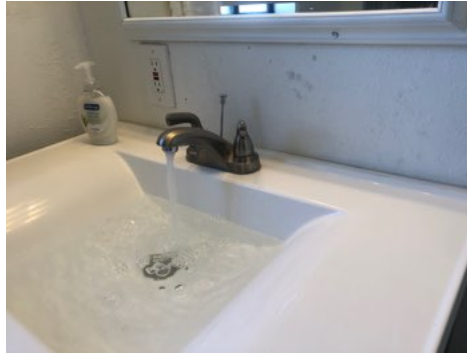
2.1. Missing proper backsplash at sink noted. Recommend to install to prevent water damage.

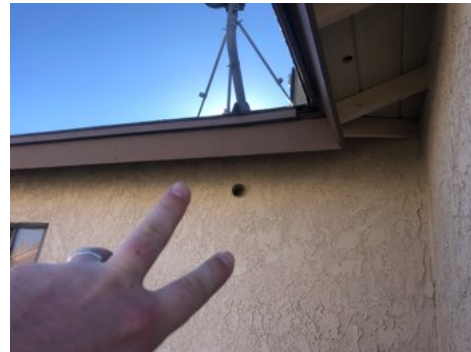
5.1. Noisy exhaust fan noted - Recommend to upgrade.

5.2. Missing exterior cover at exhaust vent. Recommend to install.

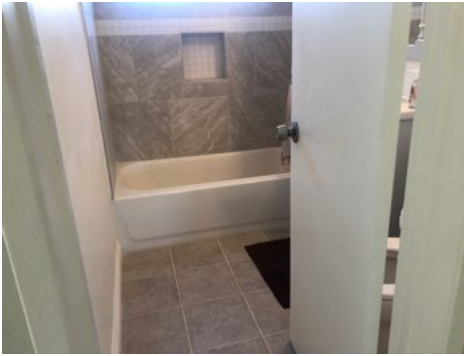
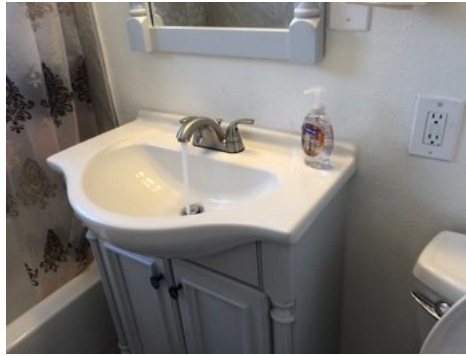
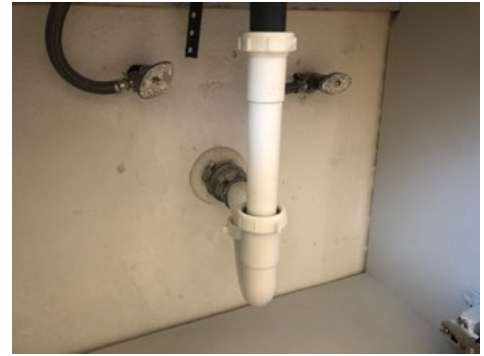
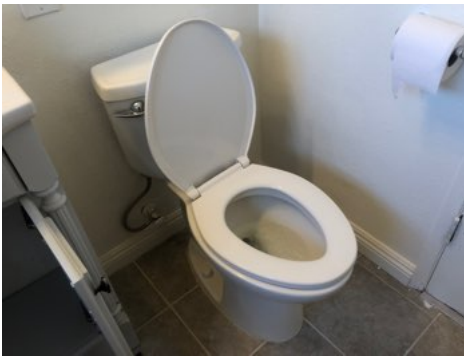
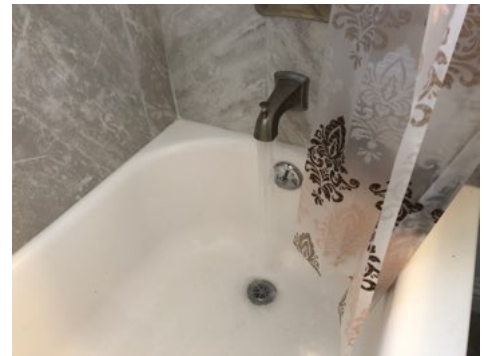
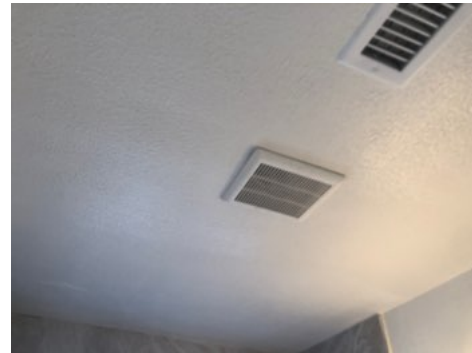
- Toilet, Sink(s), Tub
- Exhaust Fan

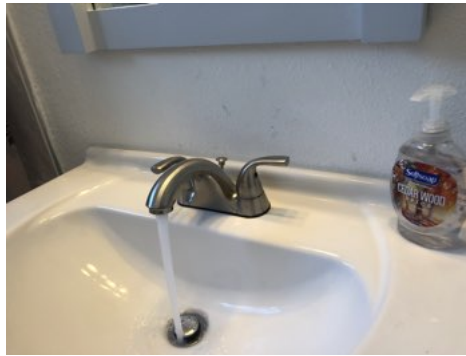
### 2. Sink(s), Faucets

- 2.1. Missing proper backsplash at sink noted. Recommend to install to prevent water damage.

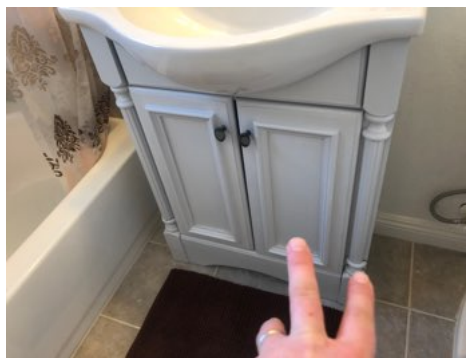
### 3. Cabinets, Floors

3.1. Right side door needs adjustment. Have checked
