## Property Inspection Report

43802 Kirkland Ave, Lancaster, CA 93535  
Inspection prepared for: Maria Rodriguez  
Real Estate Agent: Francisco Lopez - Titan Realty & Investments

Date of Inspection: 3/16/2019 Time: 3:30 PM  
Age of Home: 1957 Size: 1225 sq. Feet  
Weather: Clear  
Order ID: 9204

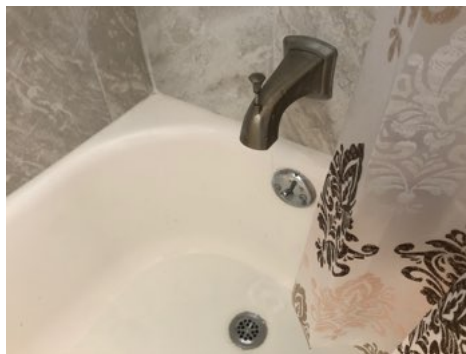
### 4. Bathtub

4.1. Leaking at downspout noted at shower mode due to defective diverter. Have it checked, repaired, replaced.

4.2. Window was set too low at tub/shower head. Recommend to install curtain to prevent water seepage, damage.

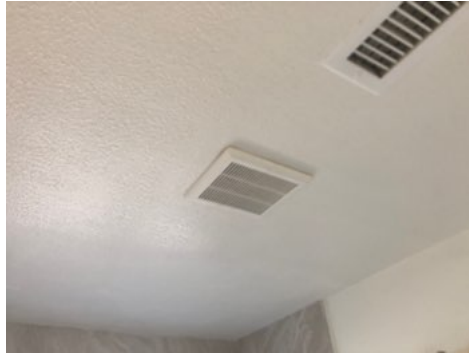
6.1. Noisy exhaust fan noted - Recommend to upgrade.

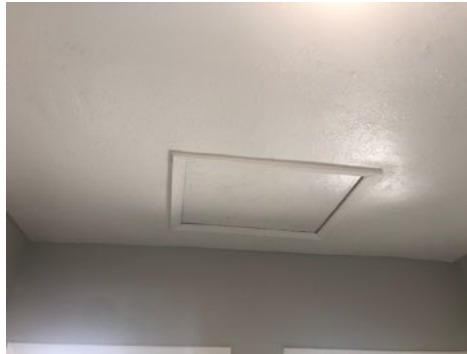
- 1.1. Attic access was located at hallway.

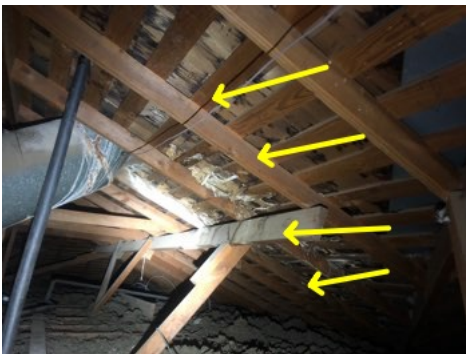
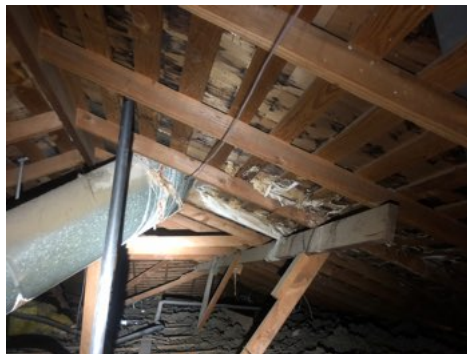
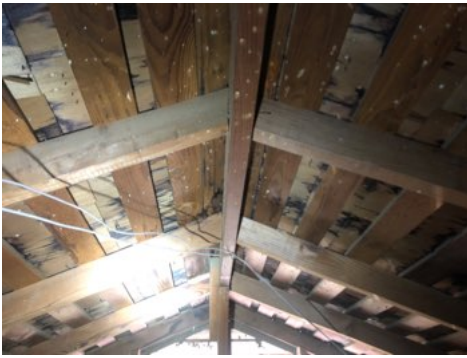
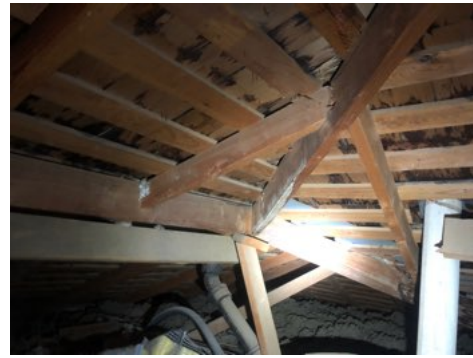
### 2. Roof Structure and Attic

**2.1. Ceiling joists were not fully visible to comment due to insulation. Check the records for any known defects, repairs.**

**2.2. Water staining was noted to the structure at the time of inspection. Unable to determine if leak is present and or been fixed. Check with the seller for any known roof leaks/repairs and have it checked by a qualified roofer to make sure roof is free of leaks.**

**2.3. Belongings/ Debris noted in the attic. Removal recommended.**

**2.4. Moisture stains/damage, signs of roof leak noted. Have checked, necessary repairs made by qualified structural pest specialist and qualified roofer**

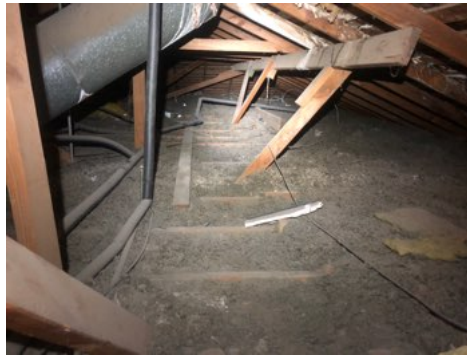
### 3. Insulation

**3.1. Inadequate insulation, poor coverage of insulation was noted - Correction recommended.**

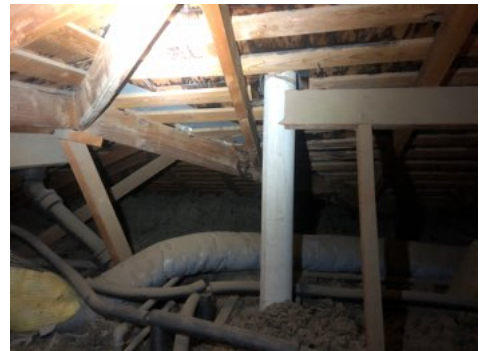
**4.3. Signs of leaking at swamp cooler vent. Have checked, necessary corrections made by qualified specialist/contractor.**

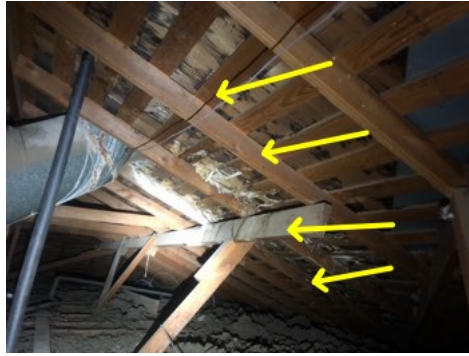
### 4. Venting

**4.2. Transite pipe noted in the Attic (Transite pipe is an asbestos-cement product which was used for both Water heater, HVAC ducts and for chimney or flue material to vent gas-fired appliances). Recommend to remove. Have it checked by a qualified specialist.**
