# Key Property Inspection Group

## Property Inspection Report

851 N San Vicente Blvd, West Hollywood, CA 90069  
Inspection prepared for:  
Real Estate Agent: Dan Stueve - Keller Williams - Hollywood Hills

Date of Inspection: 6/8/2019 Time: 9:30 AM  
Age of Home: 2002 Size: 1135 sq. Feet  
Weather: Clear  
Order ID: 28

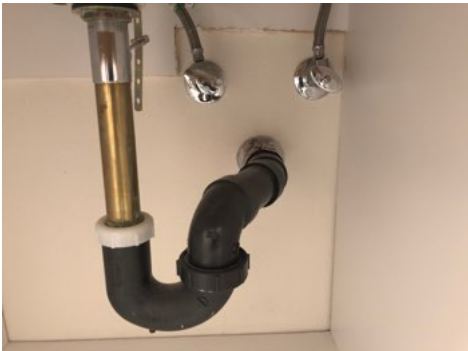
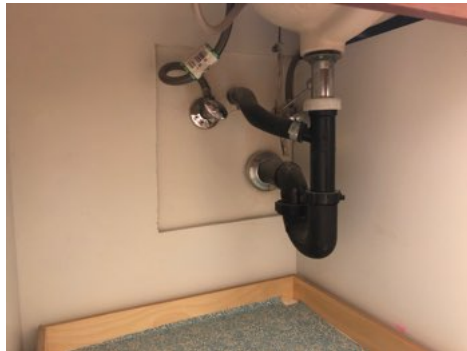
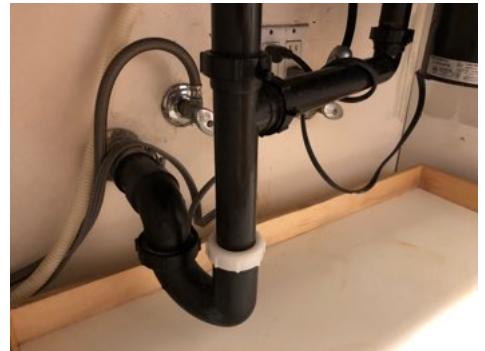
All the fixtures drained properly at the time(FYI).

- Slow draining sink at master- have checked, any necessary corrections made by qualified plumber.

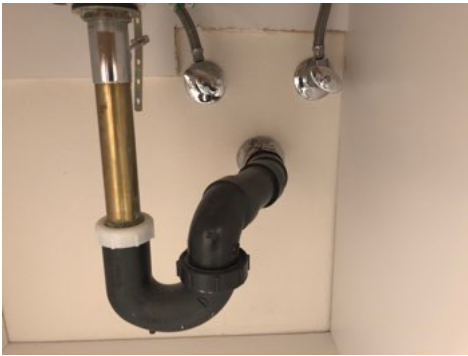
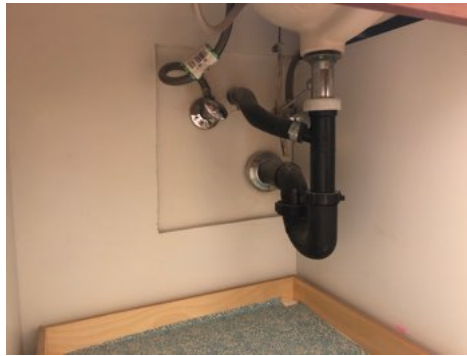
- All/most of the plumbing pipes not visible at this inspection, no leaks at visual part of the structure found at the time. Recommend to check the records for any known defects, repairs.
- As of January 1, 2017, The building standards, state law require that flow rates for fixtures in the home not exceed 1.6 gpf for toilets, 2.2 gpm for faucets and 2.5 gpm for shower heads. It is beyond the scope of this inspection to determine the flow rates of the plumbing fixtures in the home. Refer to seller and/or have it checked by a qualified retrofitter/specialist.

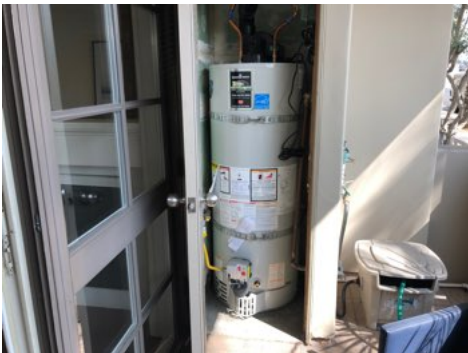
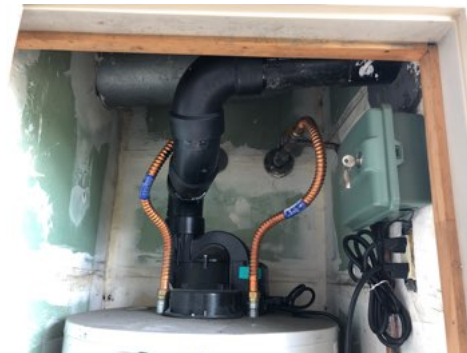
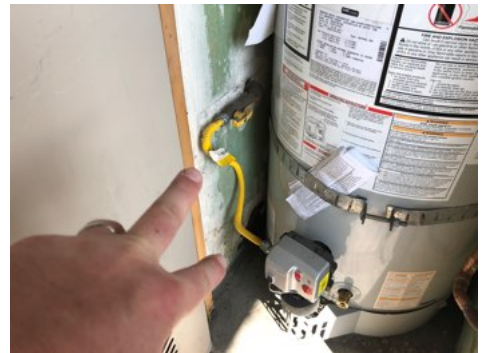
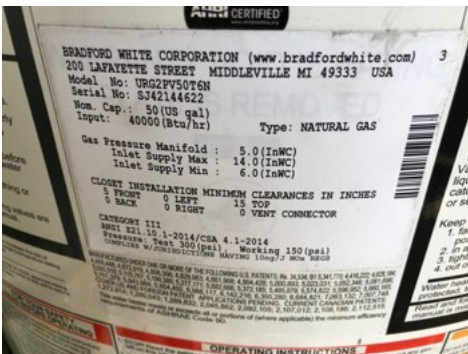
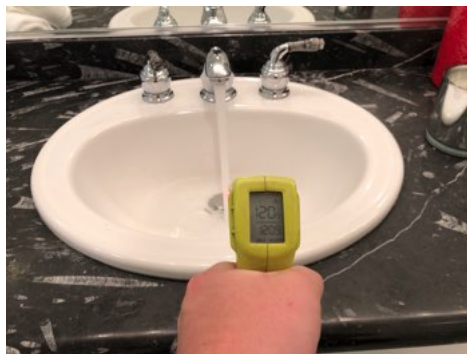
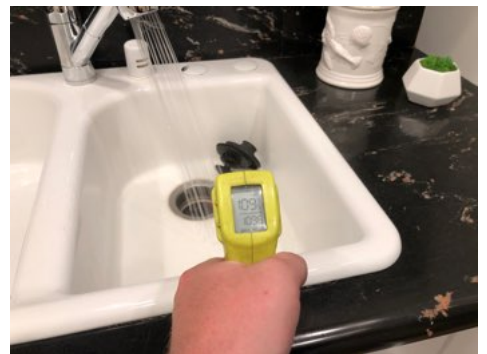
- Gas line at water heater without drip leg/sediment trap (this type installation is common for the area/age). Sediment traps serve as a collection area for sediment to reduce the chance of clogging gas valves and burners: dirt and scale can enter the gas valve and possible cause malfunctions and Lack of drip leg may void warranties. Have checked for necessary corrections/installation by qualified specialist - Check with your Home Warranty provider.

- Water heater is a newer installation - recommended to check the records, permits/warranties.
- Recommend water heater installation meet all current safety standards.

- Water heater lacks a catch pan with exterior routed line. Recommend to install.

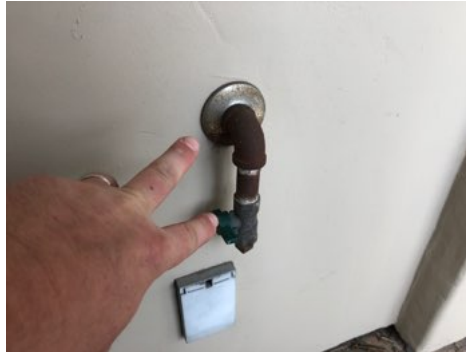
- This is a limited visual inspection of the gas system. We have partial access to burn chambers and other interior appliance parts only, and no way to inspect underground/interior wall pipes. The Gas Company has it's own testing methods, which are more intensive, and updated periodically. Recommend contacting the Gas Company for a complete inspection of the gas system and associated appliances before close of escrow.
- Exposed Gas Pipes are not sealed, painted at exterior to prevent rust/oxidation. Have it checked, sealed/painted by a qualified specialist.

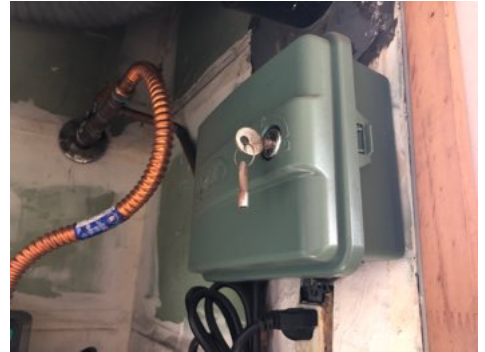
Sprinkler valve- drip system at patio

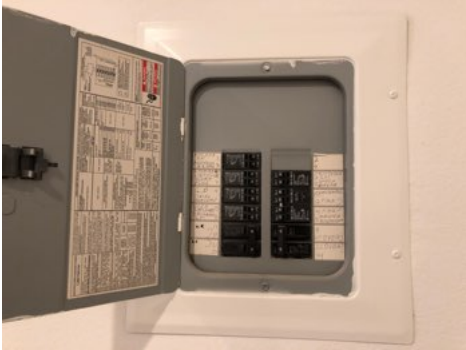
- No major defects found at sub panel and visual part of wiring at the time. (FYI)

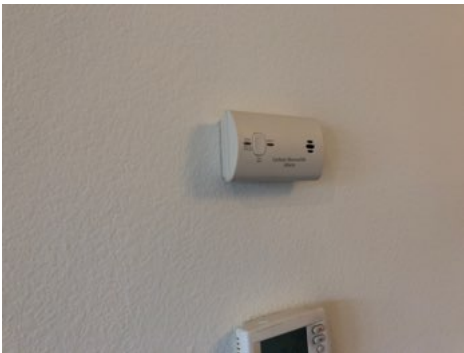
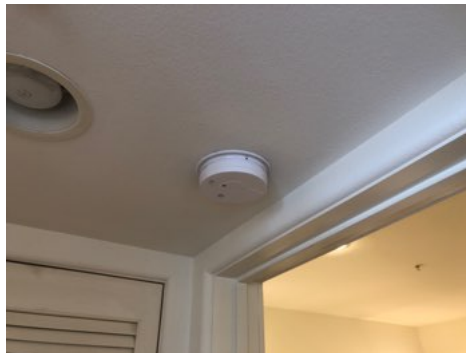
- Smoke detectors in bedrooms and hallway noted - Recommend to test them periodically.
- Carbon monoxide detector noted - Recommend to test it periodically.
- **Smoke and Carbon Monoxide detectors, fire alarms/systems not inspected. Beyond the scope of this inspection. Recommend to install smoke and carbon monoxide detectors per City/Manufacturers requirements and test them periodically. Recommend further evaluation by a qualified Retrofitter. THIS IS A HEALTH, SAFETY CONCERN.**

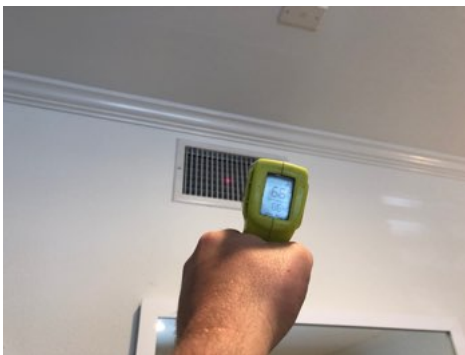
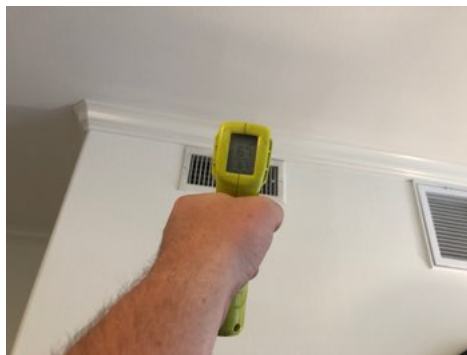
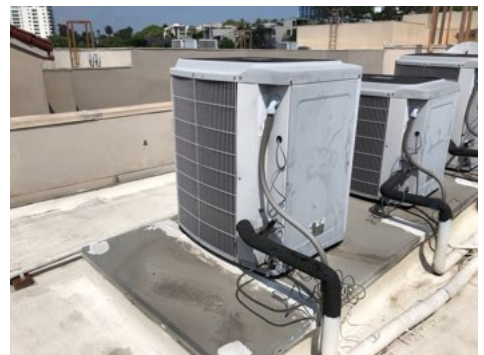
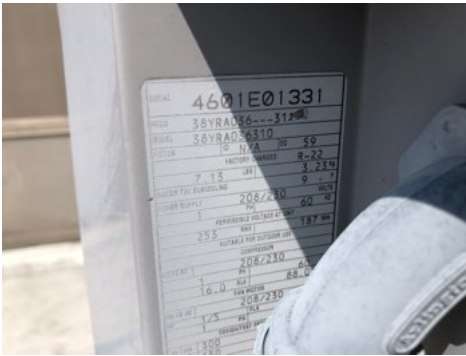
- Your AC unit is using R - 22 refrigerant. After 2020 contractors may not be able to purchase R - 22 refrigerant for servicing this type AC units. Recommend to consult with a qualified HVAC contractor for possible replacement of the HVAC system.

- Unit is not properly secured, strapped to platform/pad. Have it checked, fixed by a qualified specialist.
- Compressor outside (AC unit) is old, worn coils Noted and may last a few years more, but maybe not. I have seen units fail shortly after a home inspection during seasonal change from mild to hot weather. I cannot determine how long your AC will last before a replacement is necessary. Old unit - Limited life left. Have it checked, tested by a qualified HVAC Contractor.

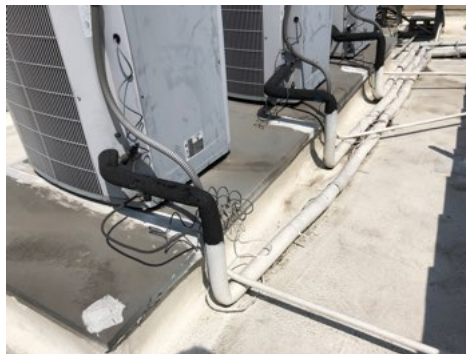
- Loose insulation at refrigerant line noted at AC unit. Recommend to correct.

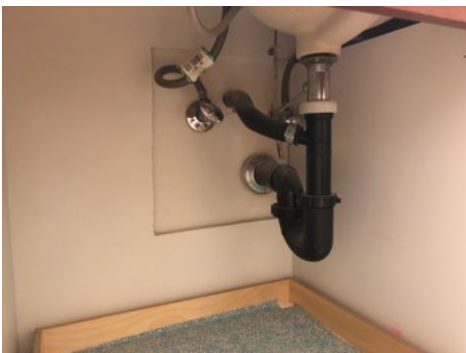
- **A/C** condensation line drains at bathroom sink (FYI). Periodic cleaning, service required.

Secondary- if ever leaking, call HVAC for repair/correction- means primary under sink is clogged

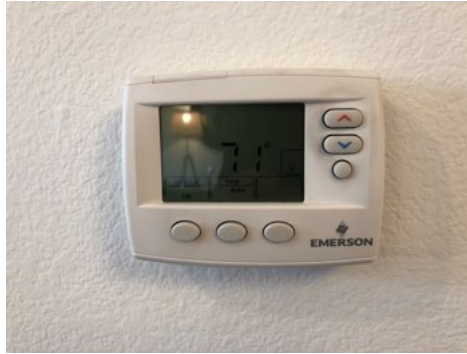
- Thermostat(s) was operational at the time of inspection. (FYI)

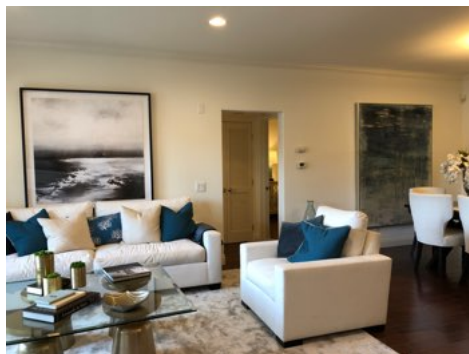
- No major defects noted- FYI
- **Common cracks and/or anchor holes were noted at the interior walls. Have checked by paint contractor.**
- **Unit was occupied at the time of the inspection, walls were not fully visible - Recommend to check the records for any known defects, repairs.**

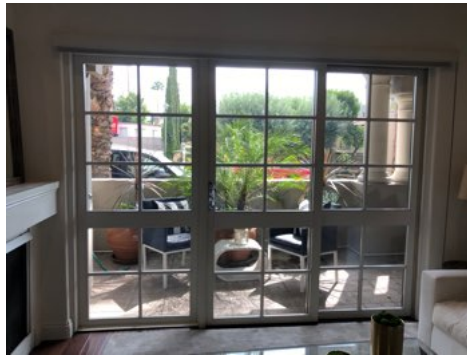
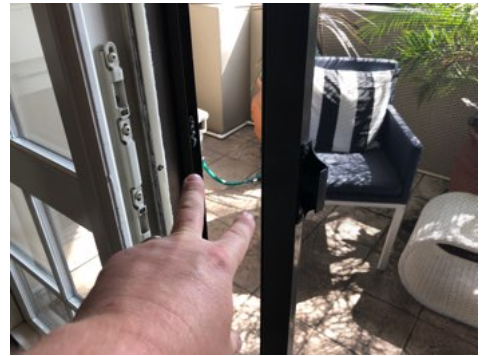
- **Recommend to install door stops to prevent wall damage.**
- **Screen door doesn't latch properly, worn rollers at slider at patio area- May require adjustment/correction by qualified specialist. Have checked.**

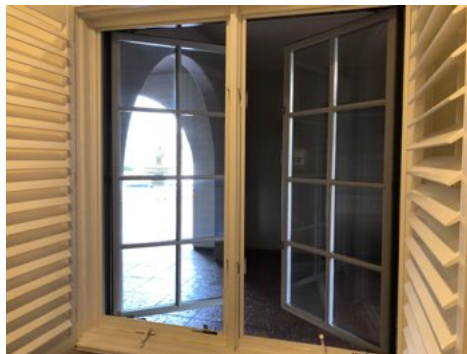
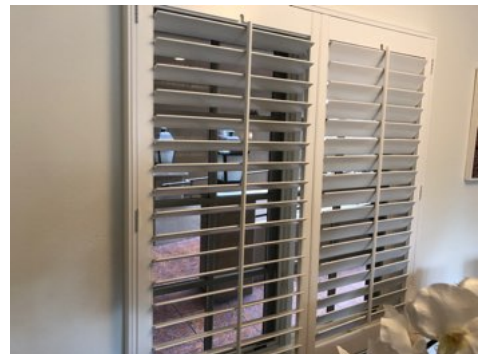
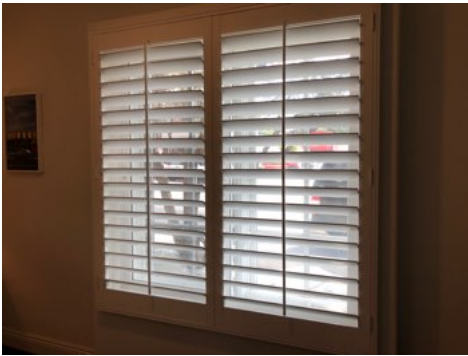
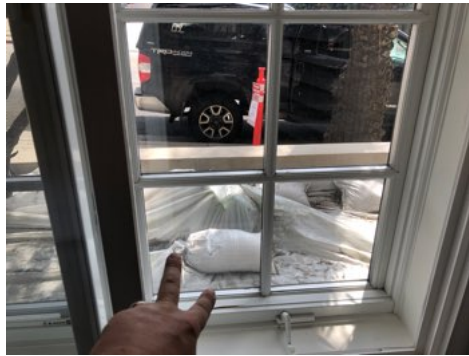
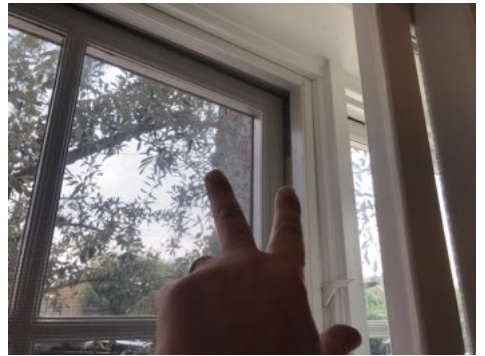
- Dual pane windows noted. It is not always possible to determine fogging of this type of window due to temperature changes, etc. Check with the seller for any know defects and/or repairs.
- Chipped/damaged wood trim at interior at master- have checked, any necessary correction/patchwork done by qualified specialist.
- Missing screen at master bedroom noted. Have checked, fixed by a qualified specialist.
- Window(s) won't open/close properly noted at- master bedroom. Have checked by qualified specialist(s) for necessary adjustment/correction.

Screen missing- master

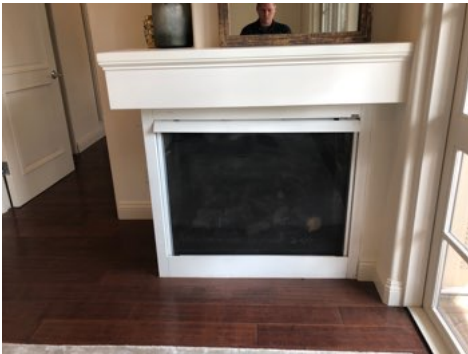
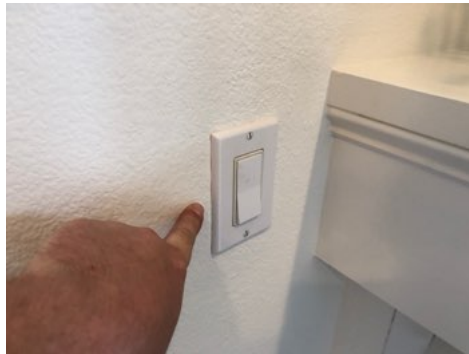
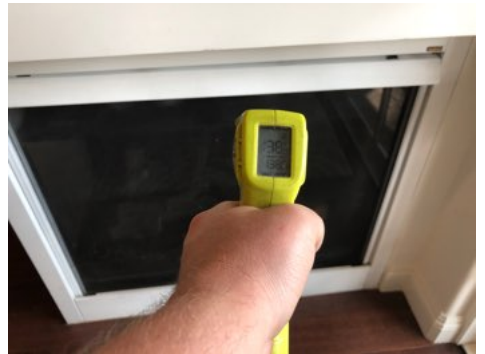
- Gas was operational at the time, Electric ignition controlled by switch at wall. Flue was not fully visible at this inspection.
- **We conduct a limited visual inspection of readily visible and accessible areas of the fireplace and chimney. A complete chimney inspection by a qualified Inspector is required in all cases. We recommend a further and complete evaluation by a qualified Chimney Inspector (this is a safety and fire concern). Video inspection of the flue by qualified Chimney Inspector is recommended.**
- **Recommend further and complete evaluation by qualified Chimney Inspector (This is a safety and fire concern).**

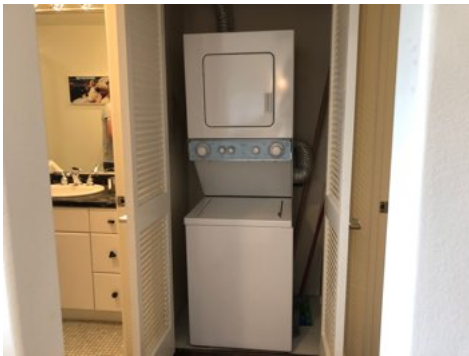
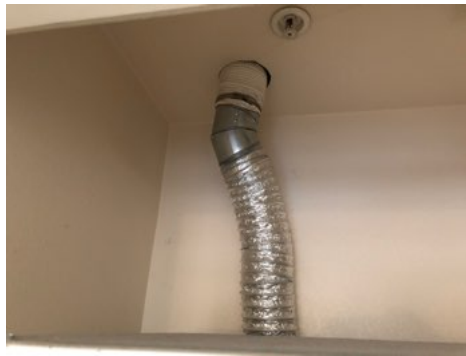
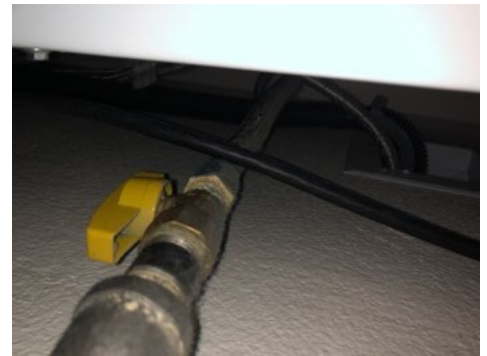
- Washing machine, laundry area without catch pan and/or drainage pipes. Recommend to install if possible to prevent damage when machines leak.
- Recommend to check the Contracts/warranties on laundry machines.
- Water supply pipes, drains not tested at this inspection. Check the records and or have it tested by a qualified plumber.
- Dirty exhaust fan noted at time of inspection. Recommend to have cleaned
- Some lint built up behind unit and/or at wall- recommend to clean.

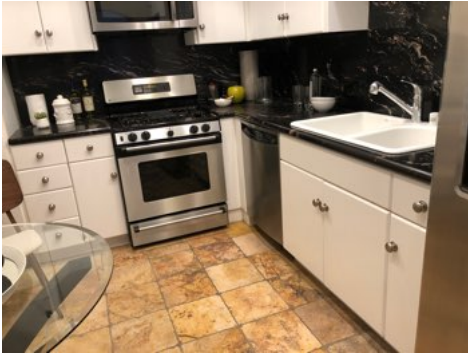
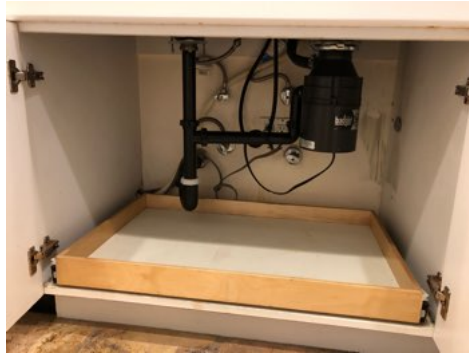
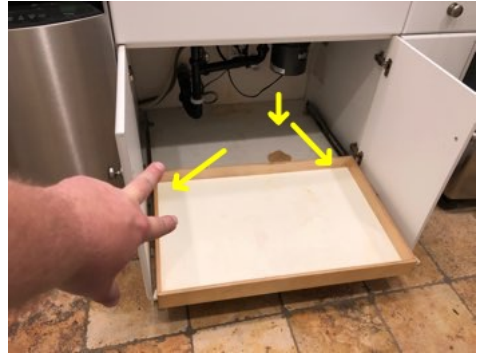
- Some cabinets, drawers are in need of adjustment, repair. pull out under sink defective/damage. Have fixed by qualified specialist.
- Moisture staining/minor damage noted to the interior of the sink cabinet. Have it checked, corrections made by a qualified structural pest inspector.
- Old water stains noted under sink cabinet. No active leak noted at the time.
- Wear and general age defects were noted to counter, cabinets at the time of inspection.

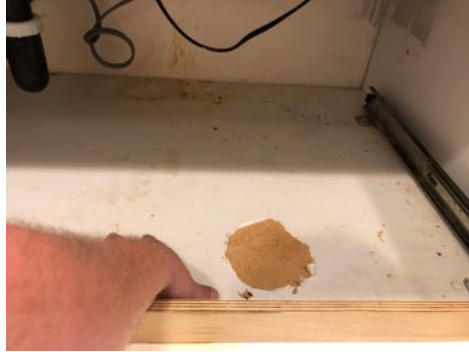
Needs repair

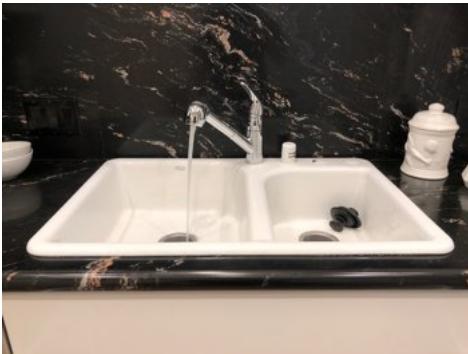
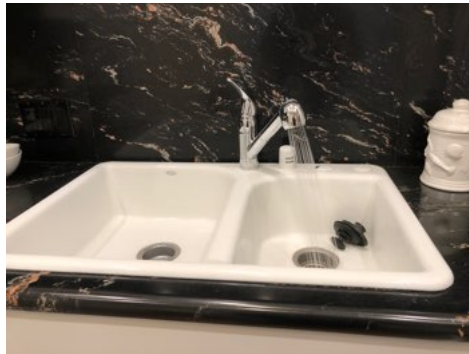
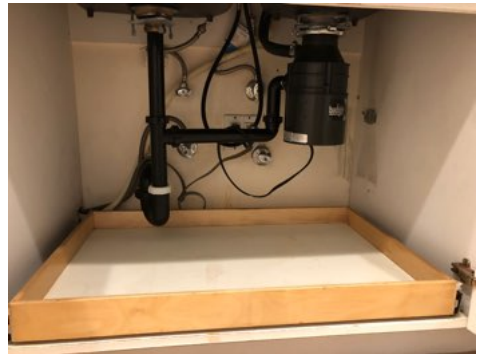
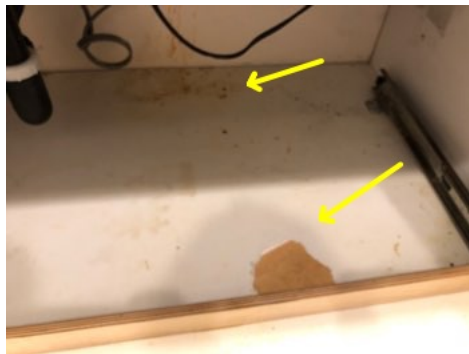
- Old water stains noted under sink cabinet. No active leak noted at the time. Have checked by structural pest specialist.
- Moisture staining/damage noted to the interior of the sink cabinet. Have it checked, necessary repairs made by a qualified structural pest inspector.

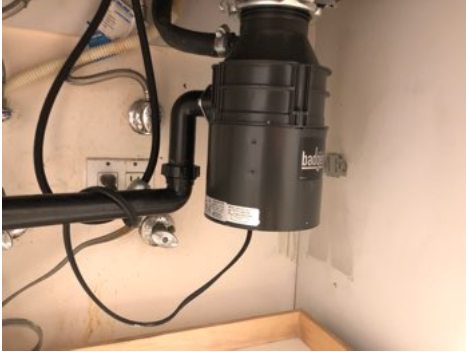
- Unit operated at the time. (FYI)
- **Missing and/or loose/damaged wire clamp noted. Have it checked, fixed by a qualified specialist.**

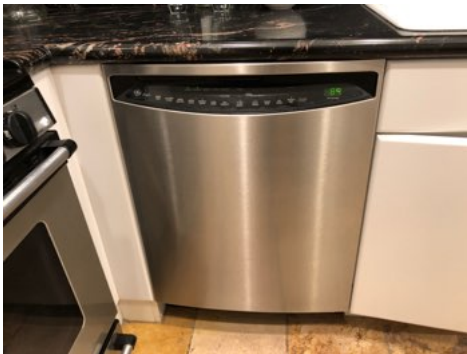
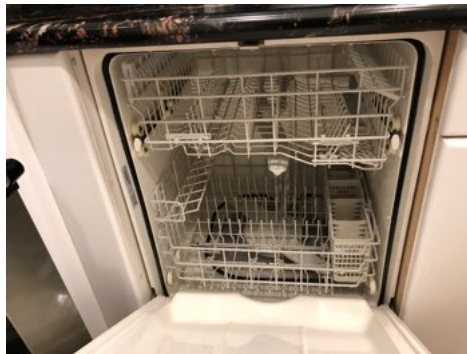
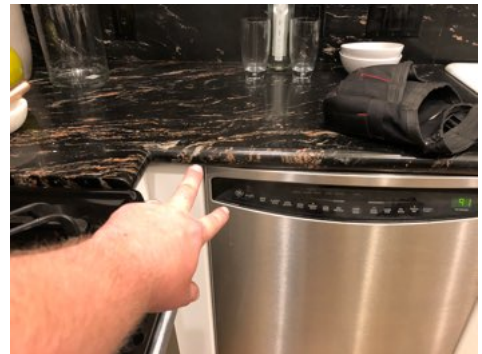
- Dishwasher operated at the time.
- **Steam leaves unit when draining- possible bad seal noted. Have checked by specialist for any necessary correction/repair.**

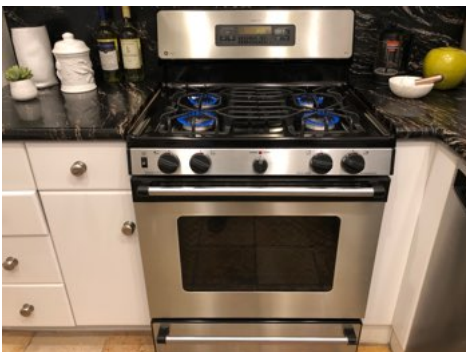
- Oven and stove top operational at the time.(FYI)
- **Missing Anti-Tip Device at the freestanding range. Recommend to add for safety concerns. Consult a licensed professional for proper installation.**

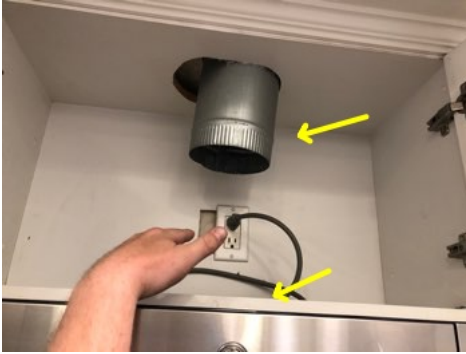
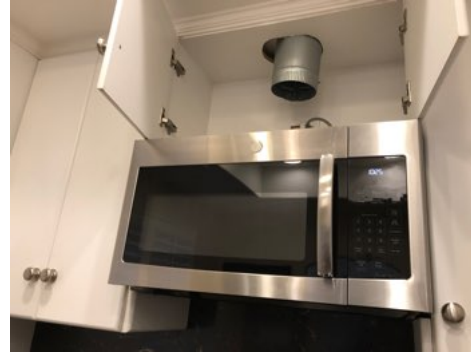
- Operational at the time. (FYI)
- **Recirculating type Hood is used at vented system. Recommend to upgrade/correct and have vented to exterior like kitchen was designed for. Have checked by qualified specialist.**

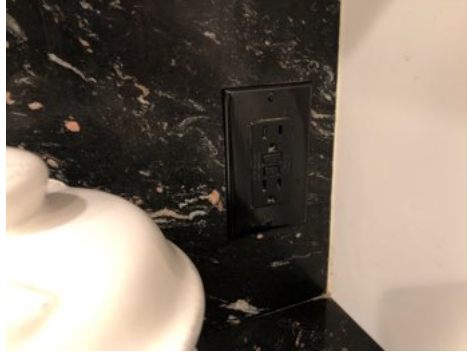
- **GFCI** type outlets at kitchen noted(FYI). Recommend to test them periodically.

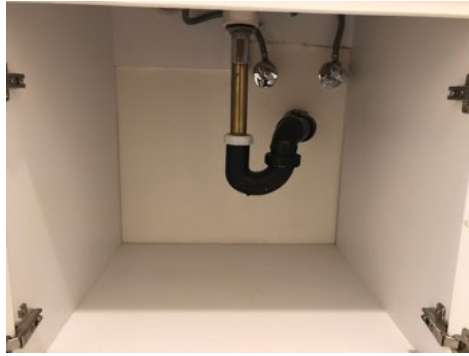
- Old supply valves/tubes(angle stops) noted- these type of valves are prone to leaks. Recommend to replace/upgrade by a qualified specialist, plumber.

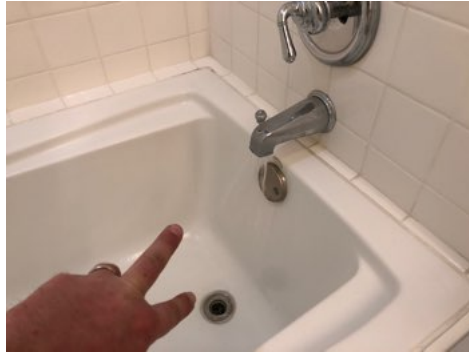
- **Missing tub stopper noted. Have it checked, fixed by a qualified specialist.**
- **Leaking at downspout noted at shower mode due to defective diverter. Have it checked, repaired/ replaced by a qualified specialist, plumber.**

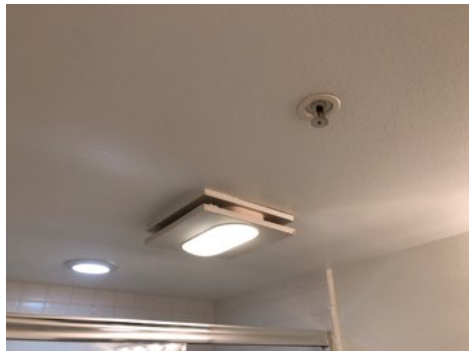
- **Dirty exhaust fan noted. Recommend to clean, service by a qualified specialist.**

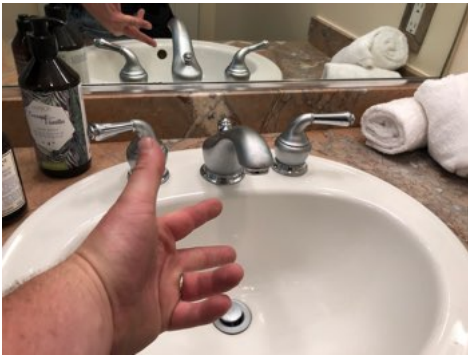
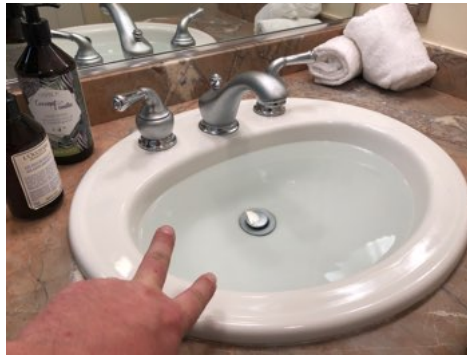
- Slow draining noted at sink. Have checked, fixed by qualified plumber.
- Old supply valves/tubes(angle stops) noted- these type of valves are prone to leaks. Recommend to replace/upgrade by a qualified specialist, plumber.

Leaks when off

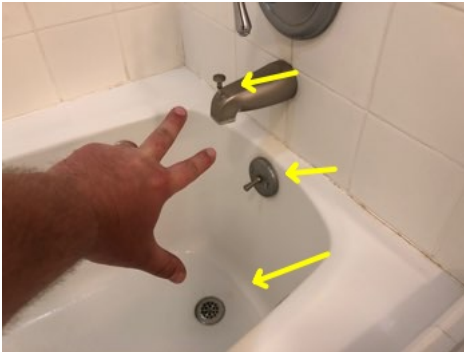
- Defective tub stopper noted. Have checked, fixed by qualified specialist.
- Defective/seized diverter valve noted, only shower mode works- In need of repair, replacement. Have checked, fixed by qualified specialist, plumber.
- Dirty and/or cracked caulking noted at shower enclosure. Recommend to re-caulk, seal at tub enclosure
- The flexible sealants (caulking) is missing and/or failing, gaps noted at the fixture valves along the base of the wall and should be sealed/caulked to prevent water seepage or damage.

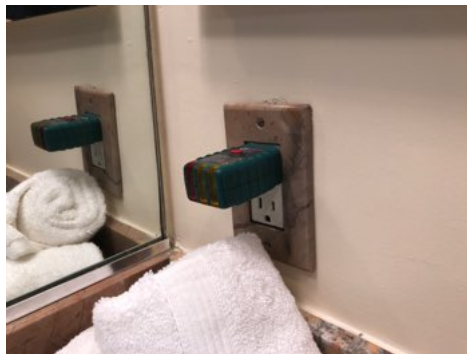
- Recommend to install GFCI type outlet at Bathroom(s) and test it periodically. This is a safety upgrade. Have checked, fixed by a qualified electrician. GFCI reset is currently at other bath- FYI

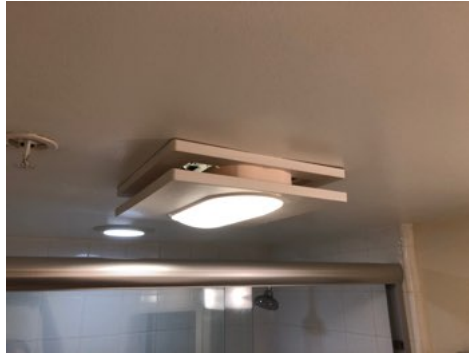
- Dirty exhaust fan noted. Recommend to clean, service by a qualified specialist.

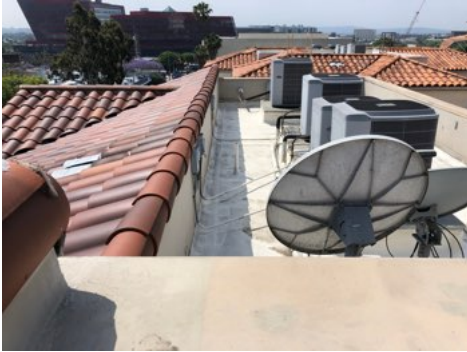
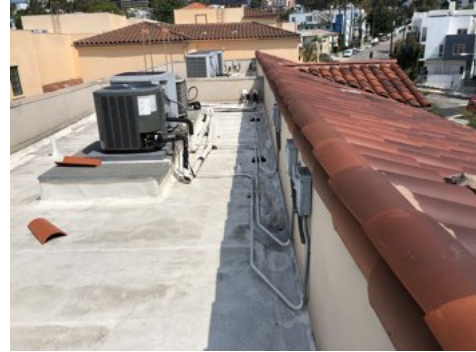
- Roofing Elements - Condominium and Cooperative unit inspections do not include evaluation of exterior and/or common elements. The appropriate Management personnel should be consulted regarding common element maintenance responsibilities, master deeds, or other pertinent pre-purchase information.
