Property Inspection Report

1082 La Grange Ave, Thousand Oaks, CA 91320
Inspection prepared for: Fidel and Maggie Rodriguez
Real Estate Agent: Alex Pineda - Keller Williams - Burbank

Date of Inspection: 11/6/2019 Time: 8:00 AM
Age of Home: 1966 Size: 1172 sq. Feet
Weather: Clear
Order ID: 61

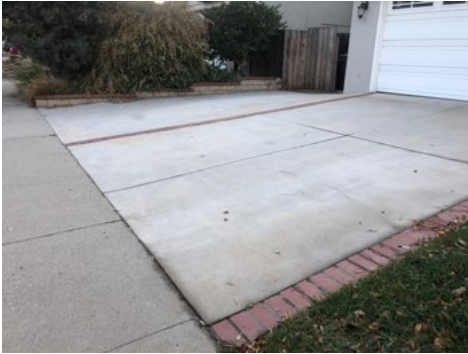
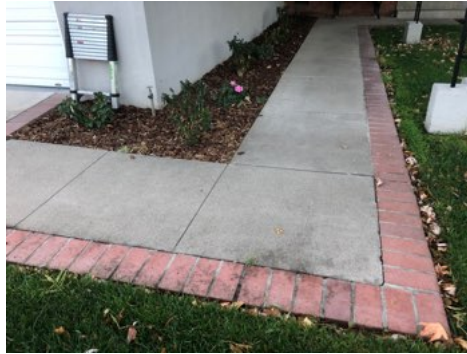
1.1. Common Cracks, some settlement present at driveway/sidewalk surfaces.

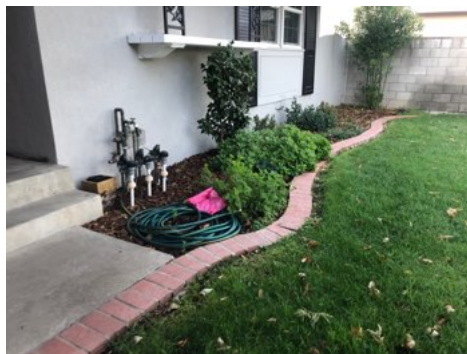
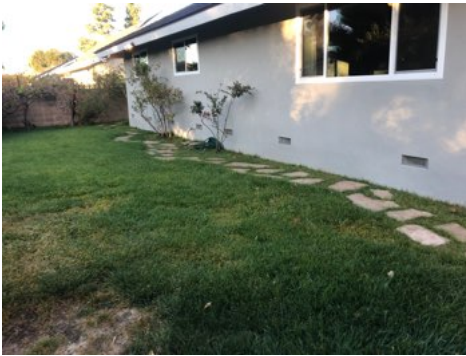
2.5. Planter(s) built at the foundation - not recommended. Recommend to remove to prevent water seepage into crawl space/foundation.

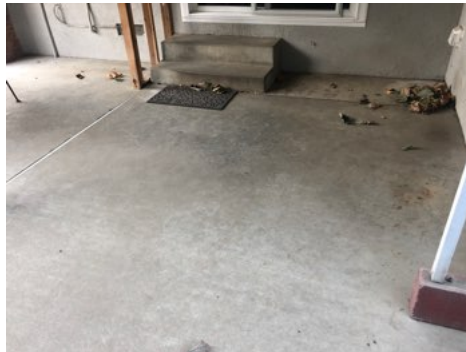
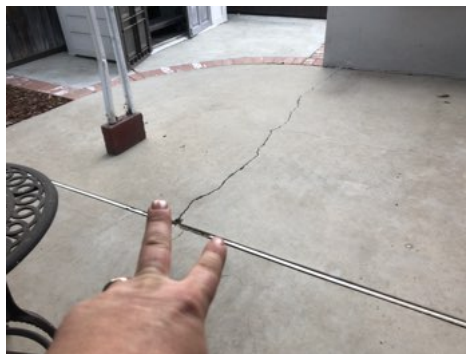
3.5. Metal covering shows cut out, bending/gaps noted at patio cover which may leak. Have checked, repairs/replacement performed by qualified specialist/contractor.

3.4. Recommend further evaluation, necessary corrections made by a qualified specialist, contractor at patio cover.

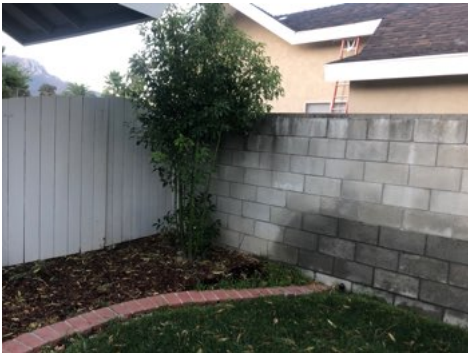
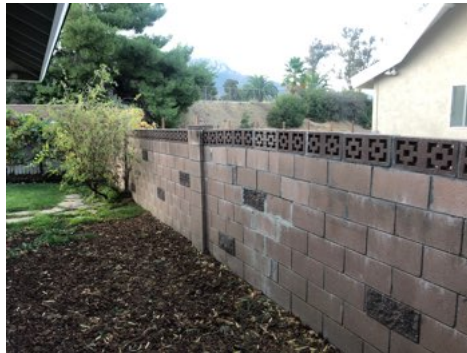
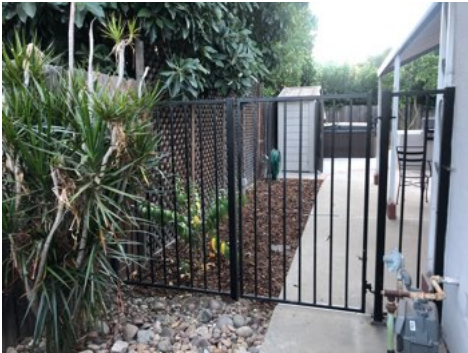
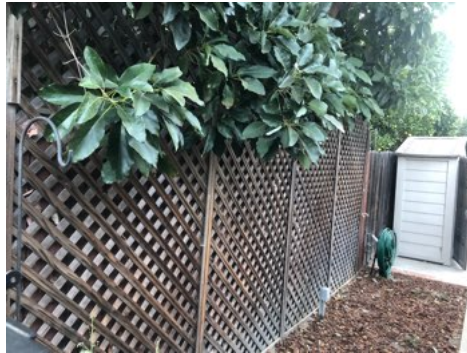
Loose/leaning

- 4.1. Common age defects noted to fencing. Recommend to monitor the condition.
- 4.2. Fencing in need of repairs at some areas. Have it checked by a qualified contractor
- 4.3. Cracks were noted, some movement noted to the masonry fencing, prior patchwork at some areas, missing mortar at some blocks noted- Have it checked, any necessary corrections made by a qualified contractor.
- 4.4. Old, weathered, fencing noted. Have it checked by a qualified specialist.
- 4.5. Fencing was loose/leaning at areas. Recommend Further Evaluation, repairs by qualified specialist.

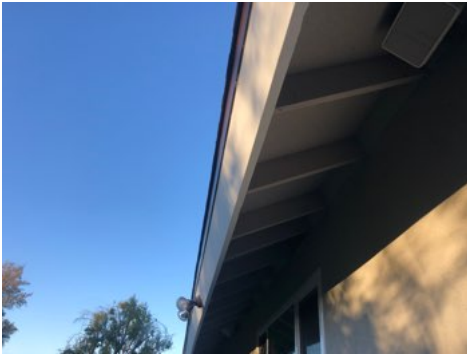
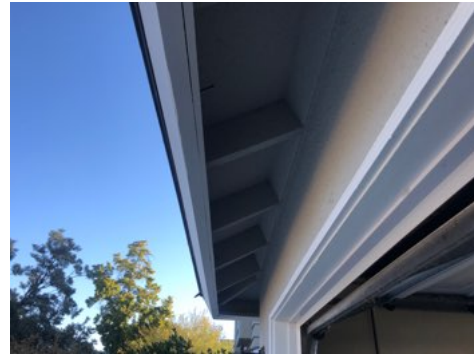
5.1. Newer paint noted which may mask older defects. Have it checked by a qualified structural pest inspector.

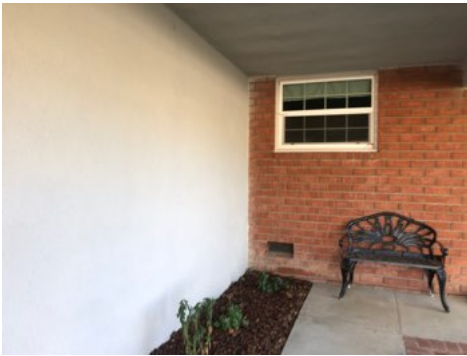
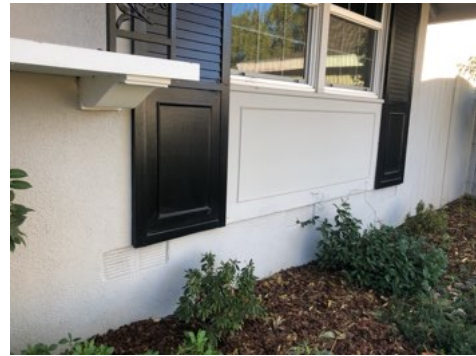
6.1. Newer paint noted which may mask older defects. Have it checked by a qualified structural pest inspector.

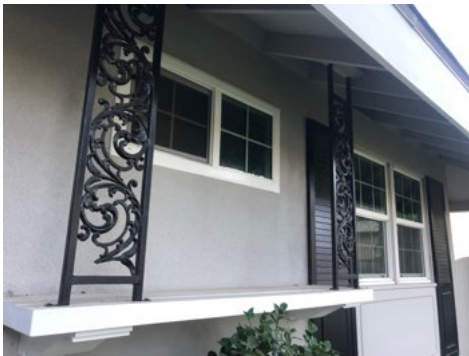
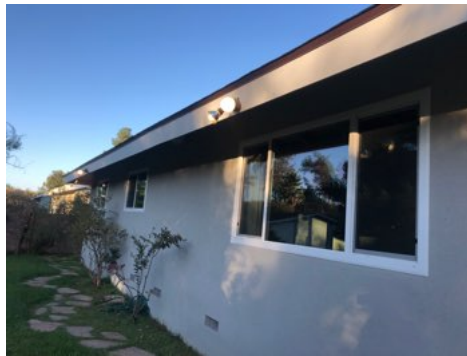
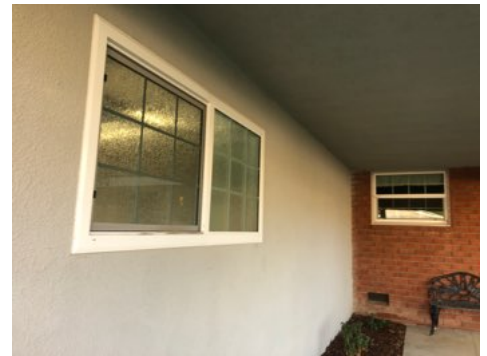
Periodic maintenance around the frame, sealant required (to prevent water seepage).

7.2. Dual pane windows noted. It is not always possible to determine fogging of this type of window due to temperature changes, etc. Check with the seller or records for any know defects, repairs.

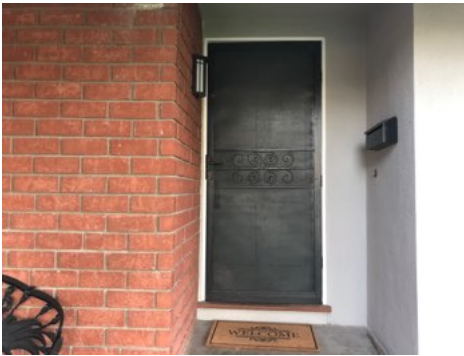
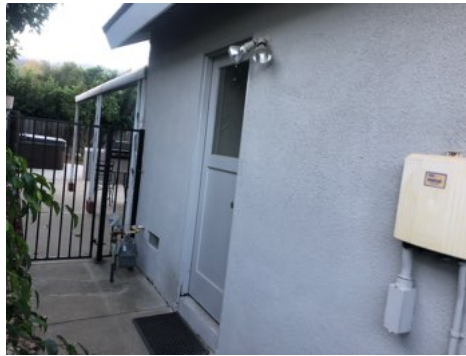
8.4. damage present at garage exterior closet door(s) - In need of replacement by a qualified contractor.

8.5. Missing threshold noted at garage exterior door(s) Recommend to install to prevent unwanted intrusion. Have checked by qualified specialist.

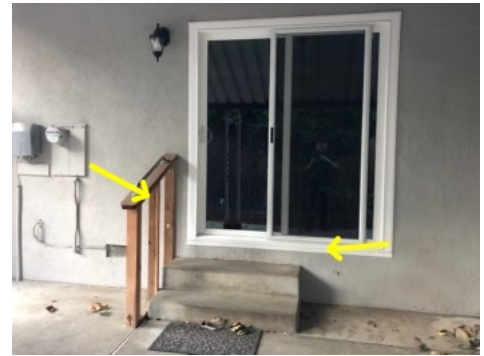
Loose railing

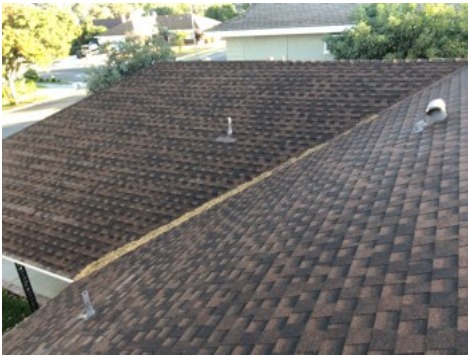
2.2. Debris noted at the Roof called flashing. May cause future leaks and/or damage. Recommend removing and further evaluation by qualified Roofer.

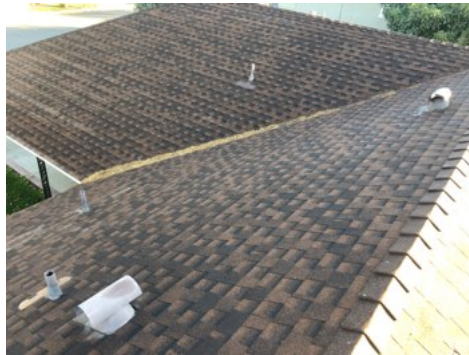
3.2. **Debris noted at the Roof called flashing. May cause future leaks and/or damage. Recommend removing and further evaluation by qualified Roofer.**

Debris- recommend to remove

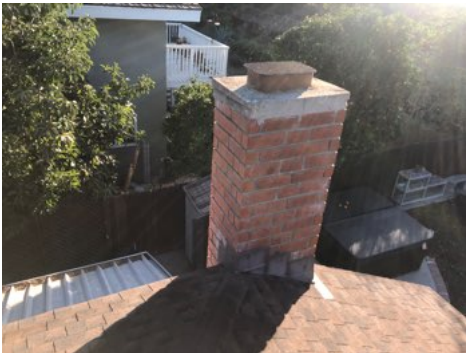
6.2. Cracks at chimney cap noted - Have it checked, sealed by a qualified specialist.

6.3. Recommend complete evaluation, any necessary corrections made by a qualified chimney inspector.

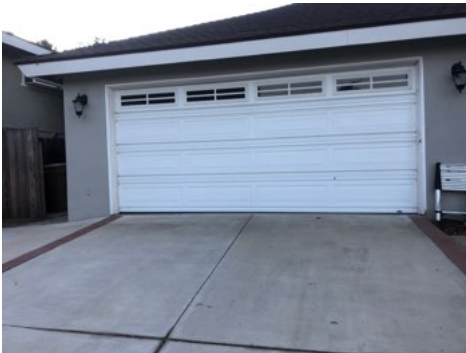
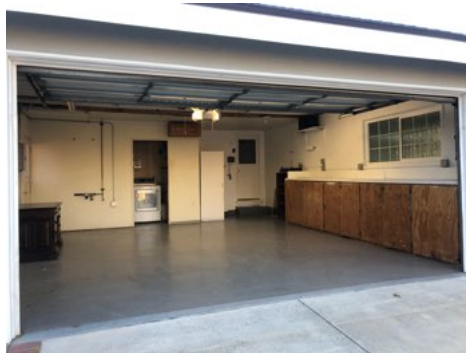
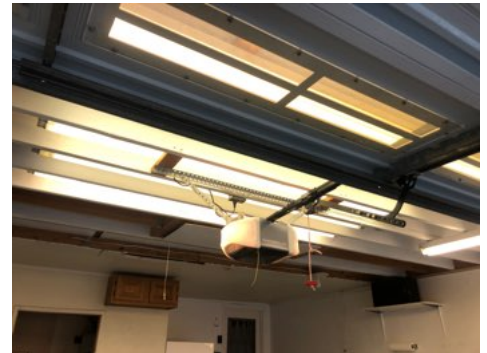
2.2. **Beginning July 1, 2019 a new law requires automatic garage door opener(s) to have a battery backup function that is designed to operate when activated because of an electrical outage for safety. Senate Bill No. 969 will make a violation of those provisions subject to a civil penalty of \$1,000 and will on or After July 1, 2019 prohibit a replacement residential garage door from being installed in a manner that connects the door to an existing garage door opener that does not meet the requirements of these provisions.**

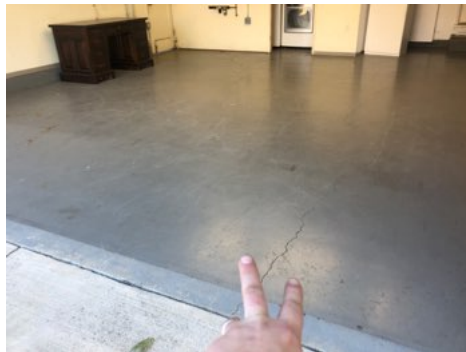
3.1. cracks, settlement were found on the garage floor. In need of further evaluation, repairs by a qualified contractor, engineer.

3.2. Floors have been painted and/or repaired. Check the records.

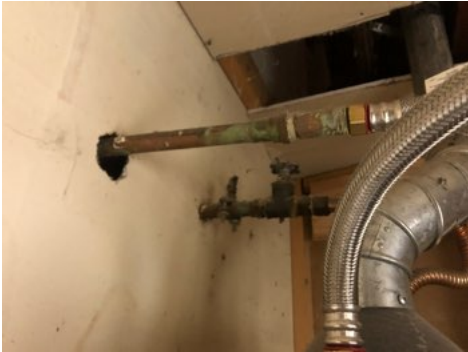
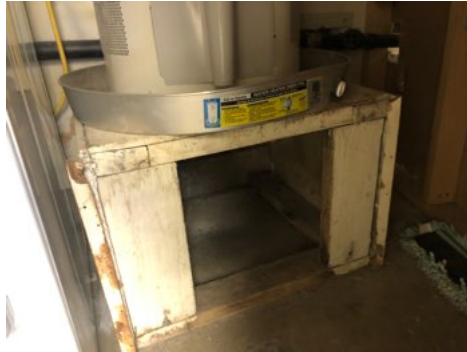
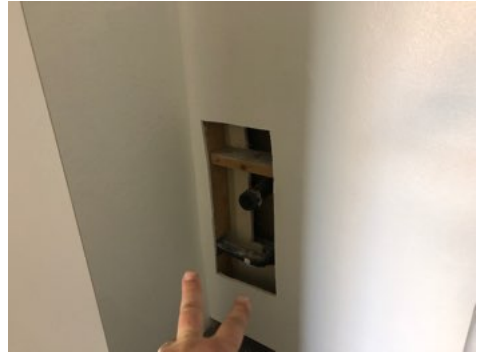
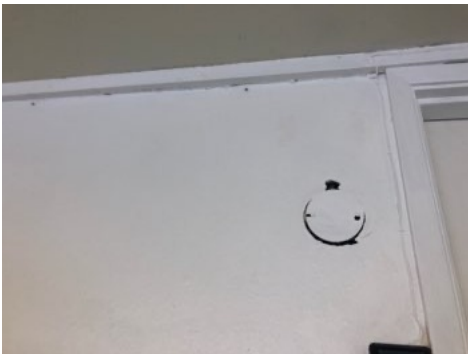
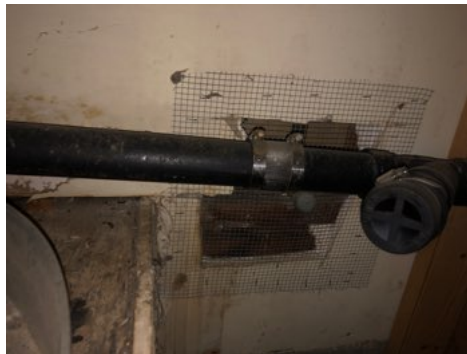
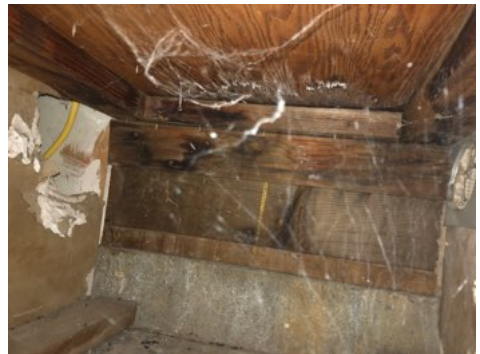
- 4.1. Holes were noted on the firewall. Have Sealed, necessary corrections made for fire safety by a qualified specialist.
- 4.2. Prior patchwork at garage wall(s) and/or firewall noted. Check the records and/or with seller of known defects, repairs.
- 4.3. cut out/holes/Damage noted at Garage walls and/or firewall. Have it checked, repairs made by a qualified specialist, contractor.
- 4.4. Water heater platform is not fire rated type material, have it checked, corrections made by a qualified specialist.

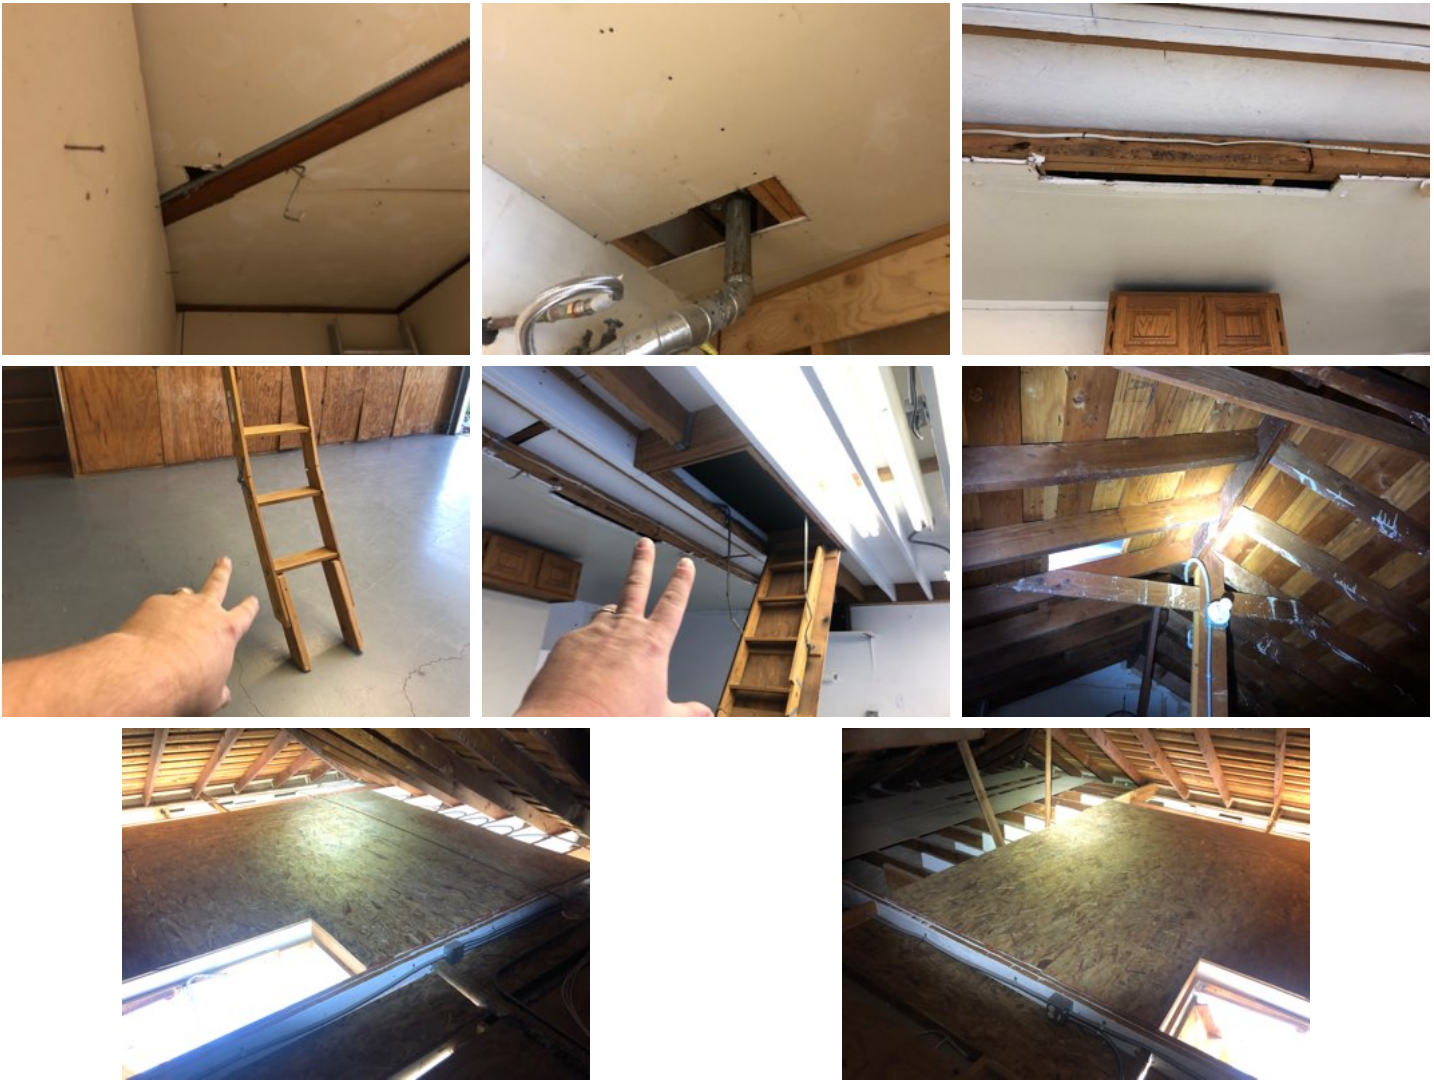
- 5.1. Hole(s) noted at the ceiling causing a breach in the Firewall ceiling, Have it repaired/sealed, corrections made by a qualified specialist, contractor.
- 5.2. Recommend to remove overhead supported storage platform in garage due to added weight/stress to the structure.
- 5.3. Pull down stairs located in the garage- not properly fire rated, not flush when closed. Recommend further evaluation, corrections made by qualified specialist.
- 5.4. Ceiling pull down stairs altered- feet don't properly touch ground. In need of complete evaluation, necessary correction/repair/replacement made by qualified specialist

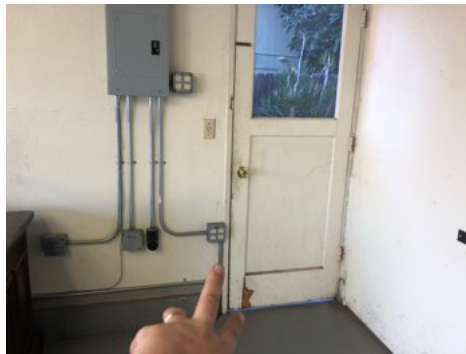
- 6.1. Damaged exterior door(s) noted at side of garage - Recommend to replace.
- 6.2. Missing threshold noted. Recommend to install threshold to prevent water seepage.

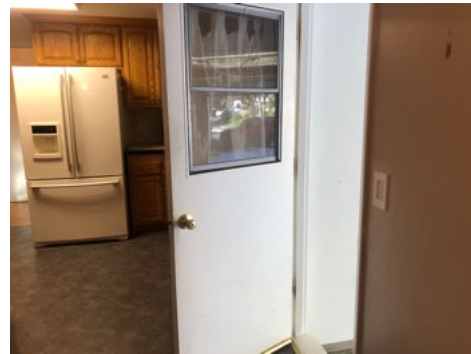
- 7.1. Door to interior lacks self closing device/weatherstripping/threshold. Have it checked, fixed by a qualified specialist.
- 7.2. Door to interior does not appear to be a fire-rated door - Not to current safety standards. Have it corrected, replaced by a qualified specialist.
- 7.3. Door to interior opens over step(s) - Trip hazard. FYI

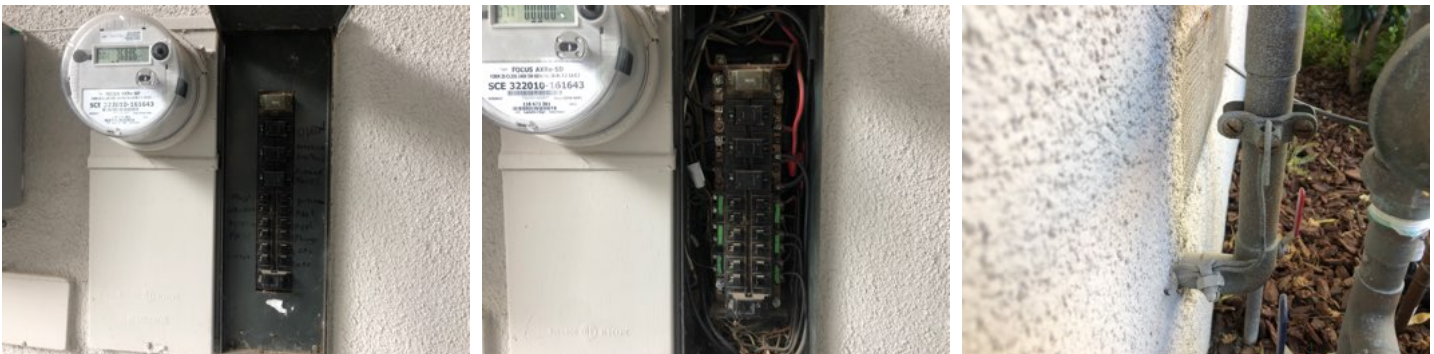
2.4. Electrical system is old Pushmatic type breakers type and is considered to be obsolete, outdated. Upgrade of the Electrical System by a qualified Electrical Contractor is recommended.

2.5. Recommend complete system evaluation, necessary corrections made by a qualified electrician.

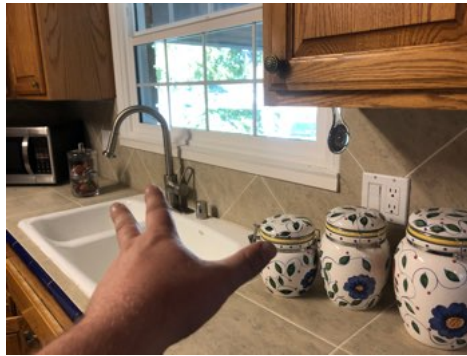
6.1. Recommend to have GFCI outlets in all wet locations as a safety upgrade, and to test them periodically. Missing at kitchen. Have checked, fixed by qualified electrician.

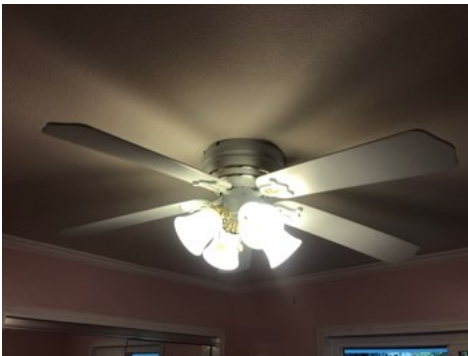
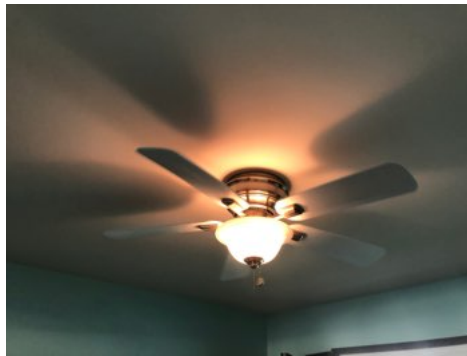
- 7.1. Electrical covers (switch, outlets, junction boxes, etc) not removed as part of this inspection - Inspection of the wiring is limited to Main panel. For a more in depth inspection recommend to hire a qualified Electrician.
- 7.2. Ceiling fans not tested for attachment/safety at this inspection. Recommend to check the records - Make sure it was installed and tested by a qualified specialist.
- 7.3. Damaged and/or missing light cover(s) at interior noted. Have checked, corrections made by qualified electrician.
- 7.4. Light(s) not working at kitchen. Have it checked, fixed by a qualified electrician.

Missing light cover- kitchen

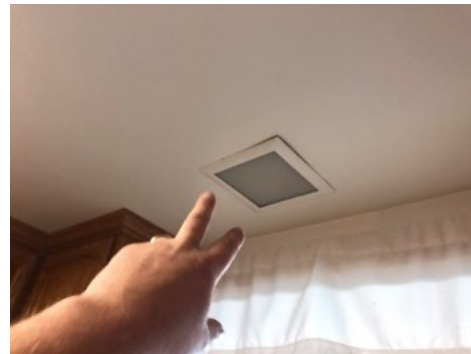
Not working

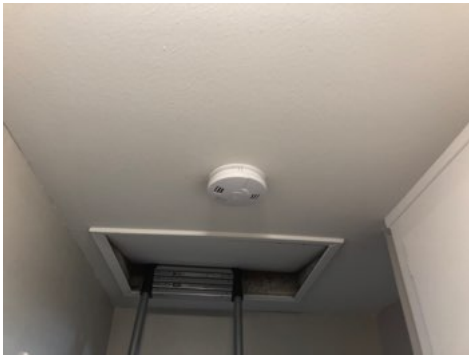
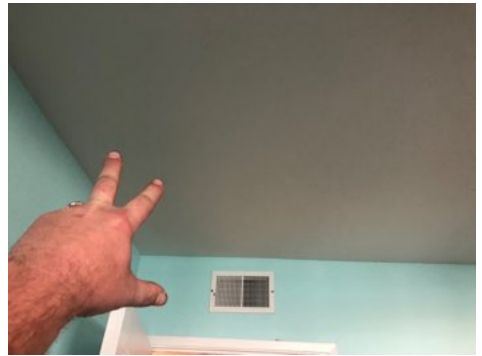
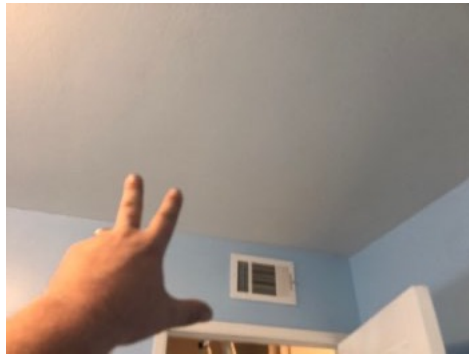
- 8.1. Carbon monoxide detector noted - Recommend to test it periodically.
- 8.2. Smoke and Carbon Monoxide detectors, fire alarms/systems not inspected. Beyond the scope of this inspection. Recommend to install smoke and carbon monoxide detectors per City/Manufacturers requirements and test them periodically - Recommend to have checked by a qualified retrofitter. **THIS IS A HEALTH/SAFETY CONCERN.**
- 8.3. Missing smoke detectors at bedrooms and/or hallway. Recommend to Install and test periodically for fire safety. Have checked by qualified retrofitter.

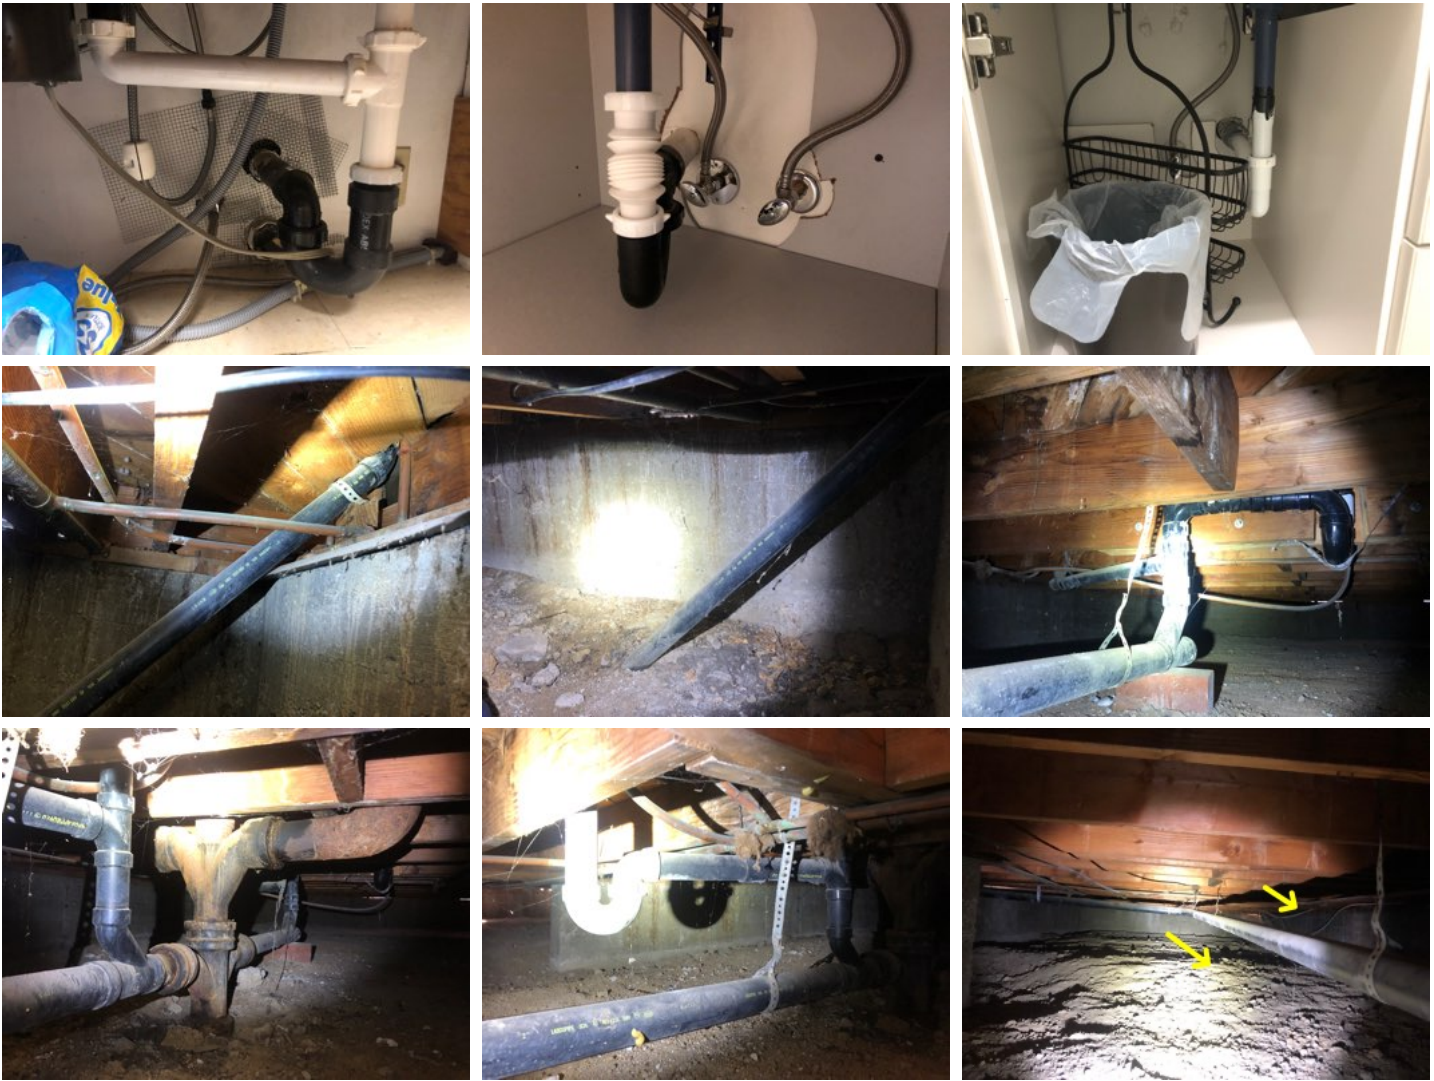
1.4. House with old, rusted/aged cast iron sewer pipes type- no leak(s) found at time of inspection. Periodic inspection recommended, **LIMITED LIFE EXPECTANCY** - In most cases cast iron sewer pipes should last 50-75 years in a residential application. Recommend to hire a qualified plumber for further evaluation for possible replacement and/or necessary upgrade(s) of the pipes.

1.6. Metal type straps were used at ABS pipes - Improper, poor workmanship noted (should be approved vinyl type straps). Have it checked by a qualified specialist for necessary corrections.

1.7. Support method of the ABS waste pipes in the crawl space are considered to be inadequate - Lacks rigid support. Have checked, properly secured and any necessary corrections made by a qualified specialist.

1.8. Combination of newer ABS pipes and old cast iron pipes noted at sewer line under house. Check records and permits for plumbing work previously completed. This indicates original pipes were failing due to age and further upgrades and replacement may be required. Periodic inspection and complete evaluation recommended by qualified plumber.

1.9. Flex type tubing was used at sink drain at bathroom - Flex tubes designed for temporary fixes. (Not recommended for permanent use due to possible debris trapping, growing of bacteria). Recommend to replace with solid tube type. Have it checked, fixed by a qualified plumber.

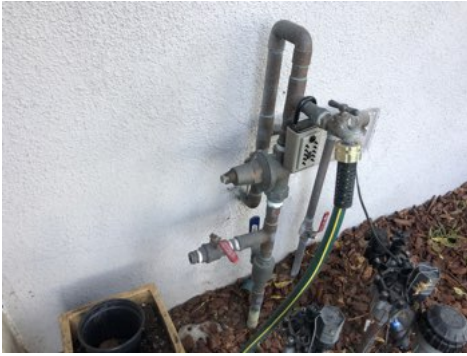
2.3. Water pressure is too high, measured at - 130 PSI - recommend adjustment, repair, replacement of the regulator to below 80 PSI.

130 psi

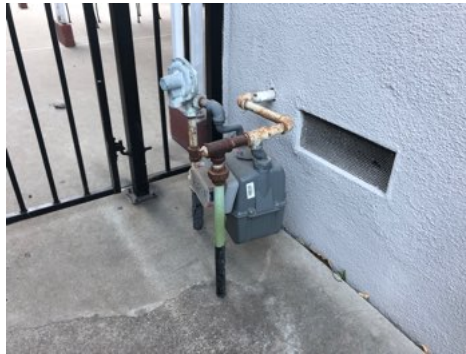
4.2. Gas meter - Seismic shut off was not present at the time of inspection, recommend to install - May not be required in the City of Location - Recommend to check the local regulations.

4.3. Underground gas pipe noted (type unknown). Have it checked for possible gas leak. Gas leaks or pipe testing not part of this inspection. Recommend to check the building records, permits for any known issues or repairs regarding gas pipes, fuel systems and/or have it tested by the Gas Co. and/or a qualified plumber.

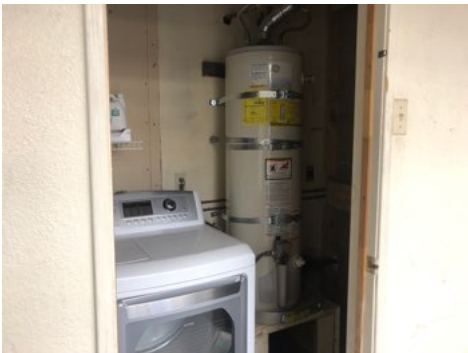
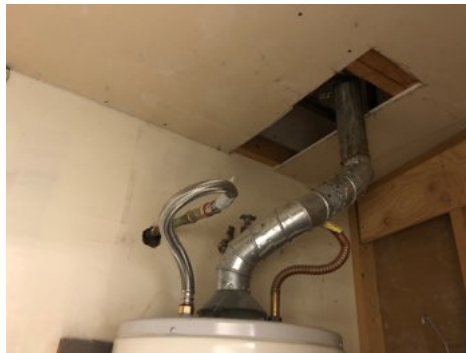
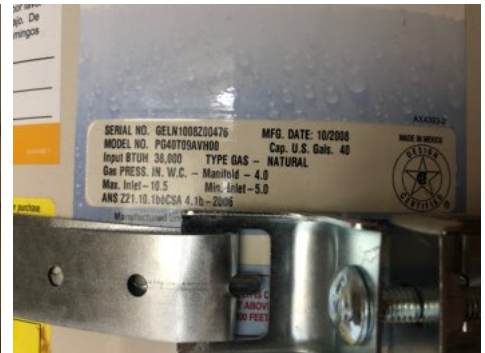
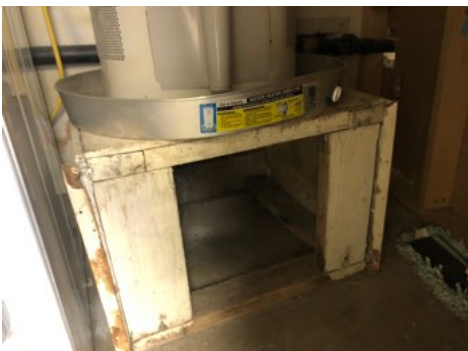
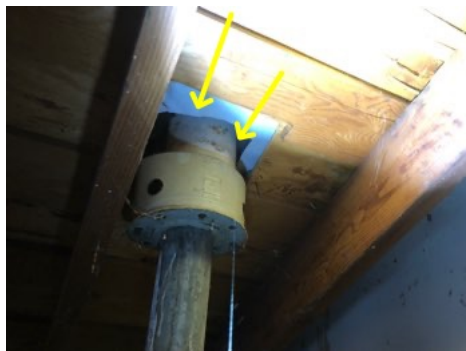
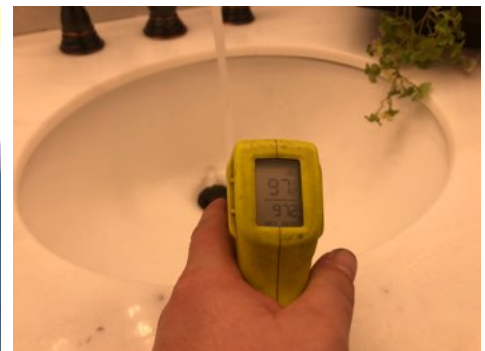
5.3. Unit is near end of life due to age (Life span of this type units are 10 to 12 years). Recommend to monitor/replace and retrofit to today's safety standards.

5.9. Water heater platform is not fire rated type material, have it checked, corrections made by a qualified specialist.

5.10. A number of defects found at water heater. Recommend complete evaluation, any necessary corrections, repairs and/or replacement by a qualified plumber.

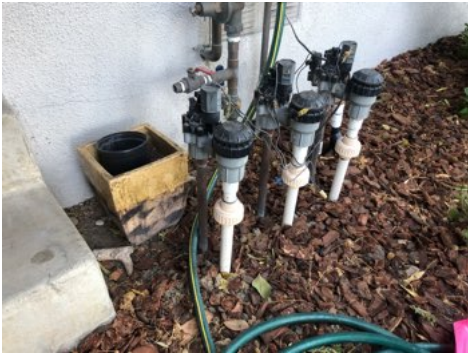
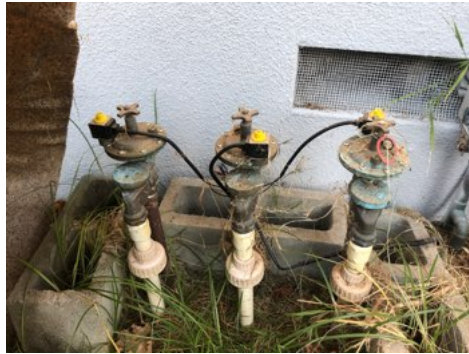
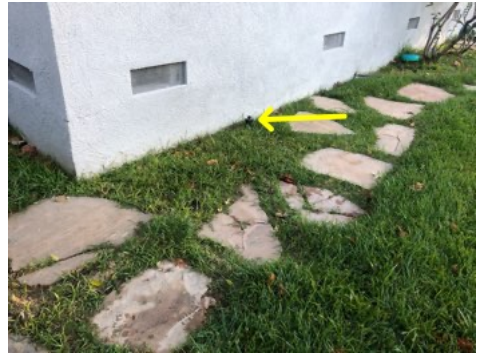
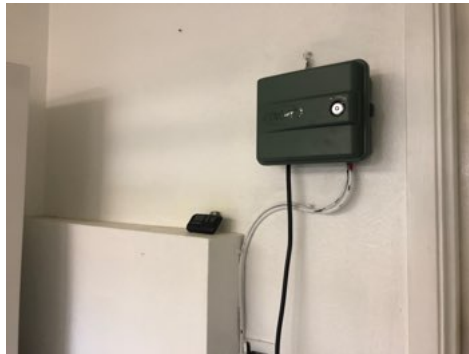
6.2. Sprinklers are set too close to the building/structure. Recommend moving minimum 2' away from structure - Recommended to keep water/vegetation away from structure/foundation. Have checked by qualified specialist for any necessary correction.

6.3. Manual operated sprinkler valves noted. Sprinkler system and these valves are not tested or part of this inspection. Have checked by qualified specialist.

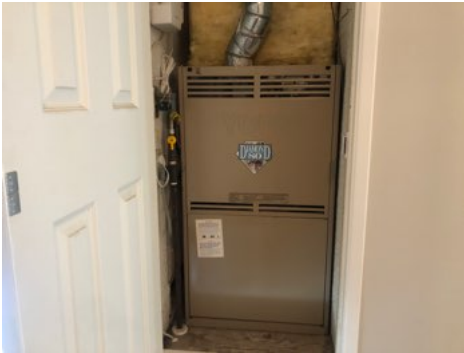
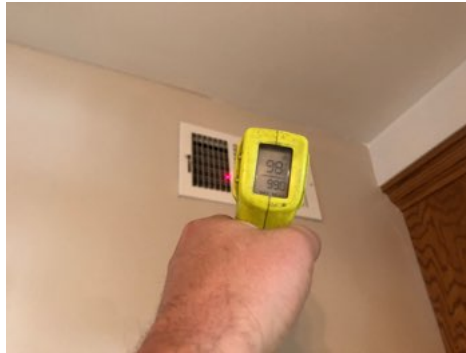
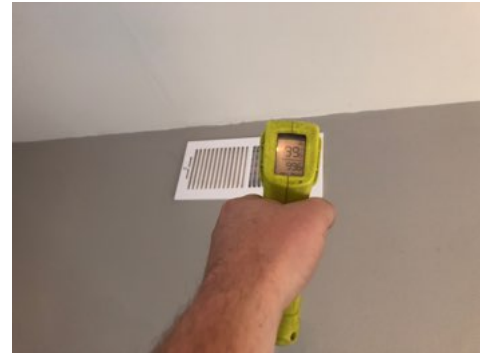
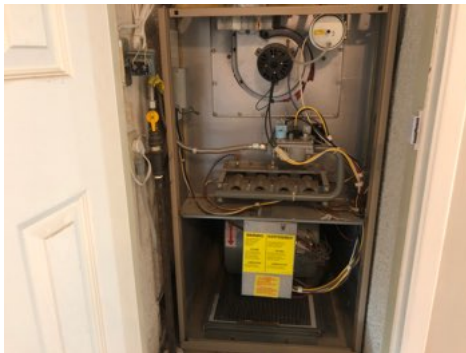
1.2. **Recommend to check the service history with the Seller and to have the unit(s) serviced by a qualified HVAC Contractor if not performed in the past year. Air flow is not a part of this inspection. Recommend to check the disclosures regarding day to day functionality. No service tags noted. This is a limited Visual Inspection - Recommend to have the unit(s) evaluated by a qualified HVAC Contractor. Annual service, evaluation and maintenance is recommended with gas fired furnaces.**

1.3. **Typical Lifespan of heat unit(s) are 15 to 20 years. Recommend to have a qualified HVAC specialist to inspect and/or evaluate the entire system to have a better understanding and expected life span of the HVAC system.**

1.4. **Furnace is old but did work at time of inspection. Unable to determine life remaining expectancy. Recommend further evaluation, any necessary service/corrections made by a qualified HVAC specialist.**

1.5. **Left latch loose at cover at heat unit- have checked/fixd**

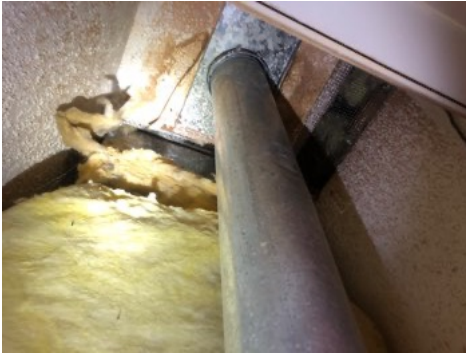
2.2. **Oxidation/rust at vent pipe noted - Indicates improper operation. Have it checked, necessary corrections made by a qualified HVAC specialist.**

Rust/oxidation- have checked/evaluated

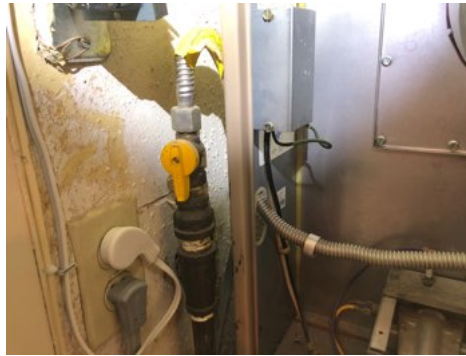
- 3.1. Gas line at heater(s) without drip leg/sediment trap, these serve as a collection area for sediment to reduce the chance of clogging gas valves and burners, dirt and scale can enter the gas valve and possibly cause malfunctions and may void any remaining appliance warranty (this type installation is common for the area/age) - Check with your Home Warranty provider. Have checked by a qualified plumber for correction.
- 3.2. Flex type gas line runs in the body of the FAU/Furnace - Improper - Subject to damage. Recommend to install rigid type pipe extension.
- 3.3. Recommend to install Weatherstripping on closet door to prevent return air and **combustion air** mixing.

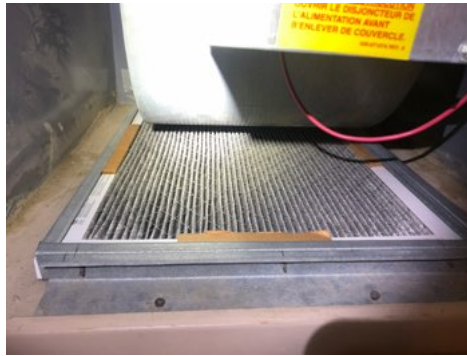
- 4.1. Air filters should be changed or cleaned regularly according to Manufacturer's instructions (seasonally and/or every 3-4 months recommended). Air flow, balance is not a part of this inspection. Recommend to check with the seller about air comfort and distribution.
- 4.2. The Filter(s) are dirty and in need of replacement. Have checked, service/maintenance performed by qualified HVAC specialist.
- 4.3. Filter is located in the unit (requires to remove panel cover to get to the filter)(FYI). Check the service records. Periodic replacement of the filter required for proper unit operation. Recommend to upgrade filter location, access.

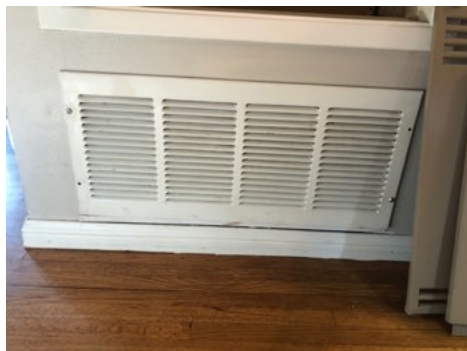
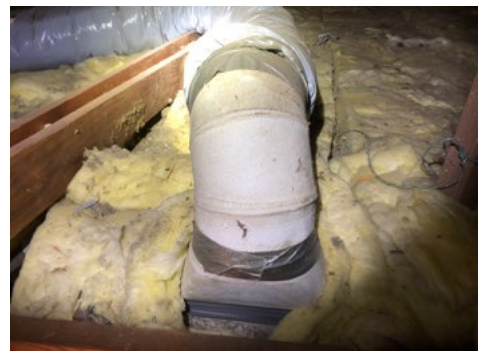
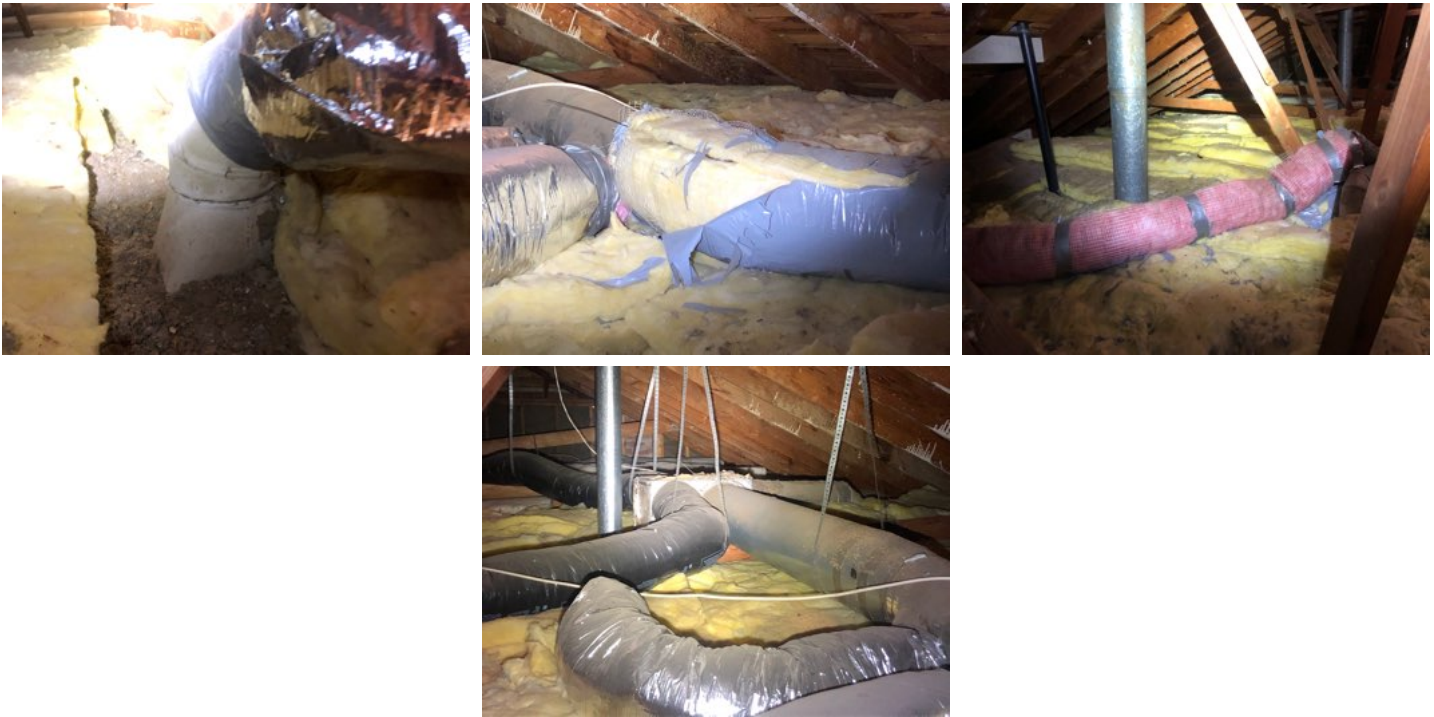
5.3. Asbestos-like materials were noted at aircan(s) and/or taping- Further evaluation, testing for abatement/removal is recommended. This is a health concern, have checked by a qualified specialist.

5.4. Damaged insulation wrap noted at ducting in the attic. Have it checked, necessary corrections made by qualified HVAC specialist.

5.6. Return air plenum is wood frame box- not with today's standards. Recommend to upgrade with an approved insulated box. Have it checked, necessary corrections made by a qualified HVAC technician, contractor.

5.7. Return air plenum is dirty and in need of cleaning, service. Recommend to have it checked, necessary corrections and service, maintenance performed by a qualified HVAC technician, contractor.

5.8. Old ducting system noted, recommend to upgrade. Have checked, necessary corrections made by qualified HVAC contractor.

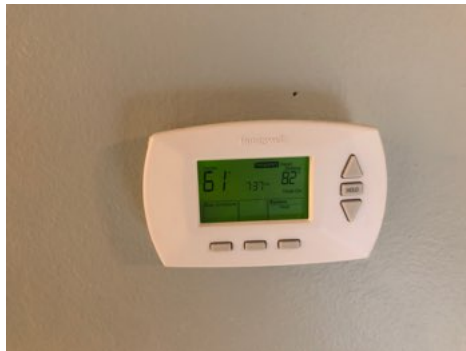
8.1. Thermostat(s) operational at the time of inspection. (FYI)

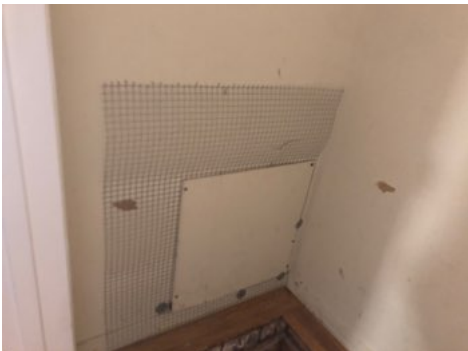
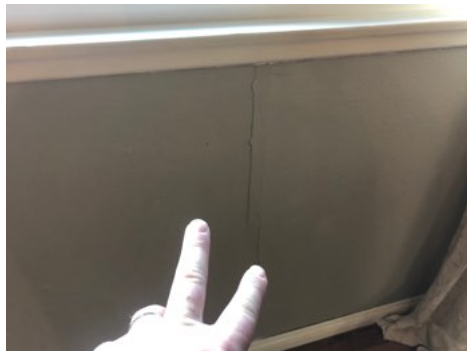
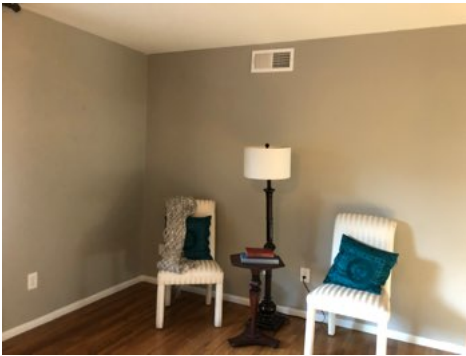
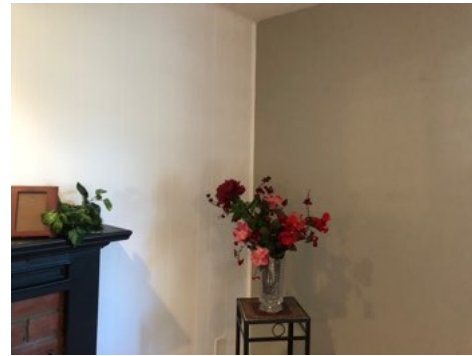
2.2. **Common cracks and/or anchor holes were noted at the interior walls.**

2.4. **Interior walls in need of patch, paint, repair- cut out/poor workmanship at patchwork at entry closet. Have checked, necessary corrections made by a qualified specialist.**

2.5. **Prior patchwork noted at interior wall(s). Check the records, permits and/or with seller of known defects/repairs.**

2.6. **Paneling is installed on the walls, unable to determine condition of the walls behind the coverings.**

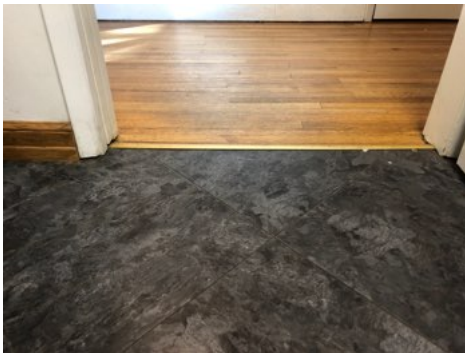
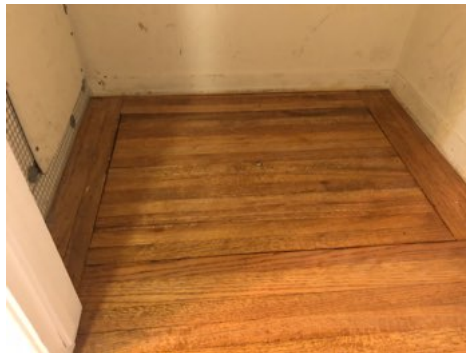
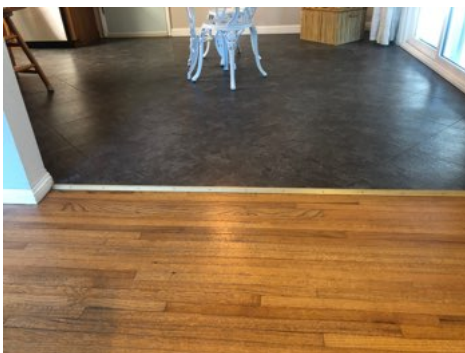
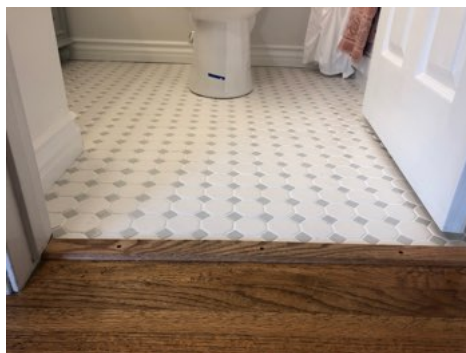
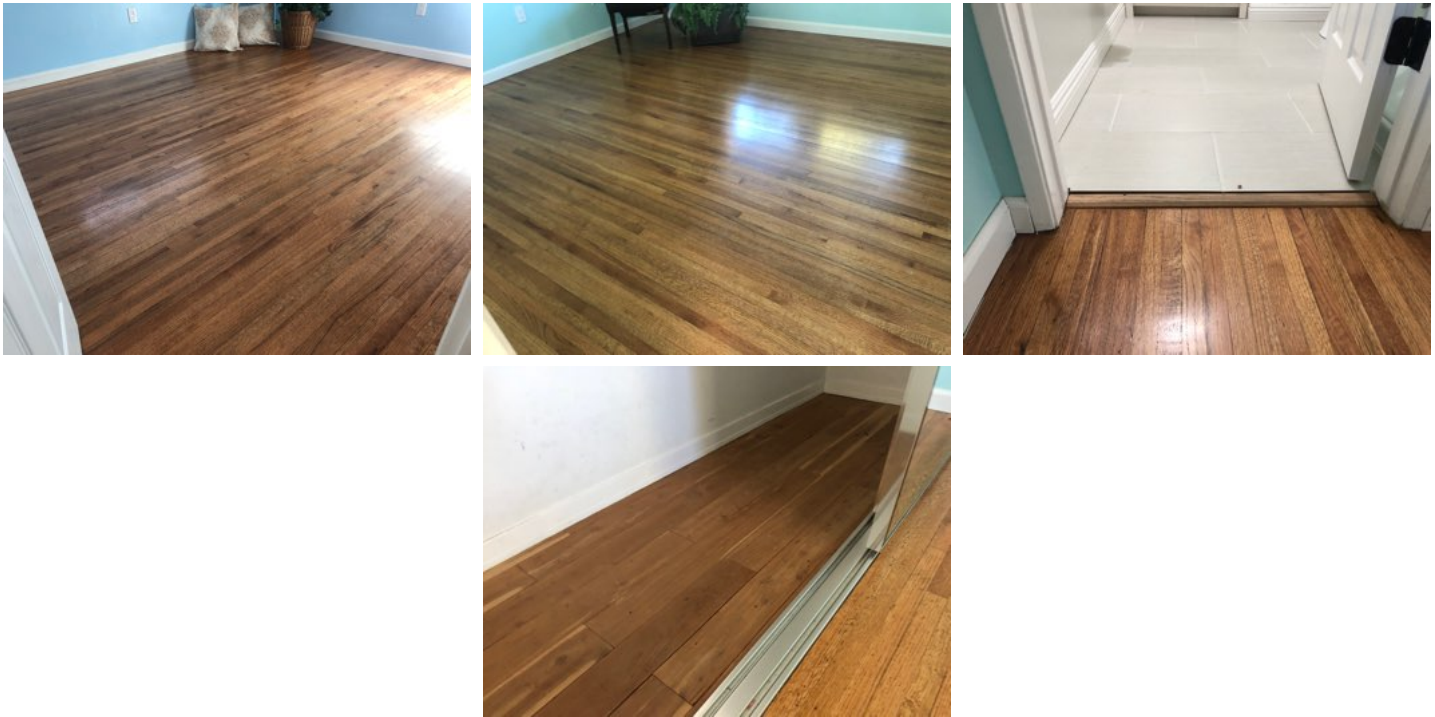
- 3.1. Floor squeaks are present at the interior of the home (common for his type structures). Have it checked by a qualified flooring contractor.**
- 3.2. Uneven areas, sloping was noted at various areas of the flooring. Check the records for any known defects, repairs and/or have it checked by a qualified specialist(s).**
- 3.3. Worn, aged flooring materials, scratches/scuff marks noted at floor(s) of the inspected property. May need repair/replacement. Have checked by qualified specialist.**
- 3.4. Trip hazards noted due to differing flooring material heights. FYI**
- 3.5. Some expanded gaps noted at flooring material joints. In need of further evaluation, corrections by a qualified floor specialist.**

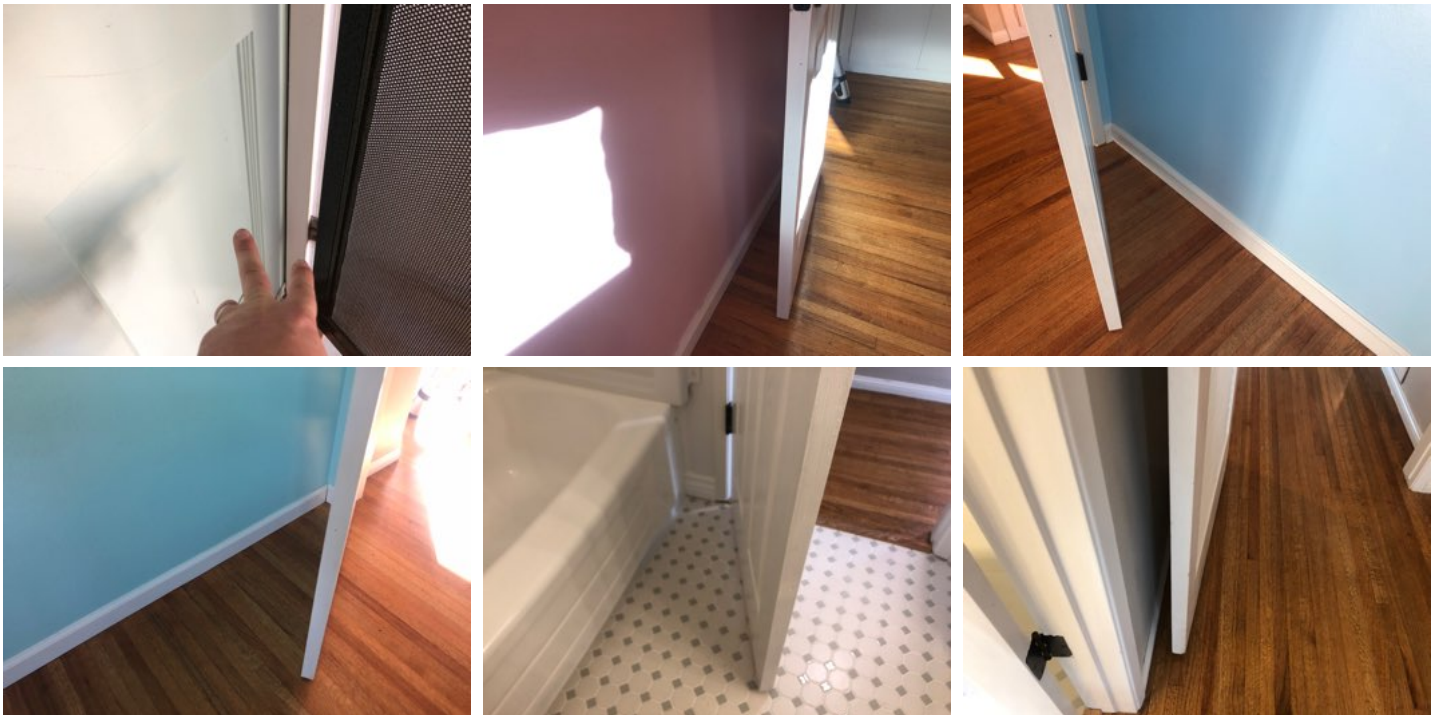
- 4.1. Recommend to install door stops to prevent wall damage.
- 4.2. Door frames are not square, some rub at frames and/or not closing, latching properly- notes at master bath - An indication of settlement or movement. Further evaluation and corrections by a qualified Contractor is recommended.
- 4.3. Exterior Slider Door(s) open over a step - A trip hazard. FYI

Won't latch- master bath
