Property Inspection Report

1082 La Grange Ave, Thousand Oaks, CA 91320
Inspection prepared for: Fidel and Maggie Rodriguez
Real Estate Agent: Alex Pineda - Keller Williams - Burbank

Date of Inspection: 11/6/2019 Time: 8:00 AM
Age of Home: 1966 Size: 1172 sq. Feet
Weather: Clear
Order ID: 61

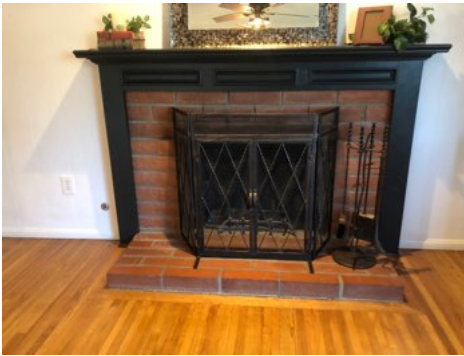
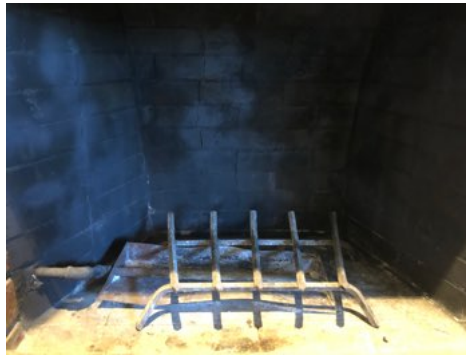
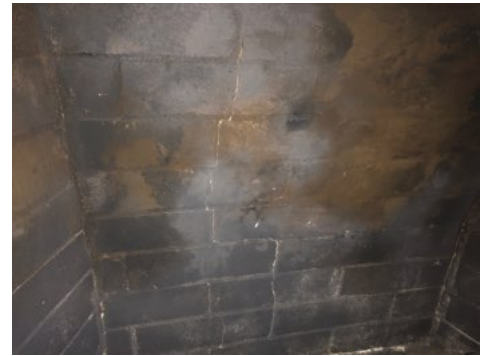
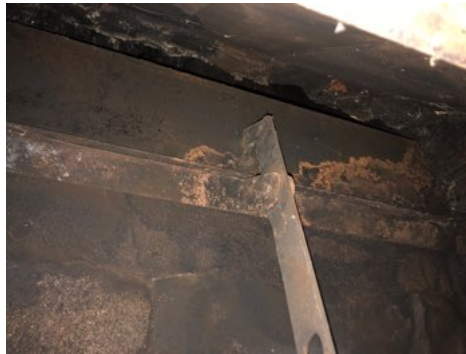
6.2. There is no damper clamp/stop to keep damper in open position. This is an important safety feature that prevents harmful gases from being discharged into the living space - recommend to install Damper Clamp. Have checked by chimney specialist for necessary correction.

6.3. Cracked bricks and/or deteriorated mortar was noted in the firebox - Recommend further evaluation by a qualified Chimney Contractor for any necessary corrections, repairs.

6.4. Fireplace: Gas was operational at the time. Recommend to keep damper at open position for safety. Keep the doors at open position when fireplace in use - Safety, Fire hazard.

6.5. Recommend further and complete evaluation, video inspection of flue by qualified Chimney Inspector - This is a Safety and Fire concern.

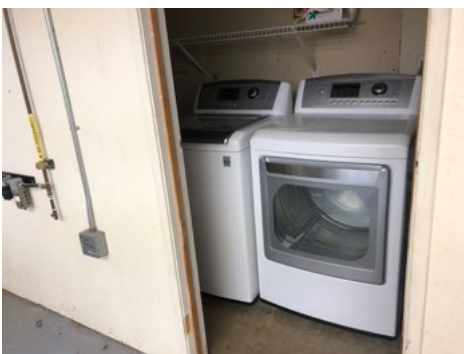
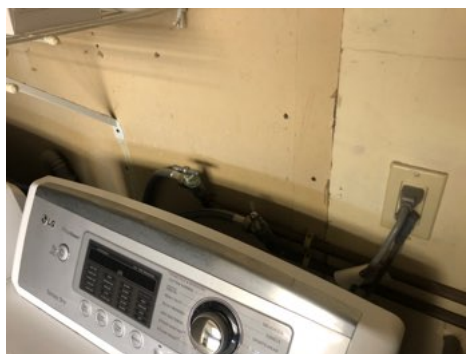
7.4. 20 GFCI Amp outlet is recommended at laundry as a safety upgrade. Have checked by a qualified specialist for correction.

7.5. Laundry area located in the garage. Laundry area was not elevated minimum 18" from garage floor- missing platform. This is a fire safety concern. Have it checked, fixed by a qualified specialist.

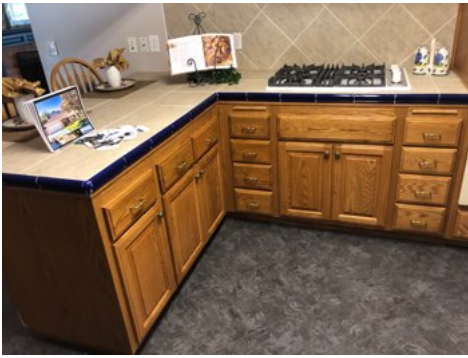
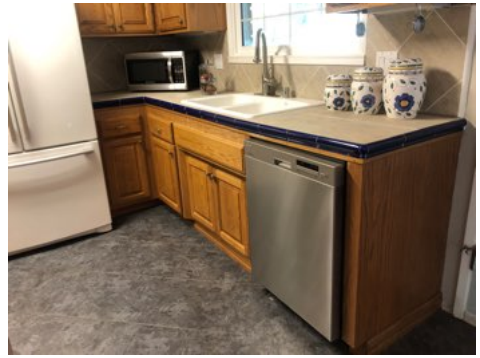
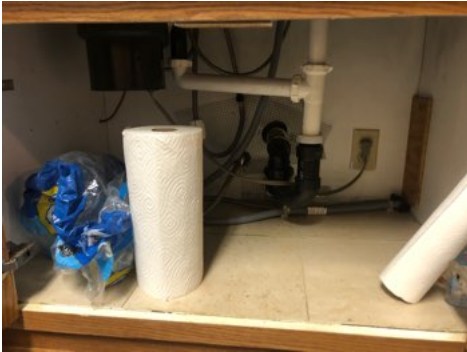
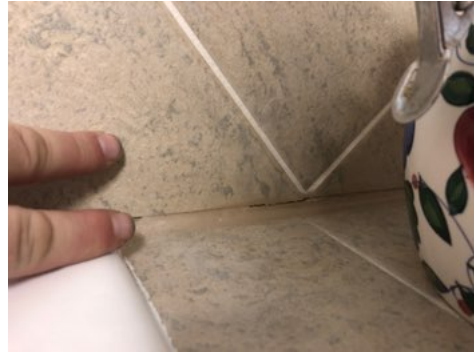
2.1. Wear and general age defects were noted to counter, some peeling at cabinets at the time of inspection. Have checked by qualified specialist for any necessary correction.

2.2. Cracked grout noted at counter/splash. Recommend to have it sealed by a qualified specialist.

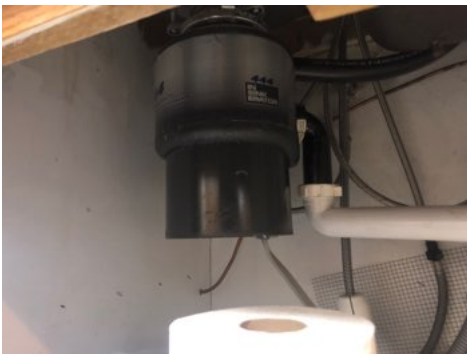
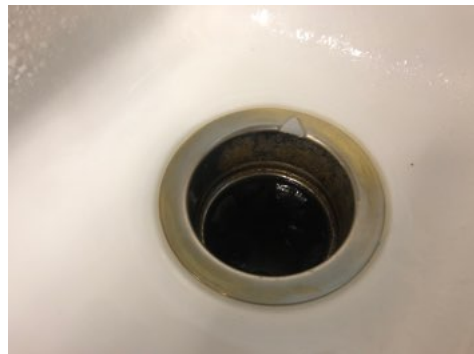
4.2. Damaged, missing splash guard noted. Recommend to replace, install.

4.3. Old, noisy disposer type. Recommend to replace, upgrade.

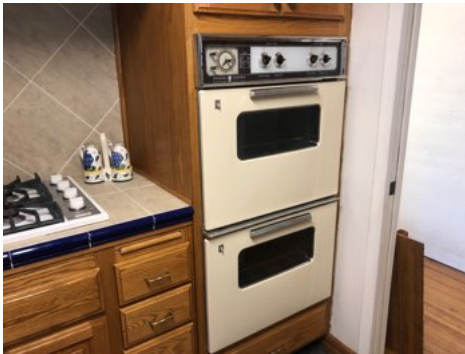
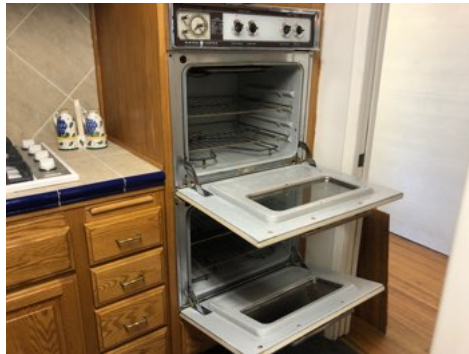
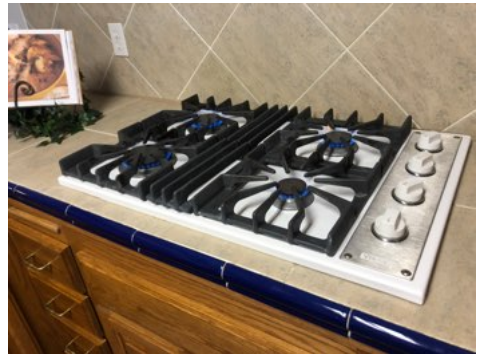
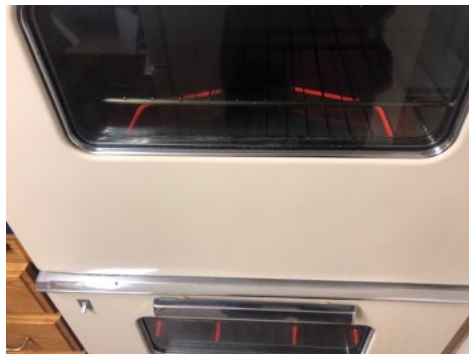
6.2. Older model(s) noted - Was operational at the time of inspection but does show wear and age defects.

6.3. Weak door springs at oven noted- FYI. May require adjustment. Have checked.

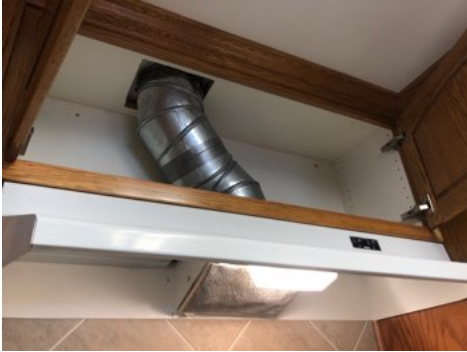
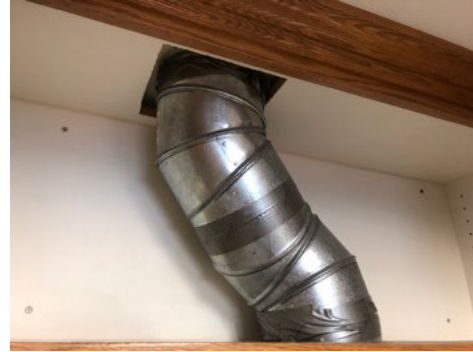
7.2. Loose, improperly installed taping noted. Recommend to Re-Tape the duct joints.

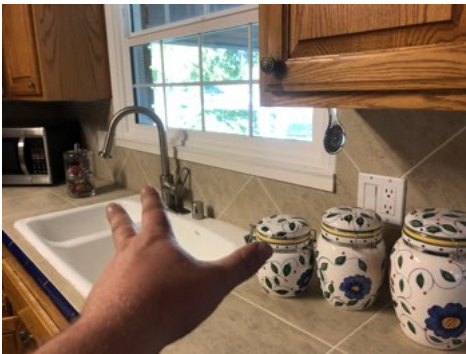
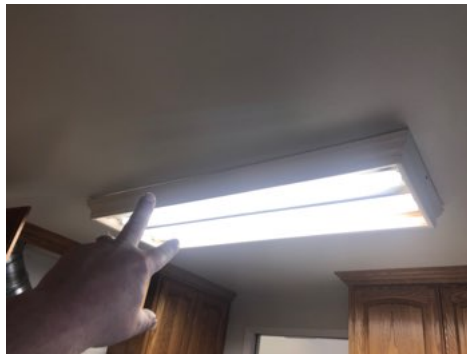
- 10.1. Recommend to install GFCI type outlets in the kitchen as a safety upgrade. Missing at kitchen at front unit. Recommend to install
- 10.2. Light Not working at kitchen. Have it checked, fixed by a qualified electrician.
- 10.3. Damaged/missing light cover(s) noted at kitchen. Have it checked, fixed, replaced by a qualified specialist.
- 10.4. This is not a Mold or Fungus inspection, it is advised to have a Mold specialist examine the property and structure and do a complete inspection to determine the presence or absence of any Mold that may affect the health or safety of the occupants. It is typical when a building is remodeled or repairs are undertaken that additional problems surface that were not noted on the inspection report.

Not working

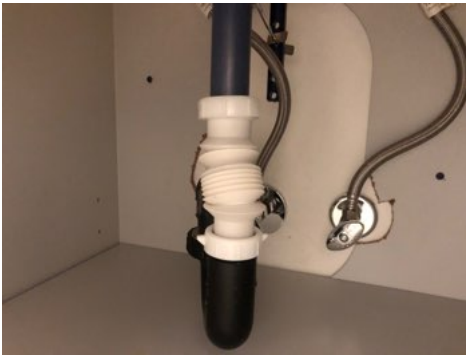
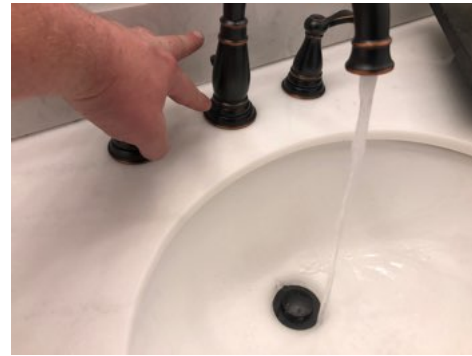
- 2.2. Defective sink stopper noted.

- 2.3. Flex type tubing was used at sink drain - Flex tubes designed for temporary fixes. (Not recommended for permanent use due to possible debris trapping, growing of bacteria).

Recommend to replace with solid tube type. Have it checked, fixed by a qualified plumber.

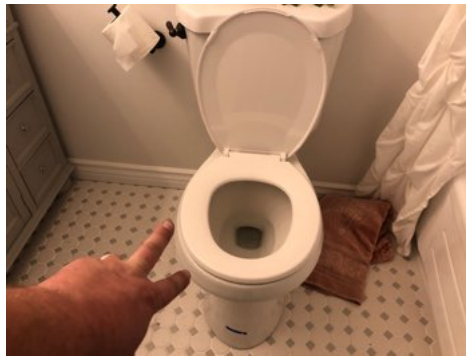
3.1. Toilet was loose at the base. Recommend to reset with new wax seal. Have checked, fixed by qualified specialist.

Loose

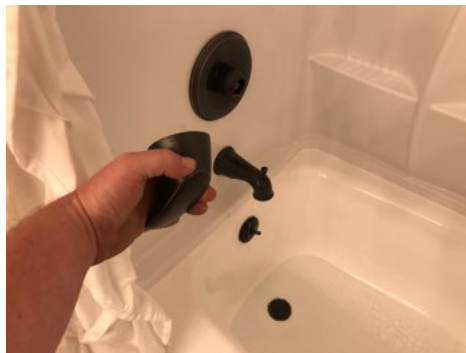
4.1. Loose tub valve handle(s) noted. In need of repair. Have it checked by a qualified plumber.

4.2. Leaking at downspout noted at shower mode due to defective diverter. Have it checked, repaired, replaced.

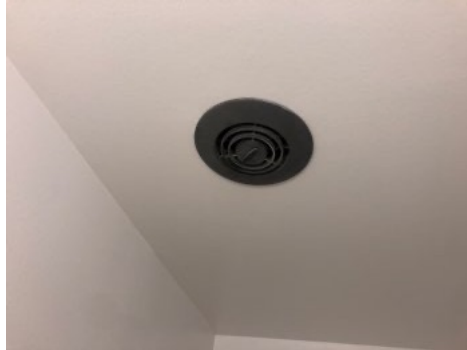
- 6.1. Dirty exhaust fan(s) noted. Recommend to clean, service.
- 6.2. Noisy exhaust fan noted - Recommend to upgrade.

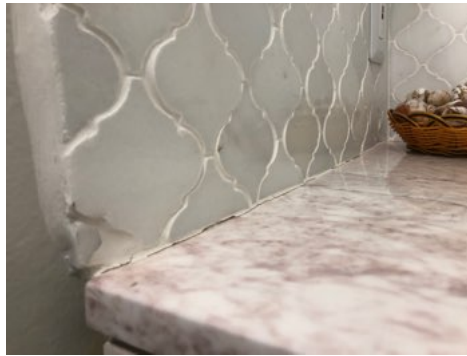
2.2. **Cracked grout noted at counter, backsplash. Recommend to have it sealed to prevent water seepage. Have it checked by a qualified specialist.**

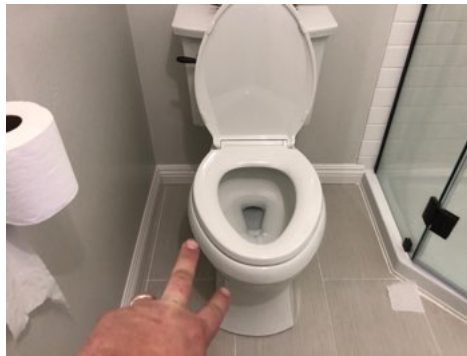
3.1. Toilet was loose at base. Recommend to check, fix and reset with new wax seal by qualified specialist.

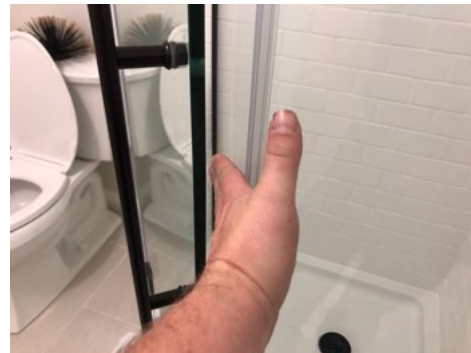
4.2. Shower door not closing flush- gap noted when close- possible due to weather stripping- may require adjustment or correction by qualified specialist/contractor- have checked

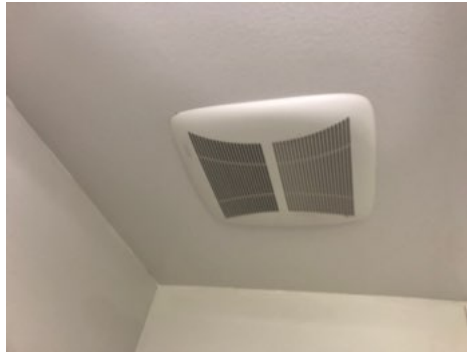
6.1. Dirty exhaust fan(s) noted. Recommend to clean, service.

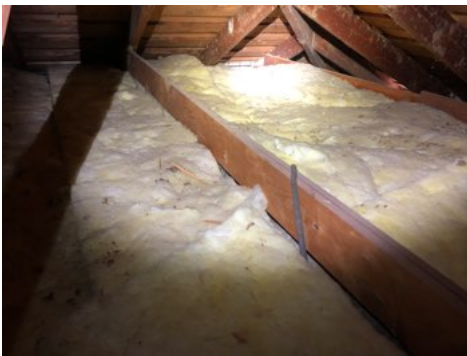
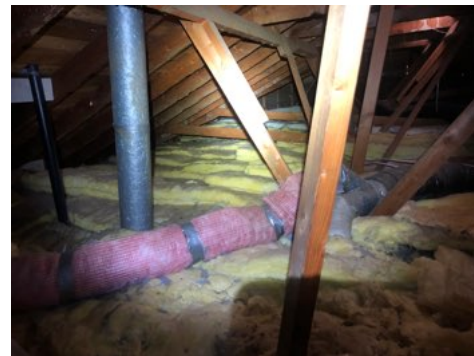
3. Insulation

Insulation Type:
 • Fiberglass

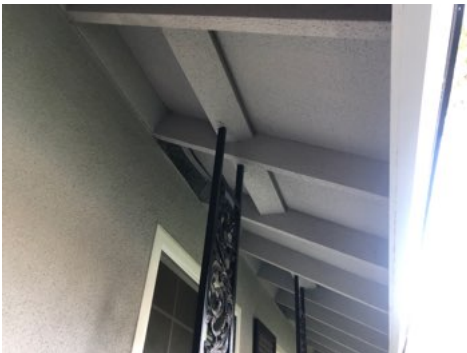
4. Venting

Venting Type:
 • Eave/Soffit Vents
 • Dormer Type

4.1. To calculate if proper size and type of attic vents are installed is beyond the scope of this inspection. You may need to hire a qualified contractor to calculate the attic space and determine if existing vents are adequate for proper ventilation.

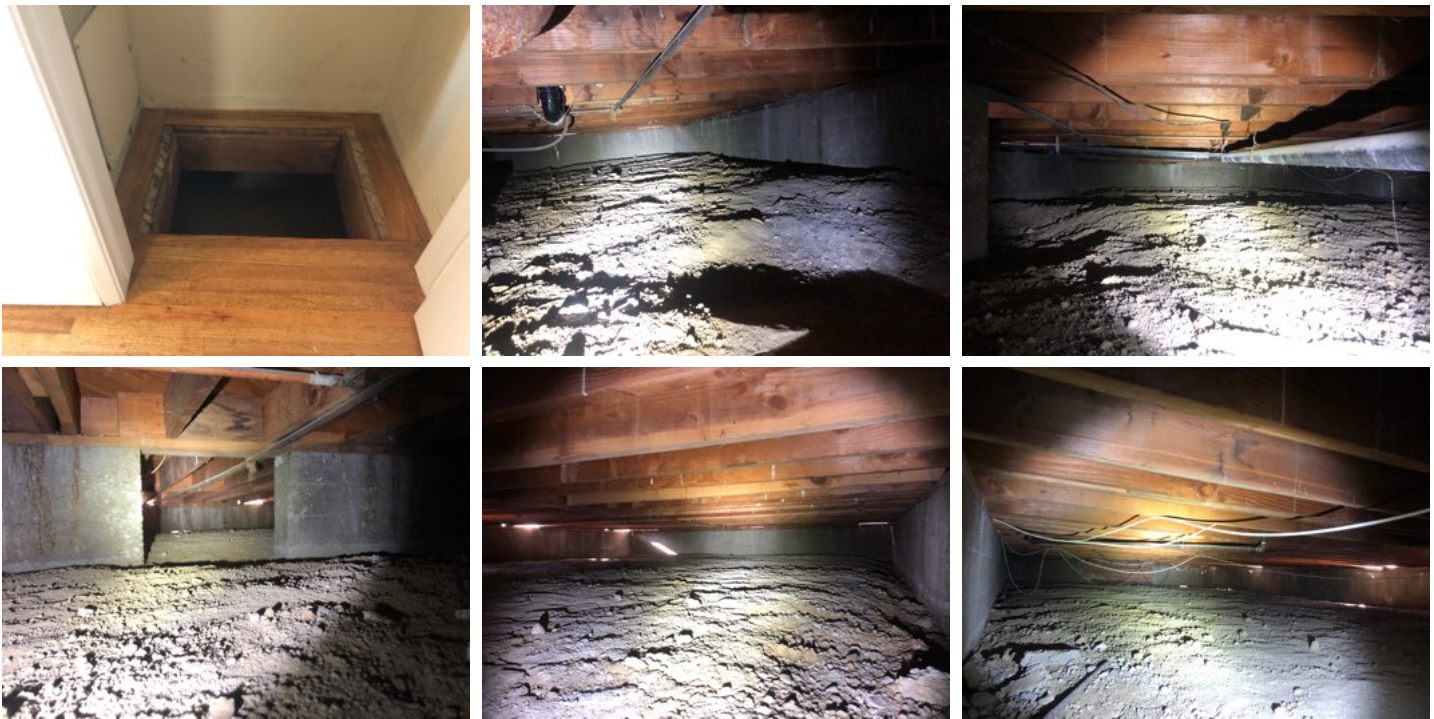
1.1. This is an Old raised Foundation type structure. Structural comments are of the conditions observed at the time of the inspection are the opinion of the inspector (who is not a structural engineer and or a foundation contractor). For expert evaluation of the structure (foundation, walls, framing, anchoring/retrofitting...) we recommend to hire a qualified structural engineer and or foundation contractor/expert.

1.2. This is an Old raised Foundation type structure. Further evaluation of foundation walls and framing by a qualified foundation contractor, inspector is recommended by This Inspection Co.

1.4. Efflorescence was noted present on the foundation walls. Recommend to keep moisture around the inspected property to a minimum.

1.5. Recommend further complete evaluation, necessary corrections made by qualified foundation specialist.

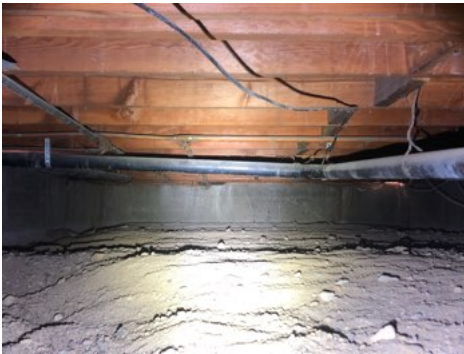
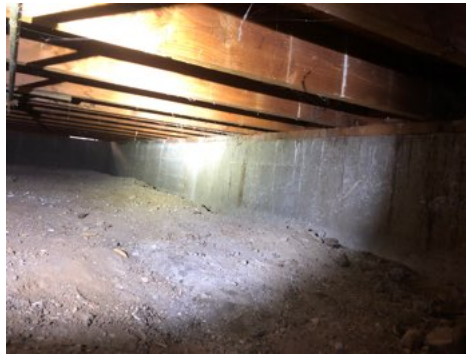
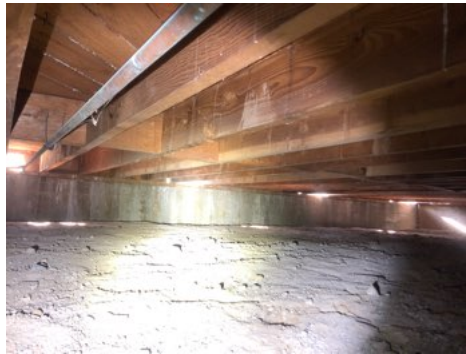
2. Walls

2.1. Efflorescence was noted present on the foundation wall. Recommend to keep moisture around the inspected property to a minimum.

2.2. Anchor bolts from time of construction were noted at the foundation wall. (FYI) Bolt size not with today's standards, recommend to retrofit.

2.3. Old, rusted bolts noted - Recommend further evaluation by a qualified foundation contractor for possible reinforcement.

2.4. Recommend further, complete evaluation by a qualified foundation specialist.

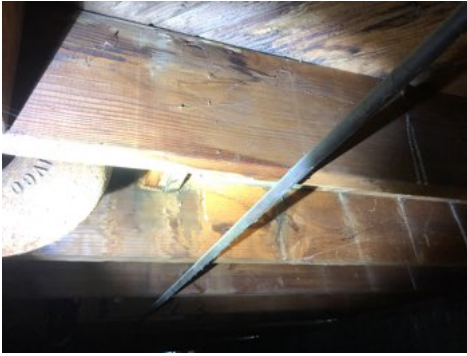
4.1. moisture staining was present at the floor structure in the crawl space. Recommend further evaluation, necessary corrections by a qualified structural pest inspector.

4.2. Floor system is not insulated. Heat loss can occur more on this home than one that is properly insulated.
