Key Property Inspection Group

Property Inspection Report

2160 Georgetown Dr, Corona, CA 92881
Inspection prepared for: David Dopson
Real Estate Agent: Susan Milhaupt -

Date of Inspection: 11/14/2019 Time: 4:30 PM
Age of Home: 1993 Size: 1506 sq. Feet
Weather: Clear
Order ID: 66

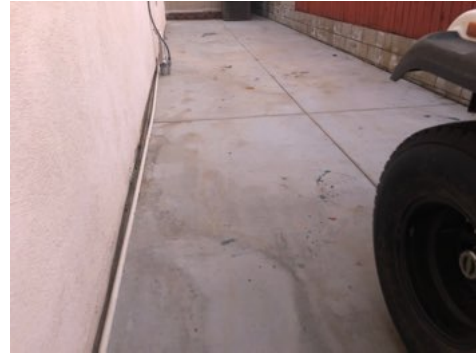
1.1. Common Cracks present at driveway/sidewalk surfaces.

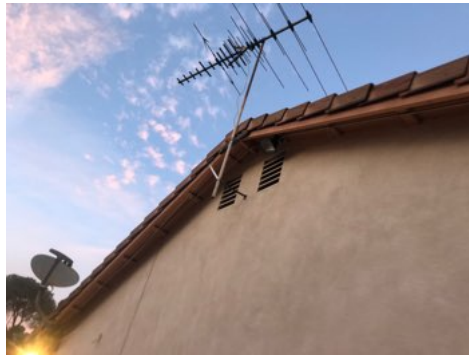
Nesting

6.2. Bee Hive and/or nesting noted at eaves. Recommend to have it checked, removed and necessary corrections made by a qualified Pest specialist.

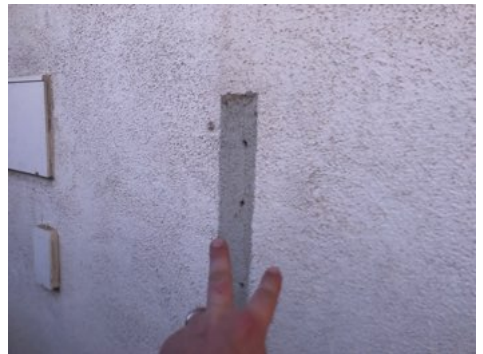
Right side exterior

7.1. Common cracks and/or anchor holes were noted in the exterior stucco walls. Have checked by paint contractor for any necessary correction.

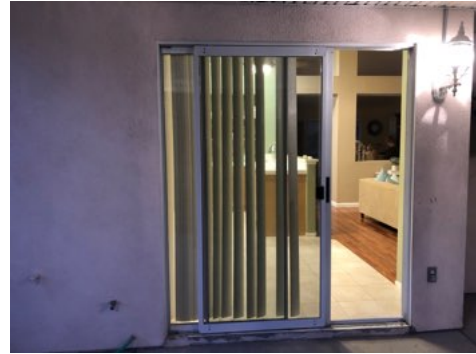
9.1. Slider doors noted installed backward - It is possible to remove the doors from the tracks from exterior even if locked - A security concern.

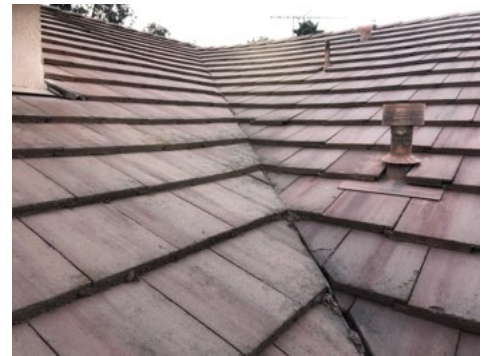
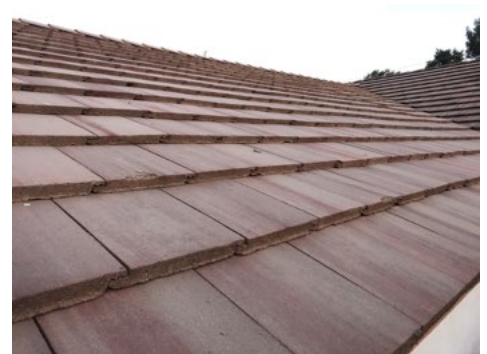
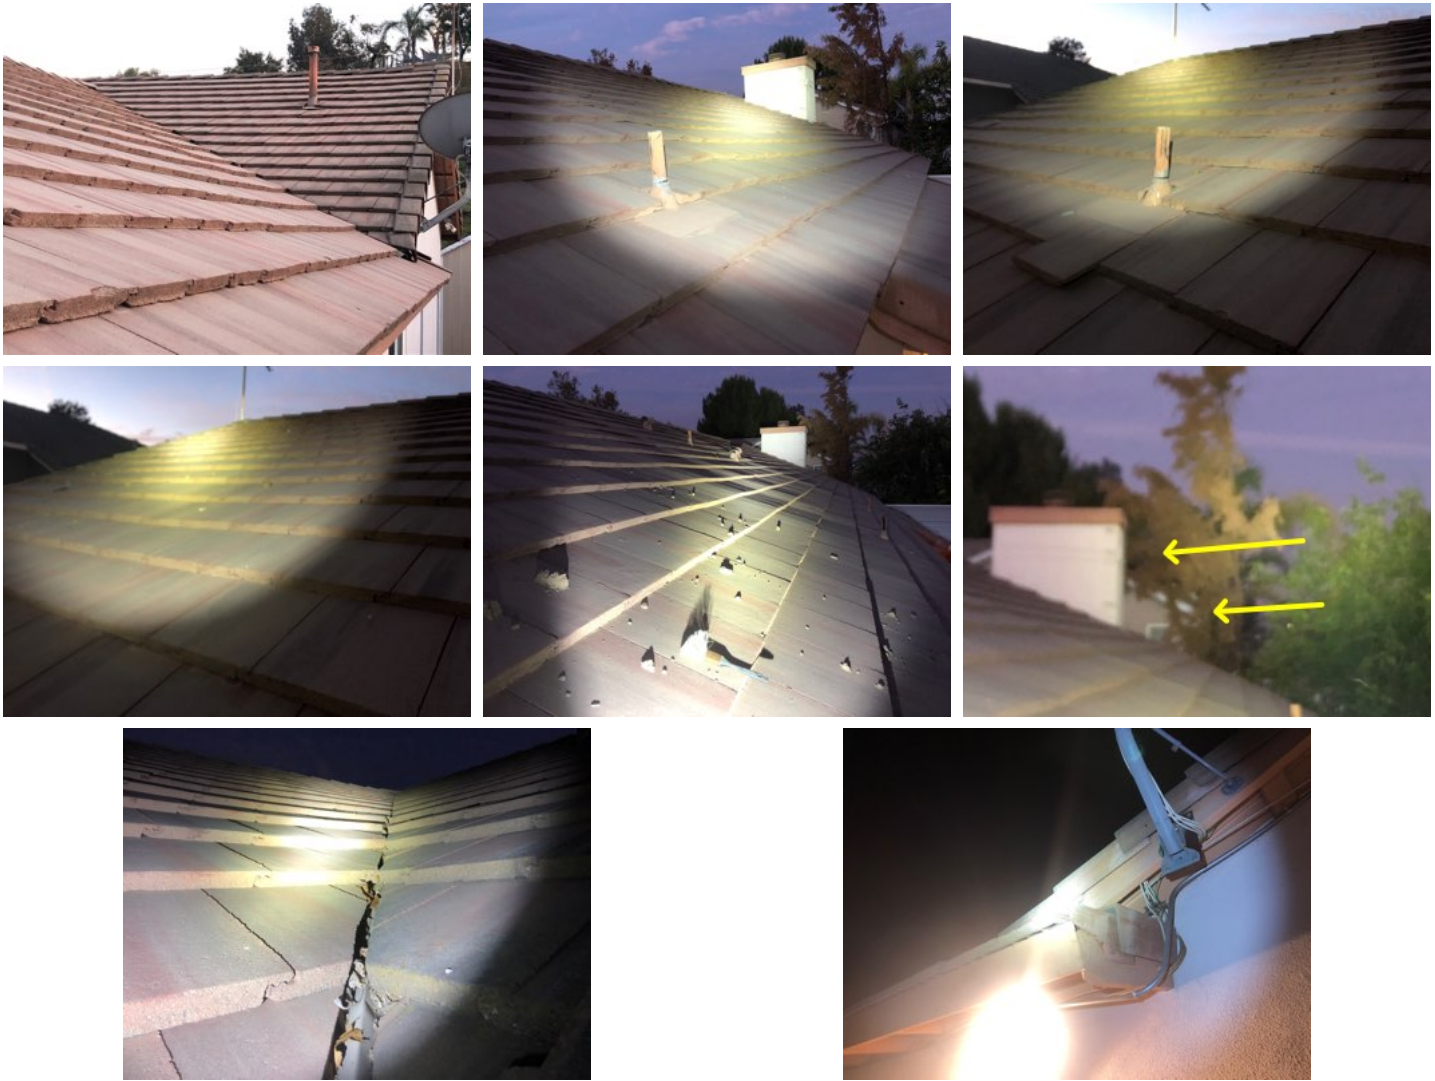
2.3. Debris noted at the Roof, **valley flashings**. May cause future leaks and/or damage. Recommend removing and further evaluation by qualified Roofer.

2.6. **Cracked and/or loose concrete/clay Tiles noted at left side eave. Have it checked, repaired by a qualified roofer.**

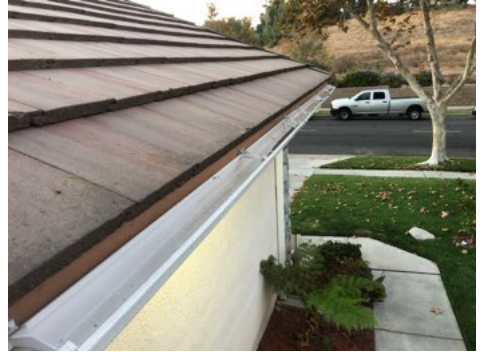
4.1. Building without proper full gutter system (missing at some sections). Recommend adding gutters and downspout(s) for proper drainage.

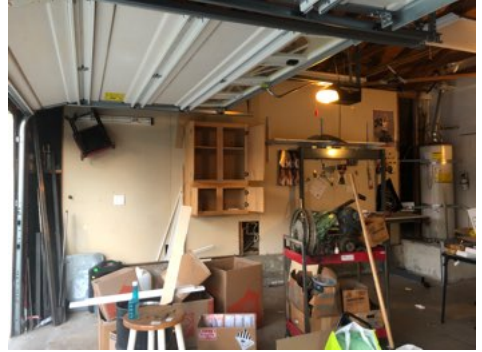
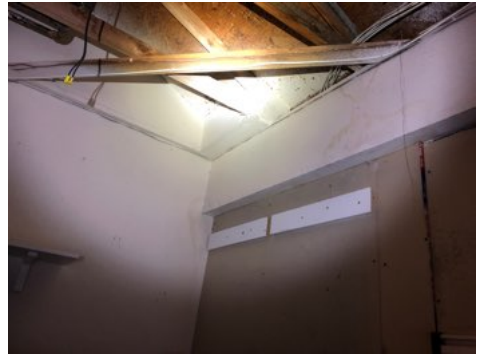
- 4.1. No major cracks, damage or holes noted at the time at visual part of the garage walls.
- 4.2. Holes were noted on the firewall. Have Sealed, necessary corrections made for fire safety by a qualified specialist.
- 4.3. Damage noted at water heater and/or utility platform/firewall. Have it checked, repairs made by a qualified specialist, contractor.
- 4.4. Moisture, Water stains present at garage walls from possible roof leak. Check with seller for known defects. Have it checked, necessary corrections/repairs made by a qualified specialist.

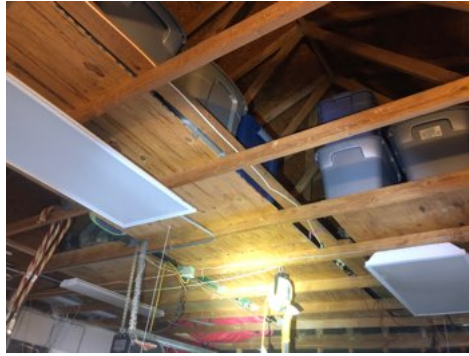
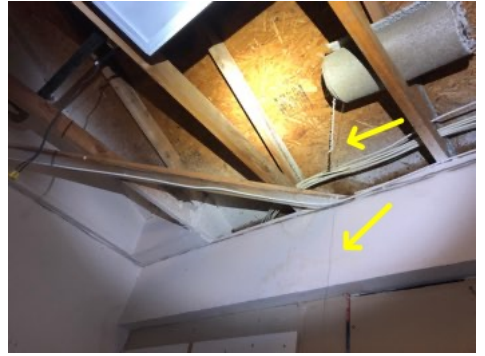
Stains

- 5.1. No major cracks, damage or holes noted at the time at visual part of the garage ceiling.
- 5.2. Dry Water stains at garage ceiling noted - Check the records and/or have it checked by a qualified specialist.
- 5.3. Recommend to remove overhead supported storage platform in garage due to added weight/stress to the structure.

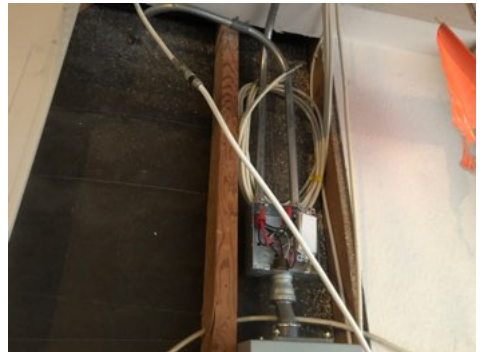
- 7.1. GFCI type outlet(s) noted in the garage - Recommend to test them periodically.
- 7.2. Open "J" box cover noted in the garage- exposed wires noted. Recommend to cover/correct by qualified electrician.
- 7.3. Exposed "Romex" type wires noted in the garage - Improper, subject to damage. Recommend to have checked, fixed by a qualified electrician.
- 7.4. Missing cover plate(s) and/or light cover(s). Have them checked, installed by a qualified specialist.

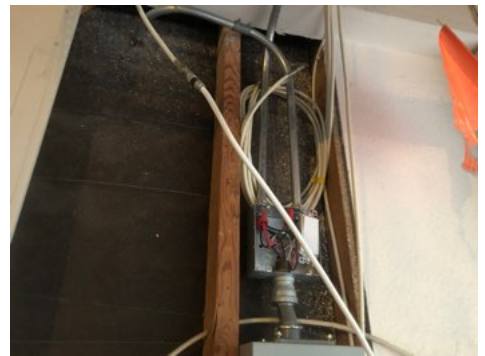
3.2. Exposed splices, missing box covers... Noted in the garage - A fire hazard/Safety concern. Have it checked, fixed by a qualified Electrician.

3.3. Exposed splices, wires at exterior post light - A fire hazard/Safety concern. Have it checked, fixed by a qualified Electrician.

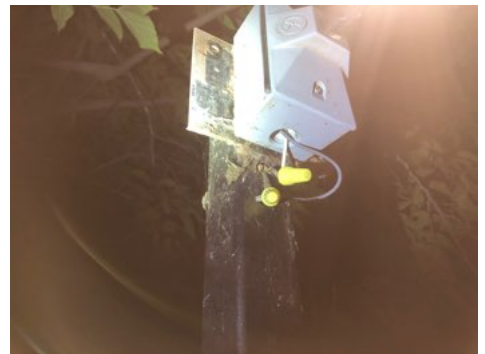
Rear patio- missing cover

4.5. Exterior outlet(s) without proper water proof cover noted. Recommend to install to prevent water seepage, damage.

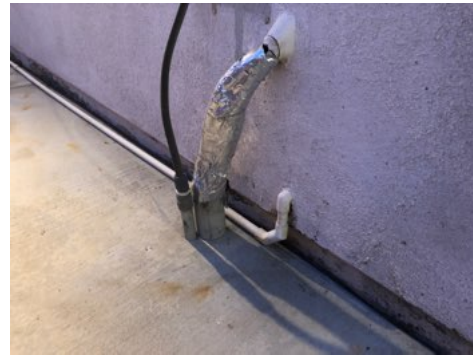
8.1. Worn insulation at refrigerant line noted at AC unit. Recommend to monitor and/or upgrade, correct.

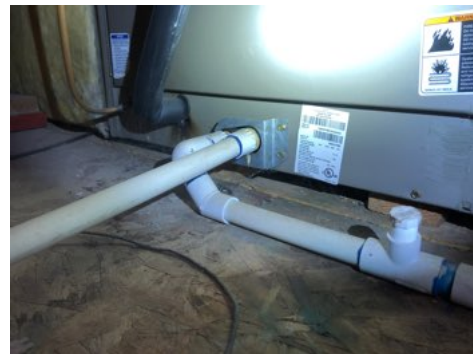
10.2. Missing secondary drain pan at evaporator (coil unit) in the attic. Recommend to install for added protection and to prevent leaks in the attic. Recommend to have checked by HVAC specialist for any necessary corrections made.

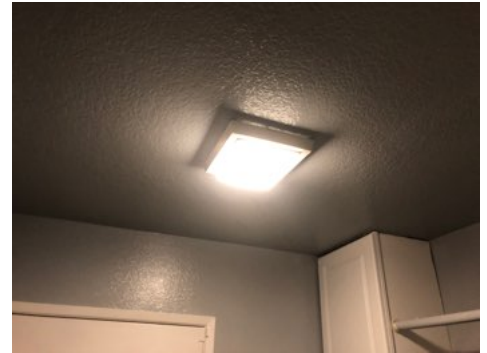
7.4. Noisy, dirty exhaust vent noted. Recommend to have it cleaned, recommend to upgrade.

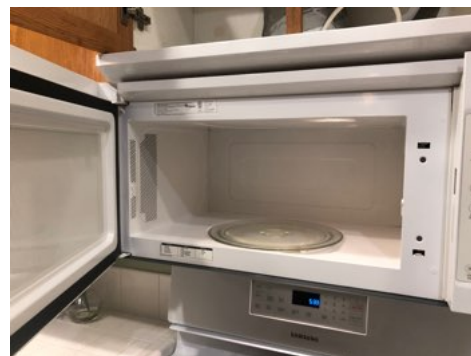
8.2. Hood, Microwave installed too close to the cook top/burner - Improper for fire safety. Have it checked, corrected

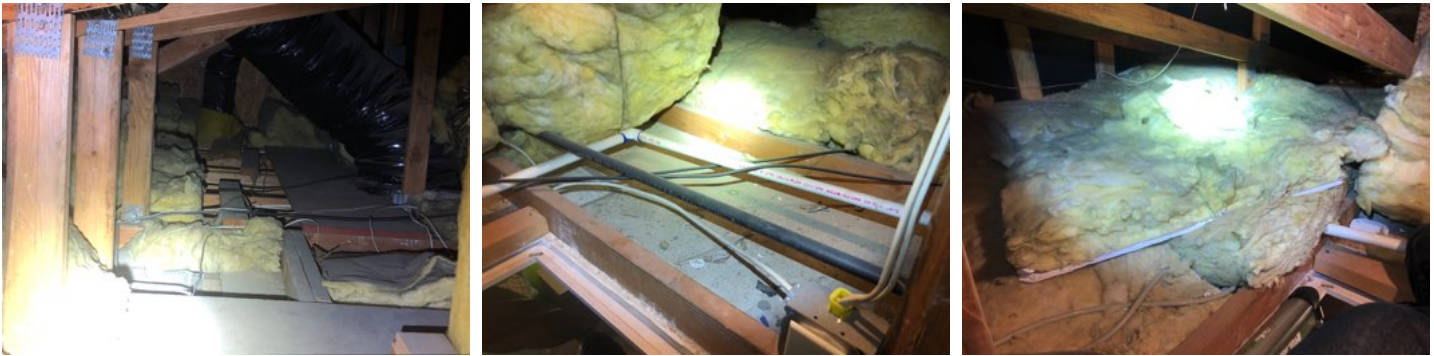
- 3.2. Some loose and/or missing insulation noted at attic space. Have it checked, fixed.
