Property Inspection Report

118 N Kings Rd #203, Los Angeles, CA 90048
Inspection prepared for: Rushabh Shah
Real Estate Agent: Tyler Kunkle -

Date of Inspection: 6/22/2020 Time: 8:00 AM
Age of Home: 2013 Size: 1414 sq. Feet
Weather: Cloudy
Order ID: 124

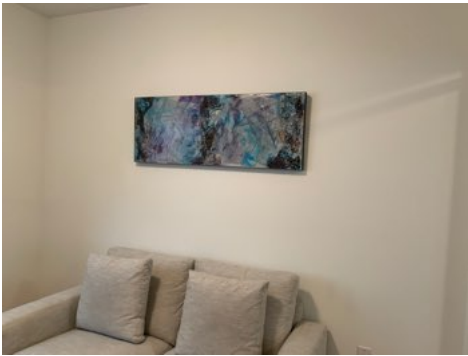
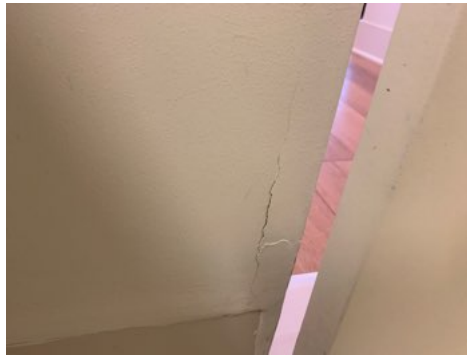
- 2.1. No major defects noted at interior walls time of inspection. FYI
- 2.2. **Common cracks and/or anchor holes were noted at the interior walls.**
- 2.3. **House was occupied at the time of the inspection (walls were not fully visible) - Recommend to check the records for any known defects and/or repairs.**

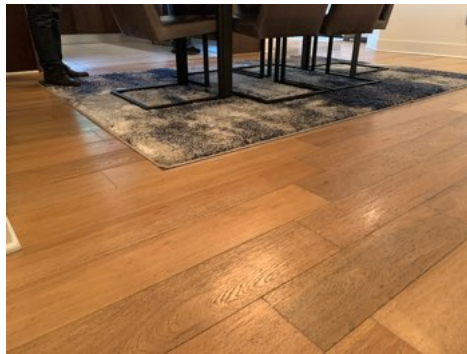
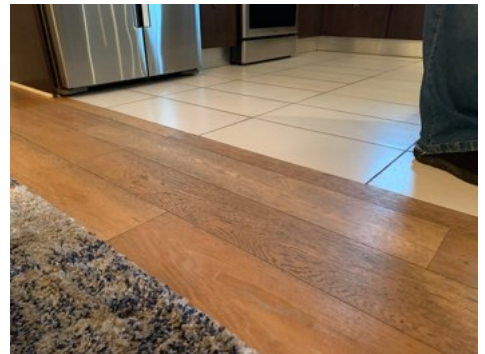
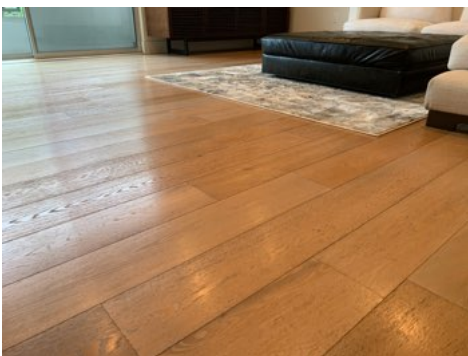
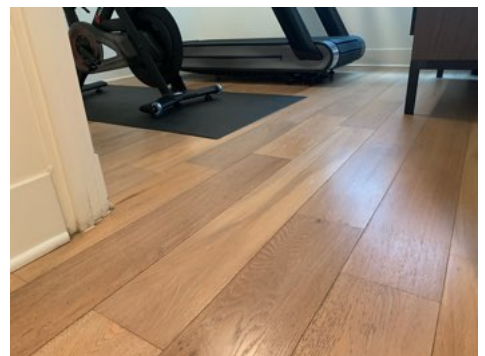
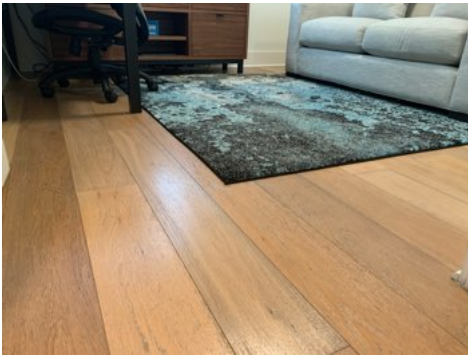
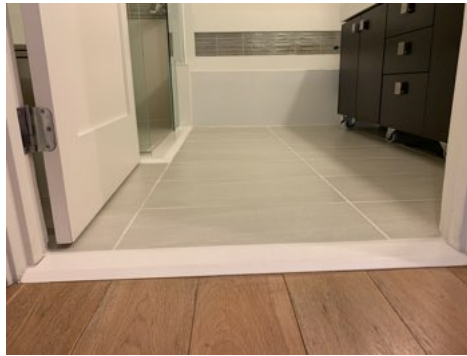
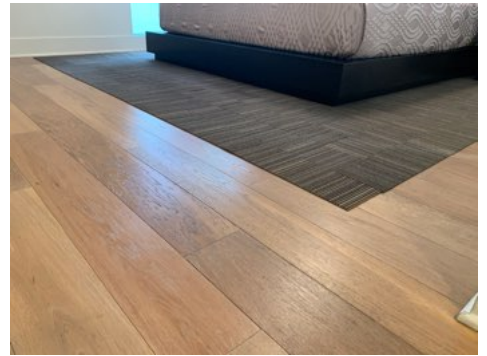
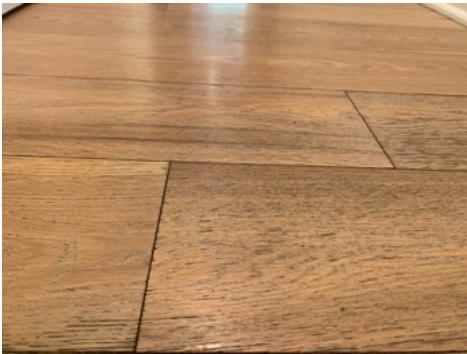
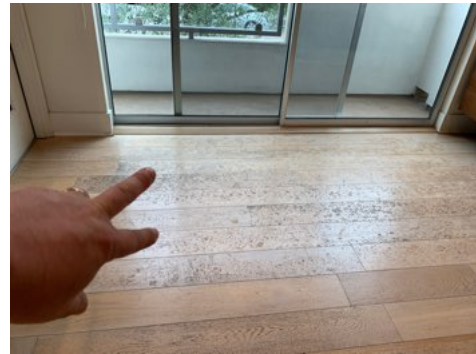
3.3. Uneven areas, sloping was noted at various areas of the flooring. Check the records for any known defects, repairs and/or have it checked by a qualified specialist(s).

3.4. Worn, aged flooring materials, scratches/scuff marks noted at floor(s) of the inspected property. May need repair/replacement. Have checked by qualified specialist.

3.5. Trip hazards noted due to differing flooring material heights. FYI

3.6. Some expanded gaps noted at flooring material joints. In need of further evaluation, corrections by a qualified floor specialist.

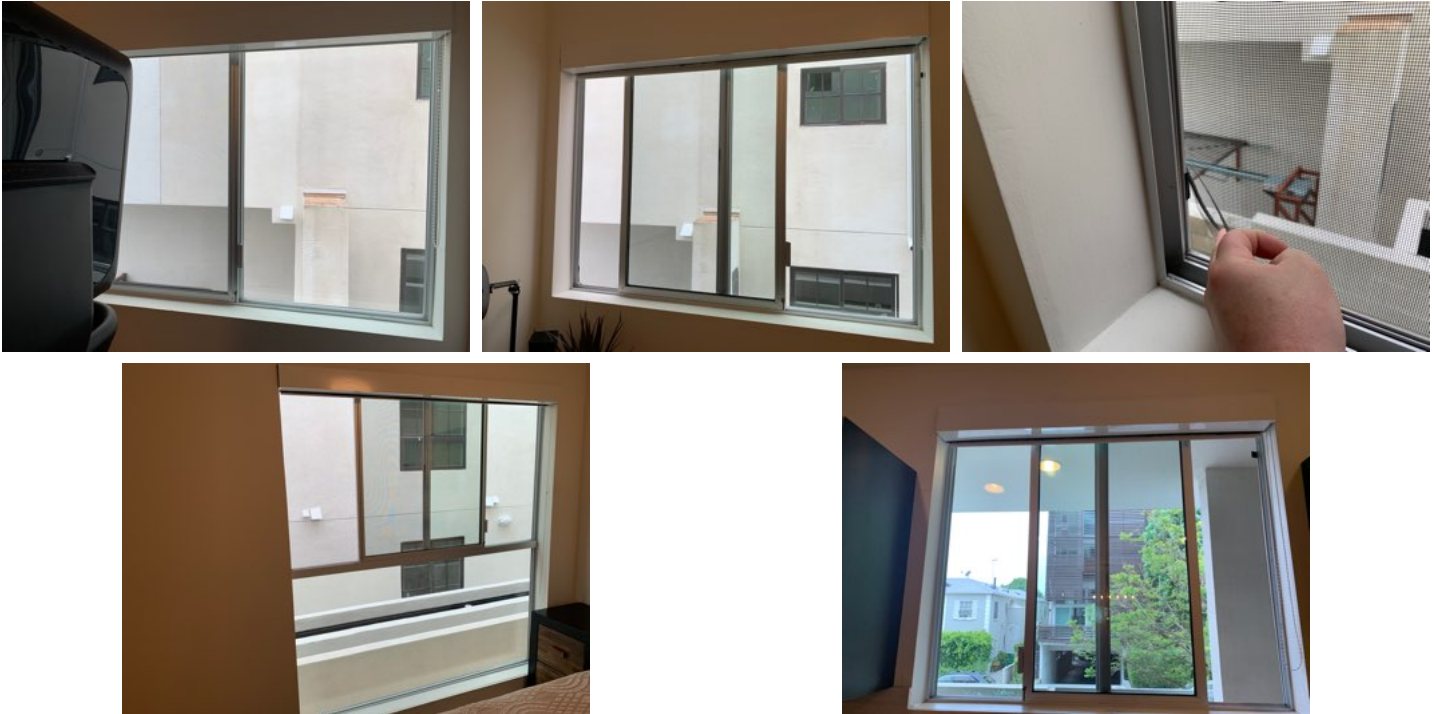
5.3. Screens at Office window was loose/damaged noted. Have checked, repaired/replaced by a qualified specialist.

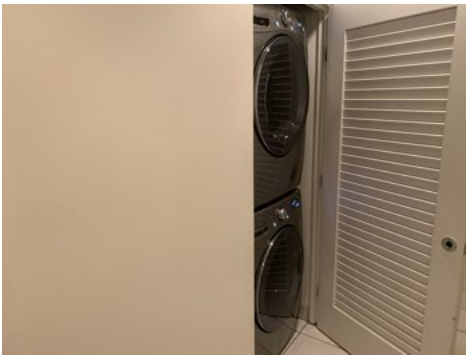
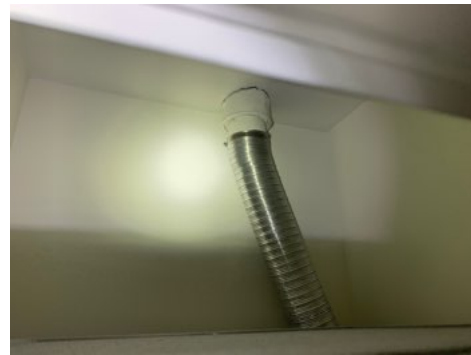
7.4. Washing machine, laundry area without catch pan and/or drainage pipes. Recommend to install if possible to prevent damage when machines leak.

7.5. 20 **GFCI** Amp outlet is recommended at laundry as a safety upgrade. Have checked by a qualified specialist for correction.

7.6. Laundry closet door not closing/patching properly- recommend to correct.

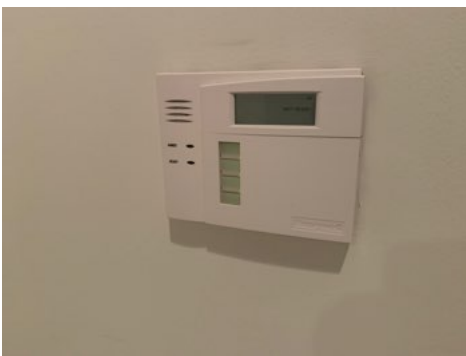
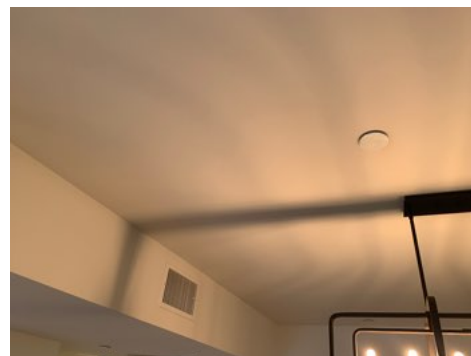
9.1. Alarm, security systems are not inspected or tested at time of inspection. Check the records, check with seller for operation or known defects.

9.2. Fire sprinkler system is not tested or part of this inspection. Check the records, with seller of any known defects, warranties

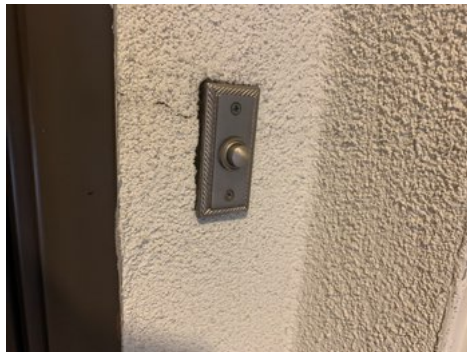
8.1. Door bell(s) functional at the time. (FYI)

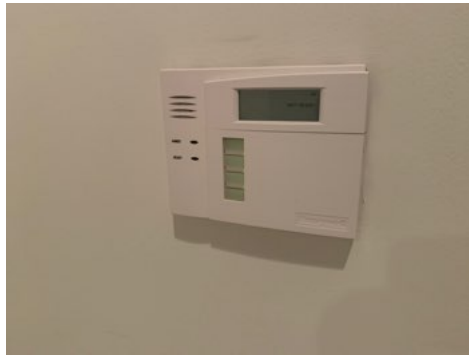
9.1. Low Voltage systems (phone, cable, security, intercom, sound...) not part of this inspection. Check with the seller.

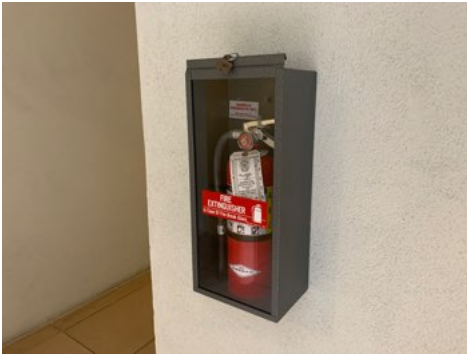
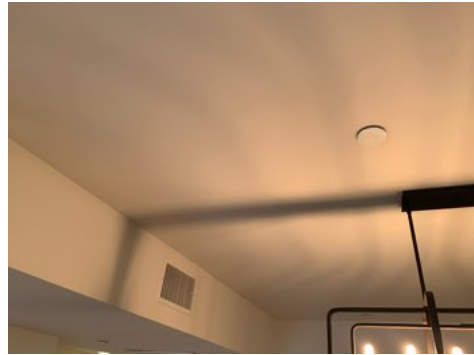
10.1. Building with Fire sprinkler system type - Not part of this inspection. Check the records for any known defects, repairs. Check the service records.

10.2. Fire extinguishers and/or hoses noted - Check the service records, contracts.

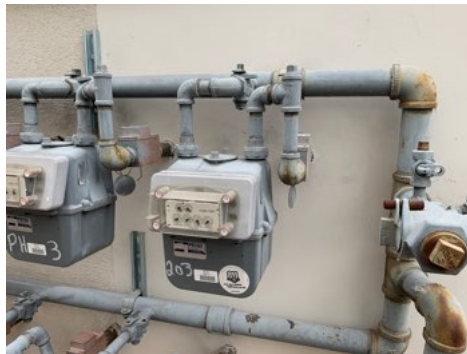
4.1. Gas meter(s) - seismic shut off was present at the time of inspection. (FYI) Not tested at this inspection check the records. Most of the plumbing pipes not visible at this inspection. Check the records for any known defects, repairs.

4.2. **This is a limited visual inspection of the gas system. We have partial access to burn chambers and other interior appliance parts only, and no way to inspect underground/interior wall pipes. Check records, permits for any known issues or repairs - Gas leaks and pipe testing is not part of this inspection The Gas Company has it's own testing methods, which are more intensive, and updated periodically. Recommend contacting the Gas Company for a complete inspection of the gas system and associated appliances before close of escrow.**

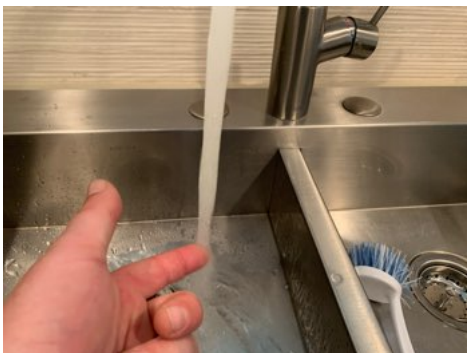
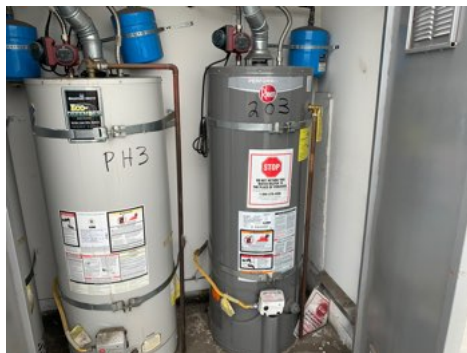
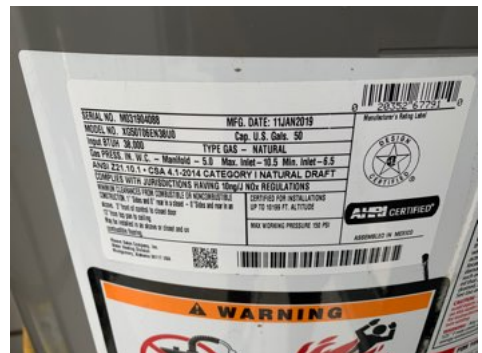
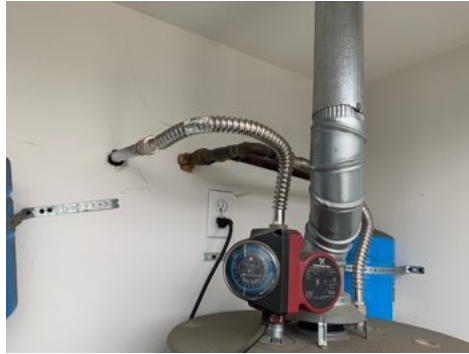
5.2. Gas line at water heater without drip leg/sediment trap, these serve as a collection area for sediment to reduce the chance of clogging gas valves and burners, dirt and scale can enter the gas valve and possibly cause malfunctions and may void any remaining appliance warranty (this type installation is common for the area/age) - Check with your Home Warranty provider. Have checked, installed by qualified plumber.

5.4. **TPR valve** line terminates unsafely. Recommend to extend outside into a safe location.

5.5. Water heater lacks a catch pan with exterior routed line. Recommend to install.

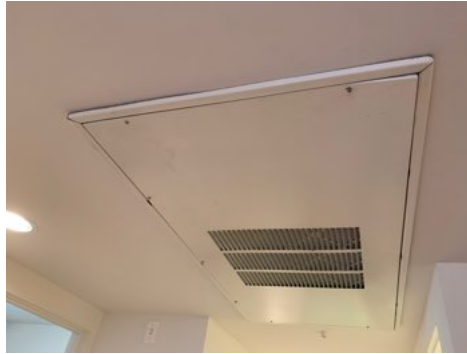
1.2. Recommend to check the service history with the Seller and to have the unit(s) serviced by a qualified HVAC Contractor if not performed in the past year. Air flow is not a part of this inspection. Recommend to check the disclosures regarding day to day functionality. No service tags noted. This is a limited Visual Inspection - Recommend to have the unit(s) evaluated by a qualified HVAC Contractor. Annual service, evaluation and maintenance is recommended with gas fired furnaces.

1.3. Typical Lifespan of heat unit(s) are 15 to 20 years. Recommend to have a qualified HVAC specialist to inspect and/or evaluate the entire system to have a better understanding and expected life span of the HVAC system.

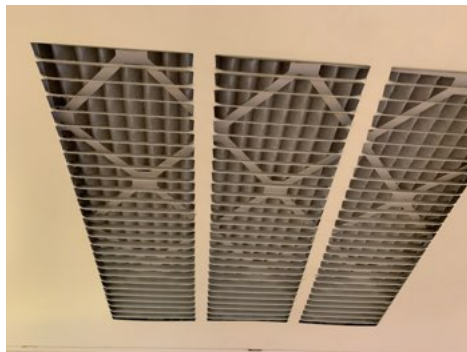
2.1. Air filters should be changed or cleaned regularly according to Manufacturer's instructions (seasonally and/or every 3-4 months recommended). Air flow, balance is not a part of this inspection. Recommend to check with the seller about air comfort and distribution.

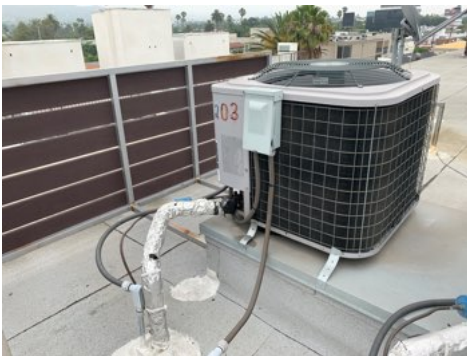
5.2. Recommend to check the service history with the Seller and to have the unit serviced by qualified HVAC Contractor if not performed in the past year. No service tags noted at the unit. Air flow/balance is not a part of this inspection. Recommend to check the disclosures regarding day to day functionality.

5.3. Ambient air test was performed by using thermometers on air handler of Air conditioner to determine if the difference in temperatures of the supply and return air are between 14 degrees and 22 degrees which indicates unit is cooling as intended. The range in Temperature drop was normal at the time of the inspection (FYI).

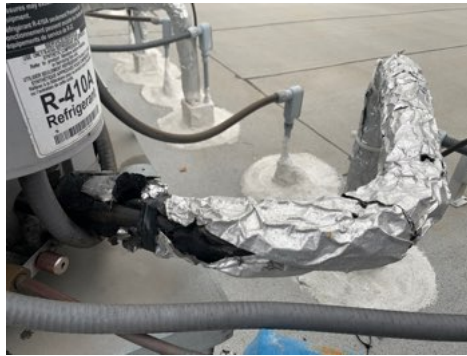
6.1. Worn insulation at refrigerant line noted at AC unit. Recommend to monitor and/or upgrade, correct.

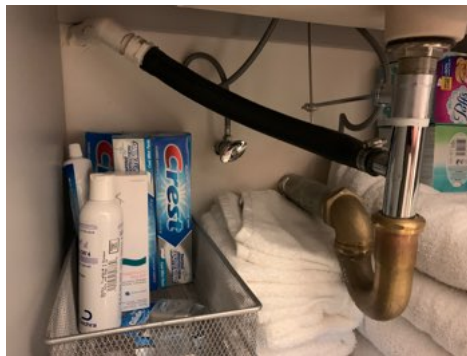
8.1. **A/C** condensation line drains at bathroom sink (FYI). Periodic cleaning, service required.

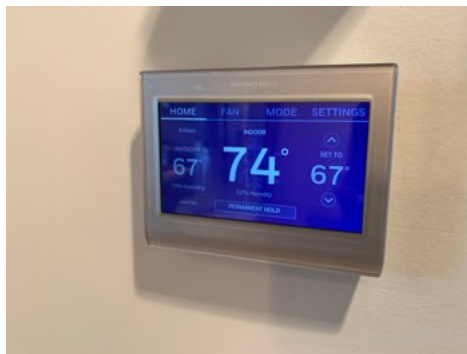
9.1. Thermostat(s) operational at the time of inspection. (FYI)

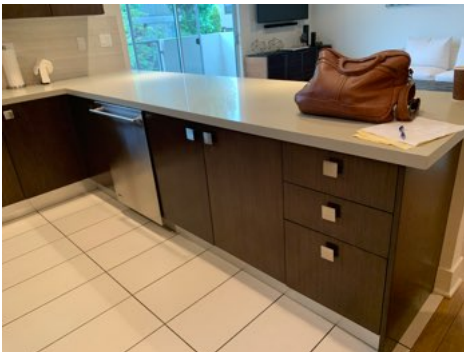
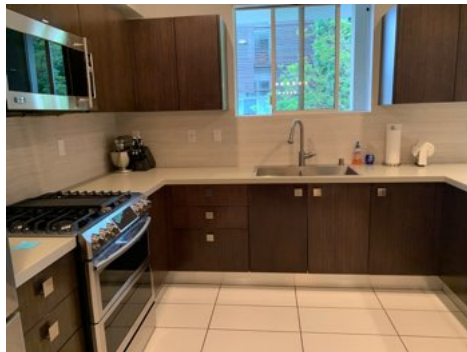
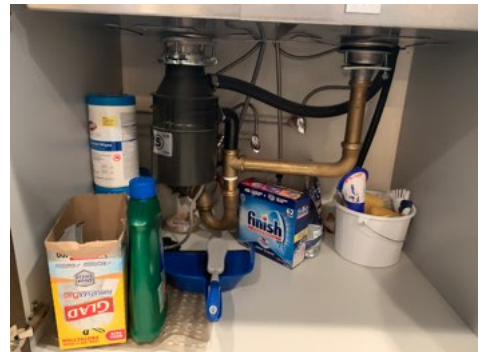
2.2. **Wear and general age defects were noted to counter, cabinets at the time of inspection.**

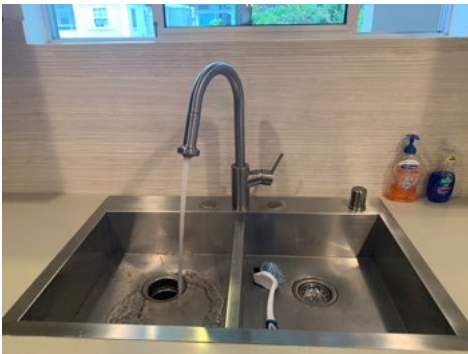
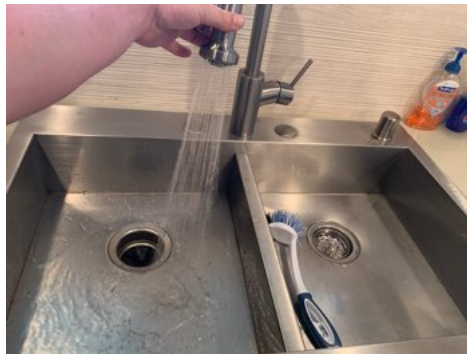
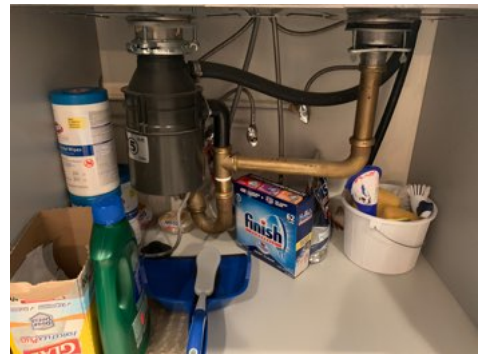
3.1. Sink faucet(s) functional at time of inspection.

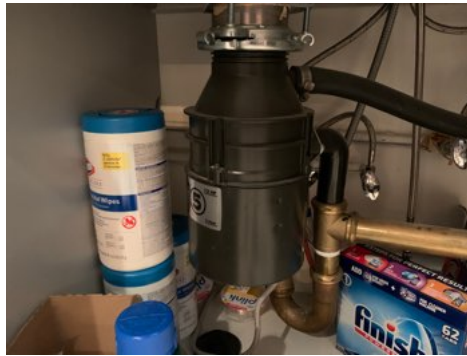
4.1. Unit operated at the time. (FYI)

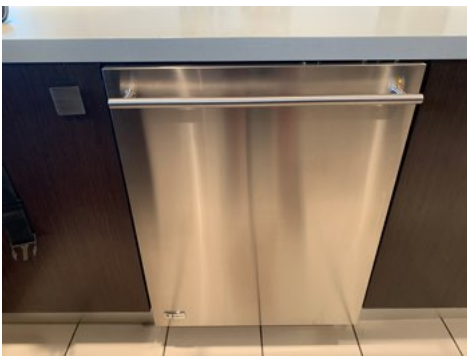
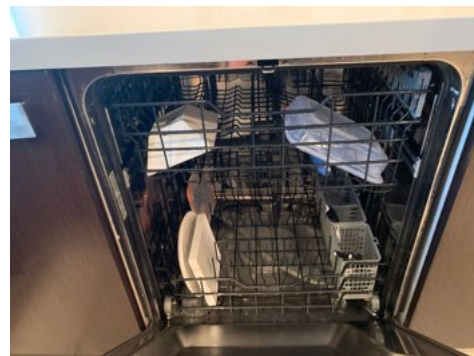
5.1. Dishwasher operated at the time. (Appliances are not removed at this type of inspection. There can be damage, defects not visible as a result). We recommend to check the records, with seller regarding any known defects or issues.

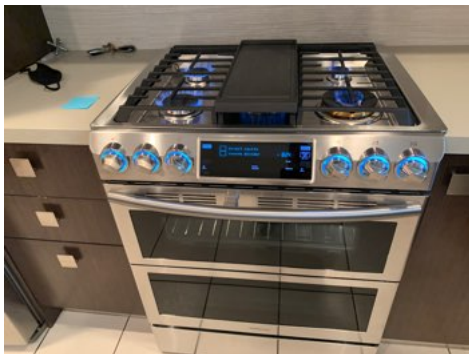
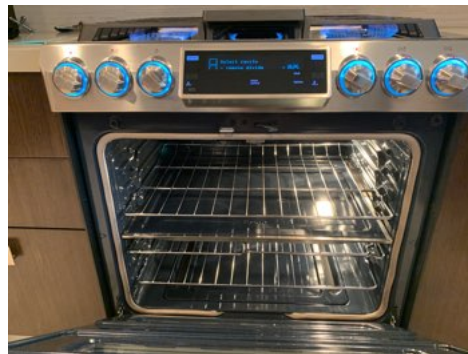
6.2. **Missing Anti-Tip Device at the freestanding range - Recommend to add for safety concerns. Consult a licensed specialist for proper installation.**

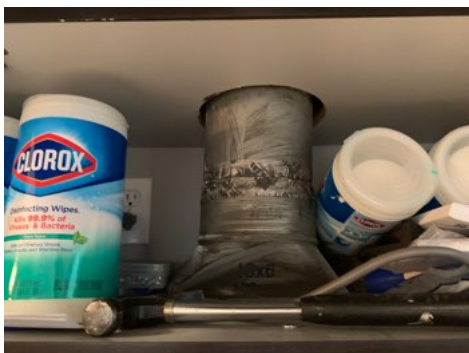
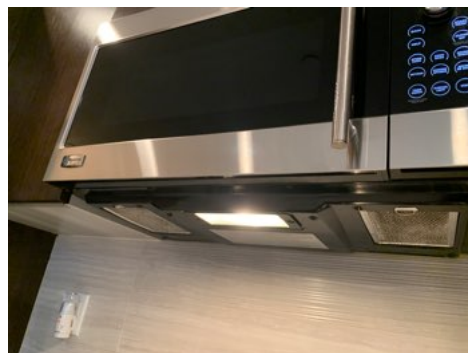
7.1. Operational at the time. (FYI)

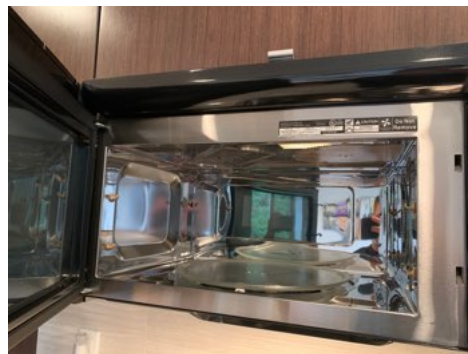
8.1. **Microwave noted - Not part of this inspection. Check with the seller. Proper operation and/or microwave leak is not part of this inspection. We turn the unit on and off and check for visual damage.**

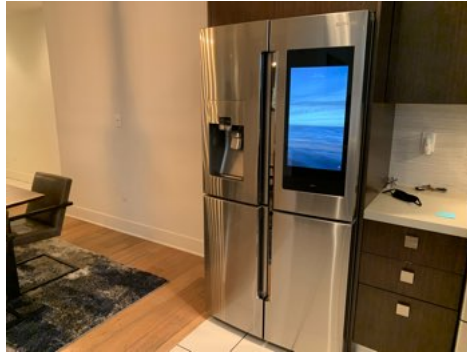
9.1. Refrigerators are not part of this inspection. Recommend to check the records with the seller for any known defects, repairs. Appliances are not removed at this type of inspection. There can be damage/defects not visible as a result. We recommend to check the records, with seller regarding any known defects/issues.

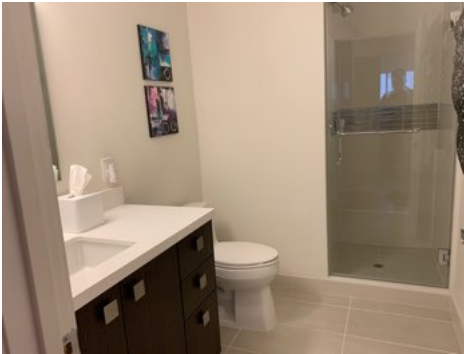
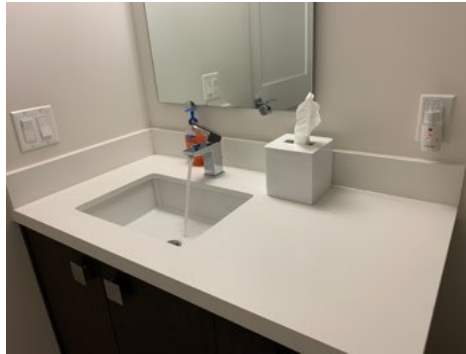
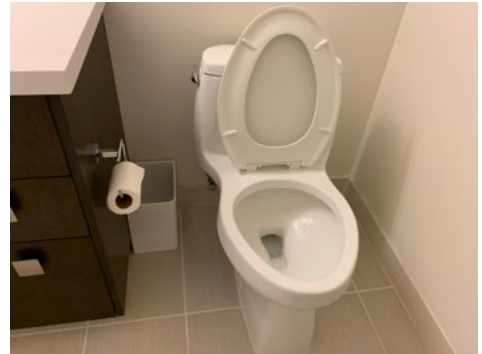
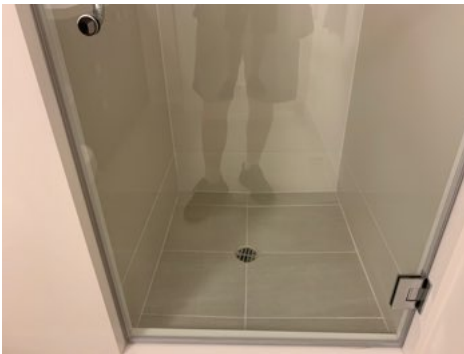
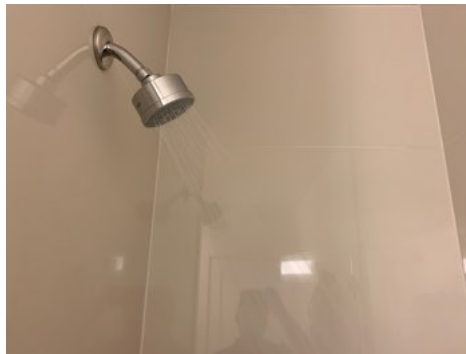
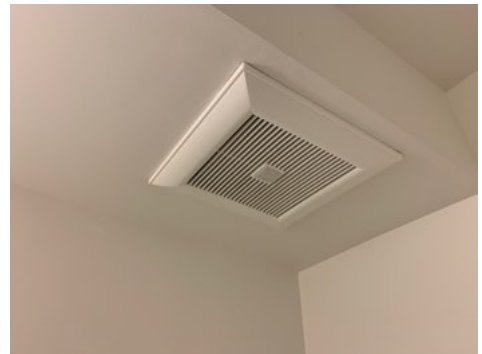
- Toilet, Sink(s), Shower
- Exhaust Fan

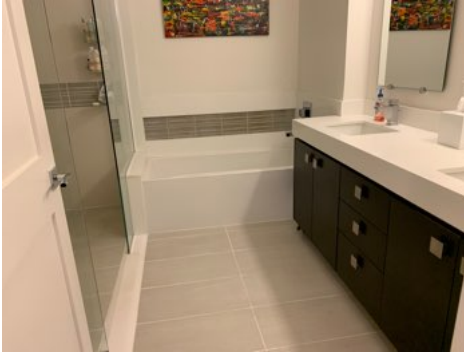
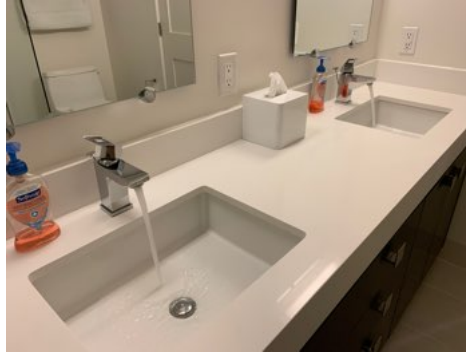
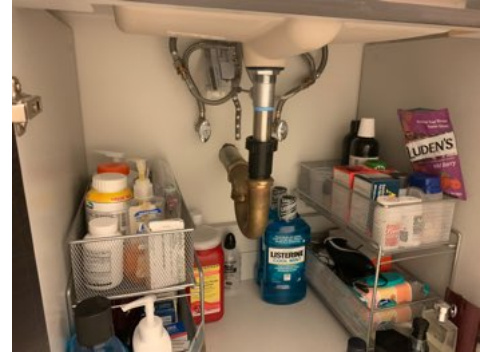
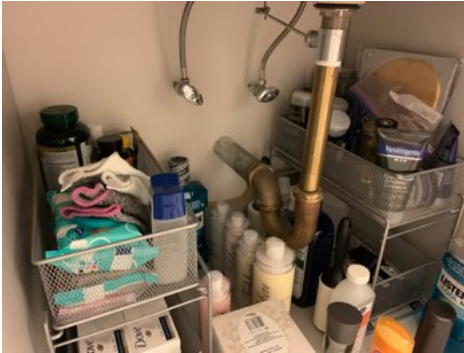
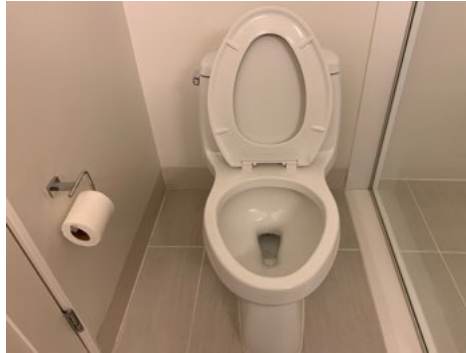
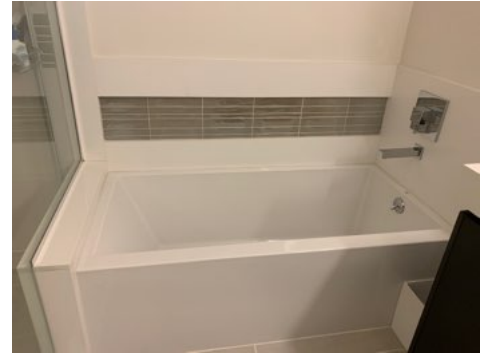
- Toilet, Sink(s), Tub, Shower
- Exhaust Fan

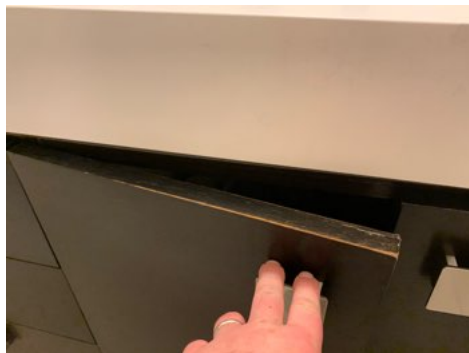
- 3.1. Age defects, wear noted to cabinets, counter.

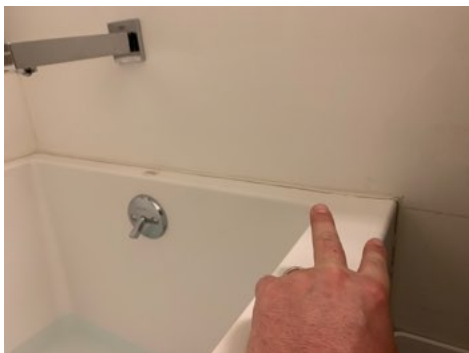
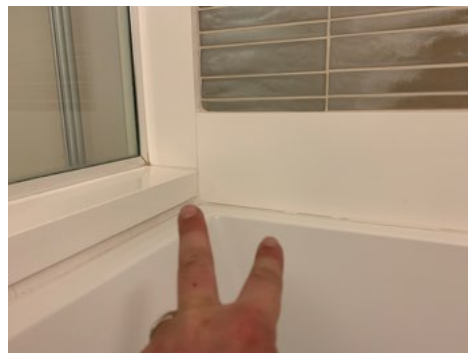
- 4.1. Cracked, dirty caulking noted at tub enclosure. Recommend to re-caulk at tub tiles and enclosure.

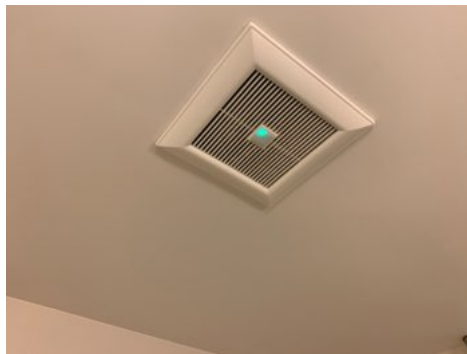
7.1. Dirty exhaust fan(s) noted. Recommend to clean, service.
