Property Inspection Report

210 E Rialto Ave, San Bernardino, CA 92408
Inspection prepared for: Jose Ramirez Oscar Moreno
Real Estate Agent: Fernando Calderon -

Date of Inspection: 7/7/2020 Time: 11:00 AM
Age of Home: 1924 Size: 1234 sq. Feet
Weather: Clear
Order ID: 130

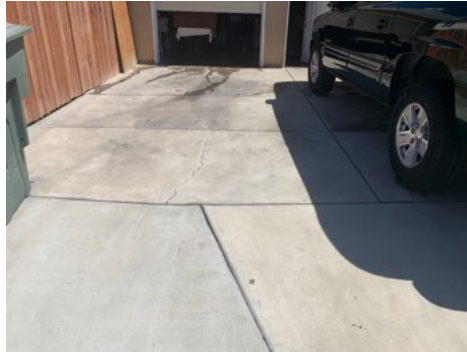
1.1. Common Cracks present at driveway/sidewalk surfaces.

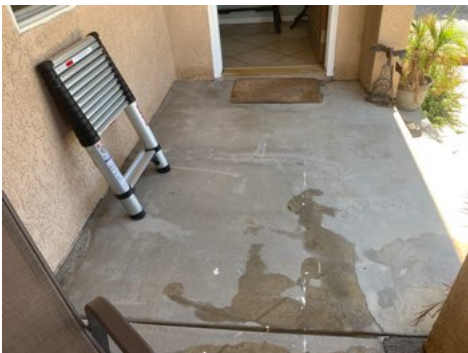
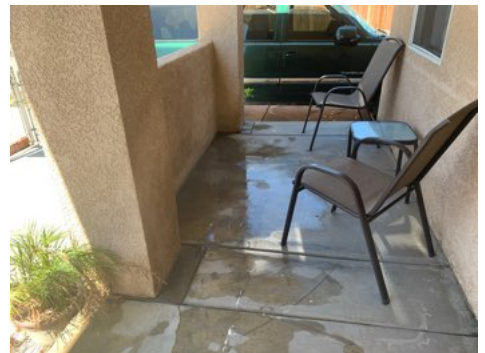
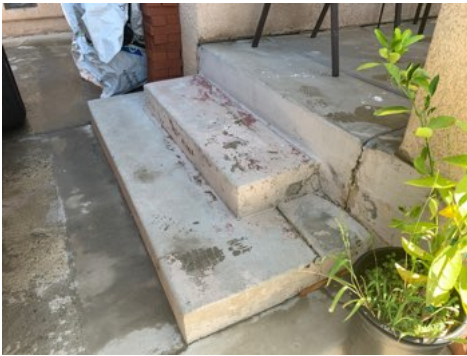
3.2. Uneven rise was noted at exterior steps- this condition present trip hazards.

3.3. Wall to deck flashing not visible, covered, and/or missing - Improper. Possible seepage can occur. Have it checked by a qualified specialist.

Recommend to have checked, any necessary corrections made by a qualified contractor.

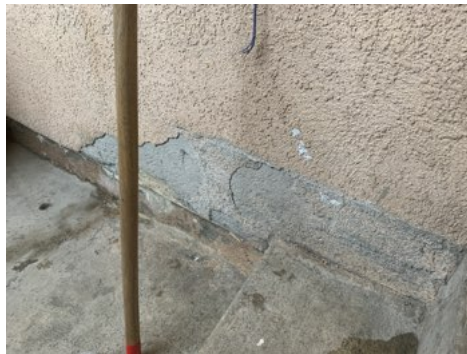
6.2. Cracked, damaged areas noted at stucco wall at rear porch area - In need of patch, paint, Repair. Have it checked by a qualified contractor(s).

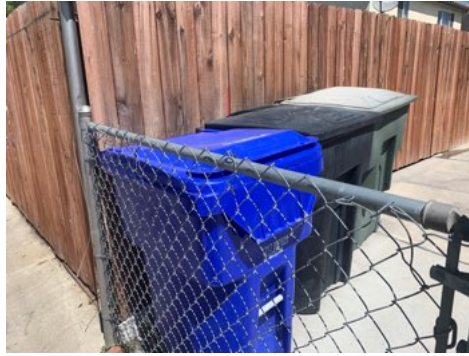
9.4. Fence at rear built close to structure, unable to walk/access most of rear side of house- unable to determine property line at time of inspection. FYI

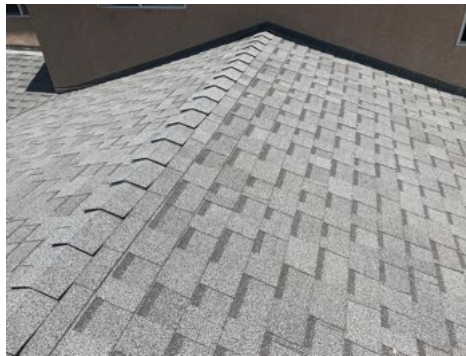
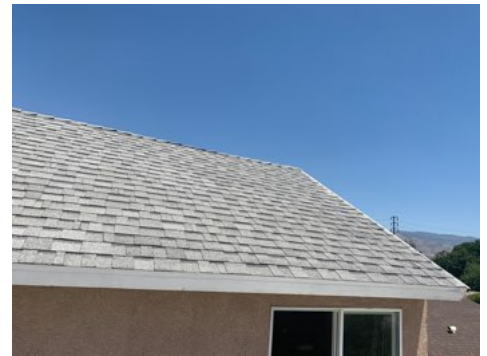
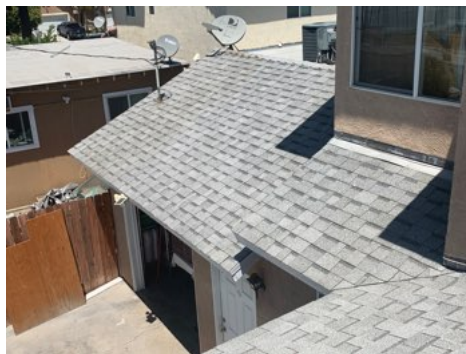
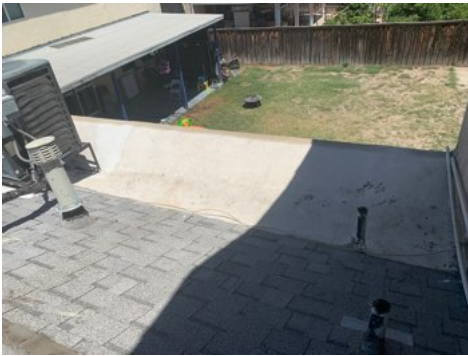
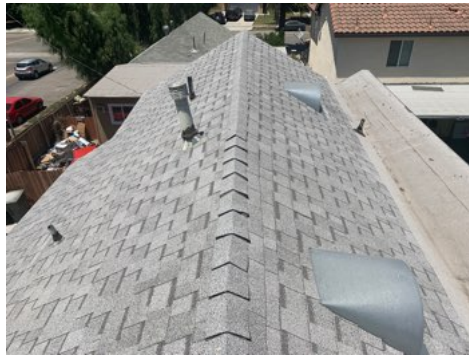
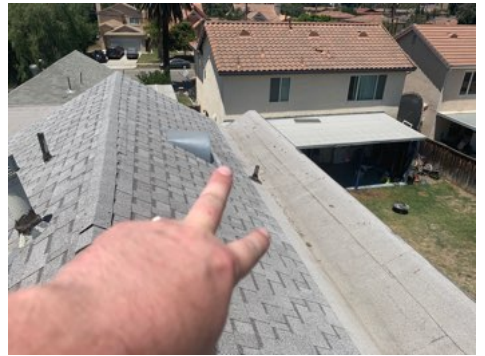
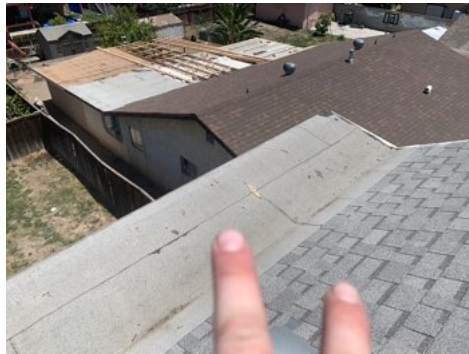
2.4. Aged flat roof cover noted. Recommend to apply roof coating to prolong life of the roof. Have it checked by a qualified roofer.

2.5. Yearly roof service contract with a qualified Roofing Company is recommended.

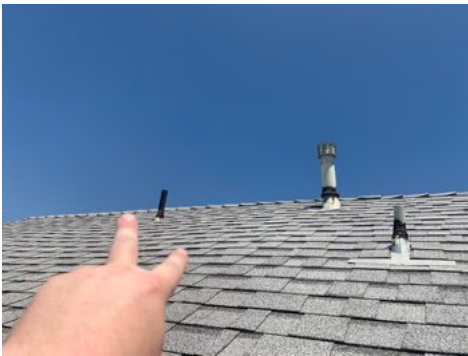
3.1. Exposed fasteners/nails noted at the roof flashing(s). Recommend to seal to prevent leaks. Have checked, corrections/maintenance performed by qualified roofer

Not seaed

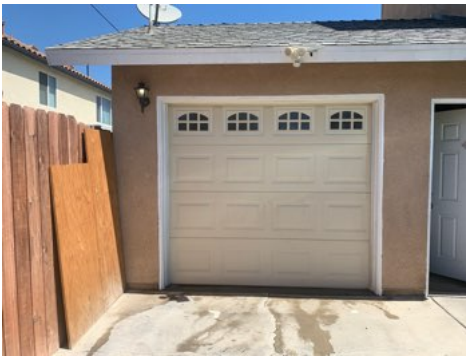
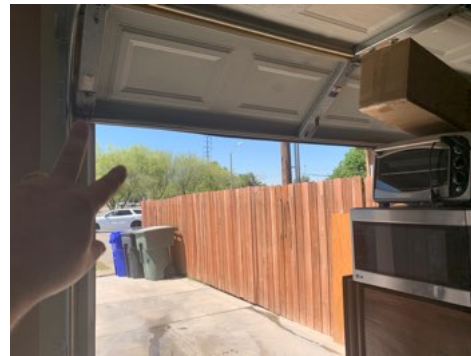
2.3. Garage door not balanced right, door shuts into own when halfway open. Have checked, corrections made by qualified specialist.

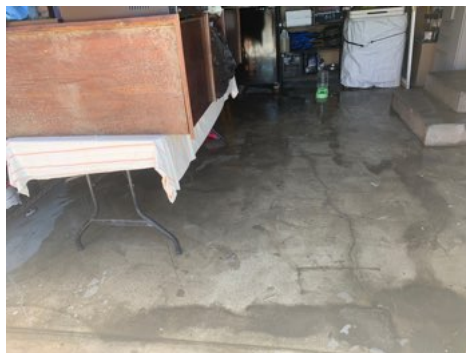
3.1. Common cracks up to 1/4" were found on the garage floor.

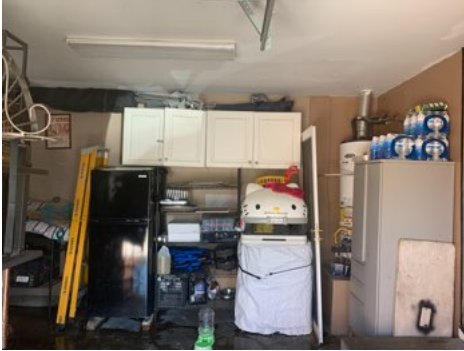
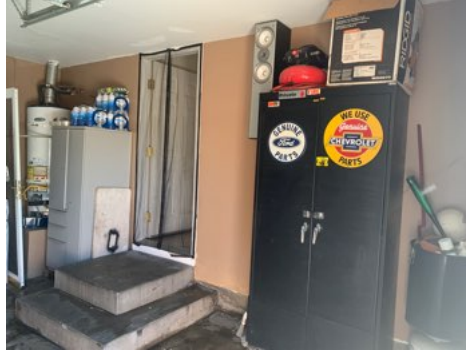
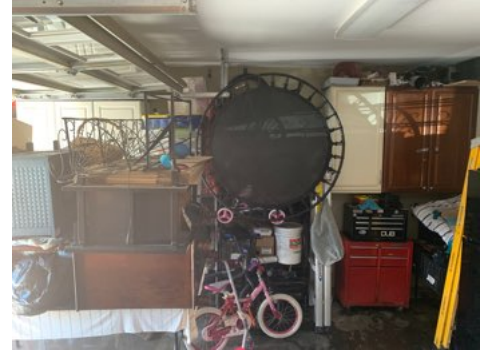
- 4.1. No major cracks, damage or holes noted at the time at visual part of the garage walls.
- 4.2. **Not fully visible due to belongings. Recommend further evaluation by a qualified structural pest specialist.**

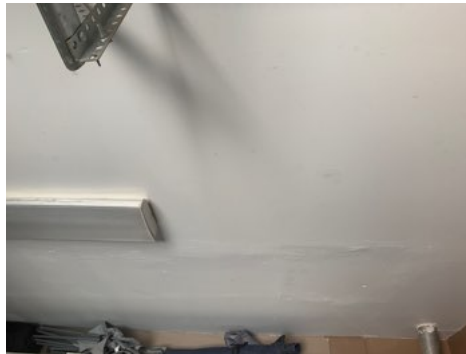
- 5.1. Prior patchwork at garage ceiling noted. Check the records and/or with seller of known defects, repairs.
- 5.2. Ceiling joists were not visible to comment at the time - Check the records for any known defects, repairs.

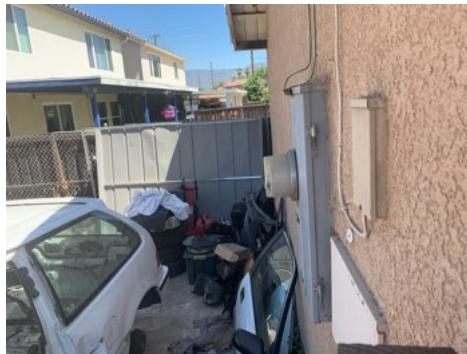
9.1. Garage was installed too close to neighbors yard, unable to fully view, access side and/or rear of garage. Have it checked.

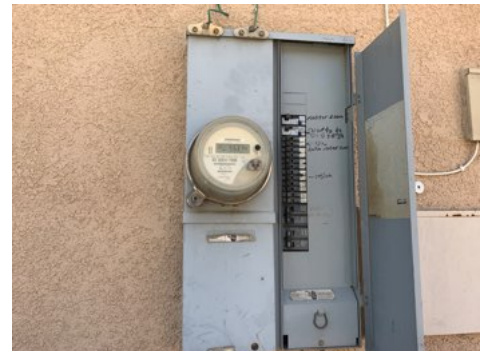
2.2. Ground rod and clamp not visible at the meter base. Possible ground rod/clamp was installed the wall (UFER ground) - was not accessible at the time. Check with the seller/building records and/or have it checked by a qualified electrician.

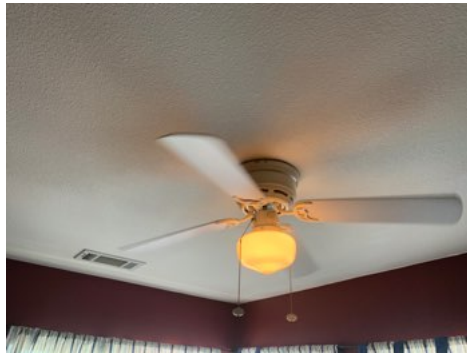
Missing light cover

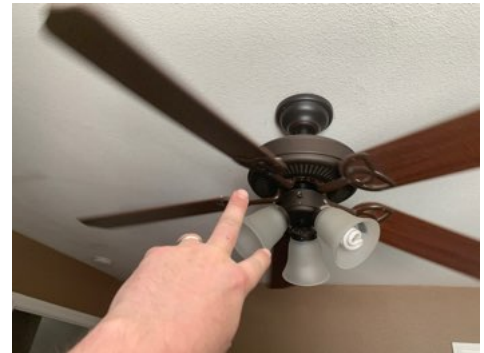
- 6.6. Damaged and/or missing light cover(s) at interior noted. Have checked, corrections made by qualified electrician.
- 6.7. Newer fixtures noted. Recommend to check the records, permits.

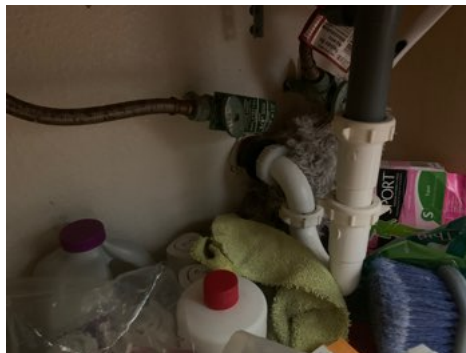
1.4. Newer ABS type waste pipes noted - Recommend to check the records, permits.

1.5. Most of the Sewer, Waste pipes are located underground not fully visible/accessible and not part of this inspection. A sewer video inspection must be completed prior to close of escrow by a qualified plumber in order to determine the true condition of the Sewer, Waste line.

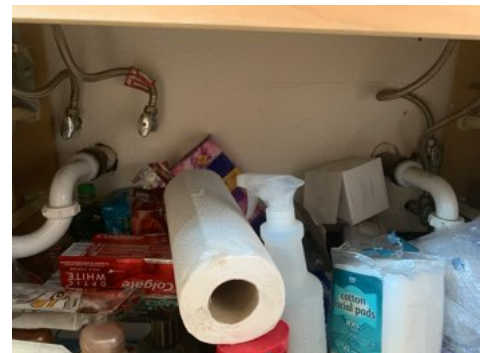
Not sealed

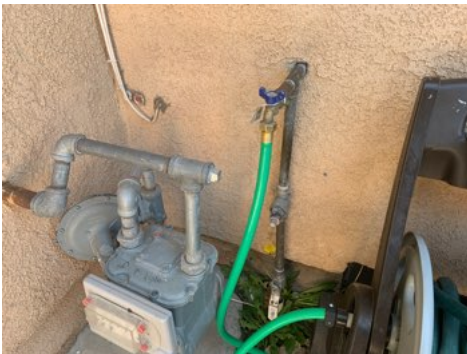
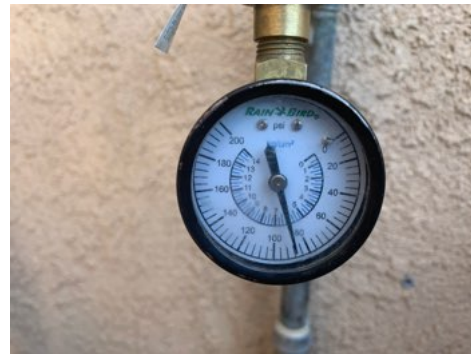
2.3. Water pressure is too high, measured at - 90 PSI - recommend adjustment, repair, replacement of the regulator to below 80 PSI.

90 psi

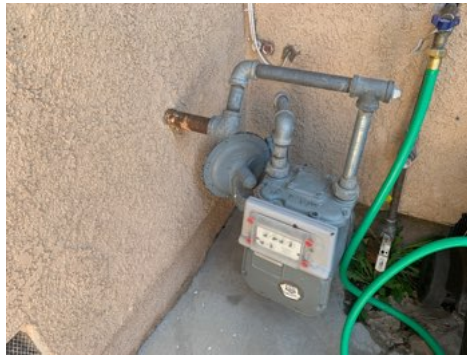
4.2. Gas meter - Seismic shut off was not present at the time of inspection, recommend to install - May not be required in the City of Location - Recommend to check the local regulations.

4.3. Underground gas pipe noted (type unknown). Have it checked for possible gas leak. Gas leaks or pipe testing not part of this inspection. Recommend to check the building records, permits for any known issues or repairs regarding gas pipes, fuel systems and/or have it tested by the Gas Co. and/or a qualified plumber.

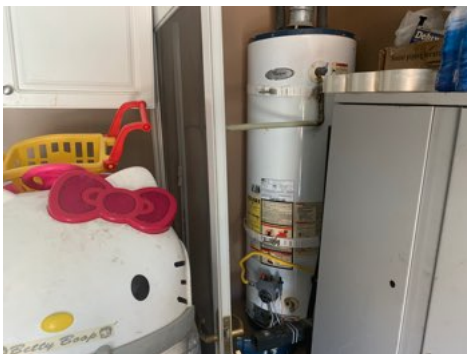
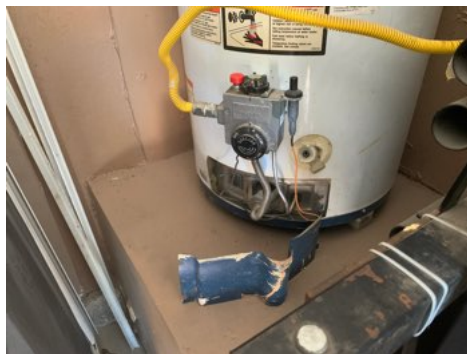
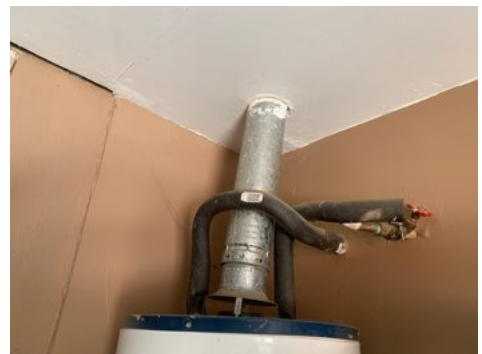
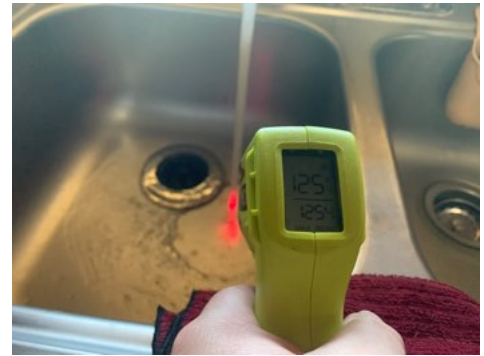
5.2. Gas line at water heater without drip leg/sediment trap, these serve as a collection area for sediment to reduce the chance of clogging gas valves and burners, dirt and scale can enter the gas valve and possibly cause malfunctions and may void any remaining appliance warranty (this type installation is common for the area/age) - Check with your Home Warranty provider. Have checked, installed by qualified plumber.

5.3. Seismic straps are too loose and/or improper bracing noted at water heater. Have it checked, fixed by a qualified specialist.

5.4. Unit is near end of life due to age (Life span of this type units are 10 to 12 years). Recommend to monitor/replace and retrofit to today's safety standards.

5.5. Loose cover plate at burner noted - recommend to install/correct.

5.7. Water heater lacks a catch pan with exterior routed line. Recommend to install.

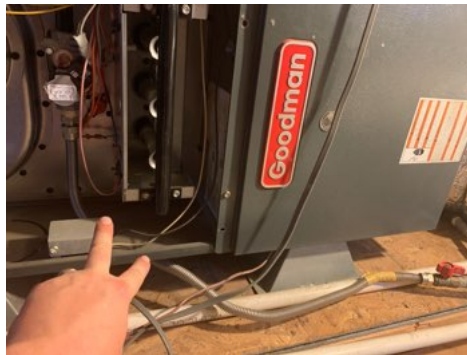
3.1. Gas line at heater(s) without drip leg/sediment trap, these serve as a collection area for sediment to reduce the chance of clogging gas valves and burners, dirt and scale can enter the gas valve and possibly cause malfunctions and may void any remaining appliance warranty (this type installation is common for the area/age) - Check with your Home Warranty provider. Have checked by a qualified plumber for correction.

3.2. Flex type gas line runs in the body of the FAU/Furnace - Improper - Subject to damage. Recommend to install rigid type pipe extension.

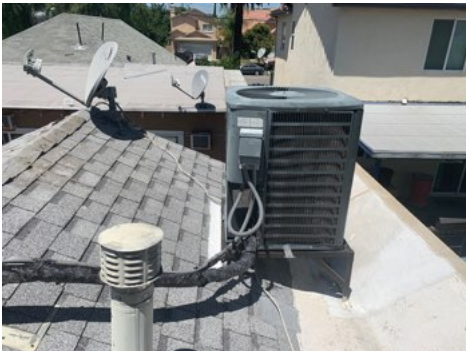
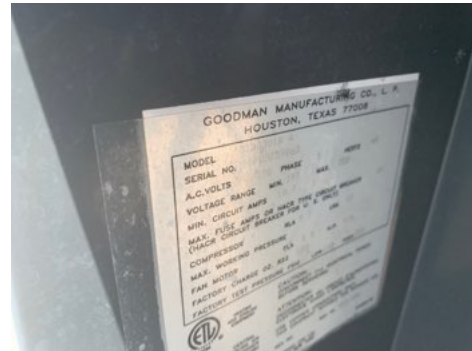
7.5. AC unit is using R - 22 refrigerant. After 2020 contractors may not be able to purchase R - 22 refrigerant for servicing this type AC units. Recommend to consult with a qualified HVAC contractor for possible upgrade/replacement of the HVAC system.

7.6. Compressor(s) outside (AC unit) old and may last a few years more, but maybe not-limited life expectancy. Possible unit(s) could fail after a home inspection during seasonal change from mild to hot weather. I cannot determine how long your AC will last before a replacement is necessary and life expectancy is not determined at this inspection. Check service records or have tested by a qualified HVAC specialist, Contractor.

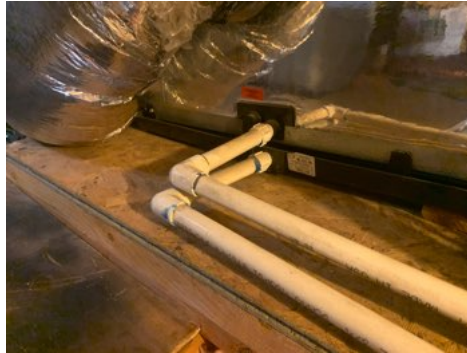
10.1. **A/C** condensation line drains at foundation - Poor location. Recommend to upgrade. Have checked, corrections made by HVAC specialist.

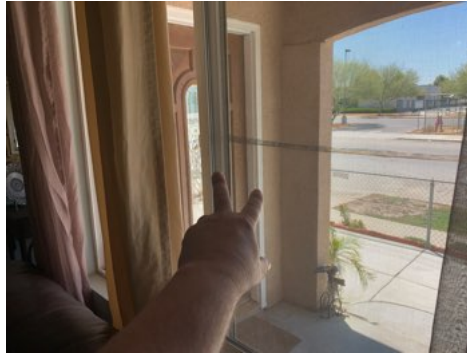
Won't lock/damaged screen

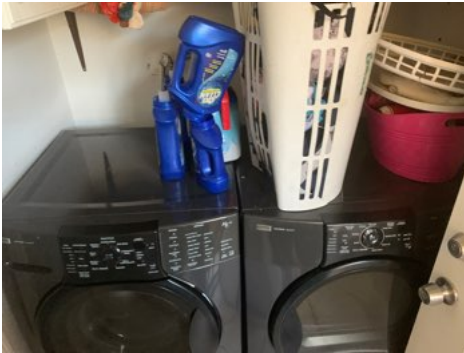
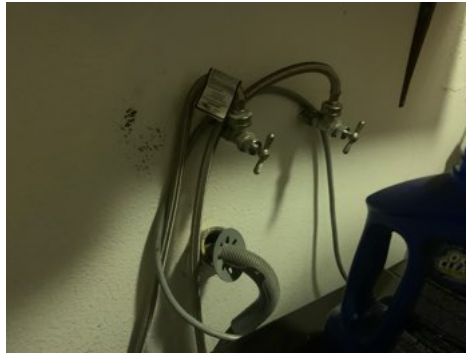
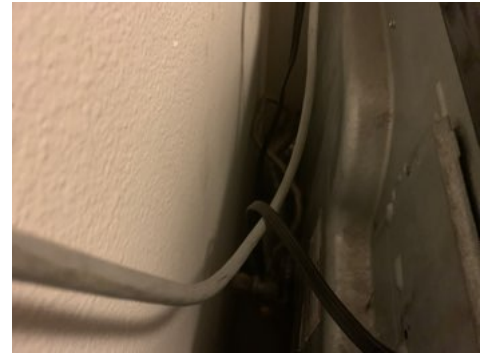
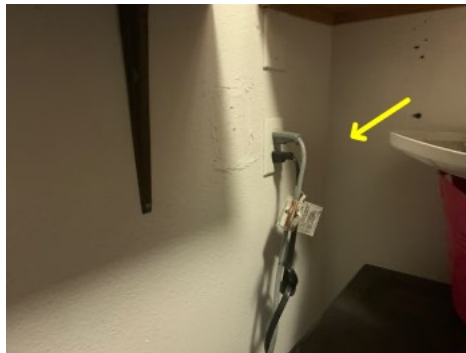
8.4. Washing machine, laundry area without catch pan and/or drainage pipes. Recommend to install if possible to prevent damage when machines leak.

8.5. 20 GFCI Amp outlet is recommended at laundry as a safety upgrade. Have checked by a qualified specialist for correction.

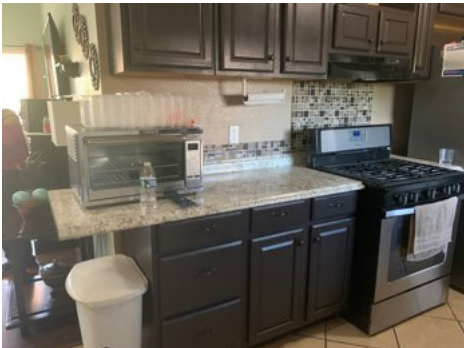
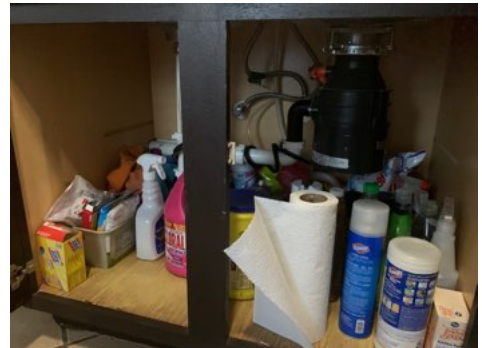
2.1. Wear and general age defects were noted to counter, cabinets at the time of inspection.

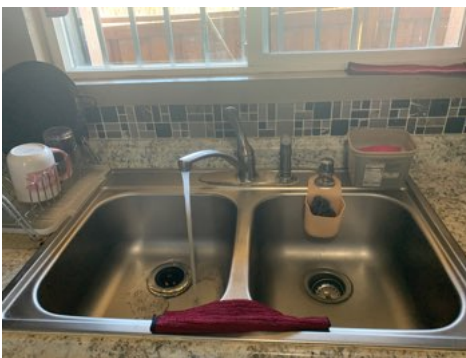
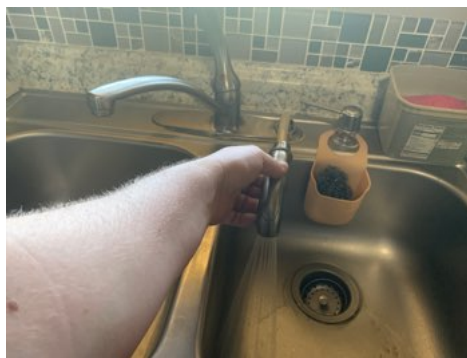
3.1. Sink faucet(s) functional at time of inspection.

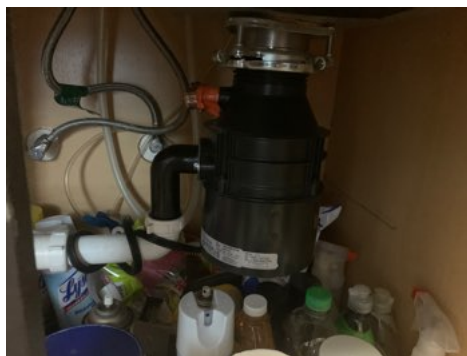
4.1. Unit operated at the time. (FYI)

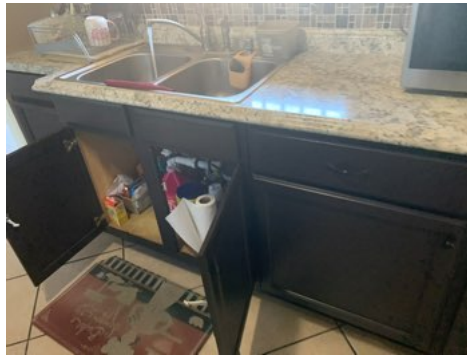
5.1. No dishwasher noted at kitchen - FYI

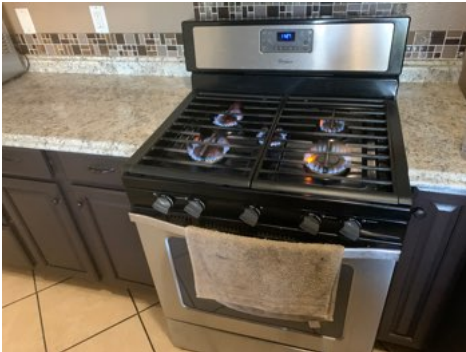
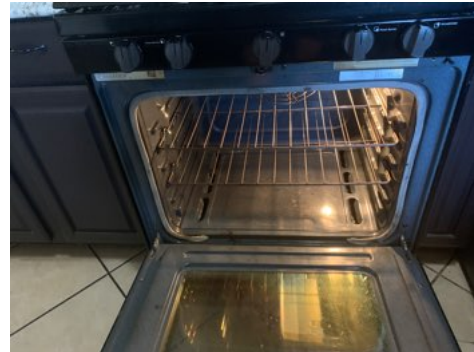
6.2. **Missing Anti-Tip Device at the freestanding range - Recommend to add for safety concerns. Consult a licensed specialist for proper installation.**

6.3. **Weak door springs noted- may require adjustment by qualified specialist .**

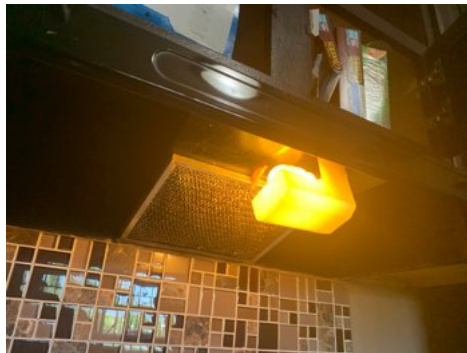
7.1. **Dirty filter(s) noted at the time of inspection. Recommend to replace.**

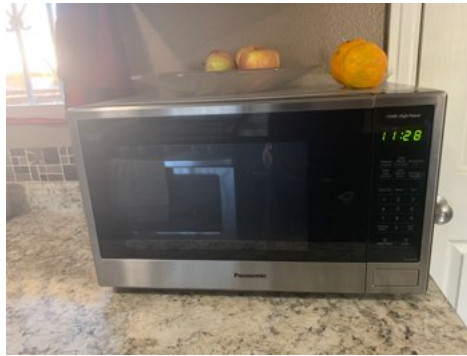
8.1. **Microwave noted - Not part of this inspection. Check with the seller. Proper operation and/or microwave leak is not part of this inspection. We turn the unit on and off and check for visual damage.**

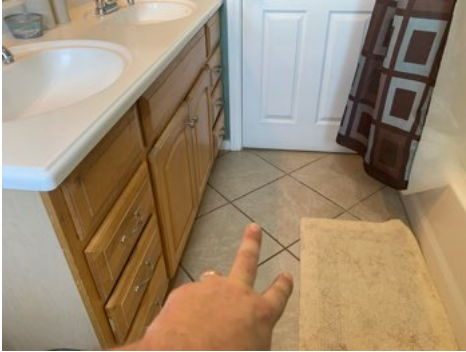
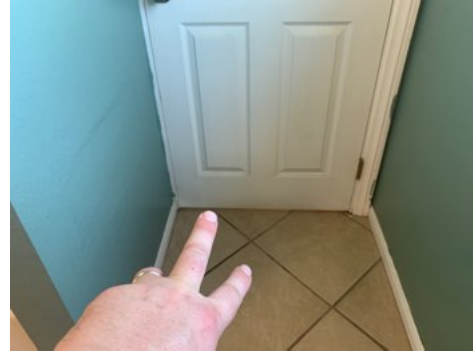
- 3.1. Cracked tiles noted at flooring. Have it checked, fixed, replaced by a qualified specialist.
- 3.2. Cracked grout, loose floor tiles noted. Have it checked, fixed by a qualified specialist.
- 3.3. Age defects, wear noted to cabinets, counter.

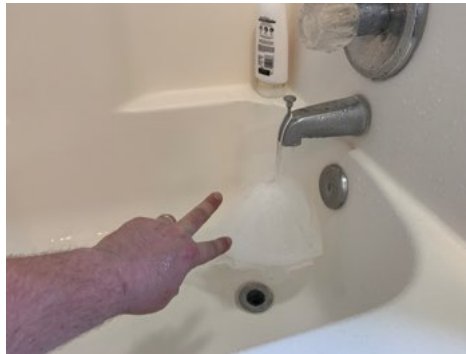
- 4.1. Missing tub stopper noted. Have it checked
- 4.2. Leaking at downspout noted at shower mode due to defective diverter. Have it checked, repaired, replaced.

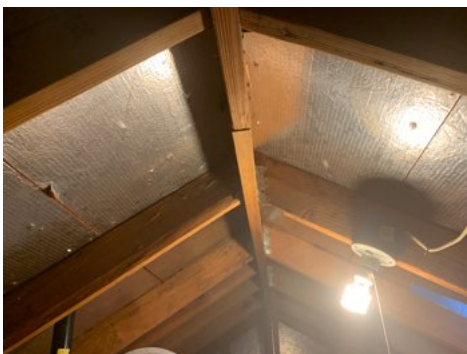
- 2.1. Ceiling joists were not fully visible to comment due to insulation. Check the records for any known defects, repairs.

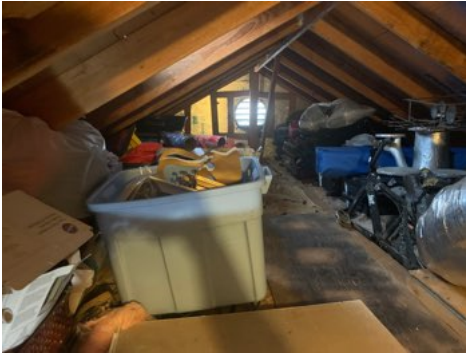
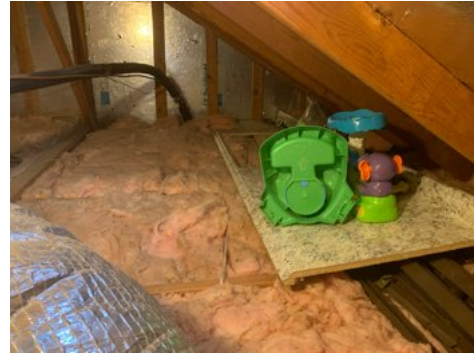
- 3.1. Belongings Build up on insulation at the attic. Recommend to remove

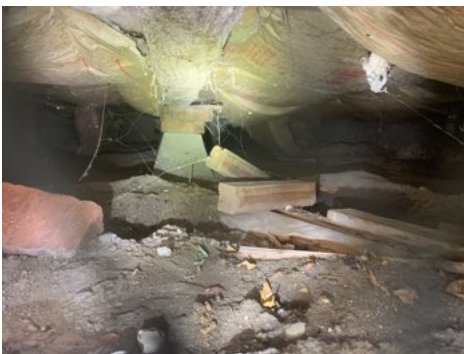
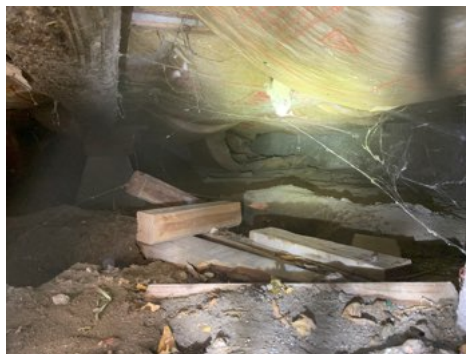
1.4. Access to crawl space too small to enter or blocked at the time of inspection. Limited to partial view, viewed from access only. Needs further evaluation by a qualified foundation contractor.

1.5. Newer work, alterations noted at crawlspace. Recommend to check the records, permits.

1.6. Foundation vents were set low at exterior soil, water seepage into the crawl space noted. Recommend to built a curb to prevent water intrusion.

1.7. Recommend further complete evaluation, necessary corrections made by qualified foundation specialist.

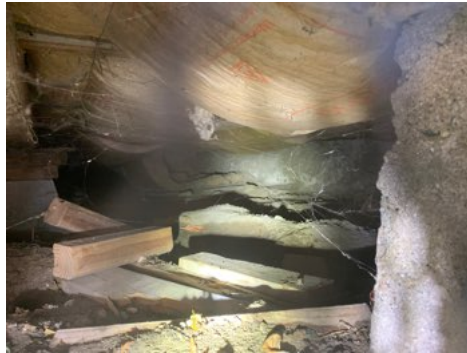
2.1. Efflorescence was noted present on the foundation wall. Recommend to keep moisture around the inspected property to a minimum.

2.2. Newer work, alterations noted. Recommend to check the records, permits.

2.4. Recommend further, complete evaluation by a qualified foundation specialist.

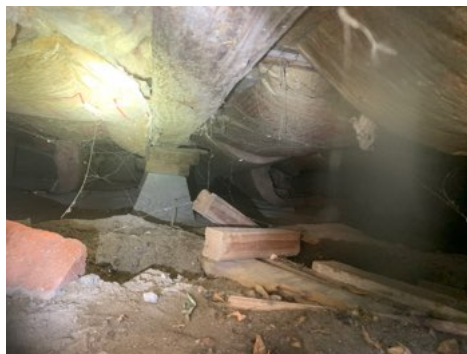
3.1. This is an Old raised Foundation type structure. Further evaluation of foundation walls and framing by a qualified foundation contractor, inspector is recommended by This Inspection Co.

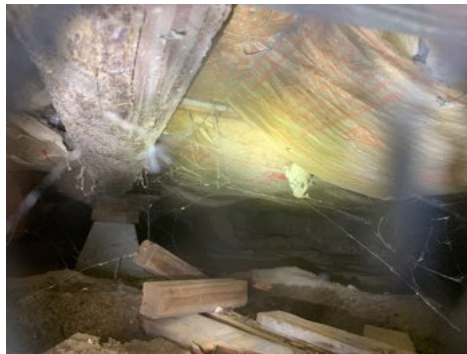
- 4.1. Floor joists were not fully visible due to insulation. Inspection was limited. Check the records for any known defects, repairs.**
- 4.2. Insulation installed Up side Down - Improper. Have it checked, fixed by a qualified specialist.**

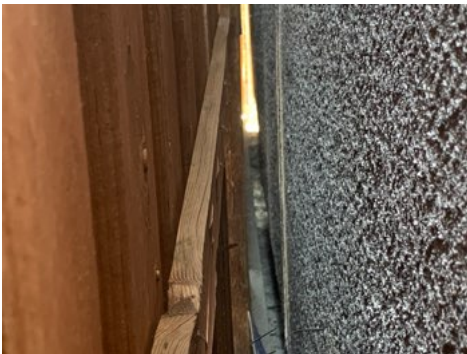
- 5.1. Foundation vent(s) are below ground level at exterior soil/slab, which can allow water to enter crawlspace. Recommend to re-grade and/or install proper flashing, curb to prevent water seepage.**
- 5.2. Missing proper crawlspace access- recommend to install by qualified foundation specialist.**
