Key Property Inspection Group

Property Inspection Report

360 E Valley Blvd, Colton, CA 92324
Inspection prepared for: Siddiq Omar
Real Estate Agent: Samson Debebe -

Date of Inspection: 5/14/2020 Time: 8:00 AM
Age of Home: 1989 Size: 10000
Weather: Clear
Order ID: 113

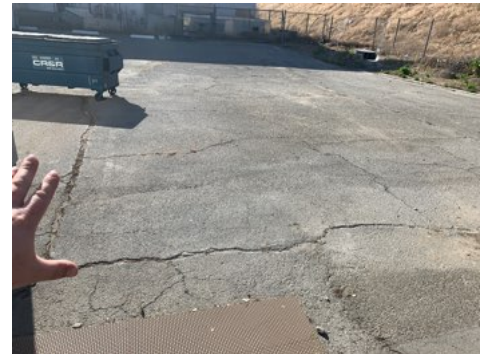
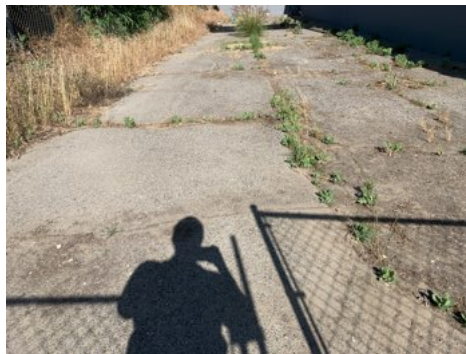
- 1.1. Driveway: old, worn, deteriorated, poor drainage noted. Have it checked by a qualified specialist.
- 1.2. Cracks, settlement present at driveway/sidewalk surfaces. Have checked, necessary repairs made by qualified specialist.
- 1.3. Evidence of Poor Drainage present at driveway/sidewalk surfaces, recommend further evaluation by qualified contractor.
- 1.4. Worn, cracked, damaged asphalt noted. Have it checked by a qualified paving contractor.

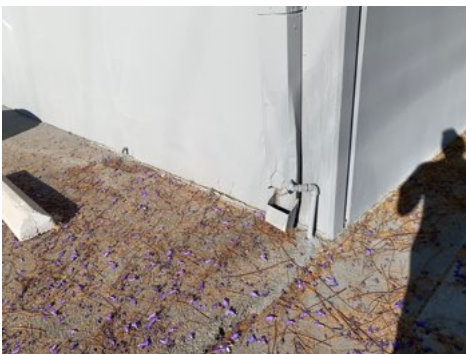
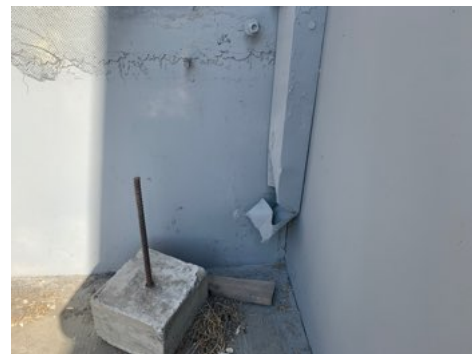
- 2.1. gutter(s) terminate at foundation - Keep water/vegetation away from structure(s). Recommend to correct by a qualified drainage contractor.

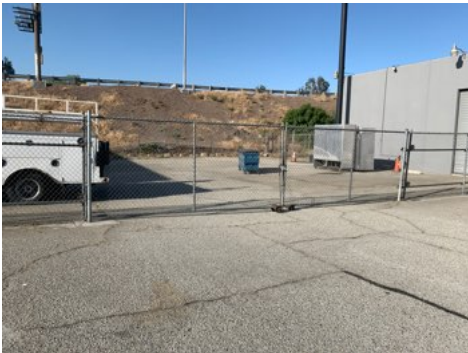
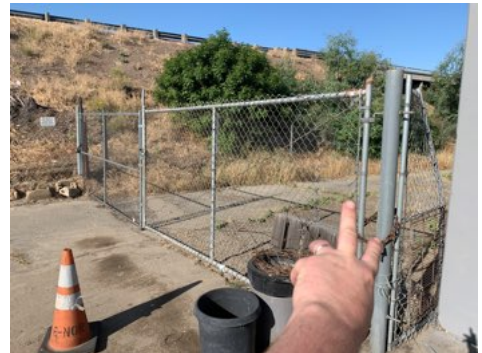
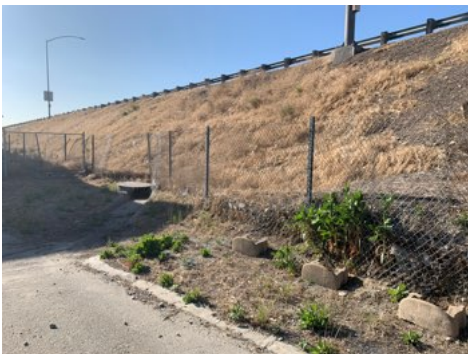
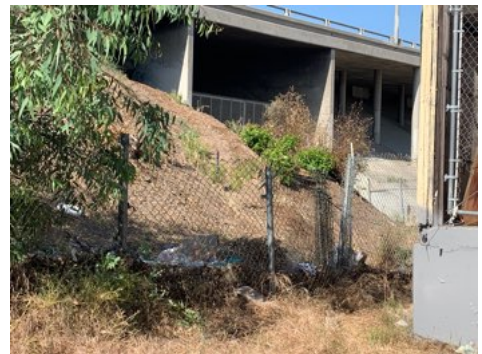
Damaged gates

- 4.1. Common age defects noted to fencing. Recommend to monitor the condition.
- 4.2. Fencing in need of repairs at some areas. Have it checked by a qualified contractor
- 4.3. Gate(s) in need adjustment or repairs noted at loading dock and driveway area. Have checked, fixed by qualified specialist.

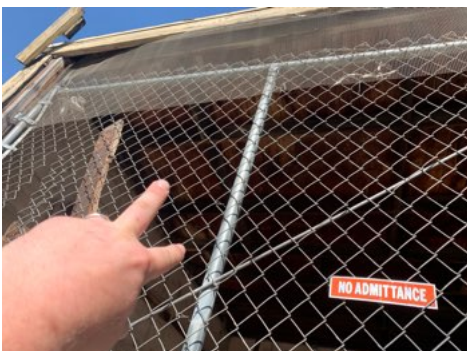
- 5.1. Age defects, peeling paint and/or moisture stains, damage were noted at the eaves and fascia/cover at loading dock. Recommend further evaluation, repairs by a qualified structural pest inspector and contractor.

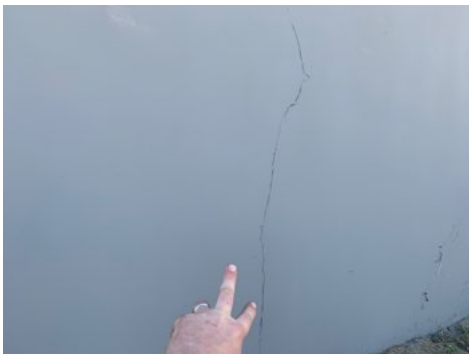
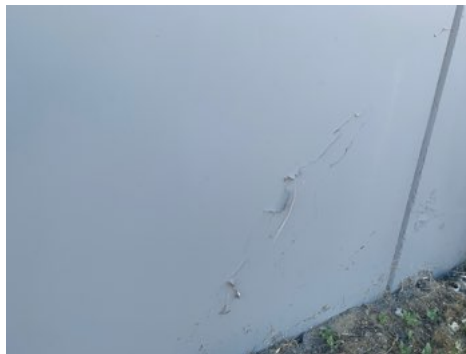
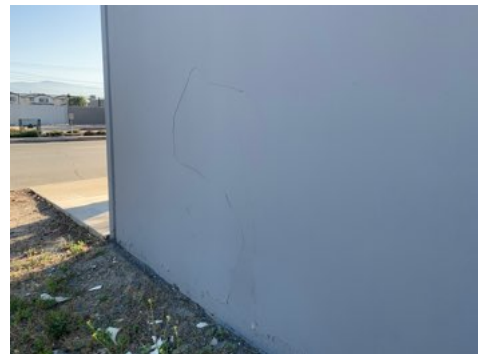
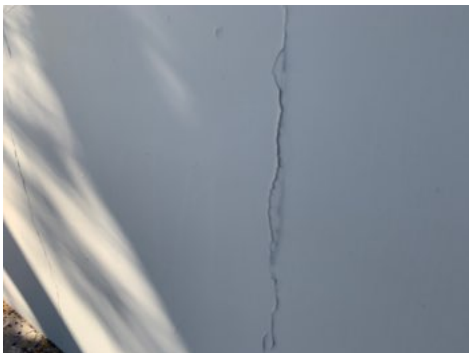
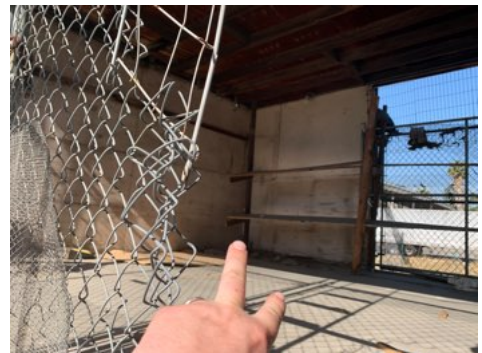
6.1. cracks/peeling paint were noted in the exterior concrete walls. Have checked by paint contractor.

6.2. Moisture damage, cracks noted in the exterior walls which require repairs by a qualified contractor. Noted at loading dock. (Hidden damage may exist inside the framing which can only be discovered by removing the wall cover (FYI).

6.3. Missing flashing at the base of the wood siding, siding is embedded in concrete curb at loading dock- poor workmanship- wood will rot- damage at wood noted. Have it checked, corrections maxe by a qualified specialist for correction.

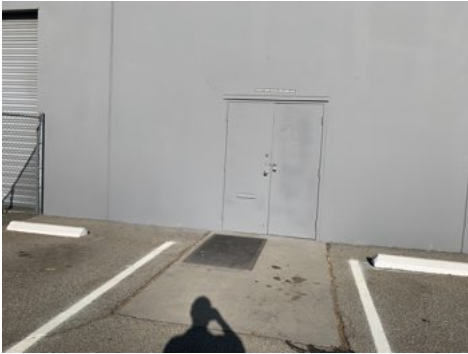
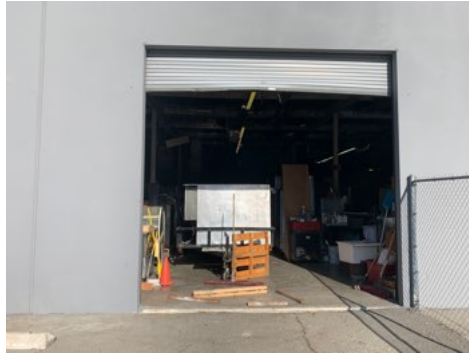
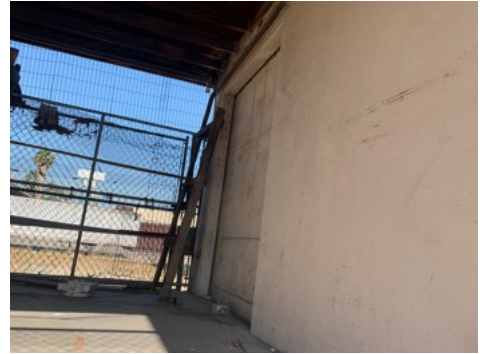
Locked

8.1. Side door at loading dock locked, check with seller for any known defects.

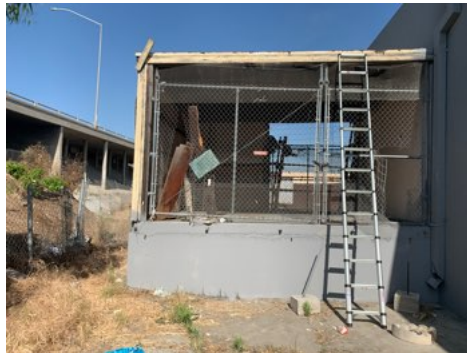
- 9.3. Recommend to check the building records, and permits with the City to make sure that the location/space is suitable for your business use.
- 9.4. Exposed bolts/damage at walls/cover at loading dock. Recommend further complete evaluation, any necessary correction/repairs made by qualified contractor(s).

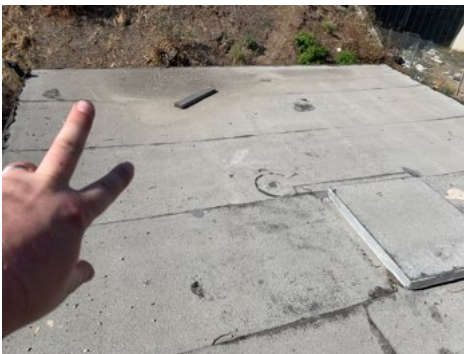
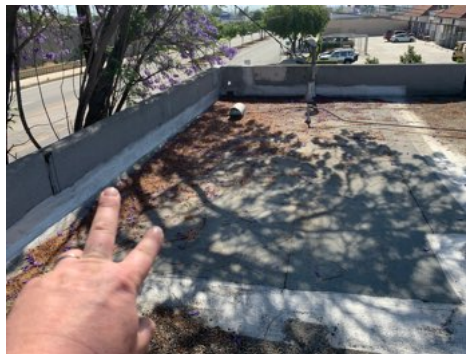
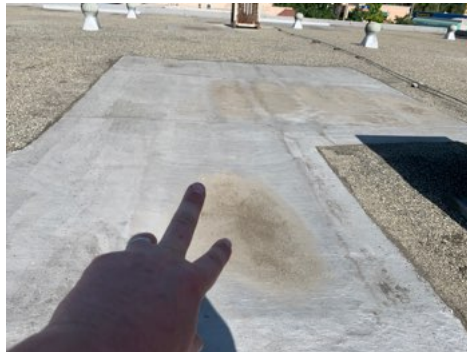
2.1. Patching and previous repairs noted to various locations/areas of the roofing. Check the records, warranties.

2.2. Debris noted at the Roof. May cause future leaks and/or damage. Recommend to clean/remove.

2.3. Weathering, aging and cracks were noted to the roofing material. Roofing material appears to be nearing end of its useful life. Have it checked by a qualified roofer.

2.4. Aged flat roof cover noted. Recommend to apply roof coating to prolong life of the roof. Have it checked by a qualified roofer.

2.5. Signs of Water ponding at sections at flat roof area noted- Recommend to have it checked, any necessary corrections made by a qualified Roofer.

2.9. Recommend further complete evaluation of roof system, necessary maintenance and/or corrections performed by a qualified roofer.

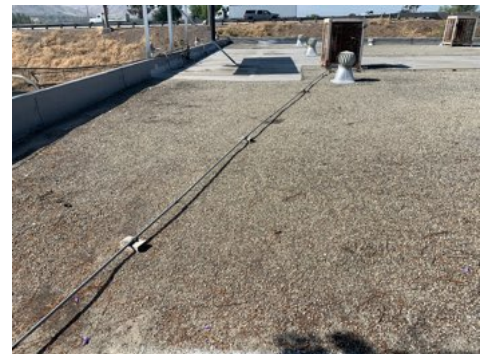
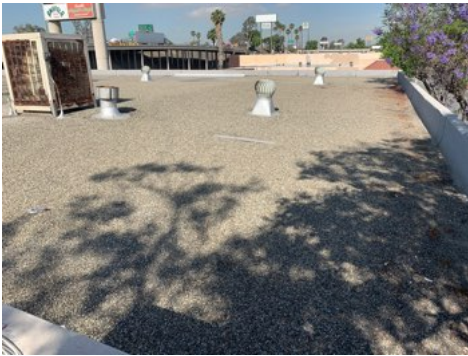
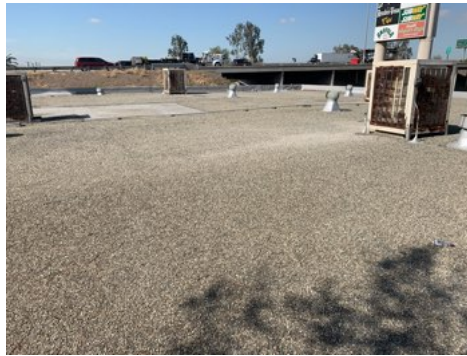
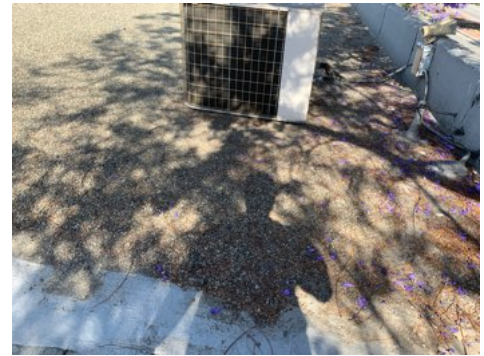
2.6. Rock cover roof noted - Difficult to evaluate. Recommend to hire a qualified roofer for further evaluation/inspection. Check the records. Life span of this type roofs are 15 to 20 years from installation date.

2.7. Signs of Leaking at interior noted at flat roof at several areas noted. Have checked, correction/repair made by qualified specialist.

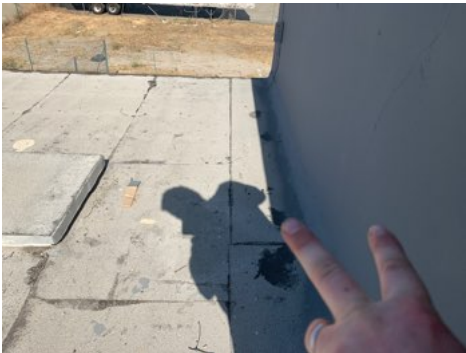
- 3.1. No major defects noted. Recommend to re-seal at flashings as a routine maintenance. Periodic inspection recommended.
- 3.2. Roof to wall flashing is not visible and/or covered with mastic (Hidden damage may exist). Periodic maintenance is required to prevent leaks. Recommend further evaluation, any necessary corrections by a qualified roofer.

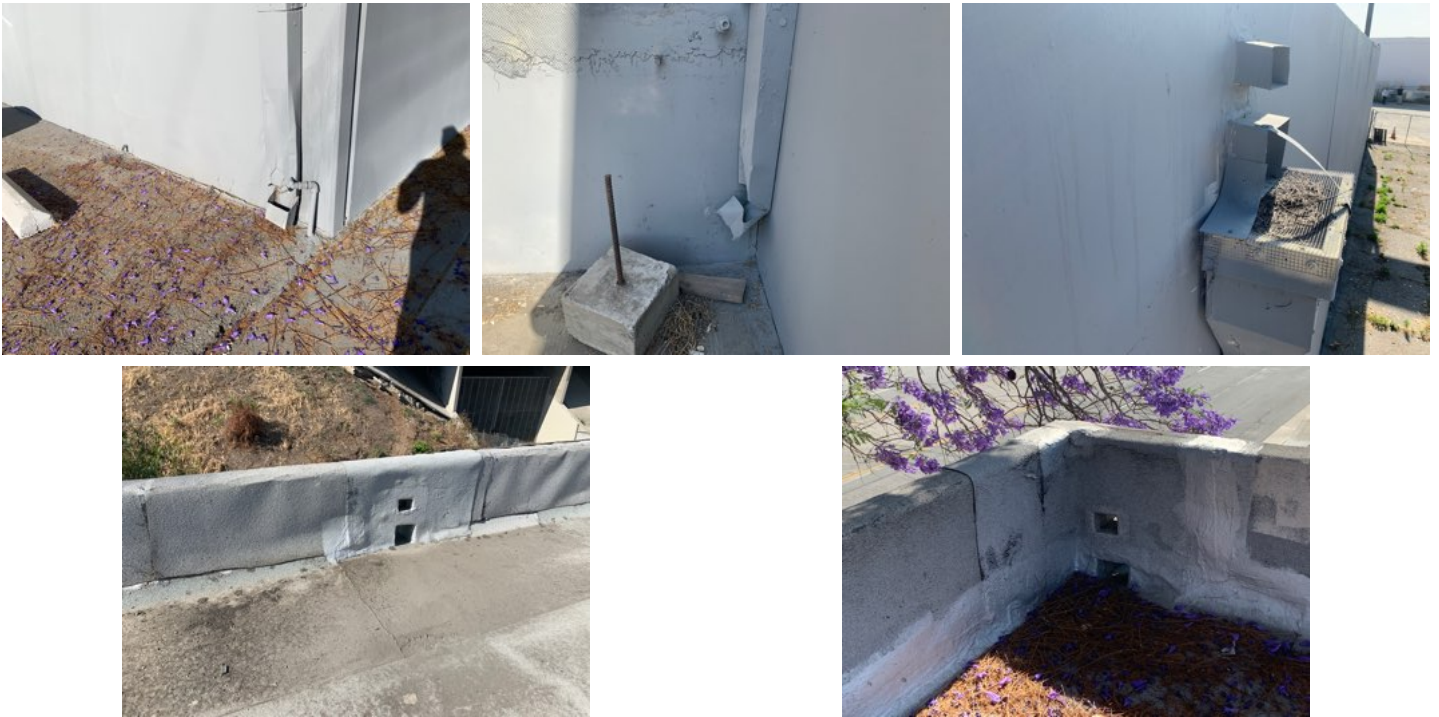
- 4.1. Downspouts terminate at foundation- Poor location. Recommend to extend away and/or install flash block(s).
- 4.2. Debris and signs of water ponding noted at roof drain(s). Drain area(s) at roofing in need of periodic cleaning, service. Recommend to clean and install proper coating at drain area roofs. Have checked by qualified specialist for any necessary maintenance, corrections.

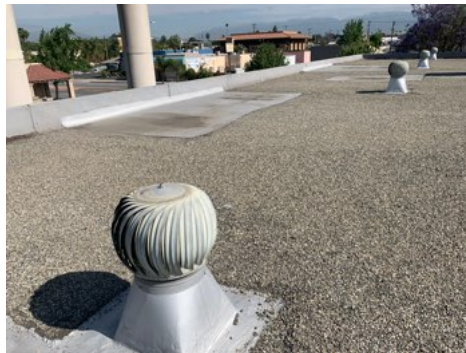
5.1. Turbine type attic vents were noted - This vent type is prone to leaks.

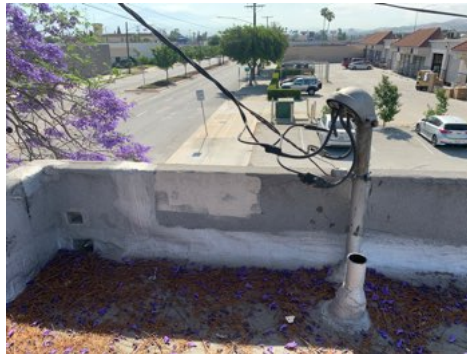
1.1. Underground service was noted. In order to inspect the condition of the wires it requires removal of panel covers. Panel covers at pull box are not removed for safety reasons and are not part of this inspection (its beyond the scope of this inspection). Recommend to check the records for any known defects, repairs. Further evaluation by a qualified Electrical Contractor and or the local Utility Co. is recommended.

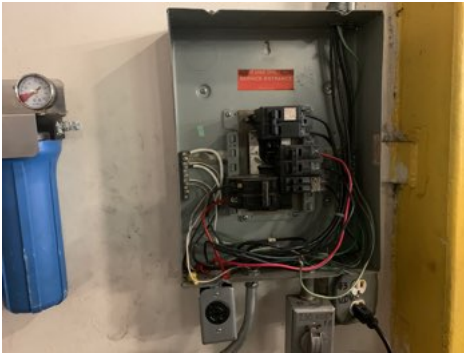
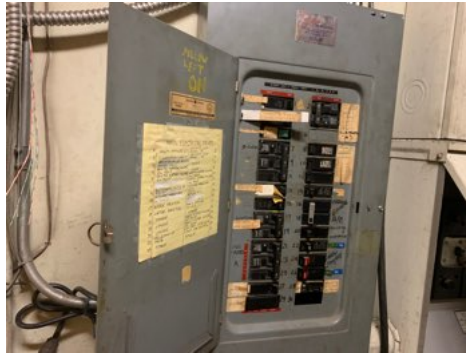
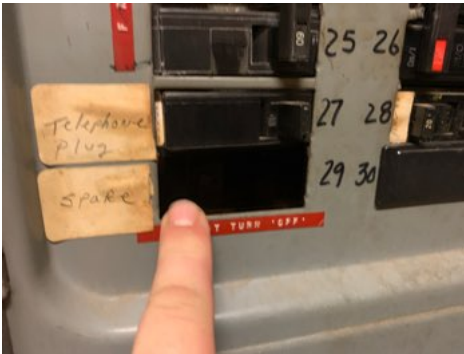
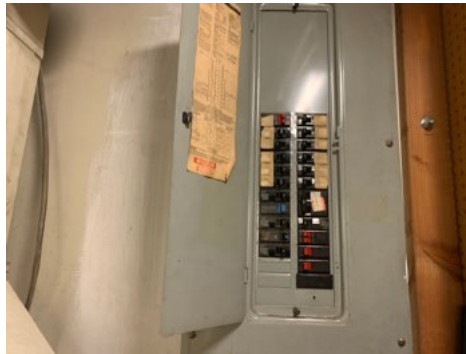
- 3.1. Breakers are not properly labeled for emergency identification.
- 3.2. Some labels are present, but illegible or confusing. Recommend correcting for safety reasons.
- 3.3. Missing screws at cover at panel. Recommend to correct by qualified specialist.
- 3.4. **Double taps** were noted at panel (two wires connected to one breaker) - This method is a potential safety hazard and is of substandard workmanship and is not allowed. Further evaluation and correction by qualified Electrical Contractor is recommended.
- 3.5. Unprotected openings at main panel cover noted - Safety hazard. Recommend to cover.
- 3.6. Recommend complete system evaluation, necessary correction made by a qualified electrician.

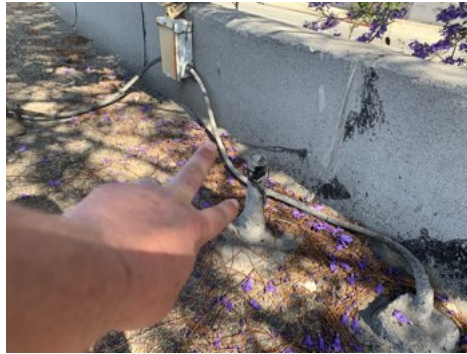
4.2. Loose, improperly supported, installed electric conduits noted at the roof. Have it checked, fixed by a qualified electrician.

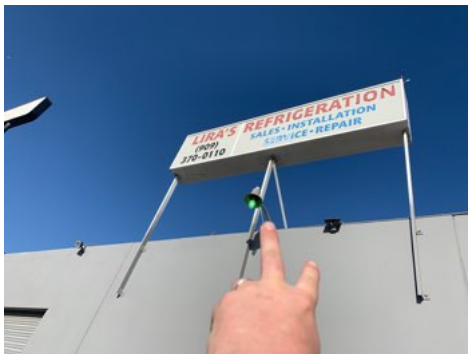
5.4. Light Cover is damaged and/or missing at the exterior. Have it replaced.

5.5. Several material, installation defects, and/or safety considerations were noted with regard to the Electrical System - Further evaluation of the system for repairs, corrections, safety upgrades by qualified Electrical Contractor is recommended.

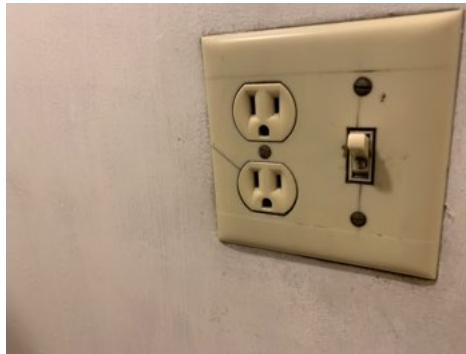
6.1. Recommend to have **GFCI** outlets in all wet locations as a safety upgrade, and to test them periodically. Missing at bathroom(s). Have checked, fixed by qualified electrician.

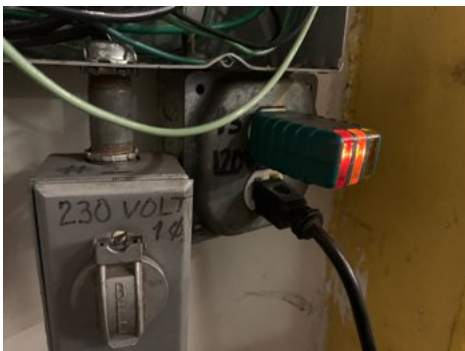
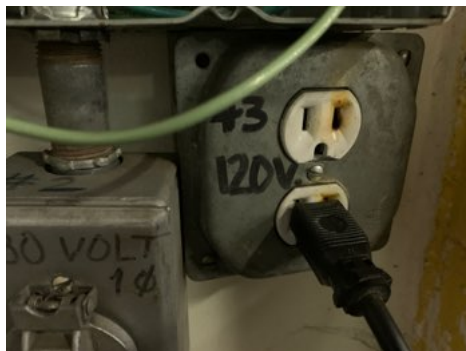
- 7.9. Several material, installation defects, and/or safety considerations were noted with regard to the Electrical System - Further evaluation of the system for repairs, corrections, safety upgrades by qualified Electrical Contractor is recommended.

Scorched

- 7.10. Recommend complete system evaluation to determine the cost and scope of work before expiration of your Contingency Period and before the Close of Escrow by a qualified electrician.

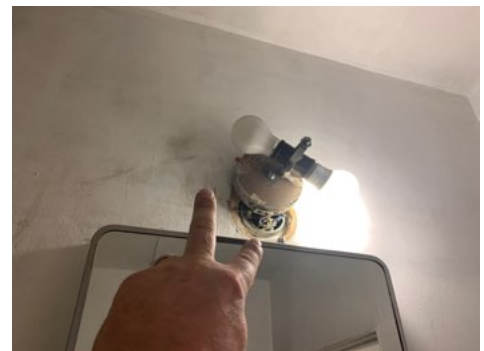
- 7.7. Missing proper lens at bathroom light noted, loose fixture/exposed wires noted- improper. Recommend to correct by electrician.
- 7.8. Scorched outlet noted at front entry wall. Have checked, replaced by qualified electrician.

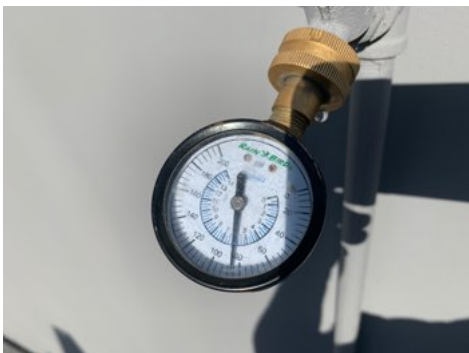
90 psi

2.5. Missing hose bib handle at front driveway- hose bib capped- FYI

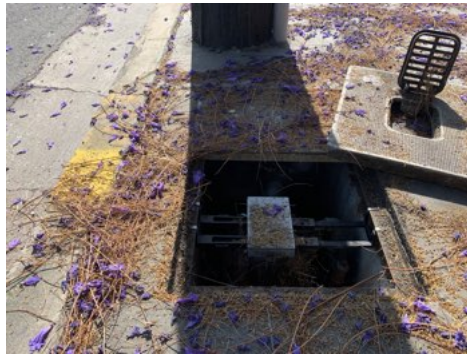
4.2. Gas meter - Seismic shut off was not present at the time of inspection, recommend to install - May not be required in the City of Location - Recommend to check the local regulations.

4.3. Underground gas pipe noted (type unknown). Have it checked for possible gas leak. Gas leaks or pipe testing not part of this inspection. Recommend to check the building records, permits for any known issues or repairs regarding gas pipes, fuel systems and/or have it tested by the Gas Co. and/or a qualified plumber.

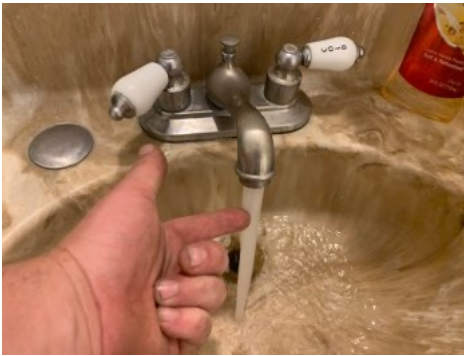
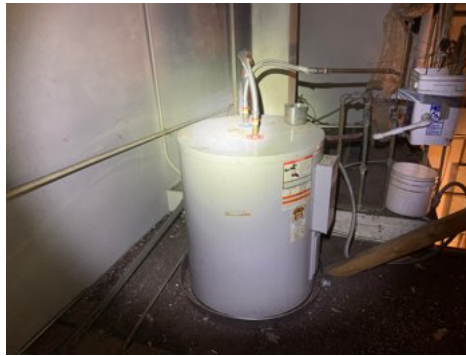
5.10. Water heater without circulating pump - it may take a while to get hot water at fixtures. Have it checked by qualified plumber for any necessary correction.

5.11. A number of defects found at water heater. Recommend complete evaluation, any necessary corrections, repairs and/or replacement by a qualified plumber.

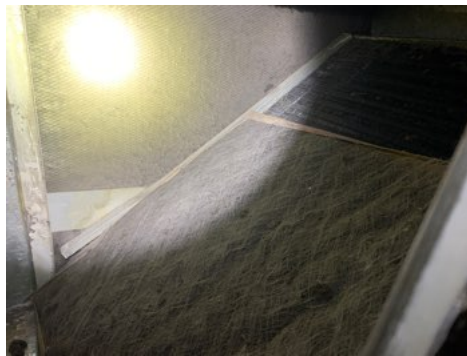
2.2. The Filter(s) are dirty and in need of replacement. Have checked, service/maintenance performed by qualified HVAC specialist.

2.3. Filter is located in the unit (requires to remove panel cover to get to the filter)(FYI). Check the service records. Periodic replacement of the filter required for proper unit operation. Recommend to upgrade filter location, access.

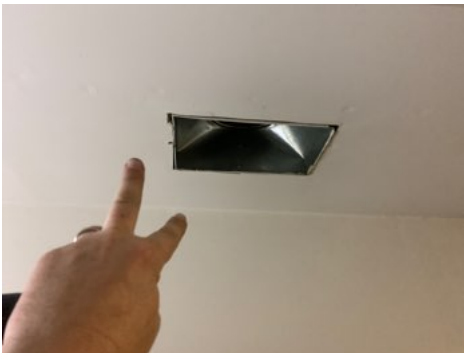
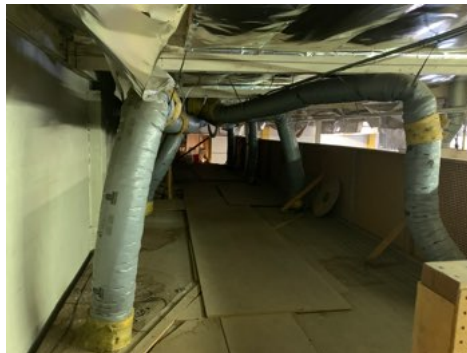
3.2. Damaged insulation wrap noted at ducting in the attic. Have it checked, necessary corrections made by qualified HVAC specialist.

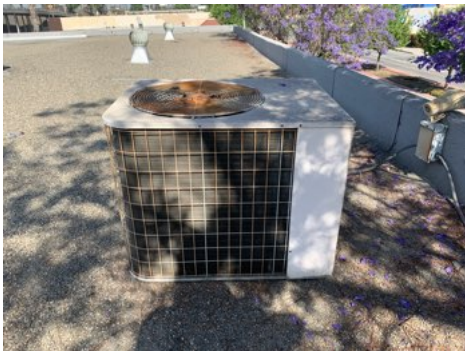
5.5. Old Evaporative Coil(s) (Swamp cooler noted, not tested at this inspection- rust/age defects noted at units at roof. Recommend further complete evaluation, necessary corrections service maintenance or upgrade made by a qualified HVAC specialist.

5.6. Recommend complete System evaluation, any necessary corrections and/or maintenance made by a qualified HVAC Contractor.

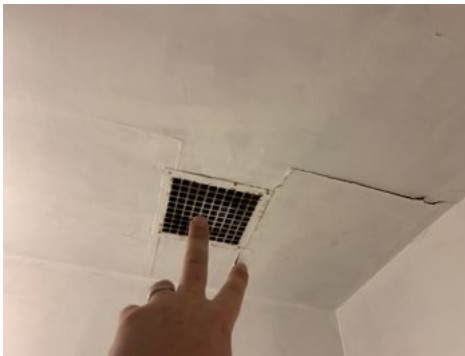
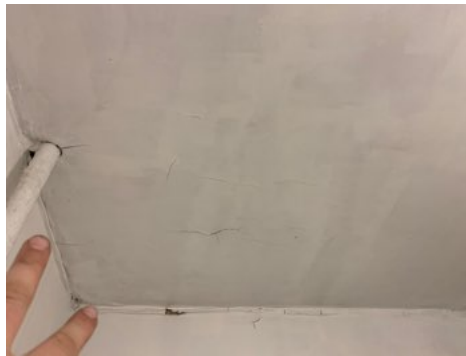
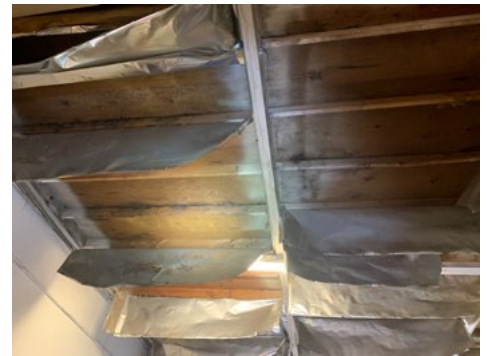
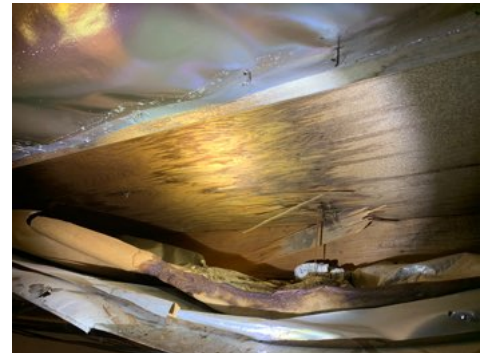
1.3. Water Stains, Damage noted at ceiling at interior. Have it checked, necessary repairs made by qualified contractor/specialist(s).

1.4. Interior ceilings in need of patch, paint, repair. Have them checked by a qualified specialist.

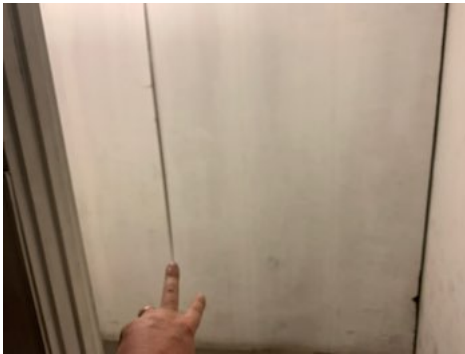
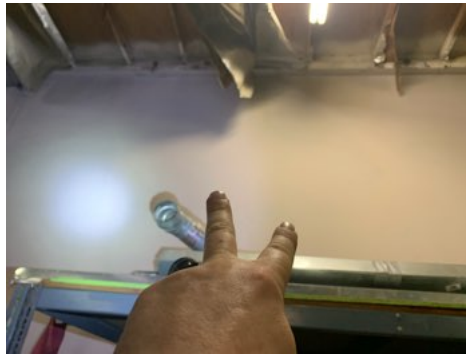
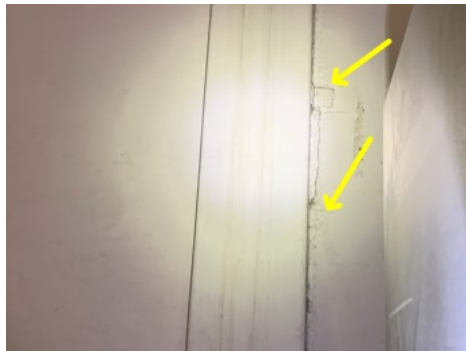
2.3. Loose, damaged paneling noted at some areas. Have it checked, fixed, replaced by a qualified specialist.

2.4. Building is a tilt up concrete building type. Some cracks noted at the walls, possible seepage noted from cracks at interior of the building (common for these type of Buildings). Recommend to patch, paint, seal the cracks from exterior. Have it checked by a qualified specialist, painting contractor.

Cracks

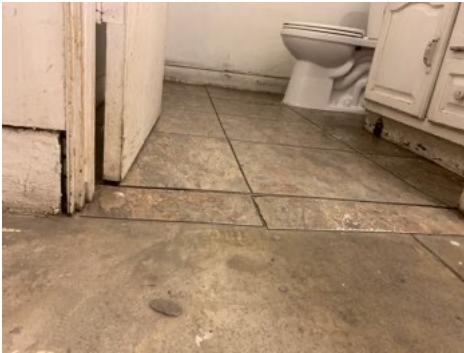
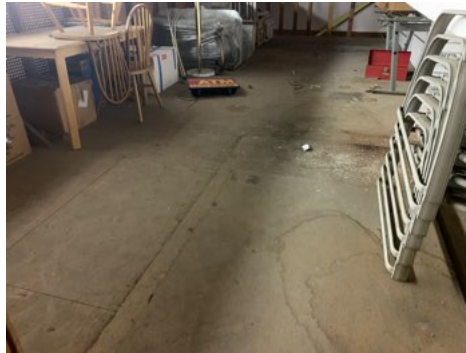
- 3.4. Trip hazards noted due to differing flooring material heights. FYI
- 3.5. Some expanded gaps noted at flooring material joints, loose laminate tiles at bathroom noted. In need of further evaluation, corrections by a qualified floor specialist.

- 3.6. Common cracks noted at floors
- 3.7. Unfinished floors at upper level storage area noted, uneven floors, dips/soft spots noted. Have checked, evaluated, any necessary correction or repair made by qualified contractor.

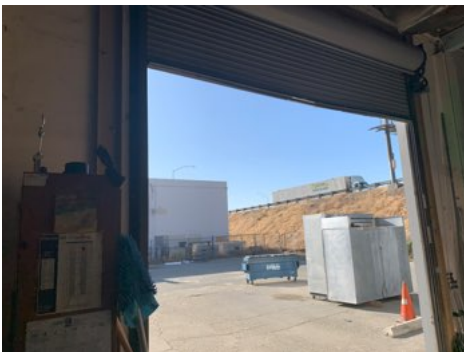
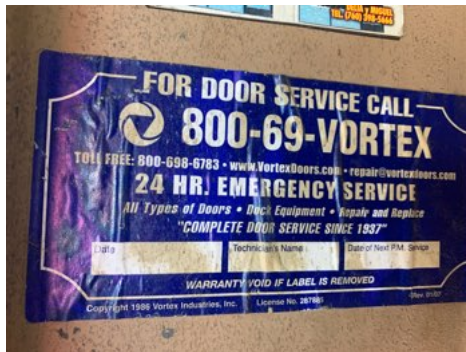
- 4.1. Side exterior door at ramp locked, unable to open- check with seller any known defects
- 4.2. Dents noted at roll up door- roll up door was operational at time of inspection- FYI

Dents noted

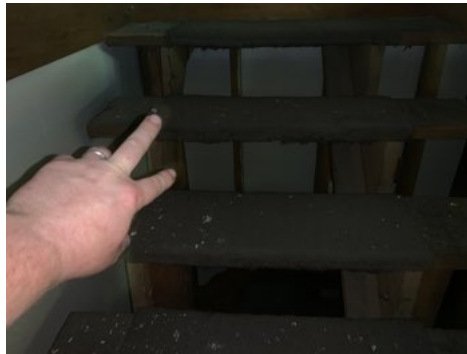
- 6.1. Handrail at interior stairs is not to current safety standards - Does not return to wall at top landing (trip/fall hazard). Correction, Safety upgrade recommended.
- 6.2. Interior railing openings are not to current safety standards. Openings too wide (this is a safety upgrade). Have it checked by a qualified contractor.
- 6.3. Loose handrail(s) noted at the time - A Safety concern. Recommend further evaluation, necessary correction/ repairs made by a qualified specialist.
- 6.4. The area behind the stair treads is open, this opening should be no more than 4" high. Recommend to have checked, necessary corrections made by a qualified specialist.

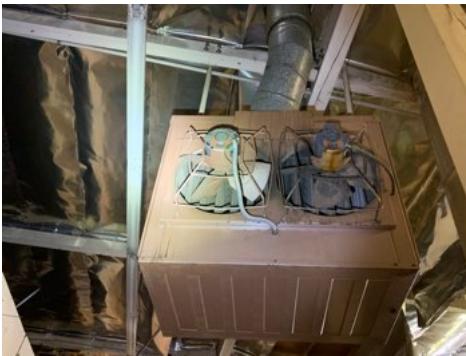
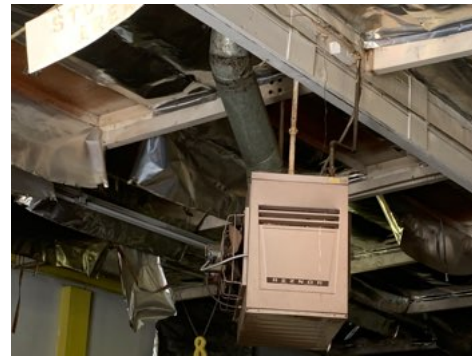
8.2. Circulating warehouse fan noted. not inspected or tested at time of inspection. Check the records, check with seller for operation, known defects or have checked, tested by qualified specialist prior to close of escrow

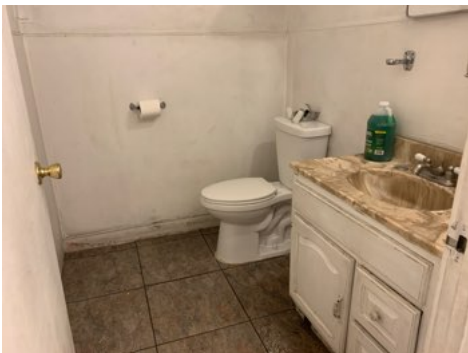
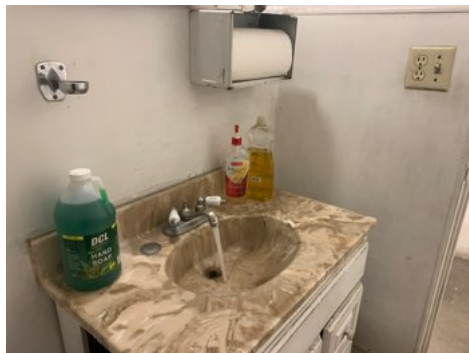
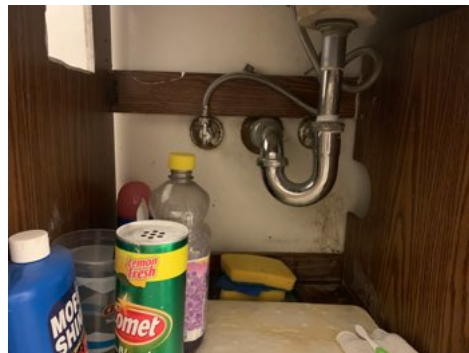
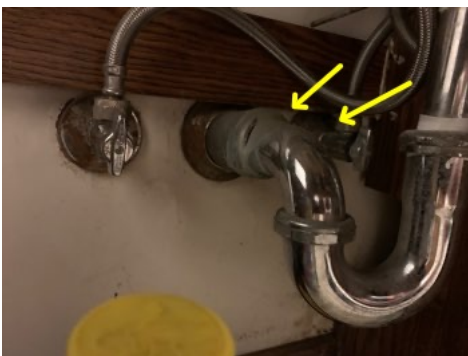
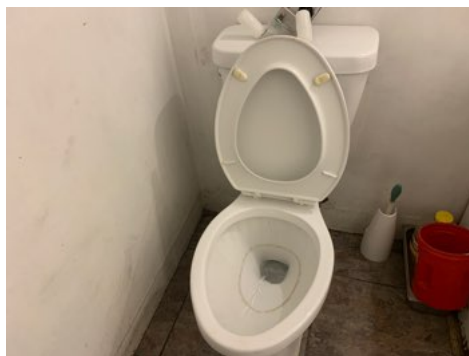
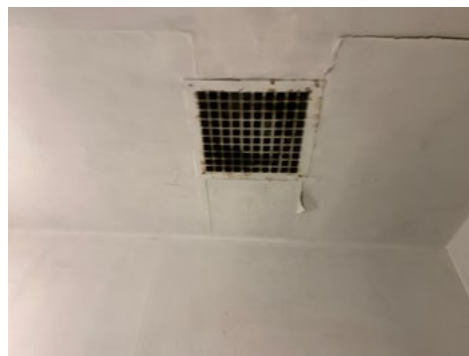
Taping

2.2. Taping noted at drain pipe under sink- improper. Recommend to remove, have evaluated, any necessary correction made by qualified plumber.

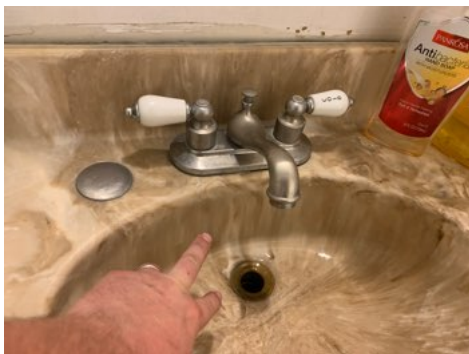
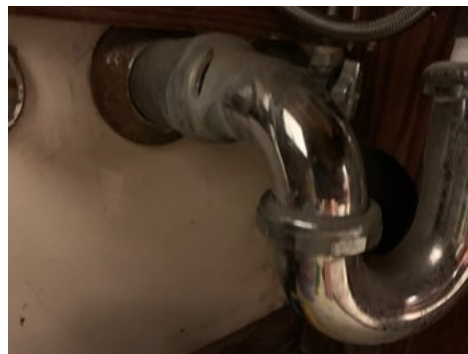
2.1. Missing sink stopper noted. Have it checked, fixed by a qualified plumber.

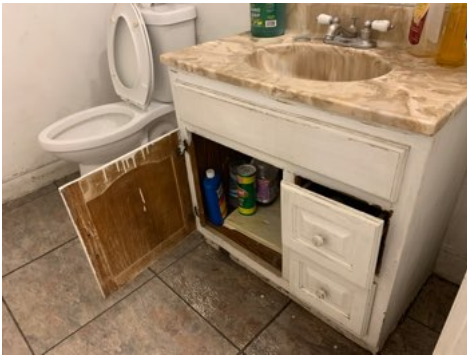
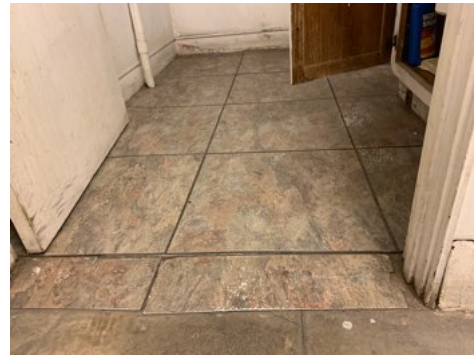
3.1. Age defects, wear noted to cabinets, counter.

3.2. Expanded gaps/loose laminate at flooring. Have checked/fixd by specialist

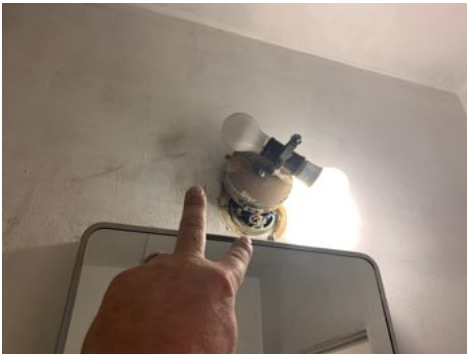
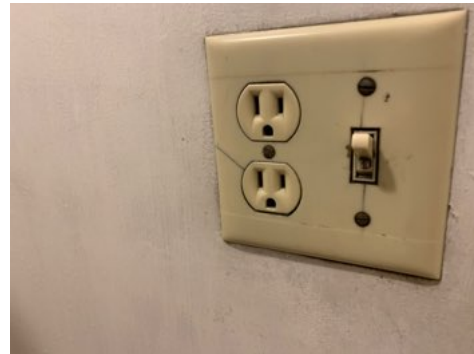
- 4.1. Recommend to install GFCI type outlet at Bathroom(s) and to test periodically. This is a safety upgrade. Have fixed by electrician.
- 4.2. Missing proper lens at bathroom light noted, loose fixture/exposed wires noted-improper. Recommend to correct by electrician.

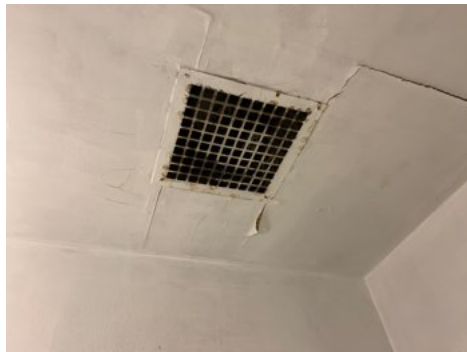
- 5.1. Dirty exhaust fan(s) noted. Recommend to clean, service.
- 5.2. Noisy exhaust fan noted - Recommend to upgrade.

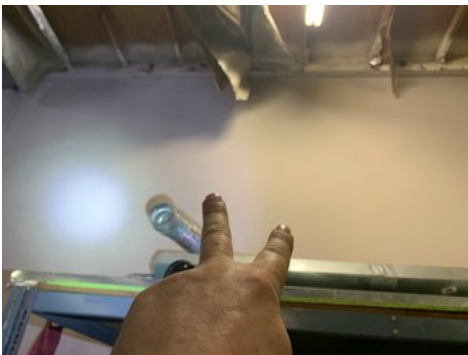
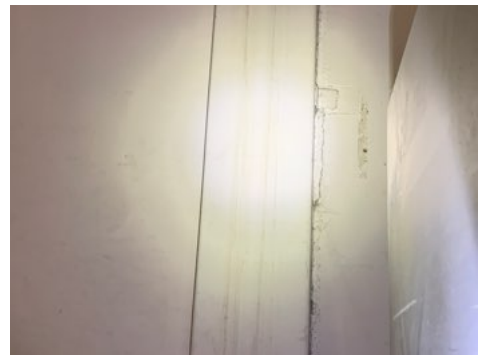
- 2.1. Building is a tilt up concrete building type. Some cracks noted at the walls, possible seepage noted from cracks at interior of the building(common for this type Buildings). Cracks in need of repair/ patch/paint. Concrete walls need to be properly painted/ sealed to prevent water seepage. Have it checked by a qualified specialist/ Painting contractor.
