# Key Property Inspection Group

## Property Inspection Report

415 Montana Ave #204, Santa Monica, CA 90403  
Inspection prepared for: Henry Dieu  
Real Estate Agent: Bonnie Truong -

Date of Inspection: 7/5/2020 Time: 10:00 AM  
Age of Home: 1973 Size: 1133 sq. Feet  
Weather: Clear  
Order ID: 131

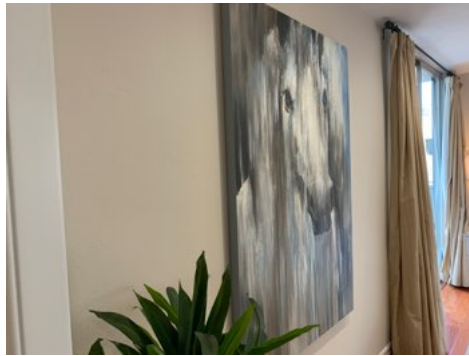
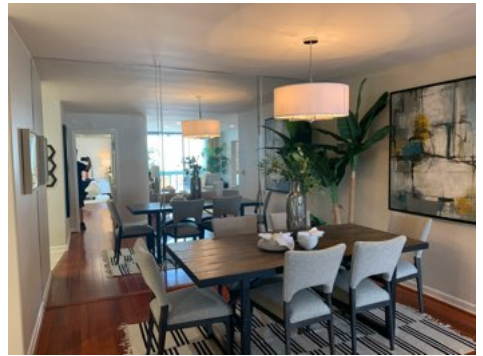
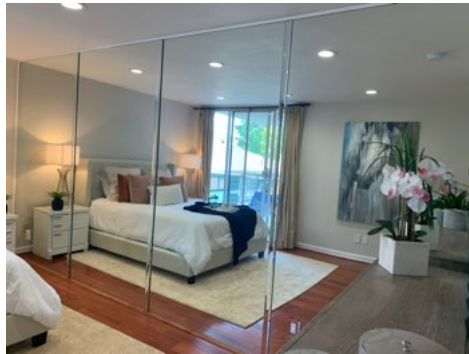
**2.2. Common cracks and/or anchor holes were noted at the interior walls.**

**2.4. Newer Paint noted - Check the records for any known defects and/or repairs.**

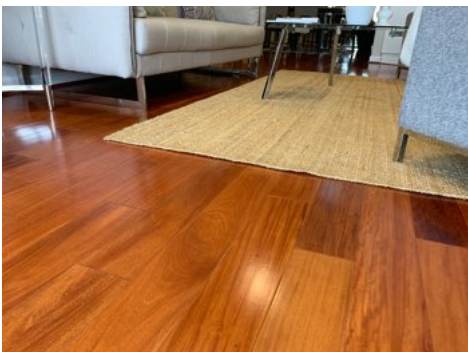
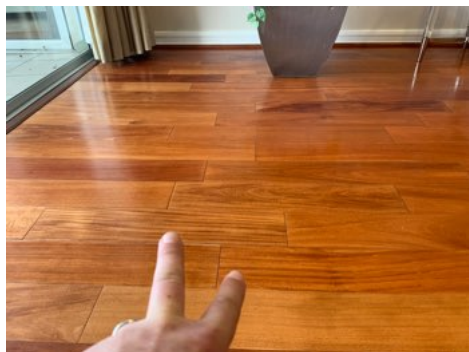
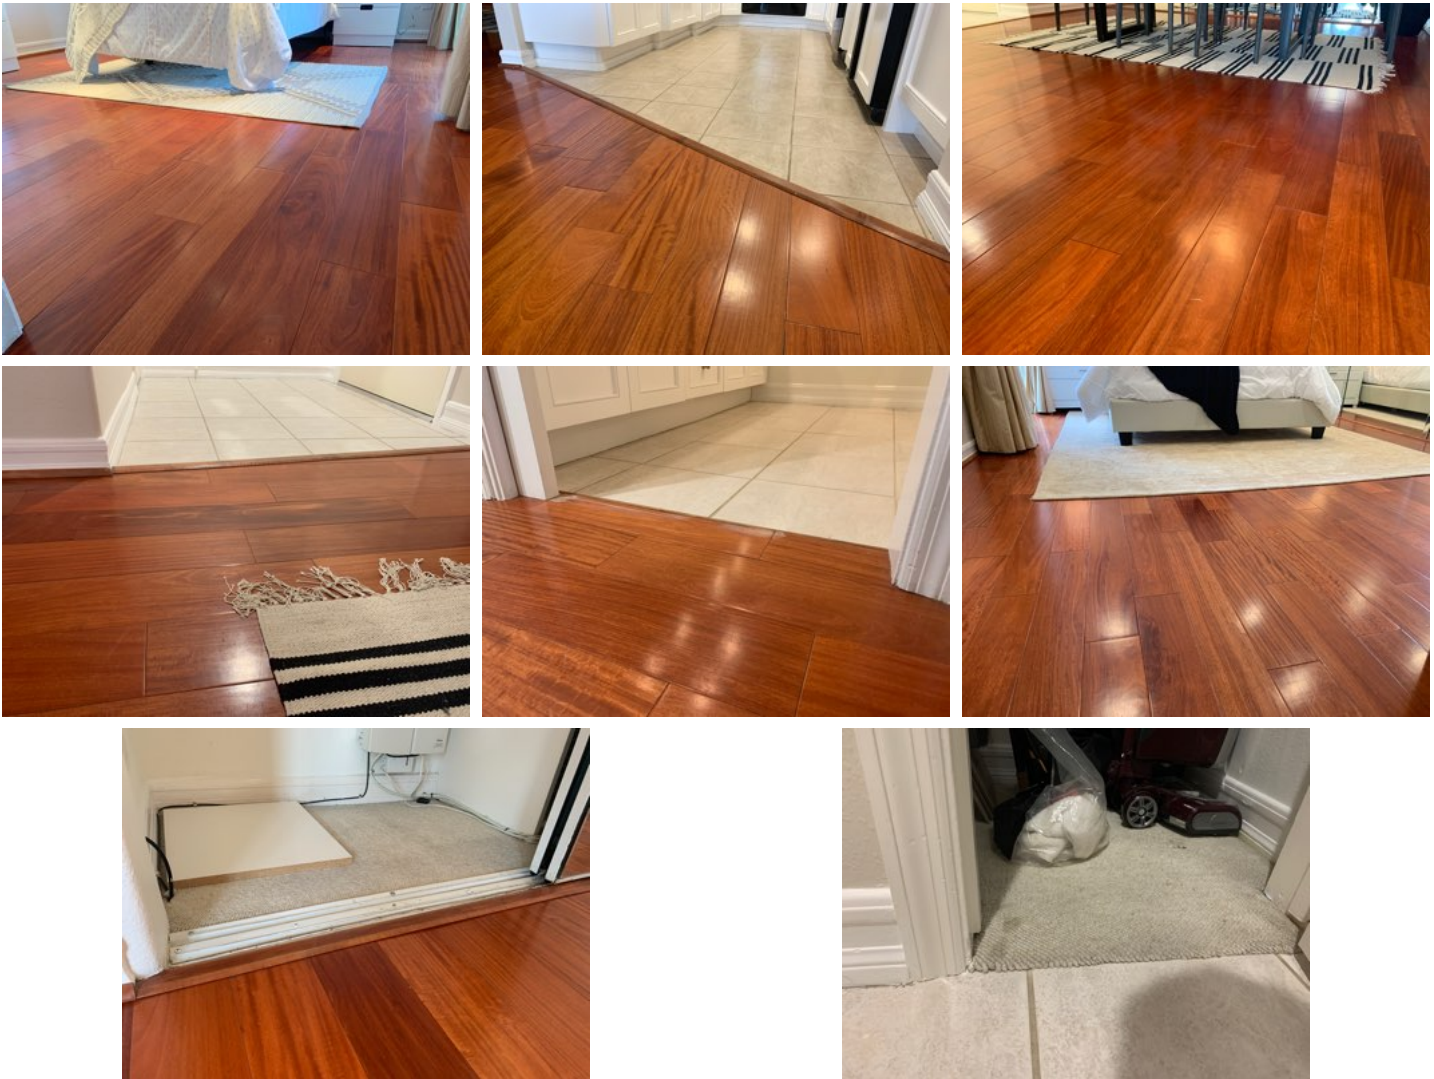
- 3.4. Uneven areas, sloping was noted at various areas of the flooring. Check the records for any known defects, repairs and/or have it checked by a qualified specialist(s).**

- 3.5. Worn, aged flooring materials, scratches/scuff marks noted at floor(s) of the inspected property. May need repair/replacement. Have checked by qualified specialist.**

- 3.8. Some expanded gaps noted at flooring material joints. In need of further evaluation, corrections by a qualified floor specialist.**

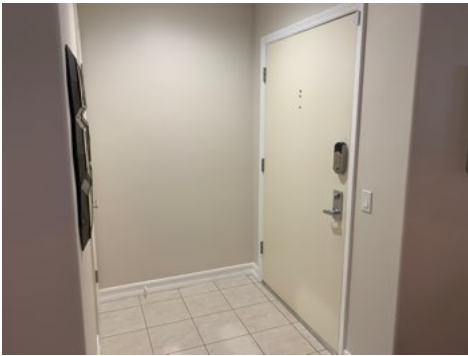
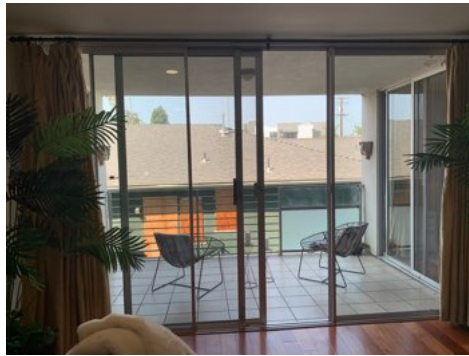
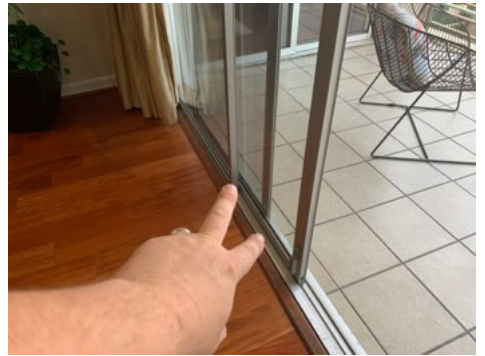
**4.2. Slider door(s) noted installed backward- It is possible to remove the doors from the tracks from exterior even if locked. A security concern. Recommend to upgrade, have checked by a qualified specialist.**

Sliders backwards on tracks- FYI

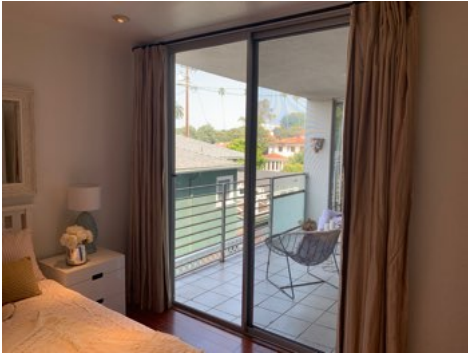
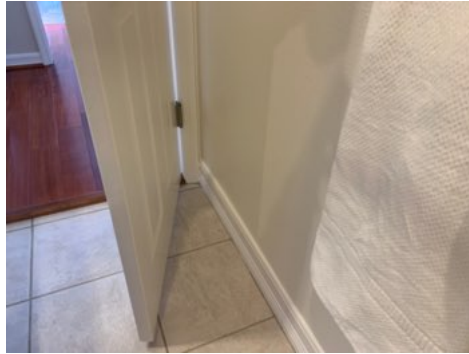
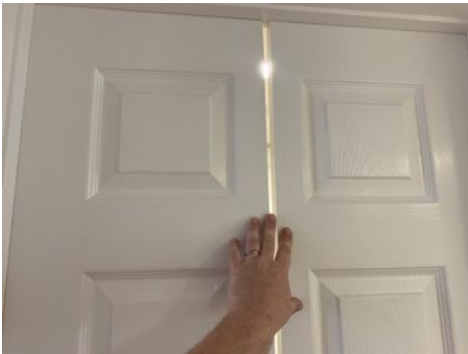
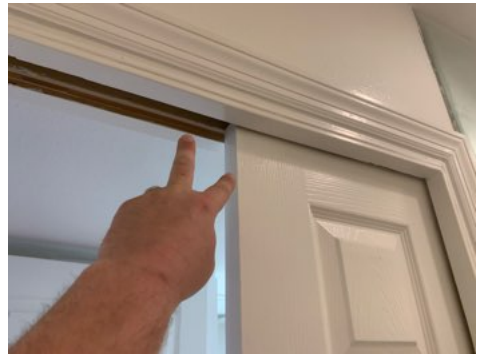
**4.4. Bathroom pocket door is not opening/closing properly- won't track noted, rubs at floor. In need of adjustment, repair by a qualified specialist**

Rubs

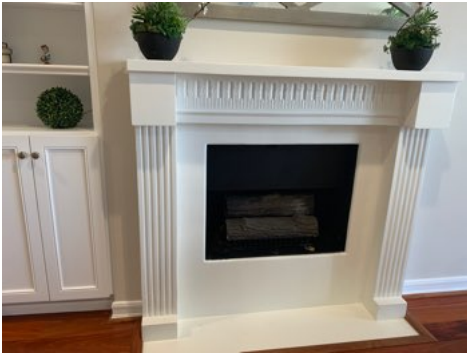
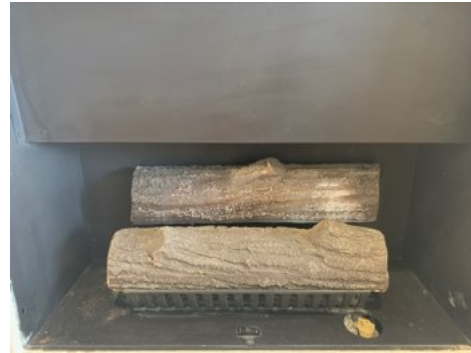
**6.2. Pilot was off, Gas valve/knob rotated at the time but appeared not operational- no gas . Flue was not fully visible at this inspection. Recommend further complete evaluation/testing of system by a qualified Fireplace specialist.**

**6.3. Gas valve was noted inside the firebox. Recommend to relocate, upgrade for safety. Have checked by a qualified chimney specialist.**

**6.4. Missing door and/or screen at fireplace. Recommend to correct by qualified specialist.**

**6.5. Recommend further and complete evaluation, video inspection of flue by qualified Chimney Inspector - This is a Safety and Fire concern.**

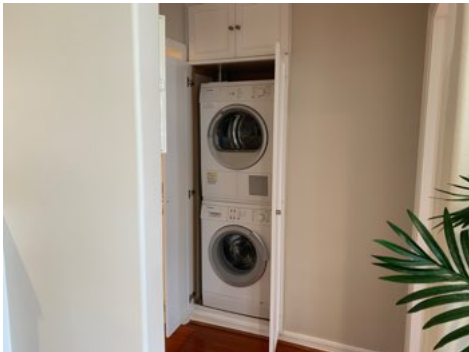
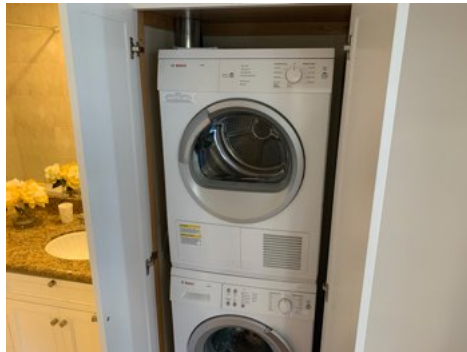
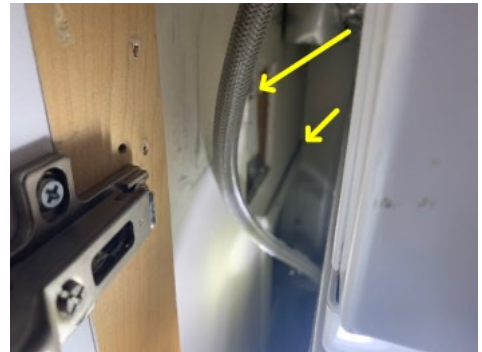
7.6. Missing coverplate at outlet at laundry closet - recommend to install

Missing cover

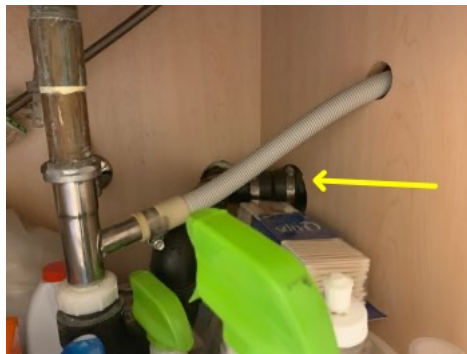
7.7. Washer drain pipe drains/terminates at sink drain- improper. Missing dedicated drain noted. Check records/permits and, or have checked evaluated by a qualified specialist for any necessary corrections. Check with building/HOA.

Washer drain- improper

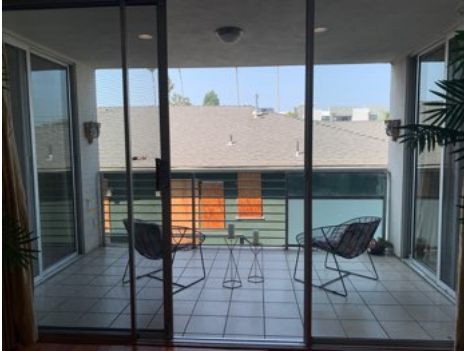
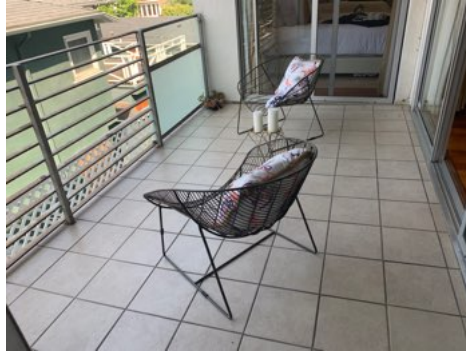
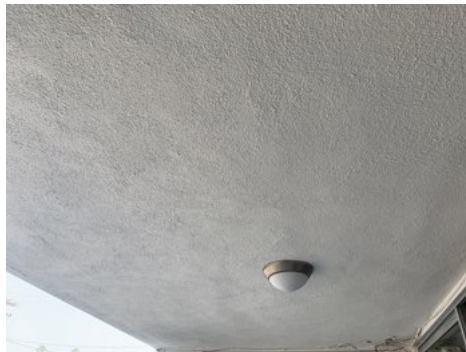
8.1. Rust/deterioration at railing noted- recommend to have checked/evaluated/weatherized/painted by qualified specialist. Check with building/HOA.

8.2. Horizontal bars noted- are climbable- (FYI for child safety)

Rusted railings

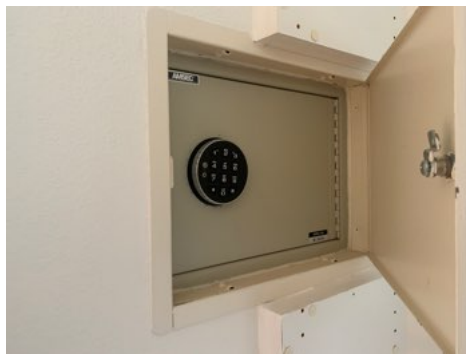
9.1. Wall safe at bedroom noted- not part of this inspection, not tested, check with seller for operation or known defects.

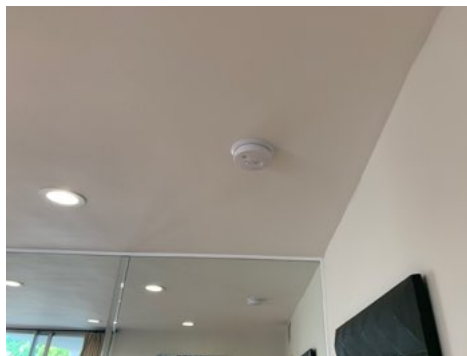
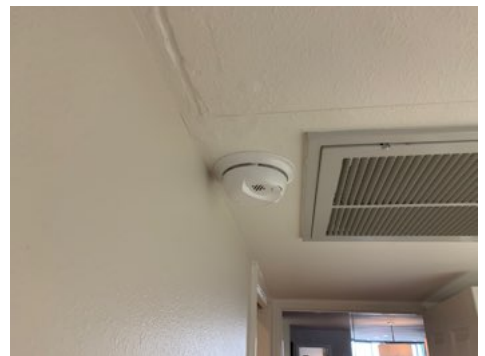
- 7.1. Smoke detectors in bedrooms and/or hallway noted - Recommend to test them periodically
- 7.2. Carbon monoxide detector noted - Recommend to test it periodically.
- 7.3. **Smoke and Carbon Monoxide detectors, fire alarms/systems not inspected. Beyond the scope of this inspection. Recommend to install smoke and carbon monoxide detectors per City/Manufacturers requirements and test them periodically - Recommend to have checked by a qualified retrofitter. THIS IS A HEALTH/SAFETY CONCERN.**
- 7.4. Missing smoke detectors at left side hallway. Recommend to Install and test periodically for fire safety. Have checked by qualified retrofitter.

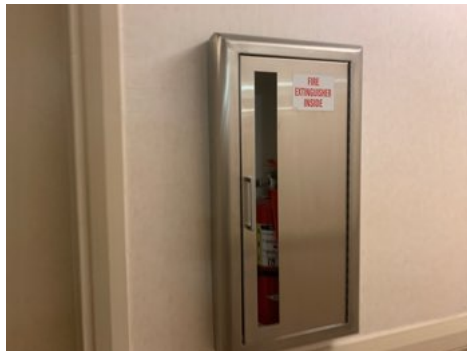
10.1. Fire extinguishers and/or hoses noted - Check the service records, contracts.

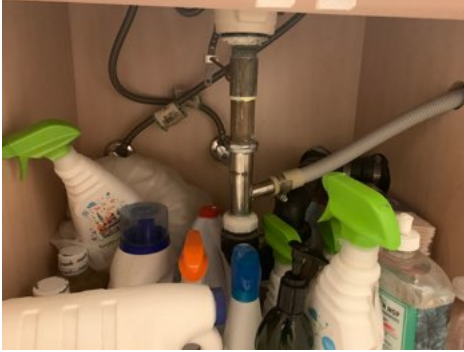
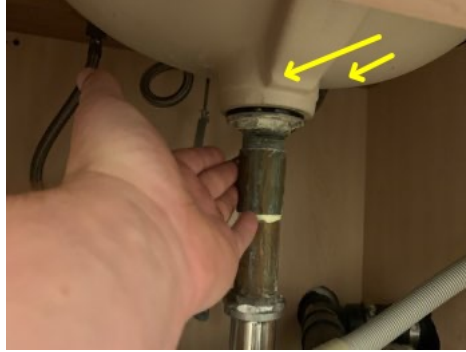
**1.1. Active Leak(s) noted at drain pipe(s) at both bathrooms at sink(s). In need of repair/replacement. Recommend to hire a qualified plumber for further evaluation for any necessary repair(s) and/or replacement.**

Leaking- bathroom

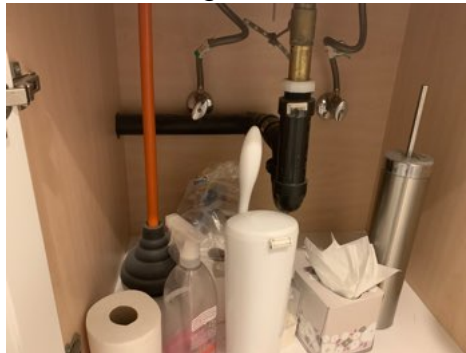
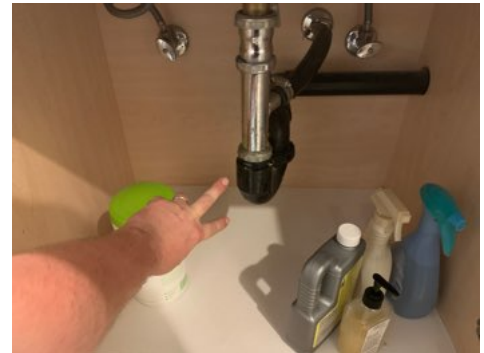
Leaking- master bath left sink

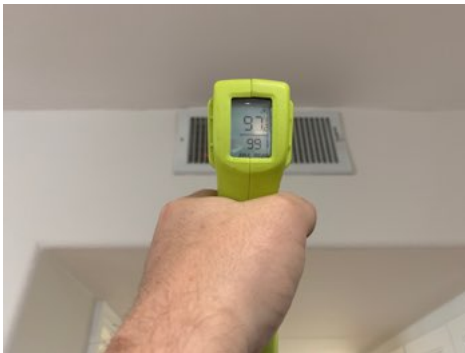
1.5. **FAU unit(s) located at hallway ceiling(s). Covers, ceiling Tiles not removed at this inspection- cover is heavily painted/sealed noted- poor access noted. Recommend to check service records. This is a limited visual inspection - Recommend to hire a qualified HVAC contractor for more detailed inspection/full evaluation of the heating/cooling units . Recommend to check the service records with the seller for any known defects, repairs.**

Access cover sealed shut

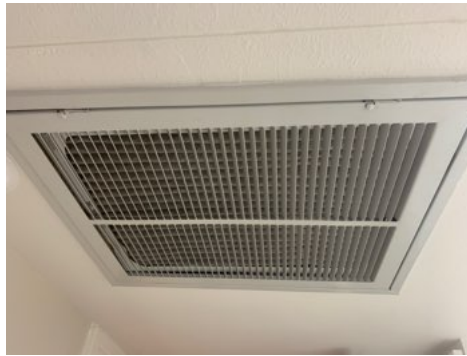
16x20x1

2.2. **The Filter(s) are dirty and in need of replacement. Have checked, service/maintenance performed by qualified HVAC specialist.**

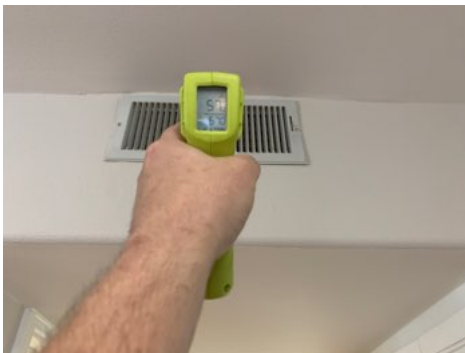
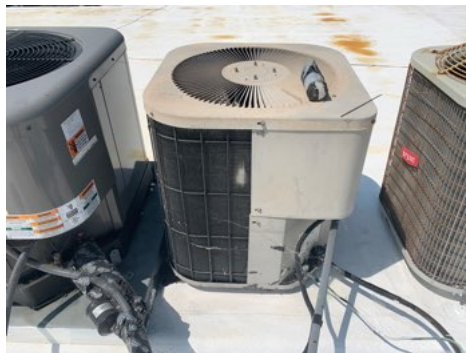
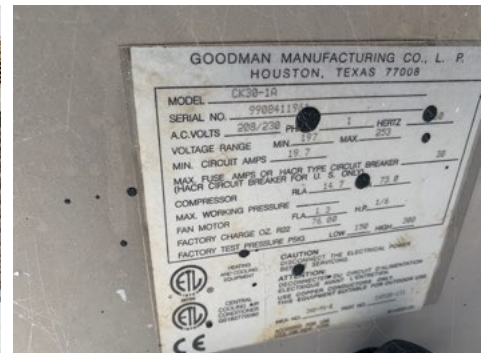
5.5. AC unit is using R - 22 refrigerant. After 2020 contractors may not be able to purchase R - 22 refrigerant for servicing this type AC units. Recommend to consult with a qualified HVAC contractor for possible upgrade/replacement of the HVAC system.

5.6. Compressor(s) outside (AC unit) old and may last a few years more, but maybe not-limited life expectancy. Possible unit(s) could fail after a home inspection during seasonal change from mild to hot weather. I cannot determine how long your AC will last before a replacement is necessary and life expectancy is not determined at this inspection. Check service records or have tested by a qualified HVAC specialist, Contractor.

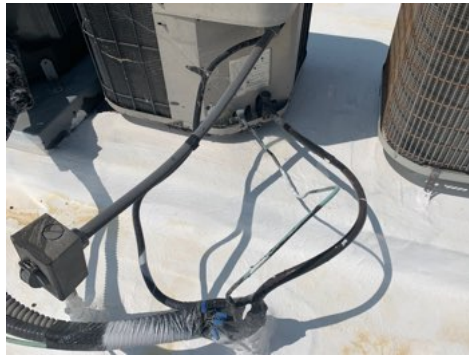
6.1. Missing insulation at refrigerant line noted at AC unit. Recommend to correct and fix for efficiency.

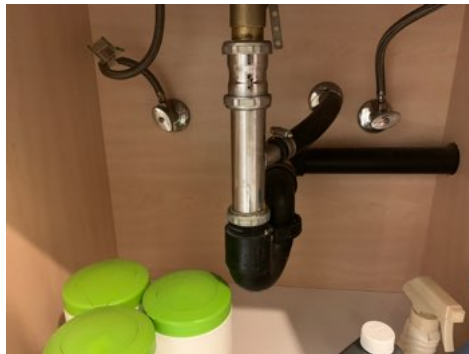
8.1. **A/C** condensation line drains at bathroom sink (FYI). Periodic cleaning, service required.

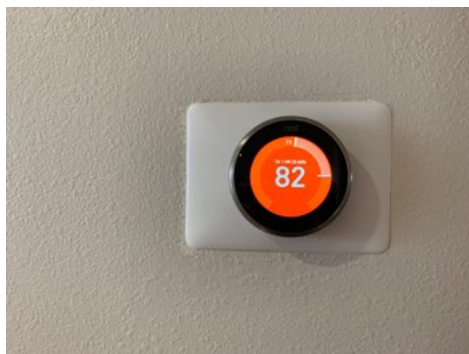
9.1. Thermostat(s) operational at the time of inspection. (FYI)

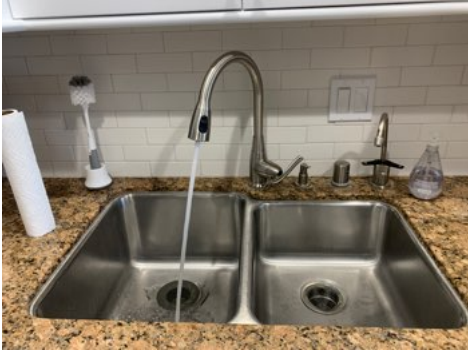
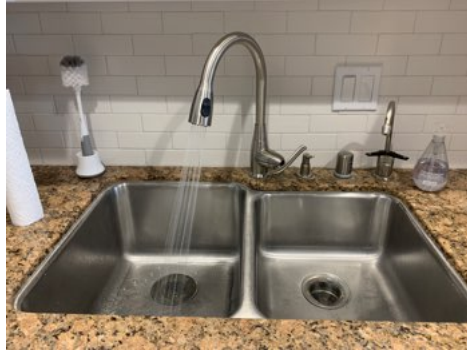
- 3.1. Sink faucet(s) functional at time of inspection.
- 3.2. View under sink cabinets was restricted due to belongings.
- 3.3. Instant Hot water Sink faucet loose at counter- leaky valves/controls. Have it checked, fixed and/or replaced by a qualified plumber.**
- 3.4. Water filter/faucet noted - Was functional at the time (FYI). Water filter system and quality of water is not part of this inspection.
- 3.5. Instant hot water dispenser noted - Was operational at the time, check the records (FYI).

Loose at counter

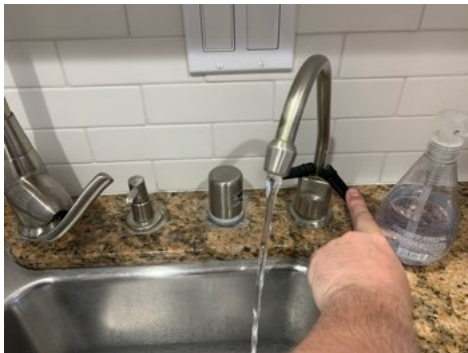
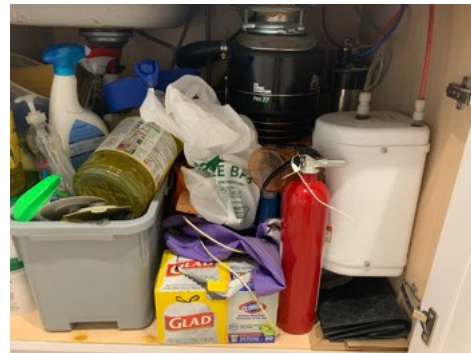
- 4.1. Unit operated at the time. (FYI)
- 4.2. Old disposer type- unable you determine remaining life expectancy - FYI
- 4.3. Worn splash guard noted. Recommend to upgrade/replace.**

Worn splashguard

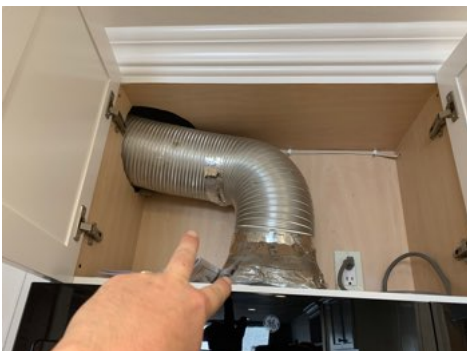
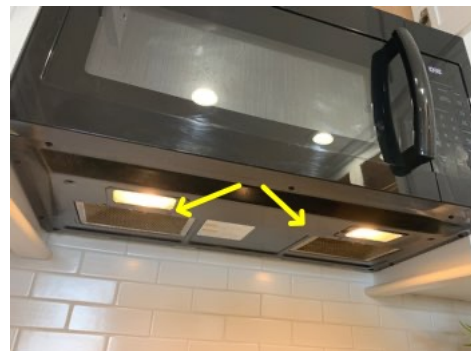
7.2. Ribbed, flex type vent pipe noted in attic space for range fan exhaust - This Vent type can contribute to a fire hazard. Recommend to change it to smooth, rigid type pipe.

7.3. Dirty filter(s) noted at the time of inspection. Recommend to replace.

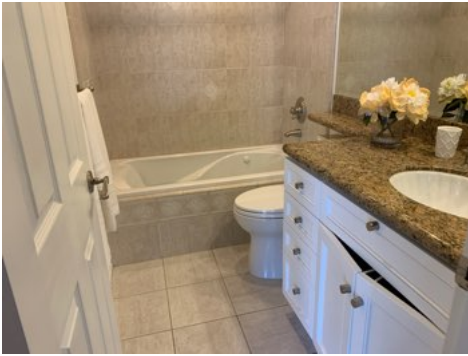
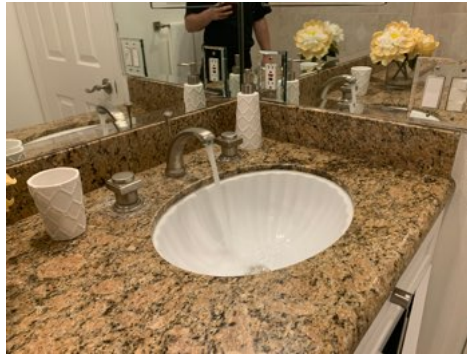
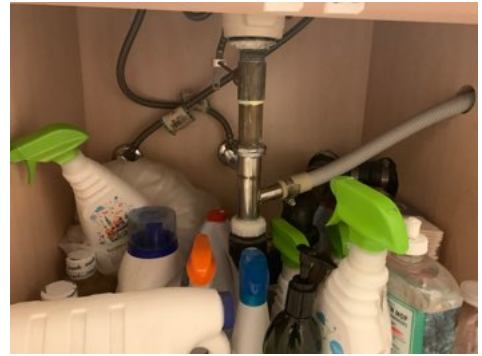
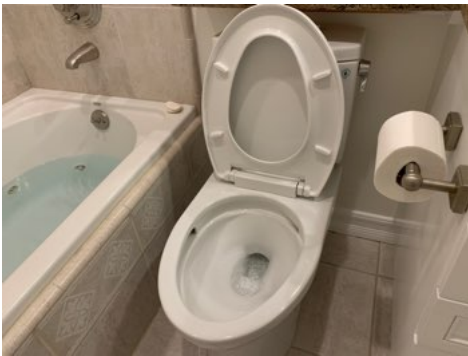
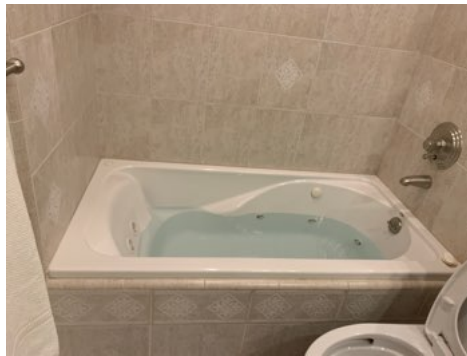
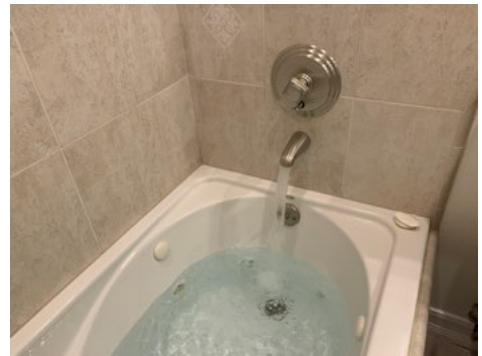
**2.3. Leaking drain line noted under the sink- In need of repair, replacement. Have it checked, fixed by a qualified specialist.**

Leaking

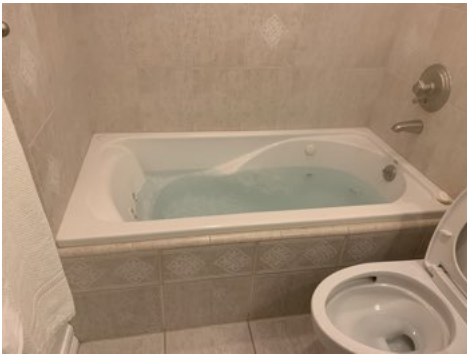
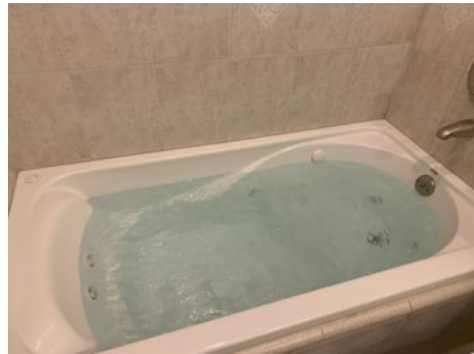
3.1. Tub jets working at the time- FYI

Jets on

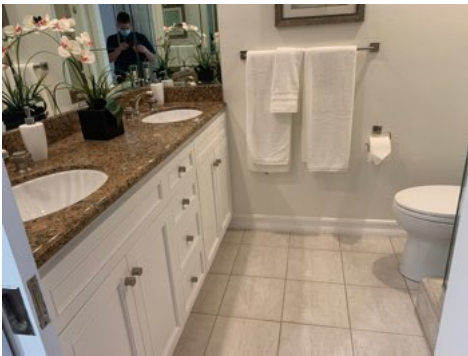
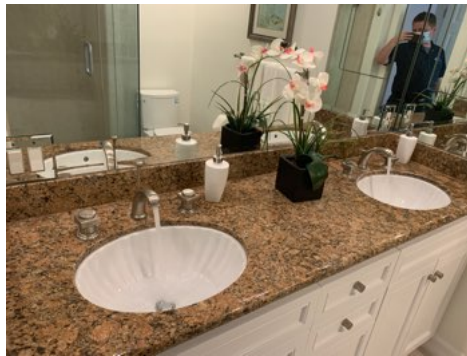
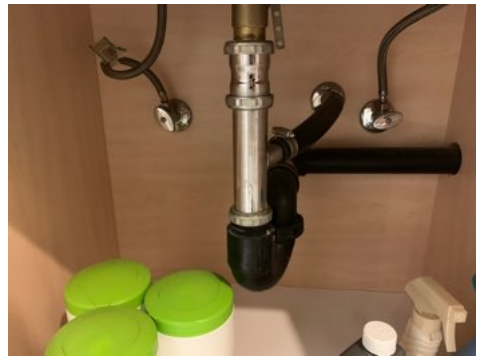
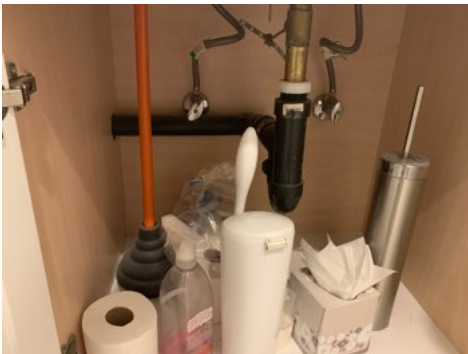
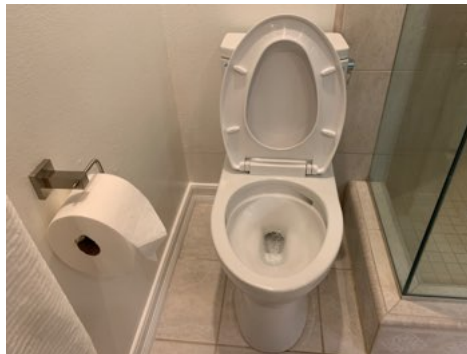
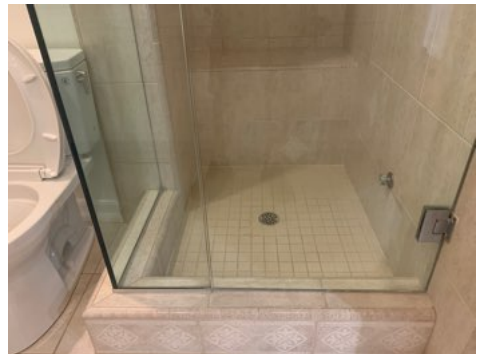
- 2.1. Sink faucet(s) functional at time of inspection.
- 2.2. Defective sink stopper at right side sink noted. Have checked/fixd.
- 2.3. Leaking drain line noted under the left side sink- In need of repair, replacement. Have it checked, fixed by a qualified specialist.
- 2.4. Sink valve(s) at left side sink not square. FYI- have checked, any necessary adjustment/correction made by qualified specialist

Leaking

Defective stopper

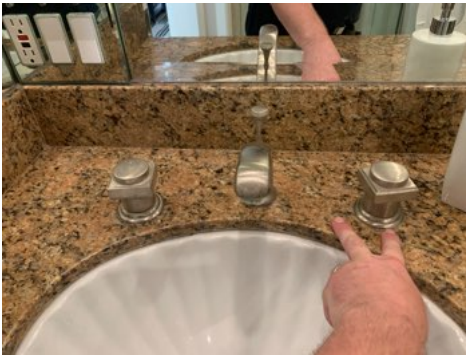
Not square

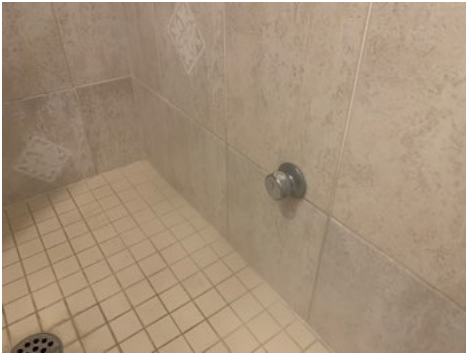
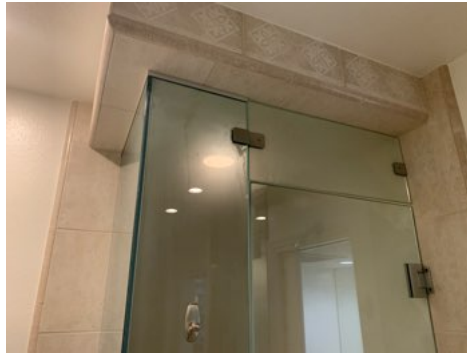
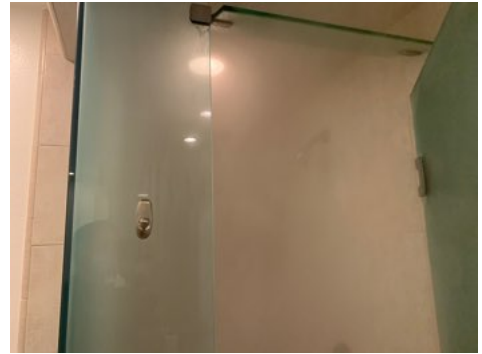
- 3.1. Steamer operated at time of inspection. Check warranties with seller. FYI
- 3.2. Steamer at shower
- 3.3. **Recommend to have a qualified termite inspector to test the shower pan for possible leaks.**
- 3.4. **Service disconnect switch missing. Have it checked and installed by a qualified electrician. (Main disconnect Shut off located at sub panel- FYI)**
- 3.5. **Missing catch pan noted. Recommend to install.**

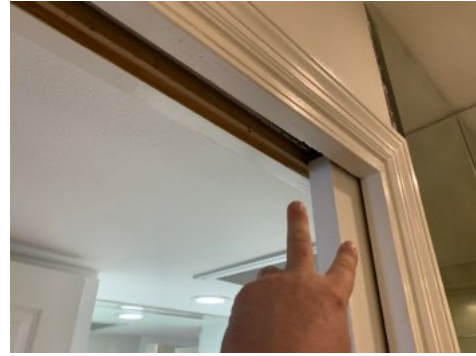
- 5.1. **Bathroom pocket door is not opening/closing properly- won't track noted, rubs at floor. In need of adjustment, repair by a qualified specialist**
