Property Inspection Report

807 Palmyrita Ct, Riverside, CA 92507
Inspection prepared for: Peter Liu Tiffany Tso
Real Estate Agent: -

Date of Inspection: 10/11/2022 Time: 11:00 AM
Age of Home: 1999 Size: 100000
Weather: Clear
Order ID: 871

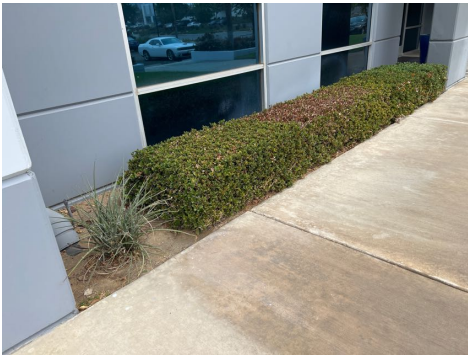
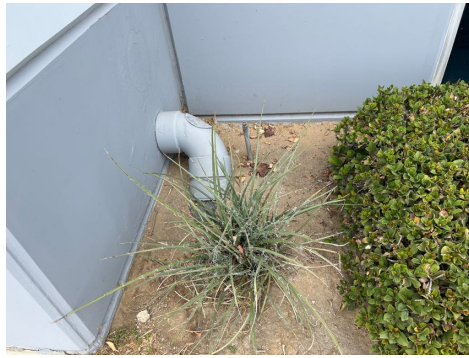
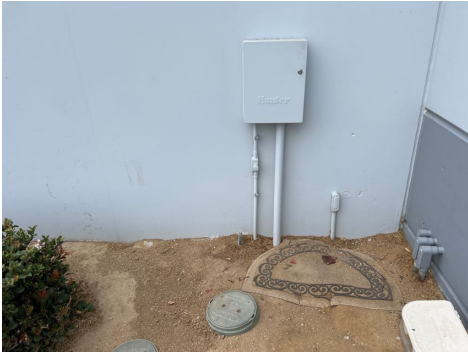
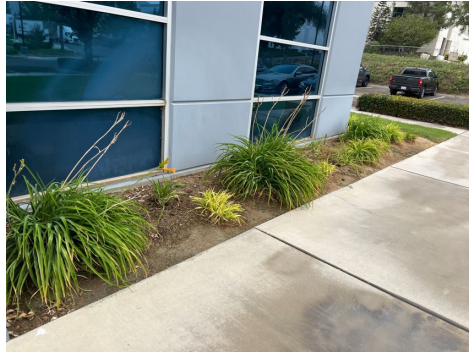
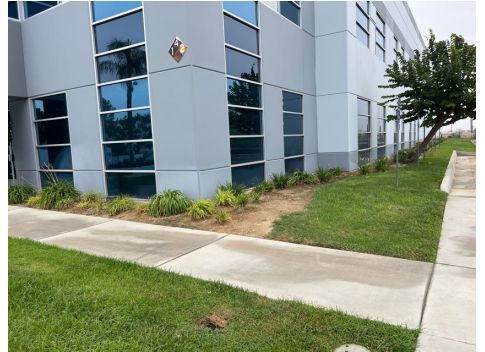
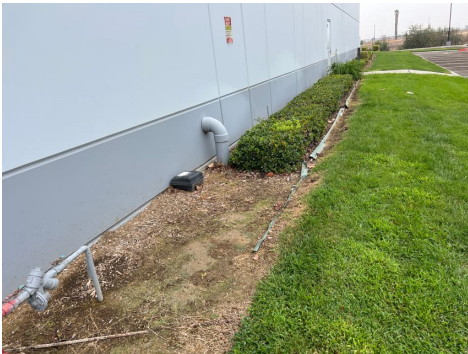
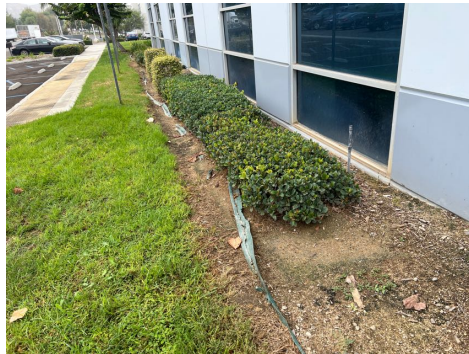
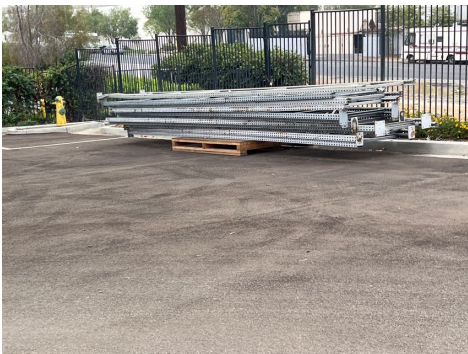
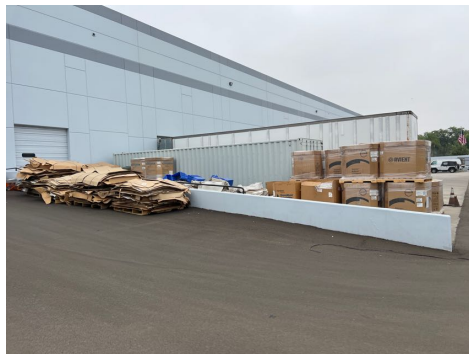
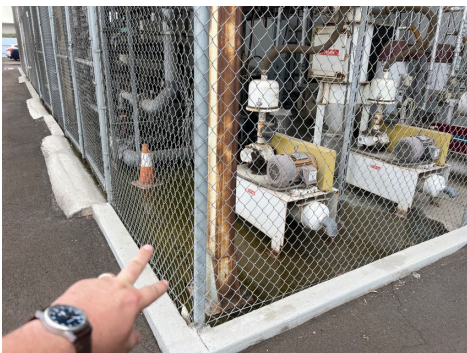
- 2.4. Planter(s) built at the foundation - not recommended. Recommend to remove to prevent water seepage into crawl space/foundation.
- 2.5. Building without drainage pipes- water ponding noted at rear near Chillers and air compressors. Have checked, evaluated by qualified specialist for any necessary correction.

Water ponding

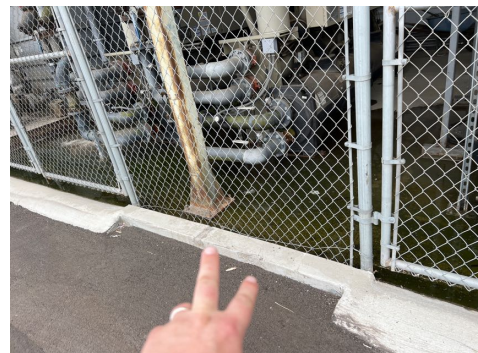
Water ponding

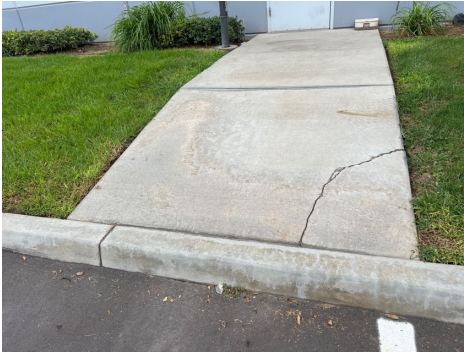
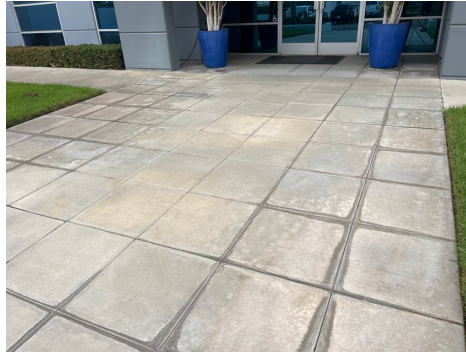
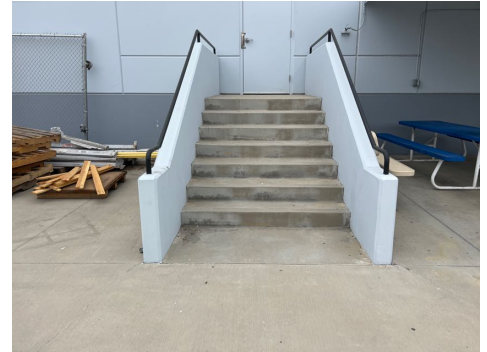
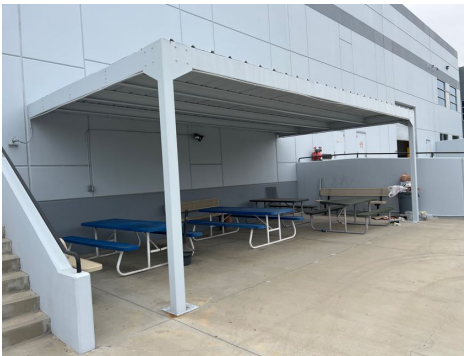
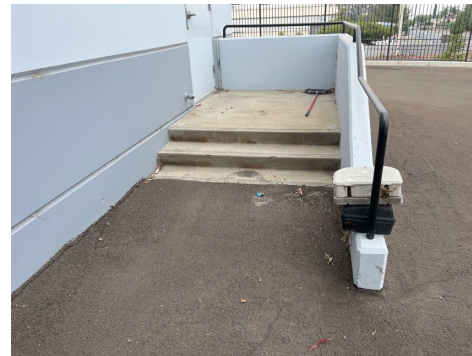
3.1. Common Cracks, settlement present at porch and/or patio area, walkways. FYI. Have checked for any necessary correction.

3.2. Metal and/or plastic patio covers Noted. These type of covers prone to leaks, regular periodic maintenance required. Check with seller for any known defects or have checked, evaluated by qualified specialist.

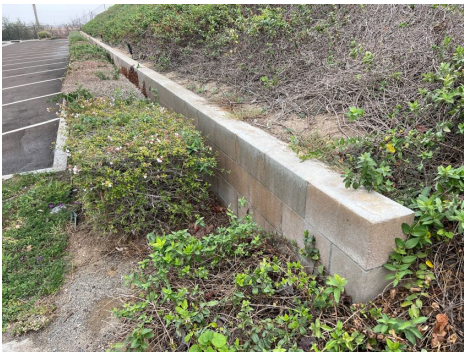
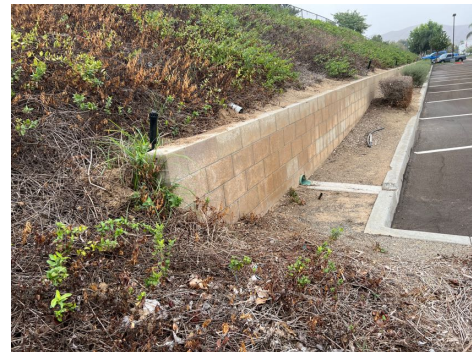
4.2. Missing trench drain/swale at retaining wall at hillside noted - Recommend to built to divert hillside water away from wall. Have it checked, evaluated by a qualified contractor for any necessary correction.

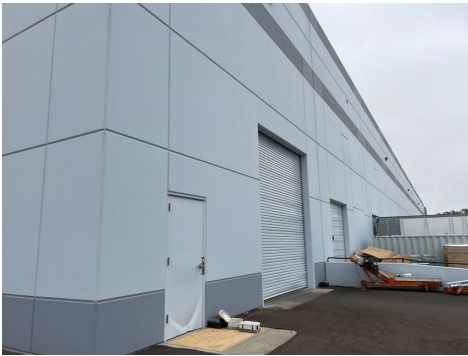
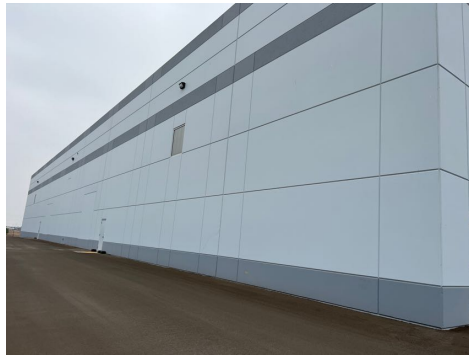
6.1. Building is a tilt up concrete building type. Some of the caulking at wall joints at rear were cracked, worn, seepage may occur from cracks at caulking at interior of the building (common for these type of Buildings). Recommend to patch, paint, seal the cracks from exterior. Have it checked by a qualified specialist, painting contractor for any necessary correction.

Cracked caulking- rear

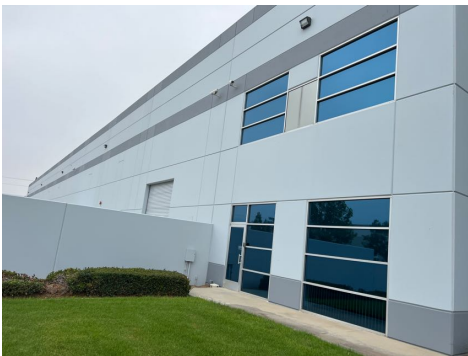
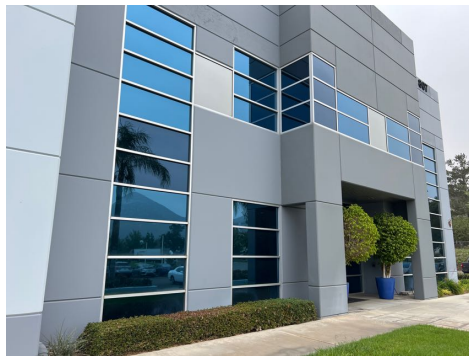
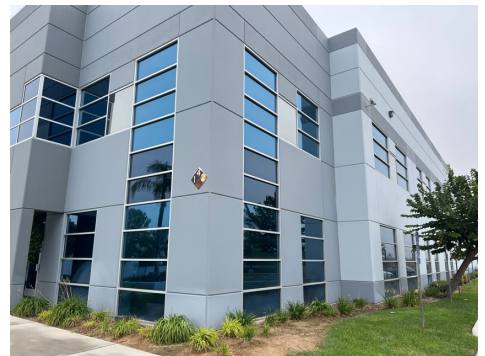
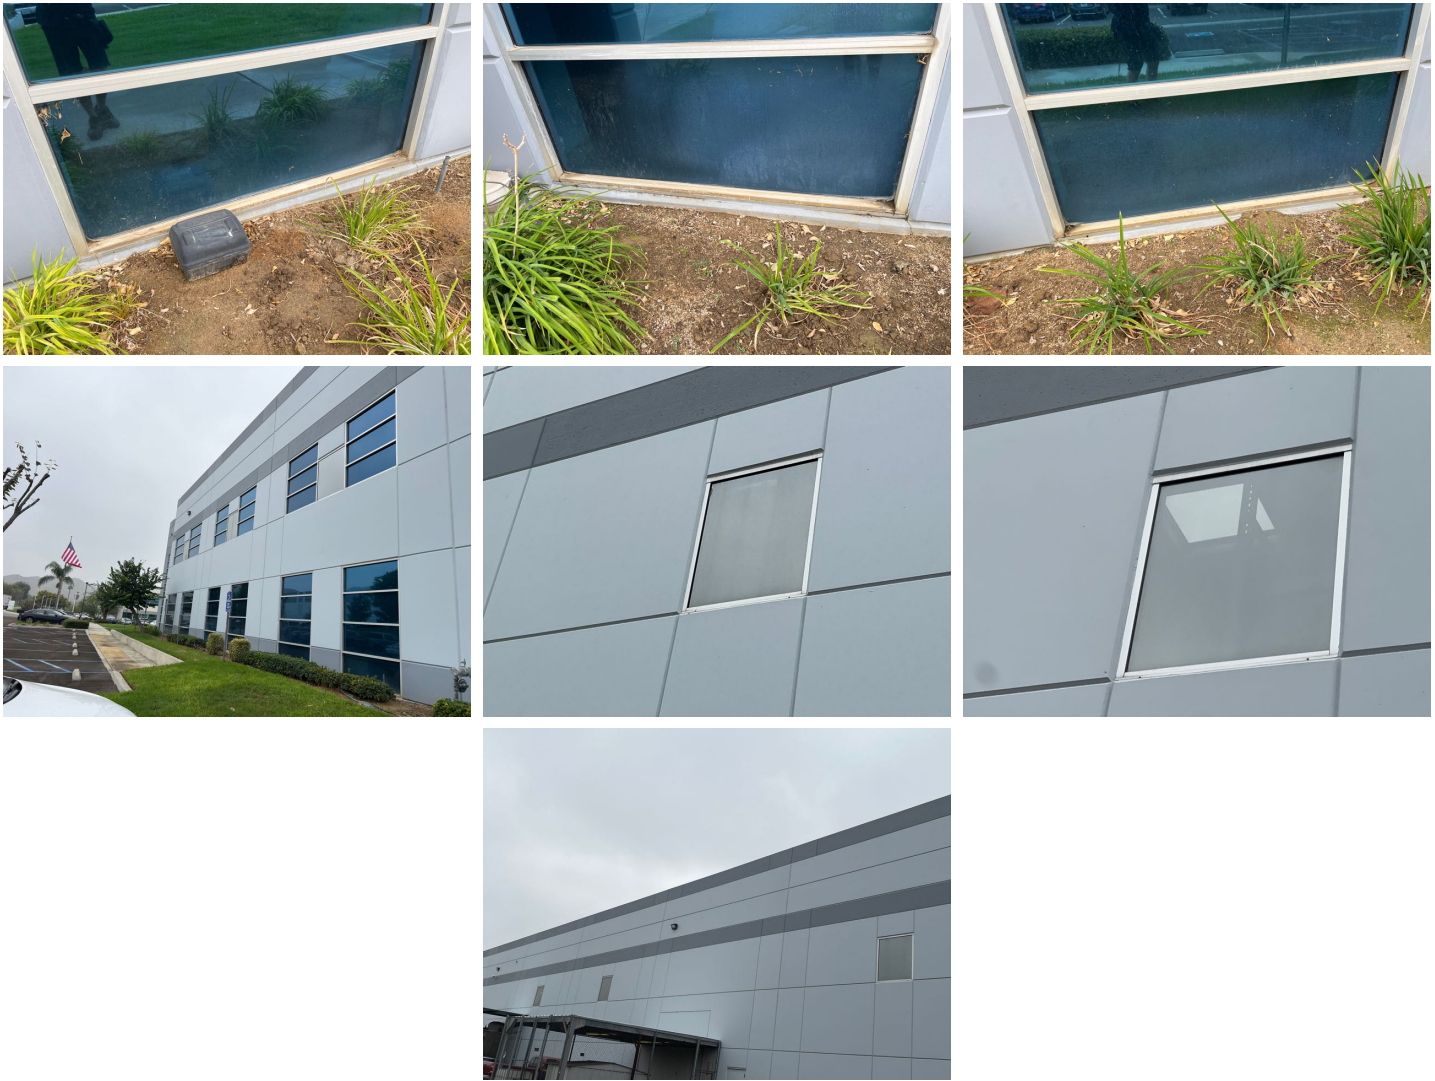
7.2. Worn weatherstripping noted at some window(s) Recommend to upgrade, correct. Have checked by qualified specialist.

7.3. Evidence of moisture seepage was noted at some interior window frames, sills. Have it checked by qualified specialist for any necessary correction/repair.

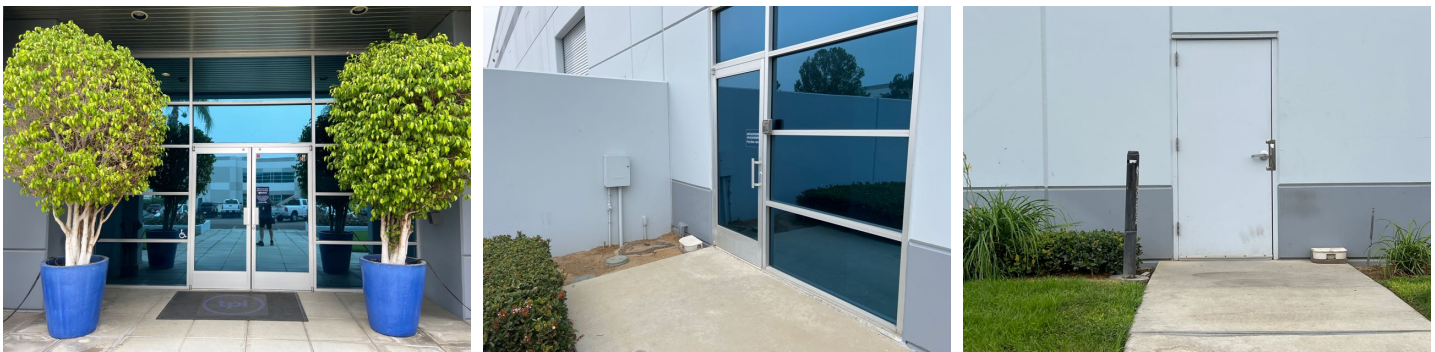
8.1. Dented exterior door noted at left rear corner. Have checked, any necessary correction made by qualified specialist.

Dented- left rear

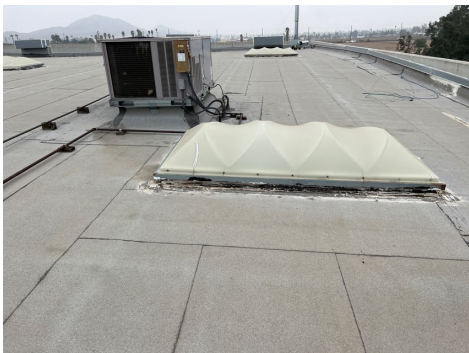
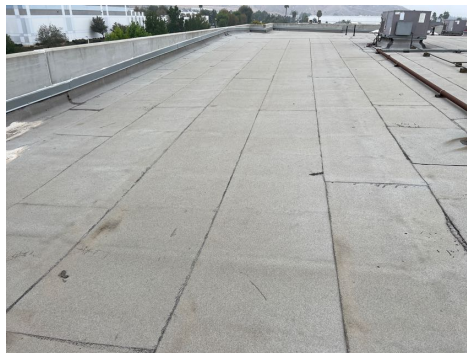
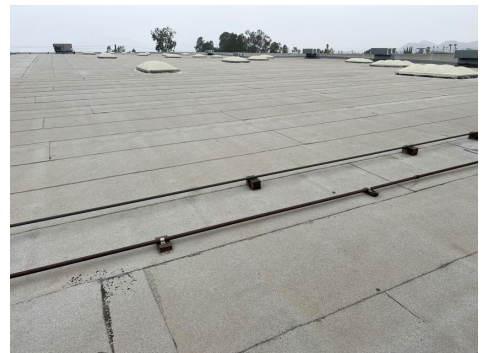
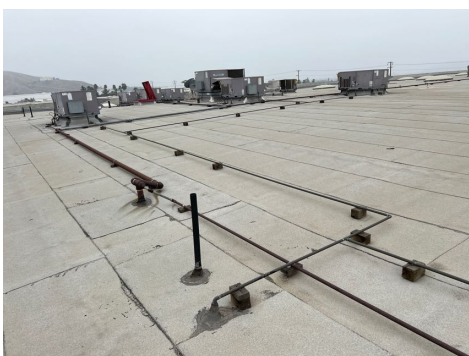
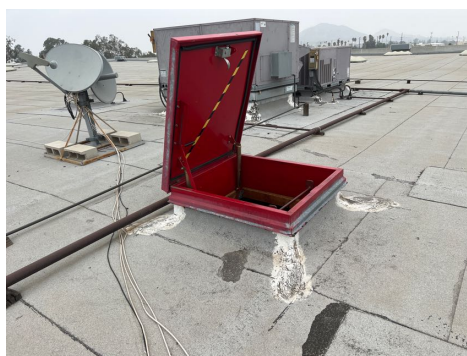
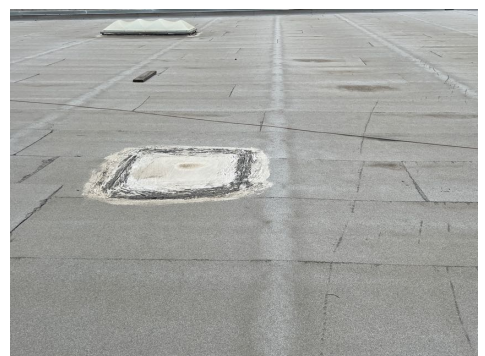
2.1. Patching and previous repairs noted to various locations/areas of roof. Check the records, warranties.

2.2. Flat Roof covering shows puckering, blistering and alligating/damage at some areas- These areas will eventually crack, leak and lead to roof being in need replacing. Have it evaluated by a qualified roofer for any necessary corrections.

2.3. Aged flat roof cover noted. Recommend to apply roof coating to prolong life of the roof. Have it evaluated by a qualified roofer for any necessary correction.

2.4. Signs of Water ponding at sections at flat roof area noted- Recommend to have it checked, evaluated and any necessary corrections made by a qualified Roofer.

2.6. Recommend further complete evaluation of roof system, necessary maintenance and/or corrections performed by a qualified roofer.

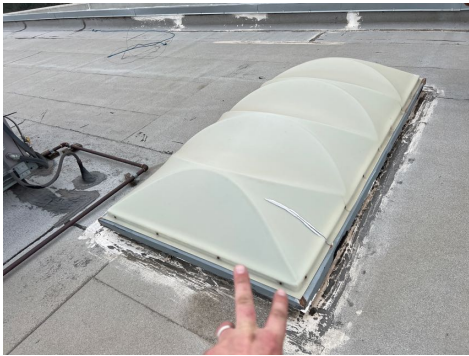
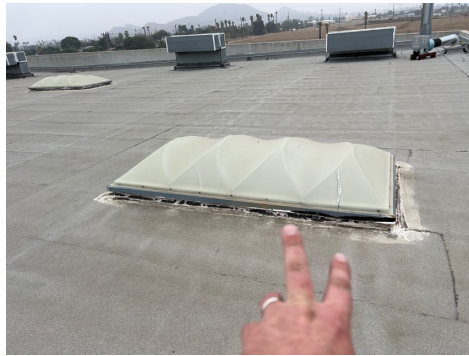
6.1. Crack(s), damage, significant wear found at all skylight(s)- 48 total. Have them all checked, any necessary correction/repair or replacement made by a qualified roofer, contractor.

48 skylights - need complete evaluation for possible repair/replacement

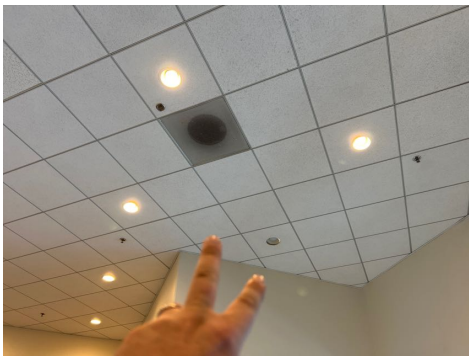
7.3. Ceiling light(s) not working at- some areas. Have them checked by a qualified specialist.

Not working - lobby

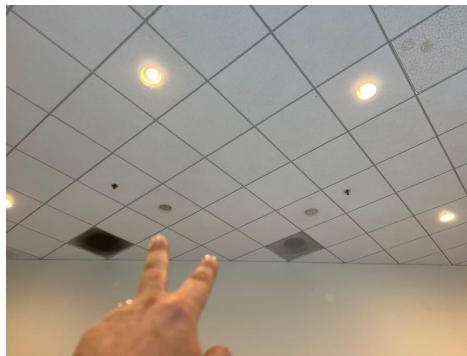
Not working - lobby

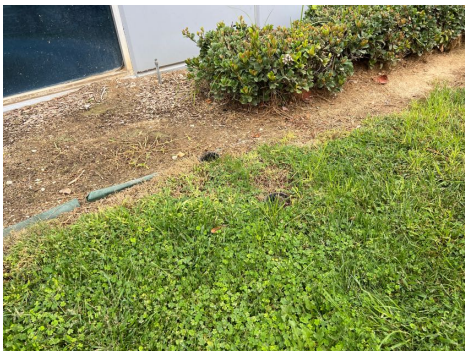
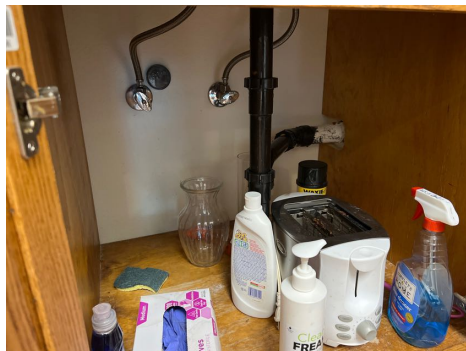
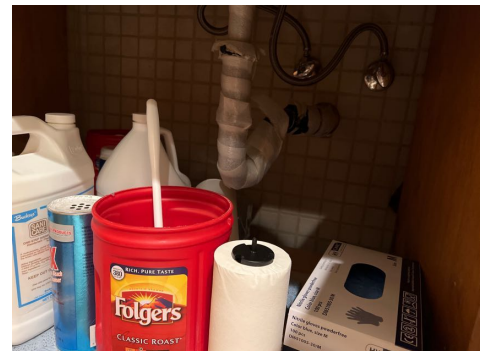
- 1.3. Sewer clean out at side yard noted - Recommend to check service records.
- 1.4. Open/Exposed clean outs noted at side exterior - recommend to install protective cover to prevent damages. Have checked, corrections made by qualified plumber.
- 1.5. Most of the Sewer, Waste pipes are located underground not fully visible/accessible and not part of this inspection. A sewer video inspection must be completed prior to close of escrow by a qualified plumber in order to determine the true condition of the Sewer, Waste line.

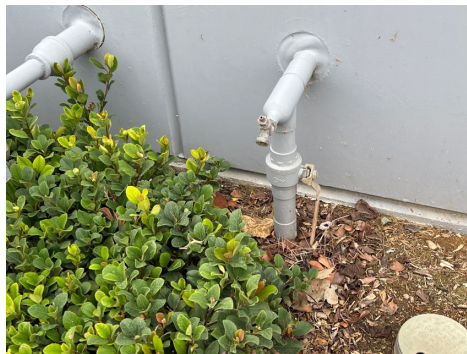
2.2. Hose Bibs: Missing anti-siphon valve at hose bibs (A anti-siphon valve is a device that prevents liquid from returning to the line from which it came if a siphon action occurs). Recommend to have checked and installed by a qualified specialist.

2.3. Unable to check the regulated pressure at the time (No regulated hose bib found)

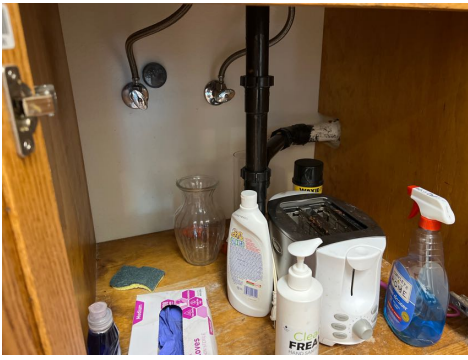
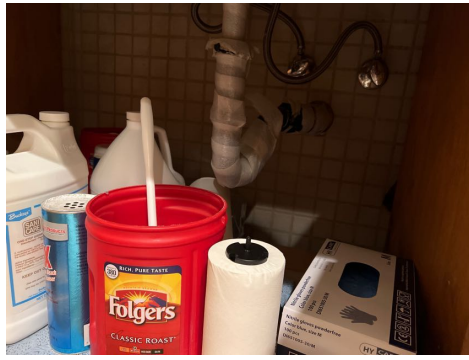
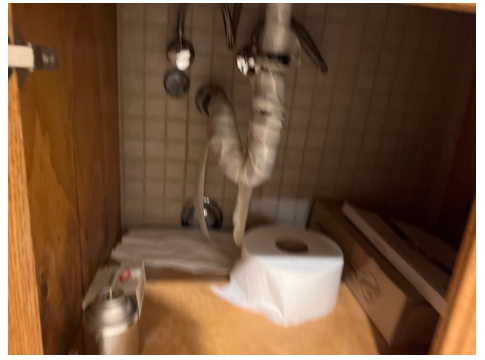
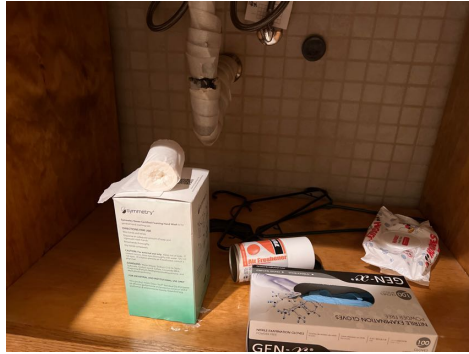
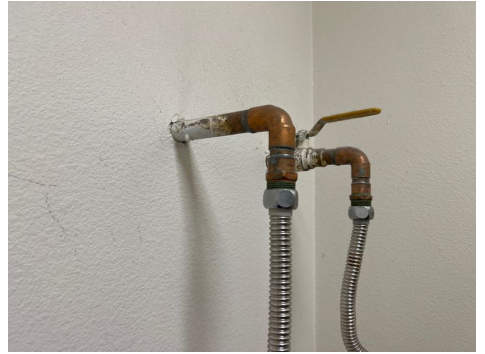
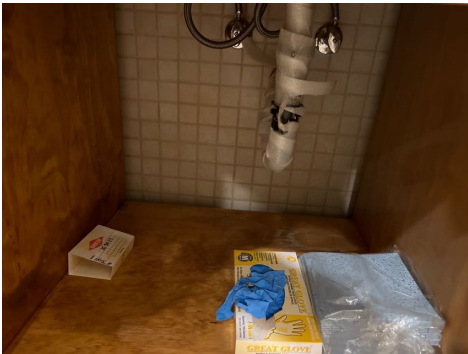
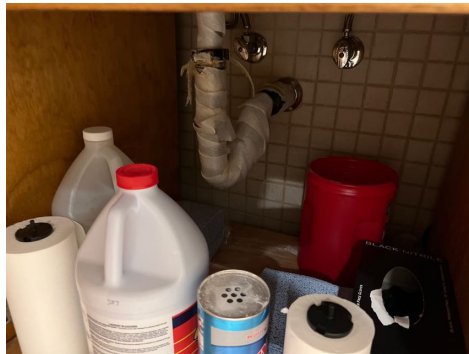
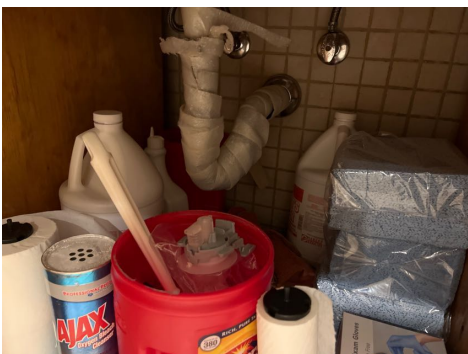
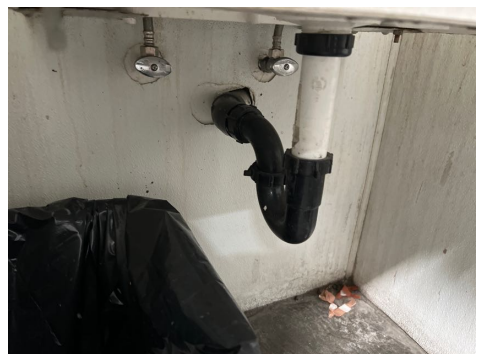
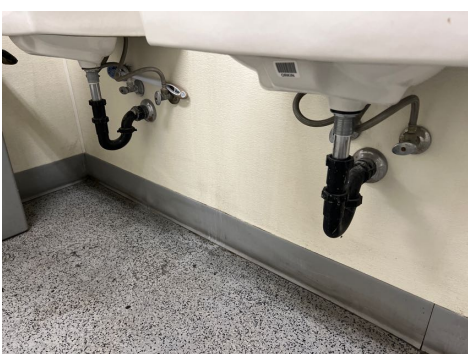
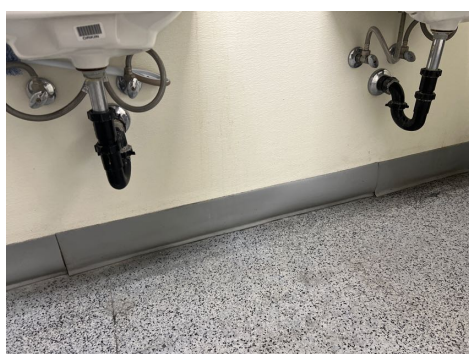
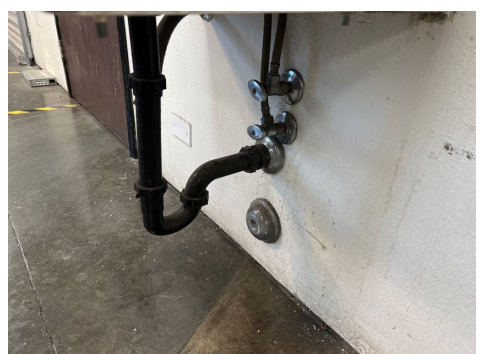
3.1. The majority of the water supply pipes, waste lines and gas lines are underground, in walls or installed in concealed parts of the structure and thus are not visible. Their condition cannot be determined and no representation is made as to their status. Check the records for any known defects and/or repairs.

3.3. Most of the plumbing pipes were not visible at this inspection. Check the records for any known defects, repairs.

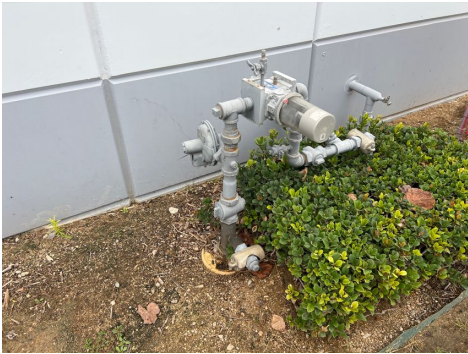
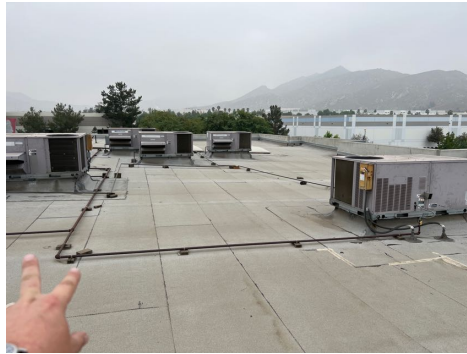
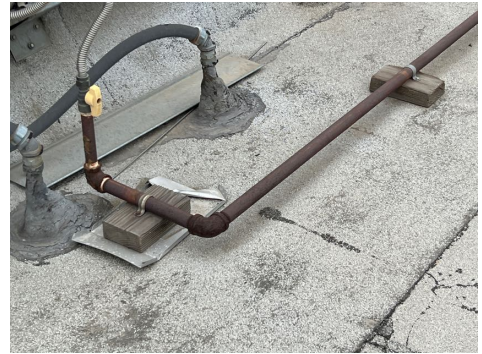
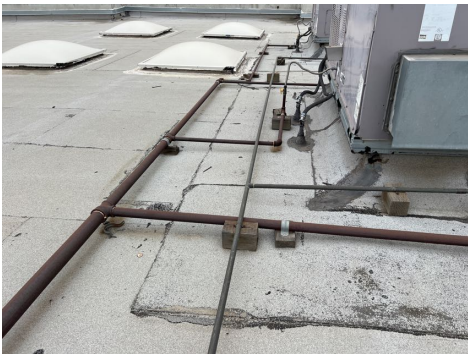
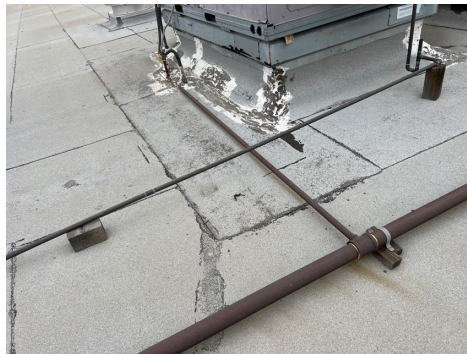
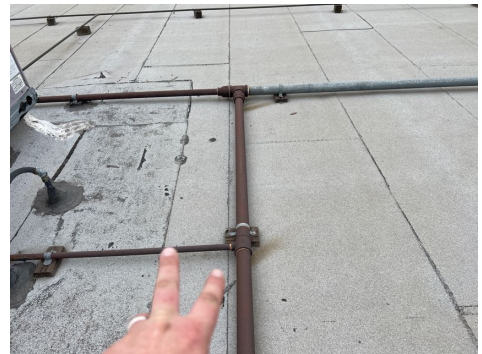
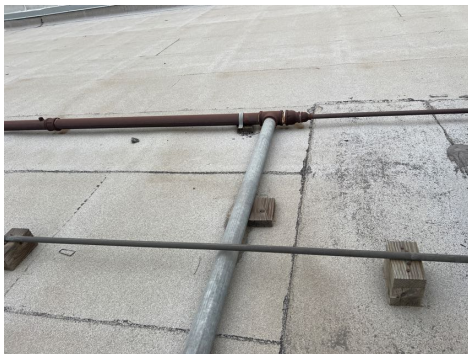
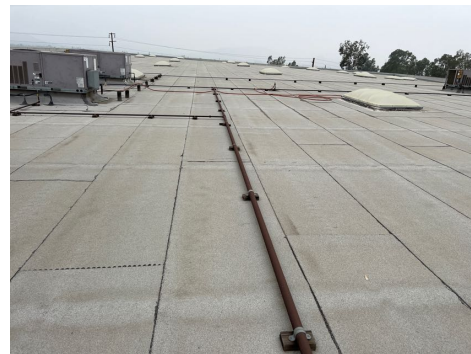
4.2. Gas meter - Seismic shut off was not present at the time of inspection, recommend to install - May not be required in the City of Location - Recommend to check the local regulations.

4.3. Underground gas pipe noted (type unknown). Have it checked for possible gas leak. Gas leaks or pipe testing not part of this inspection. Recommend to check the building records, permits for any known issues or repairs regarding gas pipes, fuel systems and/or have it tested by the Gas Co. and/or a qualified plumber.

4.4. Gas lines on roof were not sealed, painted. Have it checked, corrected by qualified specialist.

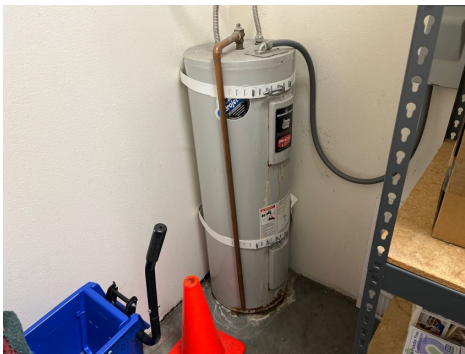
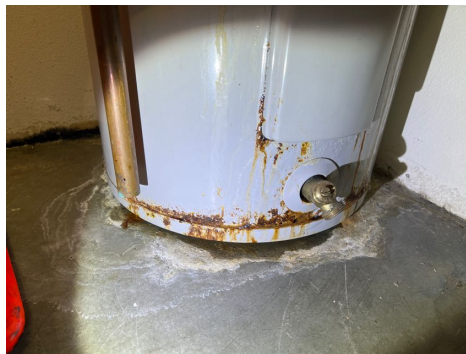
5.3. Leaking/heavy rust found at water heater at utility closet. Recommend complete evaluation, necessary corrections, repairs and/or replacement by a qualified plumber.

Leaky

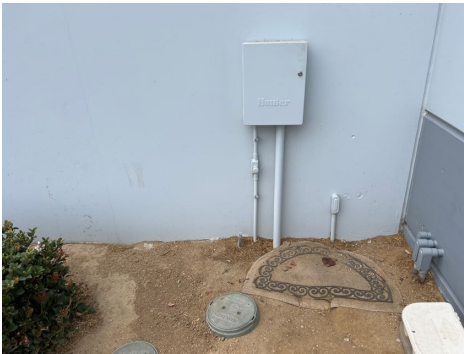
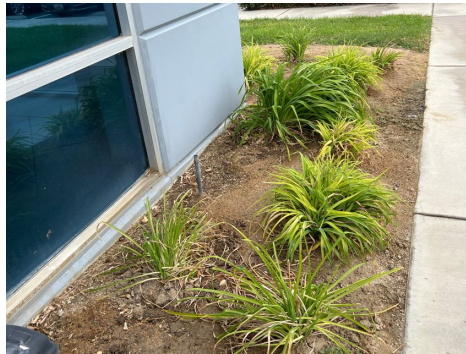
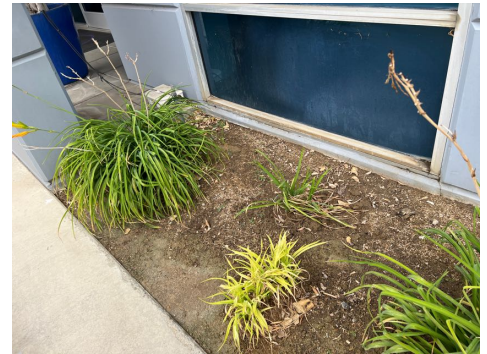
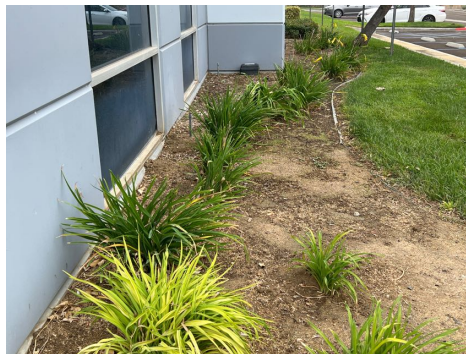
6.2. Sprinklers are set too close to the building/structure. Recommend moving minimum 2' away from structure - Recommended to keep water, vegetation away from structure/foundation. Have checked by qualified specialist for any necessary correction.

6.3. Water stains noted at exterior walls and/or lower windows due to sprinkler over-spray, some seepage noted at interior sills at lobby and lower offices. Have it checked/cleaned/adjustments and corrections made as necessary. Keep water away from structure.

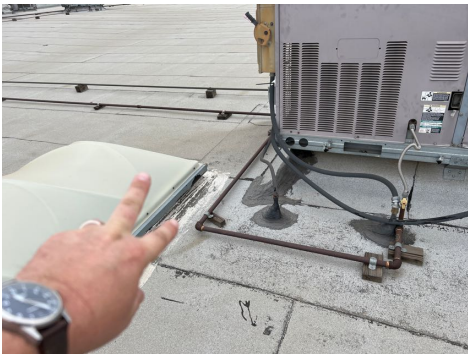
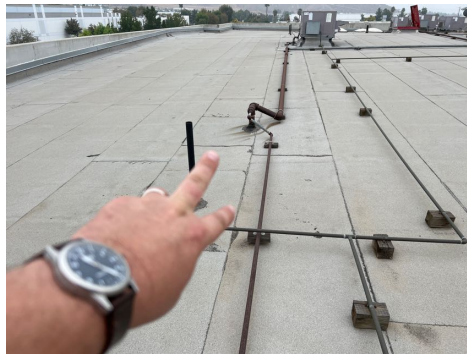
2.2. Gas pipe is not properly painted/sealed at the roof and/or unit at exterior. Have it checked, fixed by qualified specialist.

Not painted, sealed

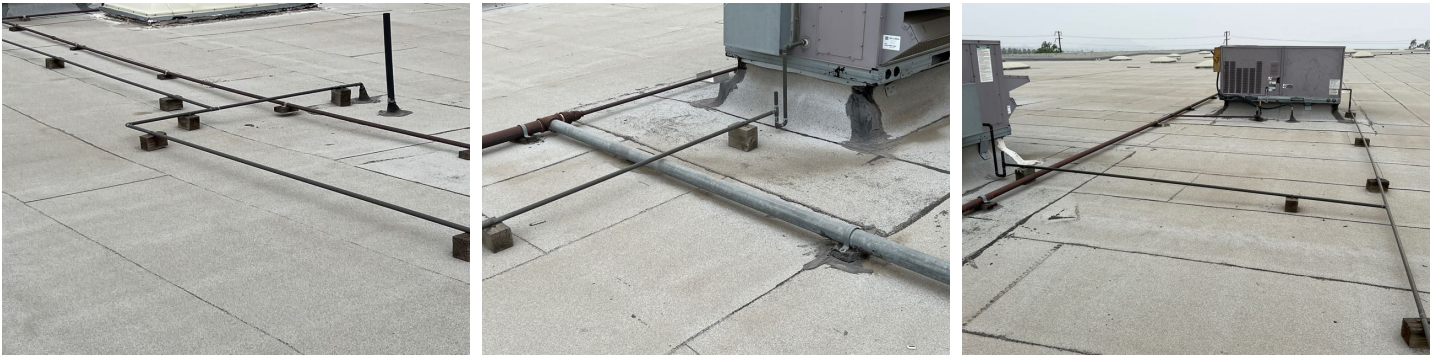
- 8.1. **A/C** condensation line termination point not found, not visible at time of inspection. Have it checked by a qualified specialist.

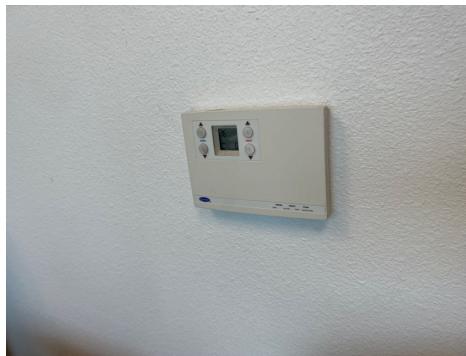
9.1. Building with possible with Zone or central control type system - Not part of this inspection (dampers not tested/inspected at this inspection). Check with the seller about operation and service and/or have it tested by a qualified specialist.

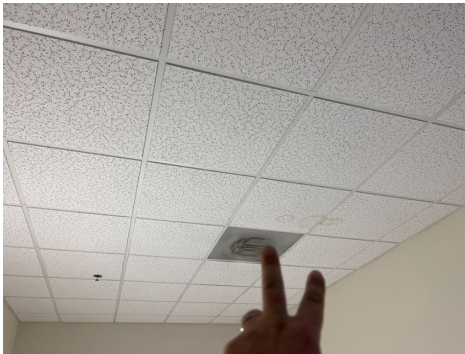
Stains- rear stairs

1.1. Water stains at drop down ceiling panels at some areas noted due to possible leak or unable to determine cause. Check the records, with seller of known defects. Have it evaluated, any necessary correction or repairs by a qualified roofer and/or qualified contractor.

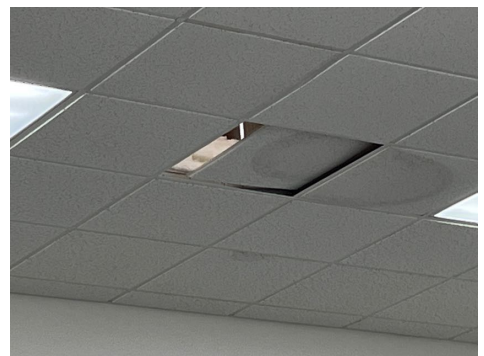
Loose- storage warehouse

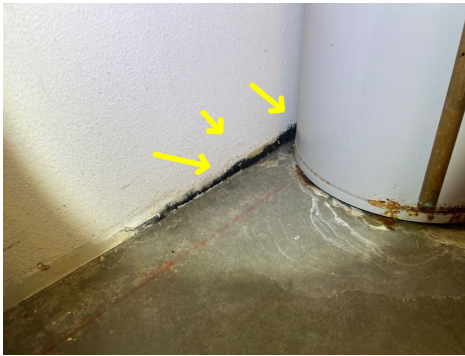
Utility closet

2.6. Signs of Mold like substance present on walls behind small water heater at utility closet. We did not inspect, test or determine if this is Mold or if this Mold like substance is or is not a health hazard. Recommend you contact a qualified Mold inspector or expert for investigation and/or correction if needed.

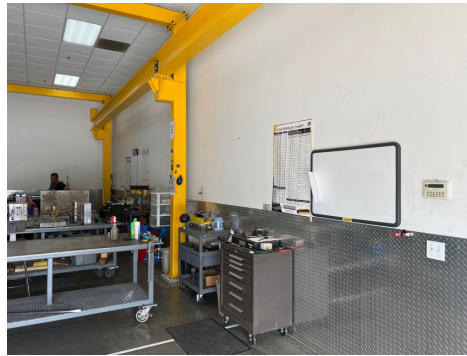
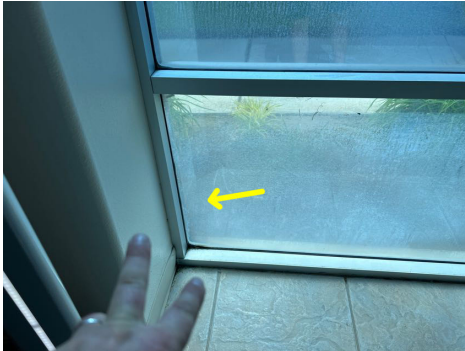
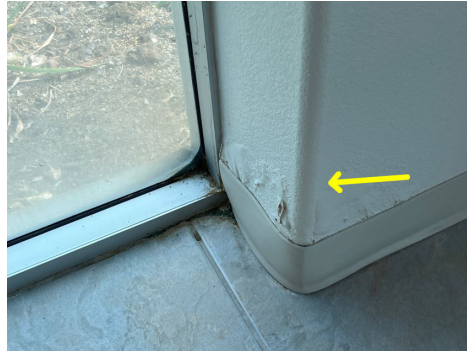
Seepage- lobby

2.7. Water Stains, bubbling at wall noted at window frame due to seepage from exterior sprinklers- noted at some areas at lobby and some offices. Have it evaluated, any necessary correction, repair by a qualified contractor.

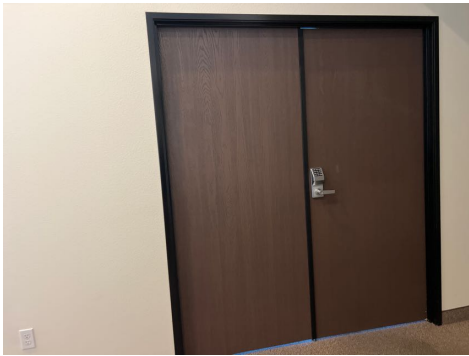
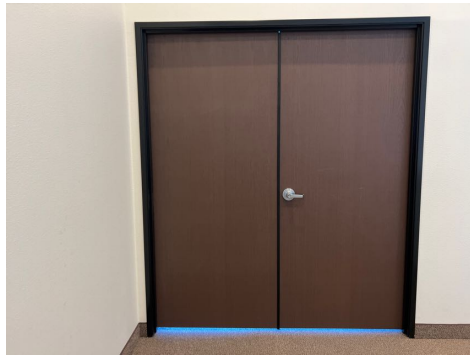
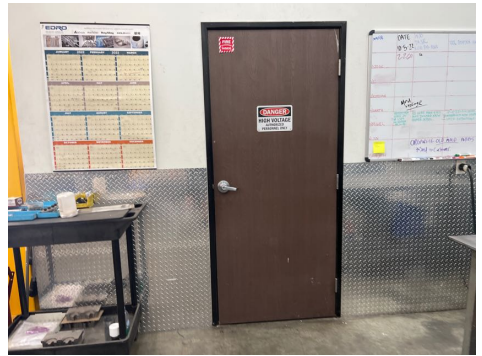
Locked

4.1. Some interior doors locked and not opened. Check with seller.

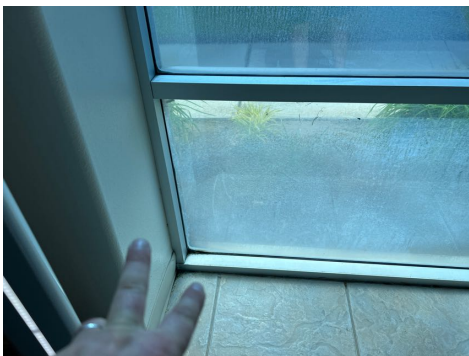
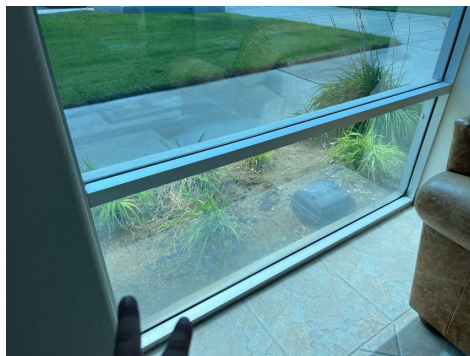
5.1. Water Stains, bubbling at wall noted at window frame due to seepage from exterior sprinklers- noted at some areas at lobby and some offices. Have it evaluated, any necessary correction, repair by a qualified contractor.

Seepage- lobby

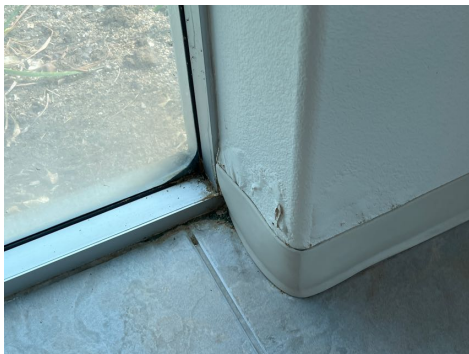
Seepage- lobby

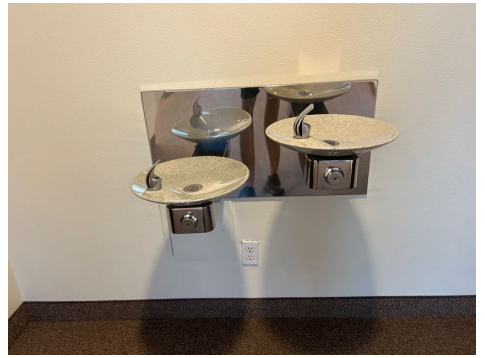
9.7. Water fountains defective and/or damaged handle at water fountain noted at right side hall and workshop. Have checked, fixed by qualified specialist.

Defective water fountain - right side

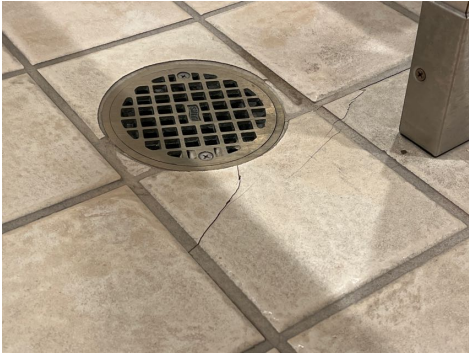
Mens room

- 3.1. Cracked tiles noted at flooring. Have it evaluated, any necessary correction or repairs replacement made by a qualified specialist.

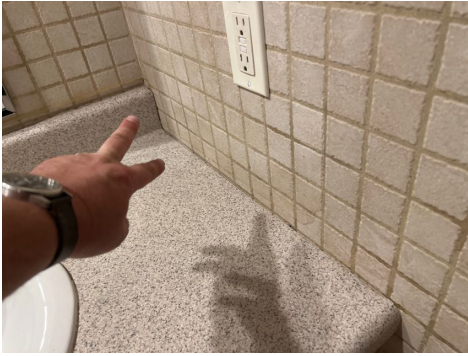
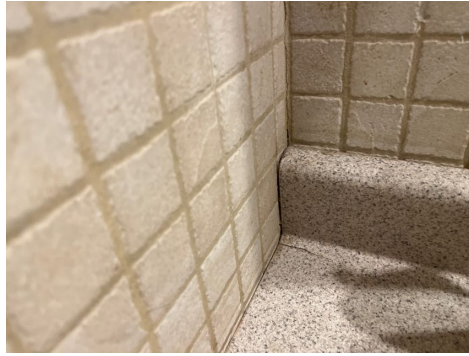
Womens bath

- 2.1. Cracked grout noted at counter, backsplash. Recommend to have it corrected, sealed to prevent water seepage. Have it checked by a qualified specialist.

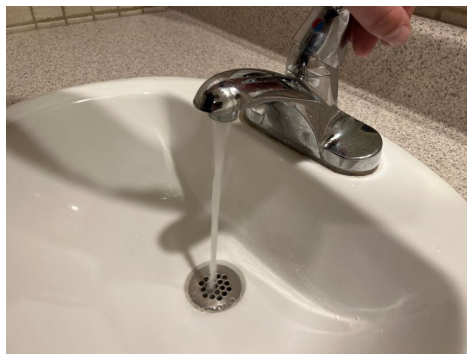
2.1. Aerator defective, irregular water flow noted. In need of repair, replacement. Have it checked, fixed by a qualified specialist.

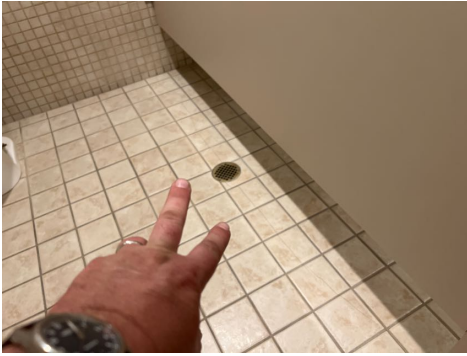
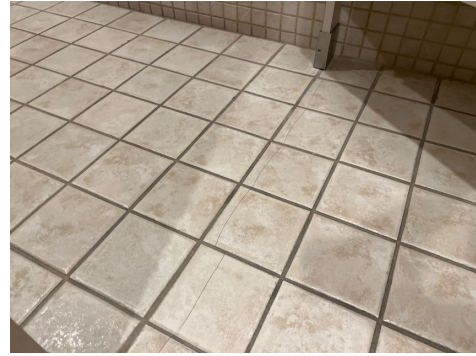
Cracked tiles - upstairs mens bathroom

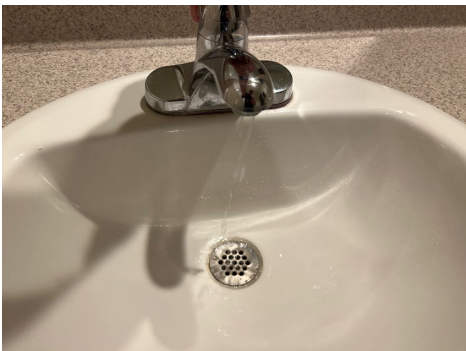
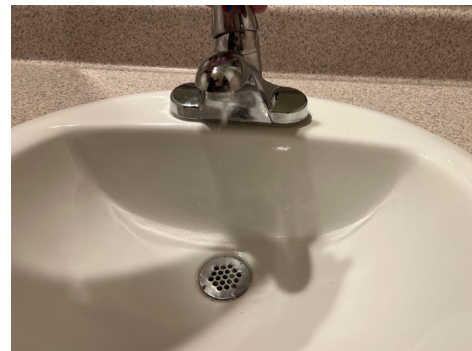
2.1. Aerator defective, irregular water flow noted. In need of repair, replacement. Have it checked, fixed by a qualified specialist.

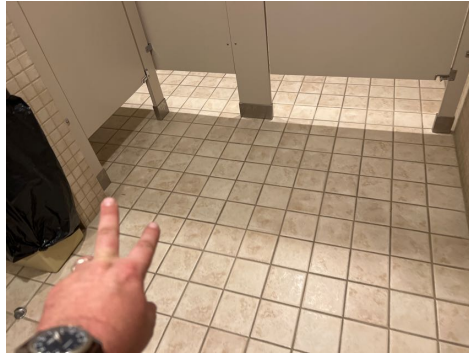
3.1. Cracked tiles noted at flooring. Have it evaluated, any necessary correction or repairs replacement made by a qualified specialist.

Women's upstairs restroom - cracked tiles

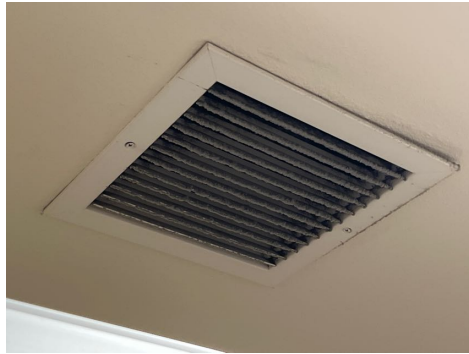
4.1. Dirty exhaust fan(s) noted. Recommend to clean, service.

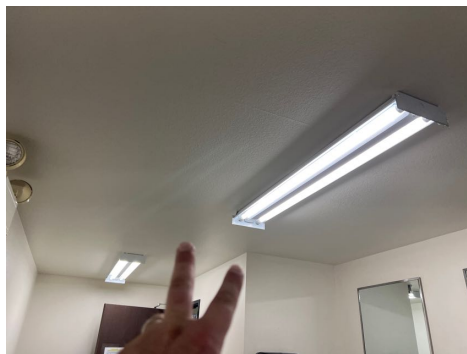
2.1. Light cover is damaged and/or missing. Recommend to have checked, fixed by a qualified specialist.

Missing covers - mens workshop bsth

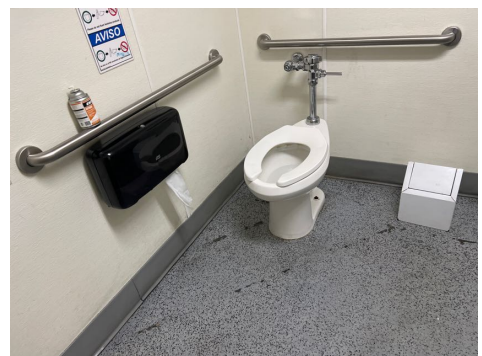
Womens workshop bath

Defective

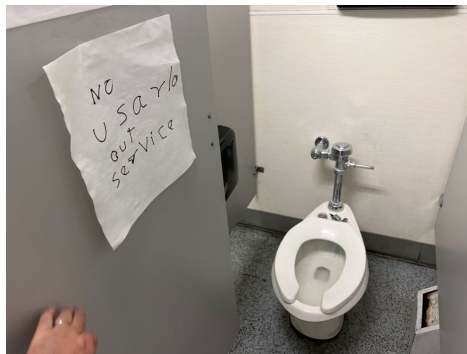
2.1. Defective flapper, toilet not working properly. Have checked, fixed by qualified plumber.

Defective

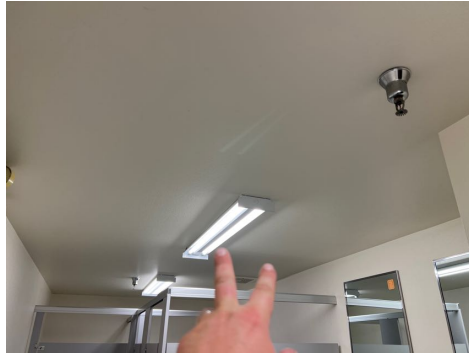
3.1. Light cover is damaged and/or missing. Recommend to have checked, fixed by a qualified specialist.

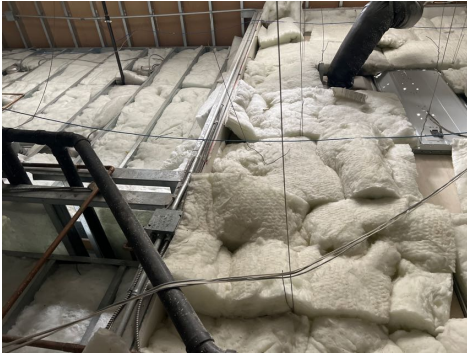
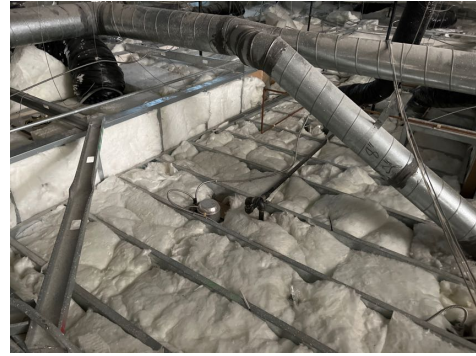
- 2.1. Ceiling joists were not fully visible to comment due to insulation. Check the records for any known defects, repairs.

Insulation Type:

- Fiberglass
