Property Inspection Report

807 Palmyrita Ct, Riverside, CA 92507
Inspection prepared for: Peter Liu Tiffany Tso
Real Estate Agent: -

Date of Inspection: 10/11/2022 Time: 11:00 AM
Age of Home: 1999 Size: 100000
Weather: Clear
Order ID: 871

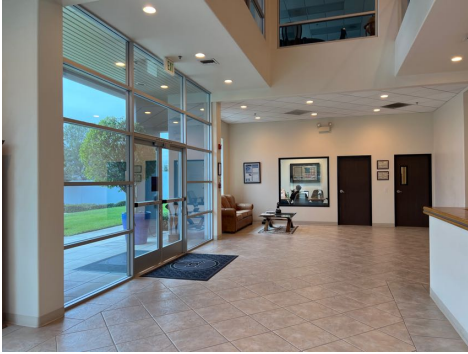
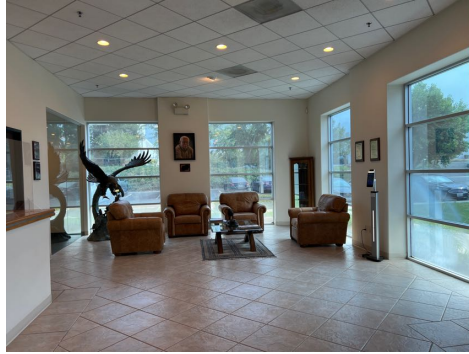
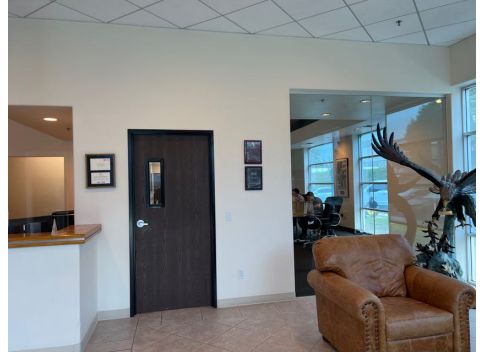
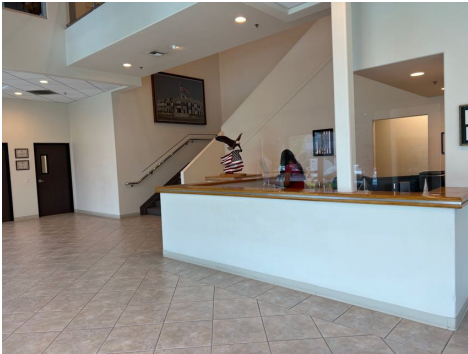
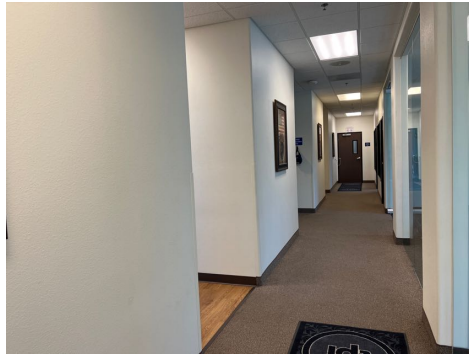
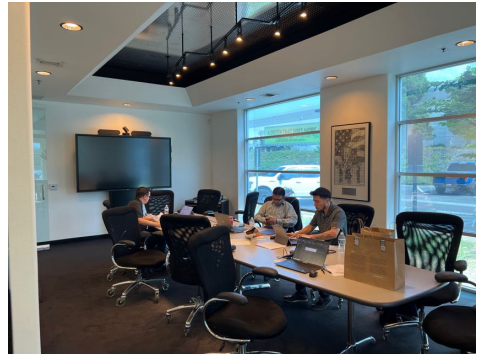
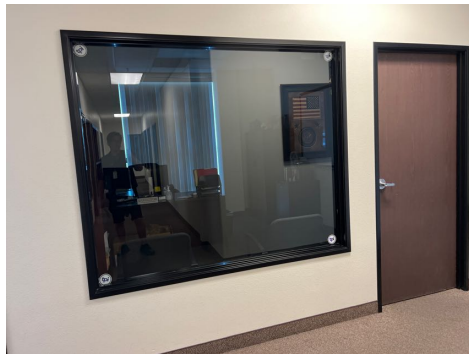
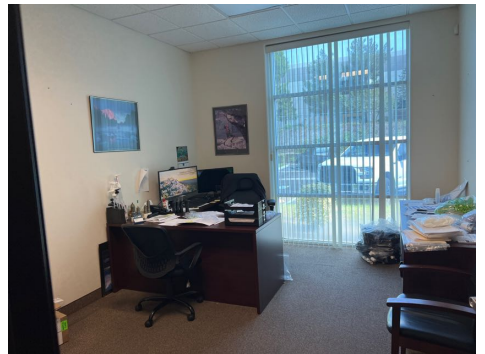
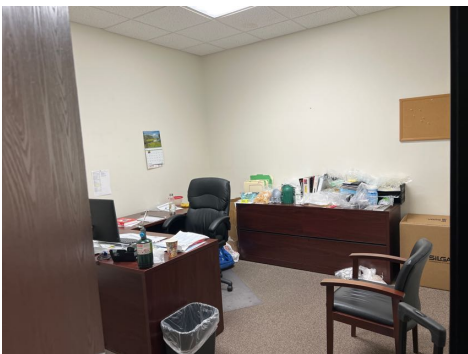
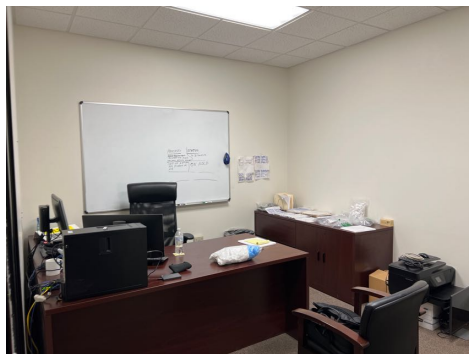
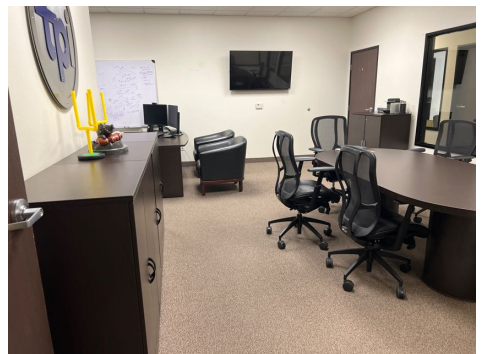
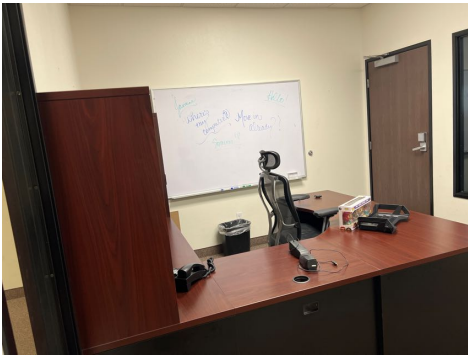
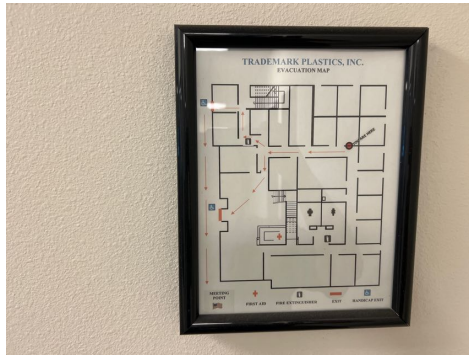
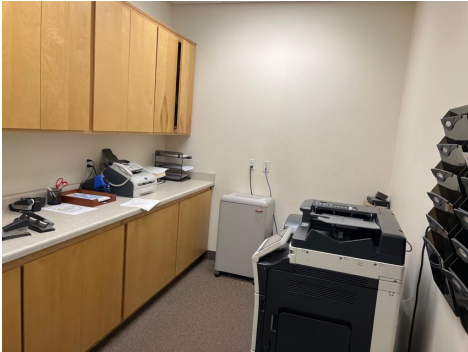
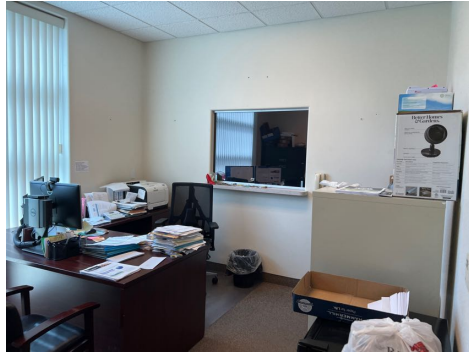
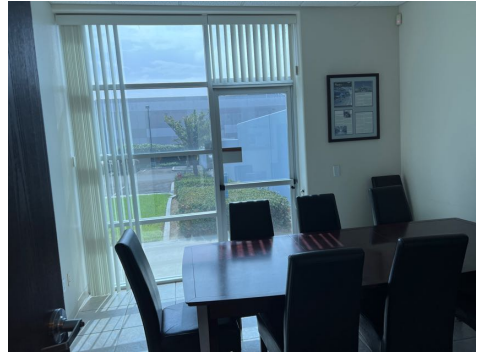
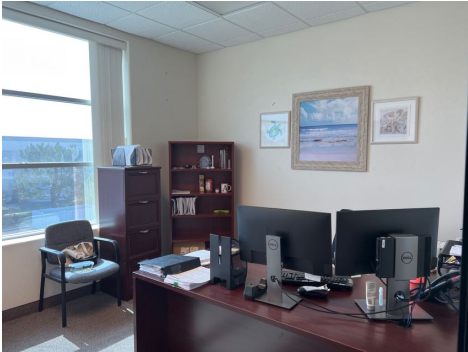
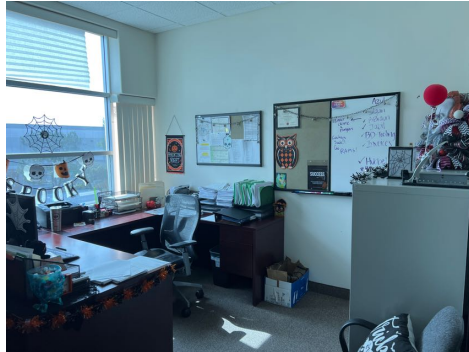
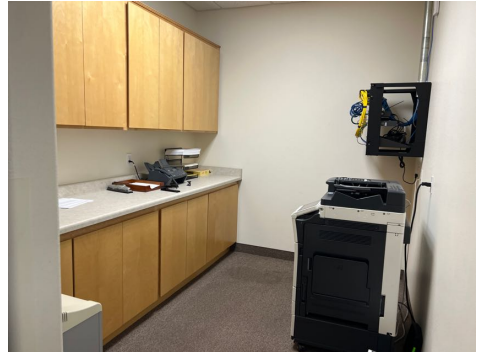
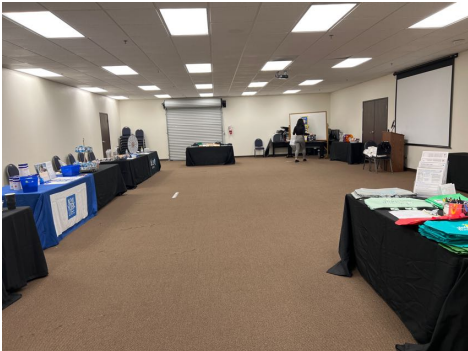
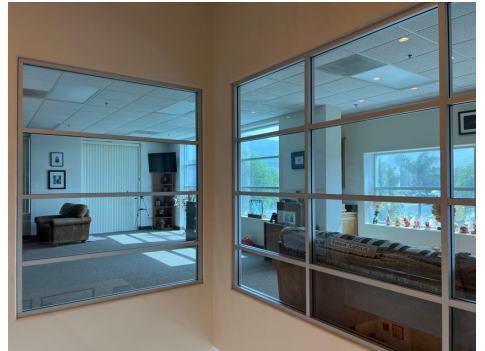
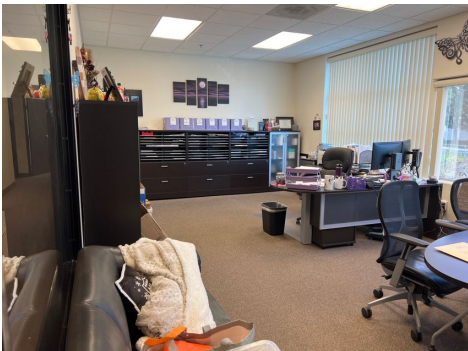
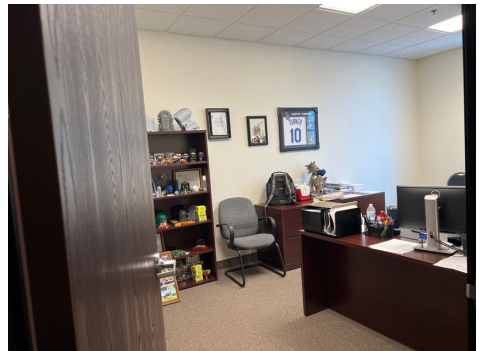
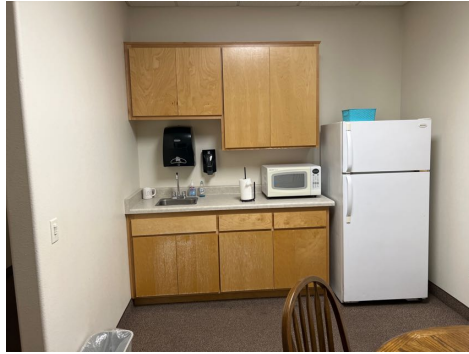
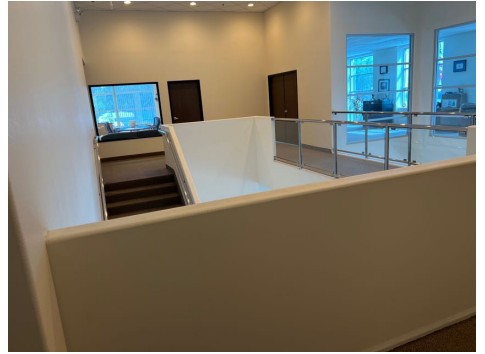
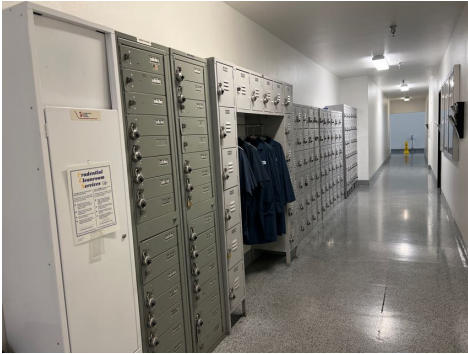
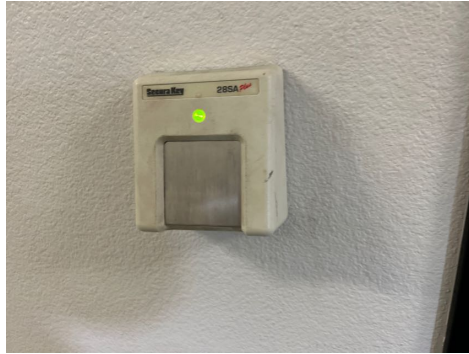
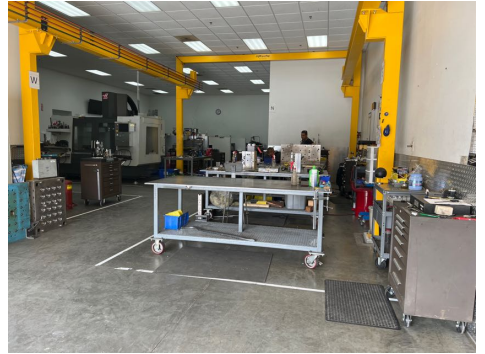
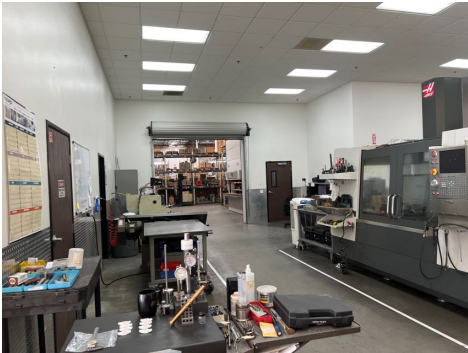
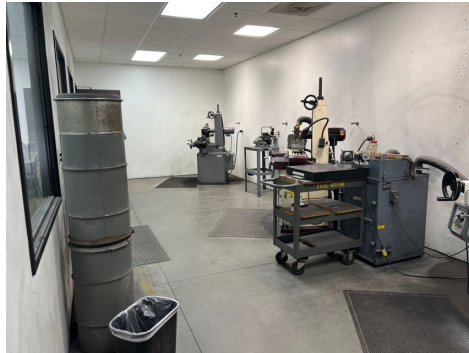
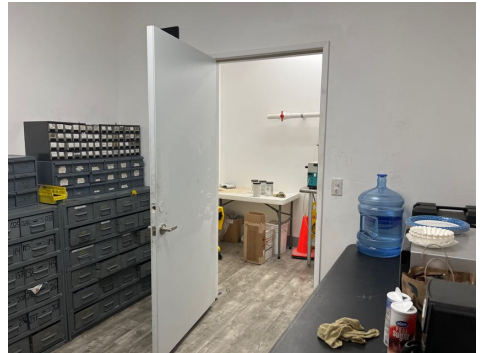
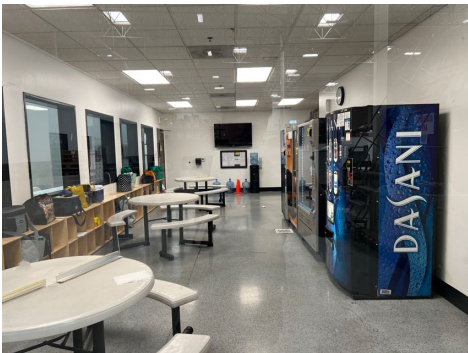
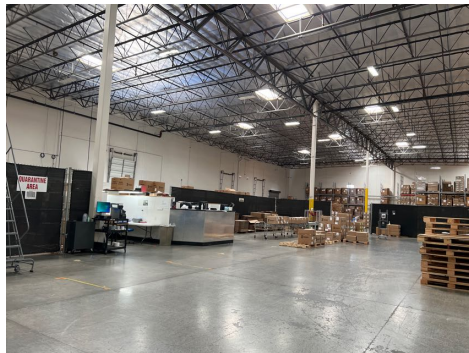
1. Interior Photos

Observations:
1.1.
