Property Inspection Report

14916 Round Valley Dr, Los Angeles, CA 91403
Inspection prepared for: Mike and Tammy Lang
Real Estate Agent: Gerardo Reyes - LA Group Realty

Date of Inspection: 7/25/2023 Time: 3:00 PM
Age of Home: 2019 Size: 4170 sq. Feet
Weather: Clear
Order ID: 1096

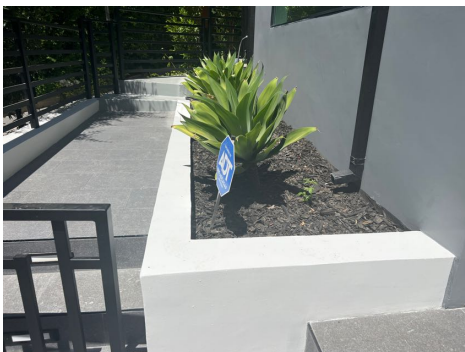
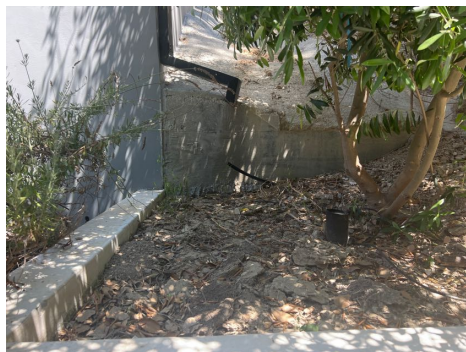
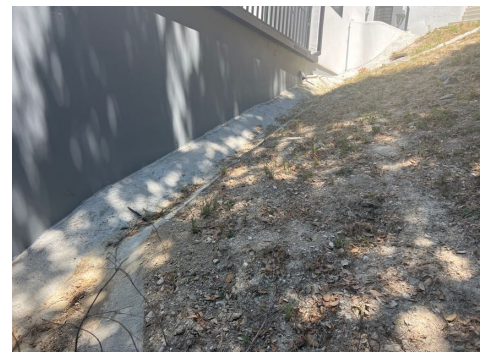
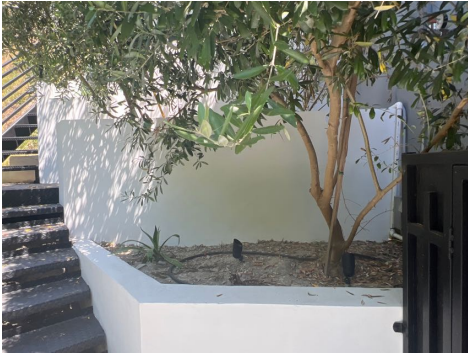
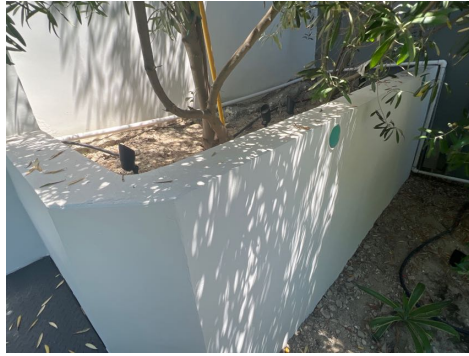
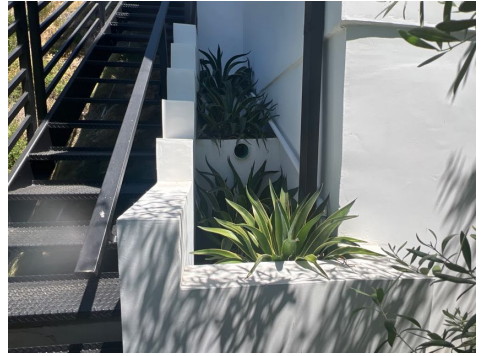
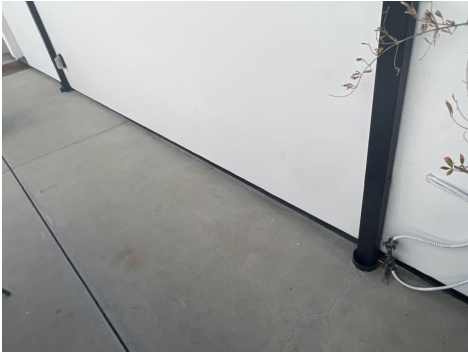
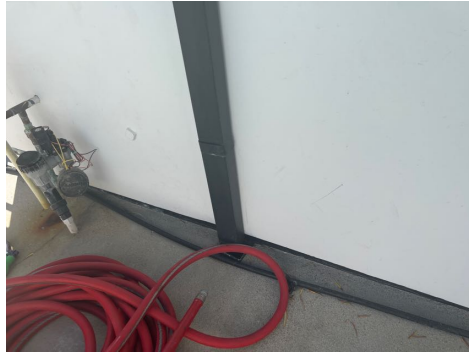
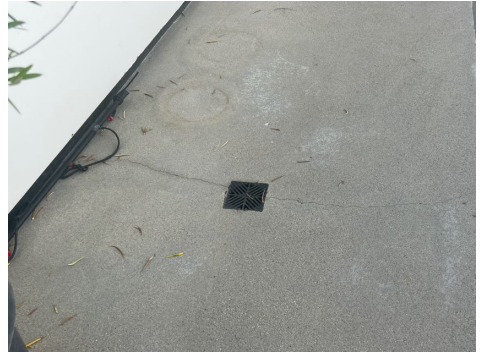
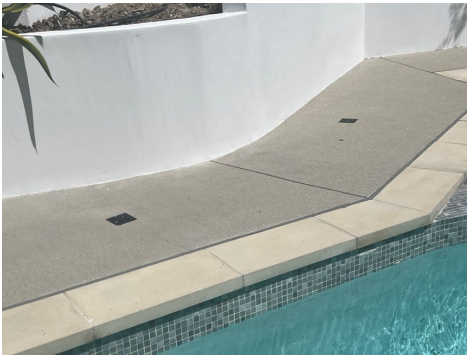
2.6. House built on steep hillside grade - In these cases further evaluation by a qualified Structural Engineer and/or Geological evaluation is recommended by this Property Inspection Company. Hillside is not part of this inspection, property lines are not checked - FYI

2.7. Room was built lower at exterior grade (I am not sure if proper retaining wall and waterproofing was installed at the time of Construction. Check the building records). Recommend to hire a qualified drainage contractor for complete system evaluation and any necessary corrections.

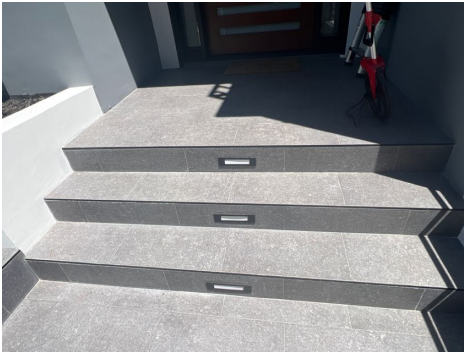
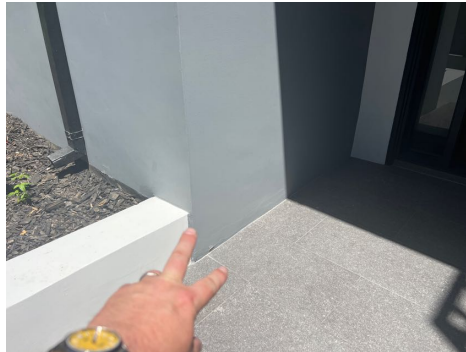
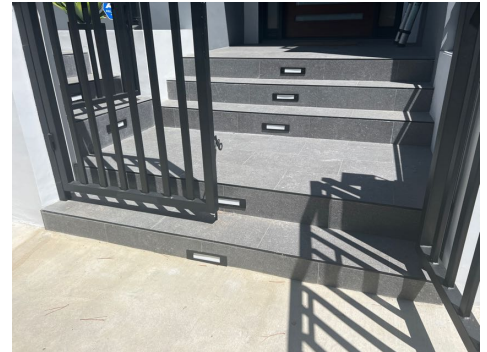
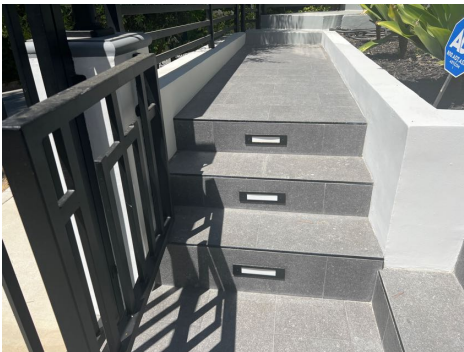
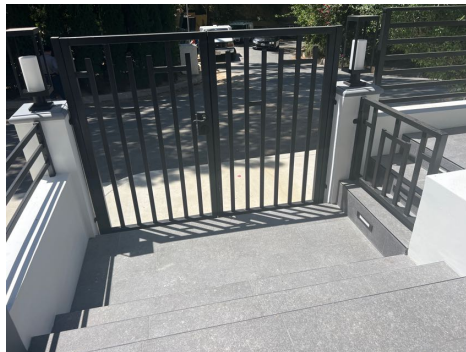
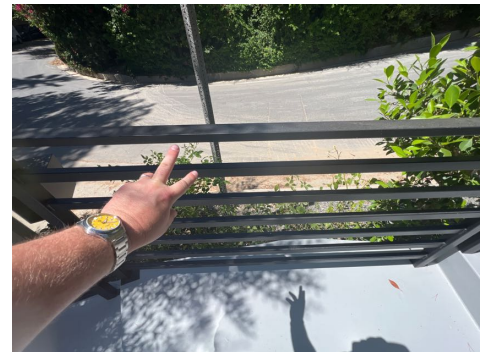
- 3.7. Small deck area off primary bedroom not accessible. Check building records and/or have checked by a qualified specialist for any necessary correction.

- 3.8. Common Cracks, settlement present at porch and/or patio area, walkways. FYI. Have checked for any necessary correction.

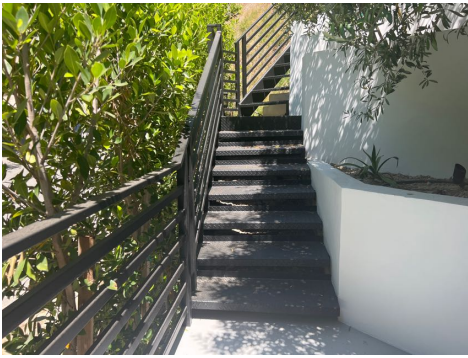
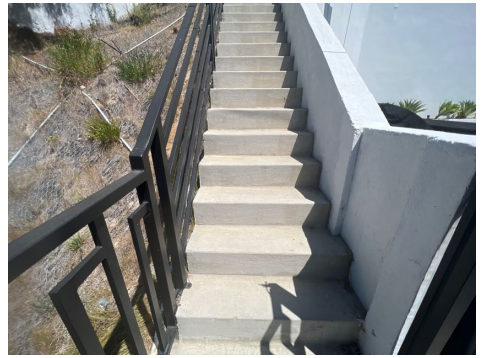
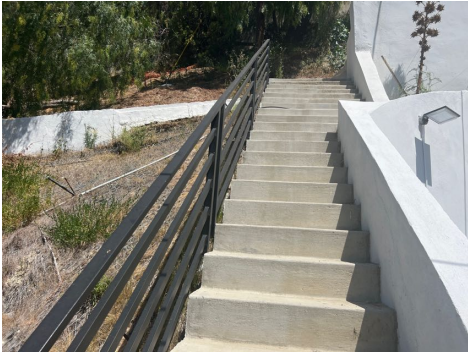
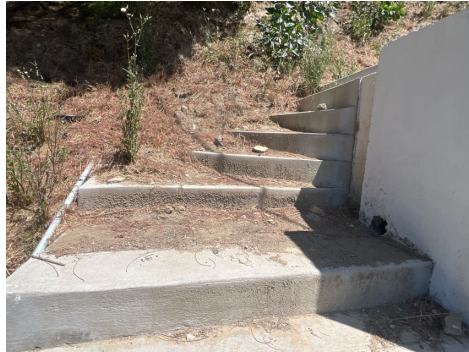
missing railing

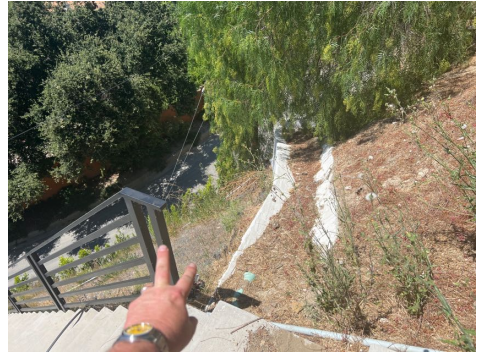
- 3.1. Railings are recommended at all stair locations of three or more steps as a safety upgrade. Missing at front entry steps, left rear at hillside steps and missing at right side steps leading to pool equipment. Recommend to install.

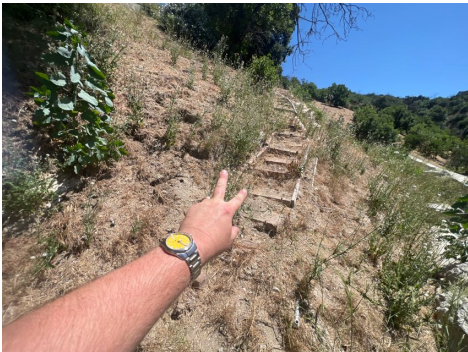
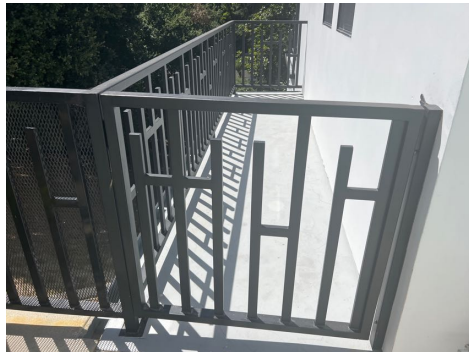
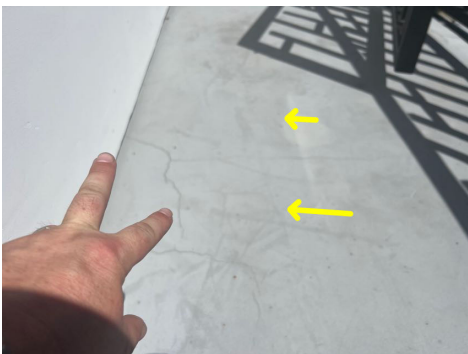
Cracked waterproofing - deck by pool

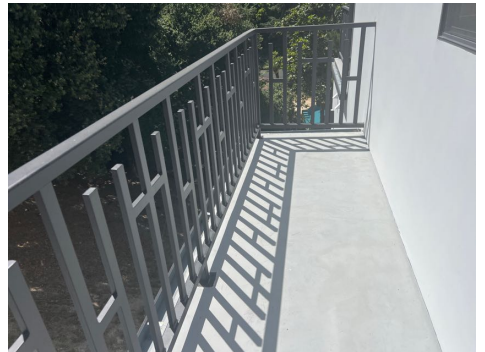
- 3.6. Cracks, wear at waterproofing noted at decking material at all waterproof decks. In need of further evaluation, any necessary corrections/repair made by qualified specialist.

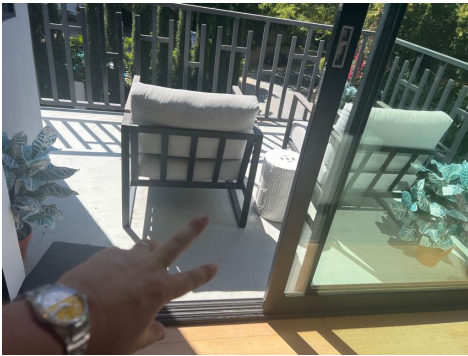
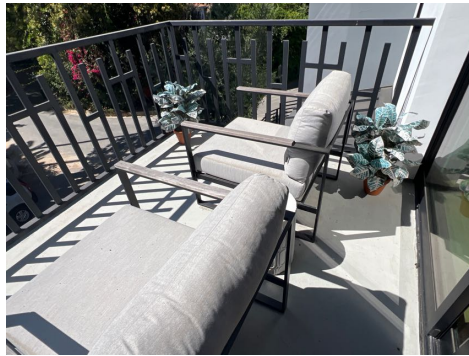
Missing screen- living area slider

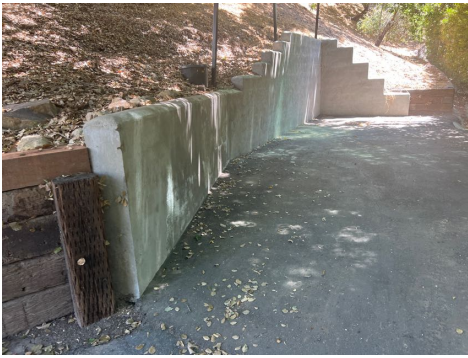
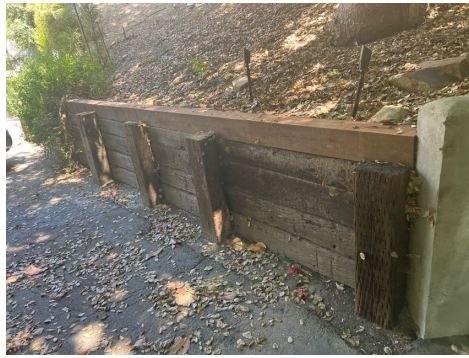
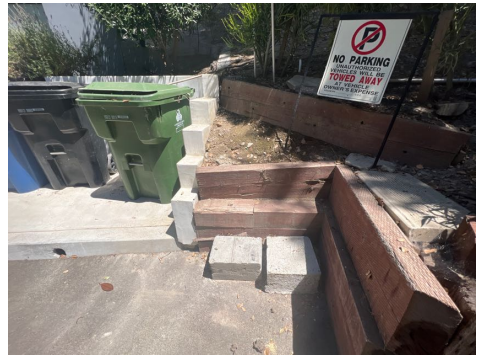
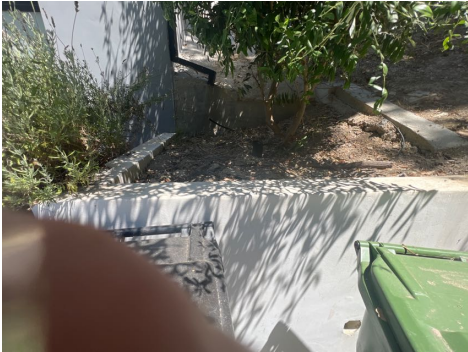
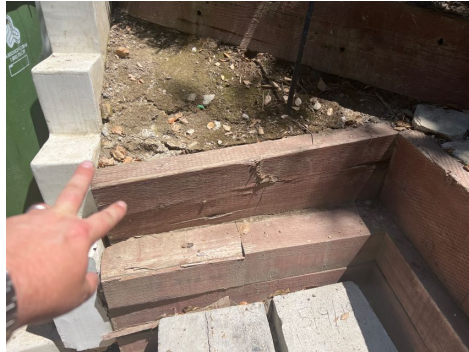
4.3. **Timber/Railroad ties noted at exterior, Loose boards and/or deterioration/age defects noted. Recommend to have them evaluated, any necessary corrections, repair or replacement made by qualified specialist.**

Loose

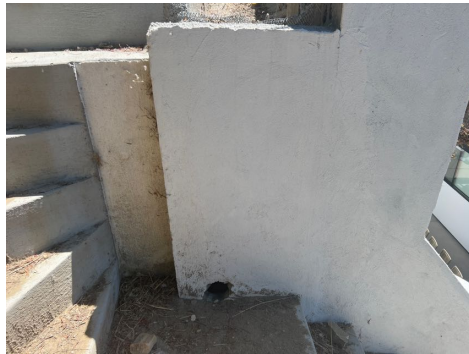
4.4. **Some exposed cement board and exposed rebar at backside of retaining wall at hillside and near pool equipment noted. Have checked by qualified specialists for any necessary correction**

rebar

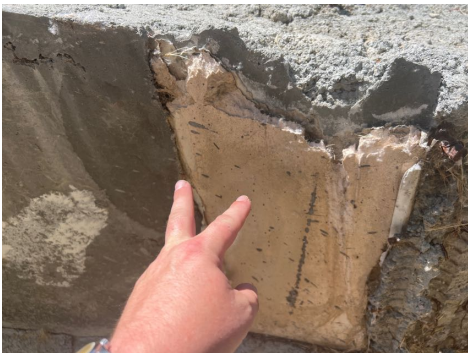
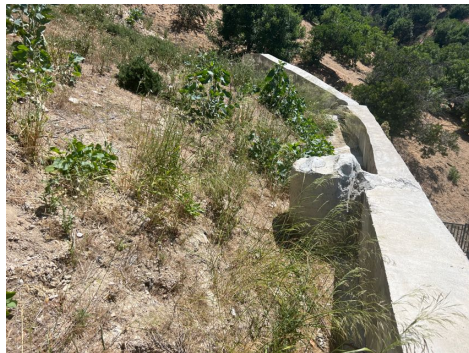
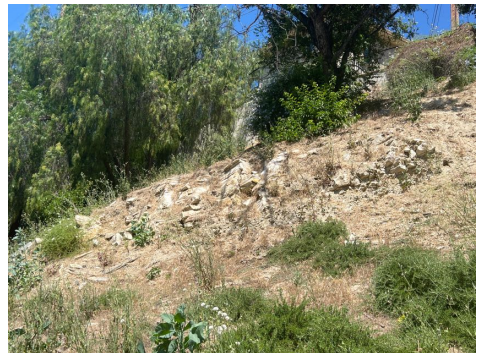
Exposed cement board/backer board.

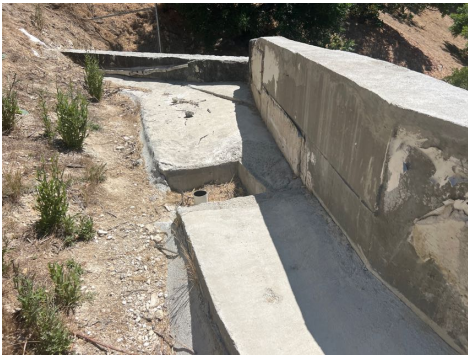
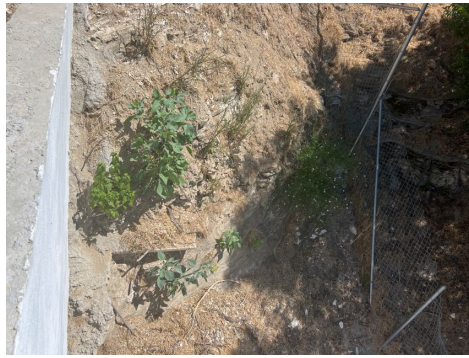
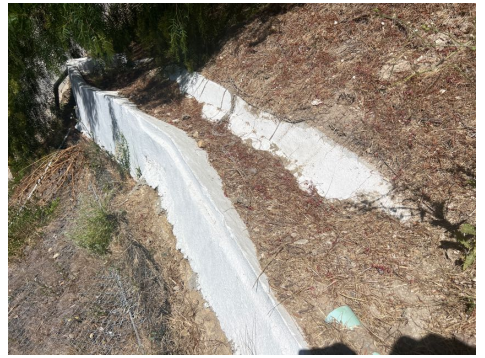
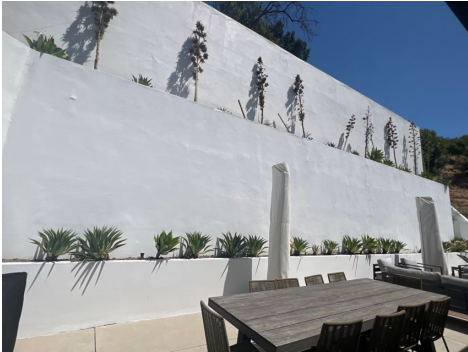
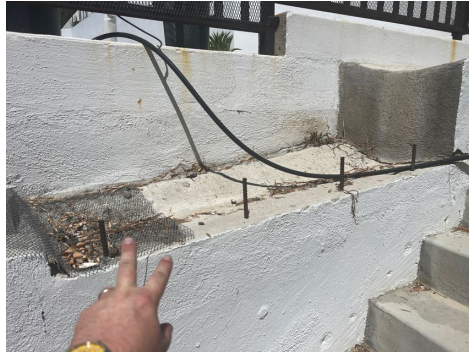
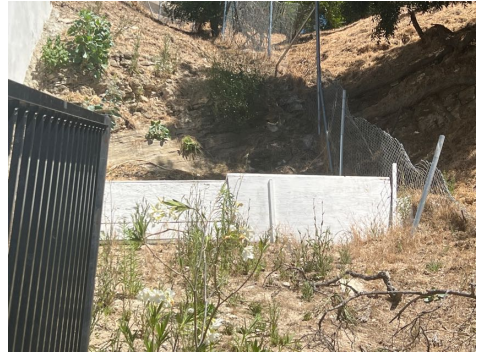
Exposed rebar

Wood boards

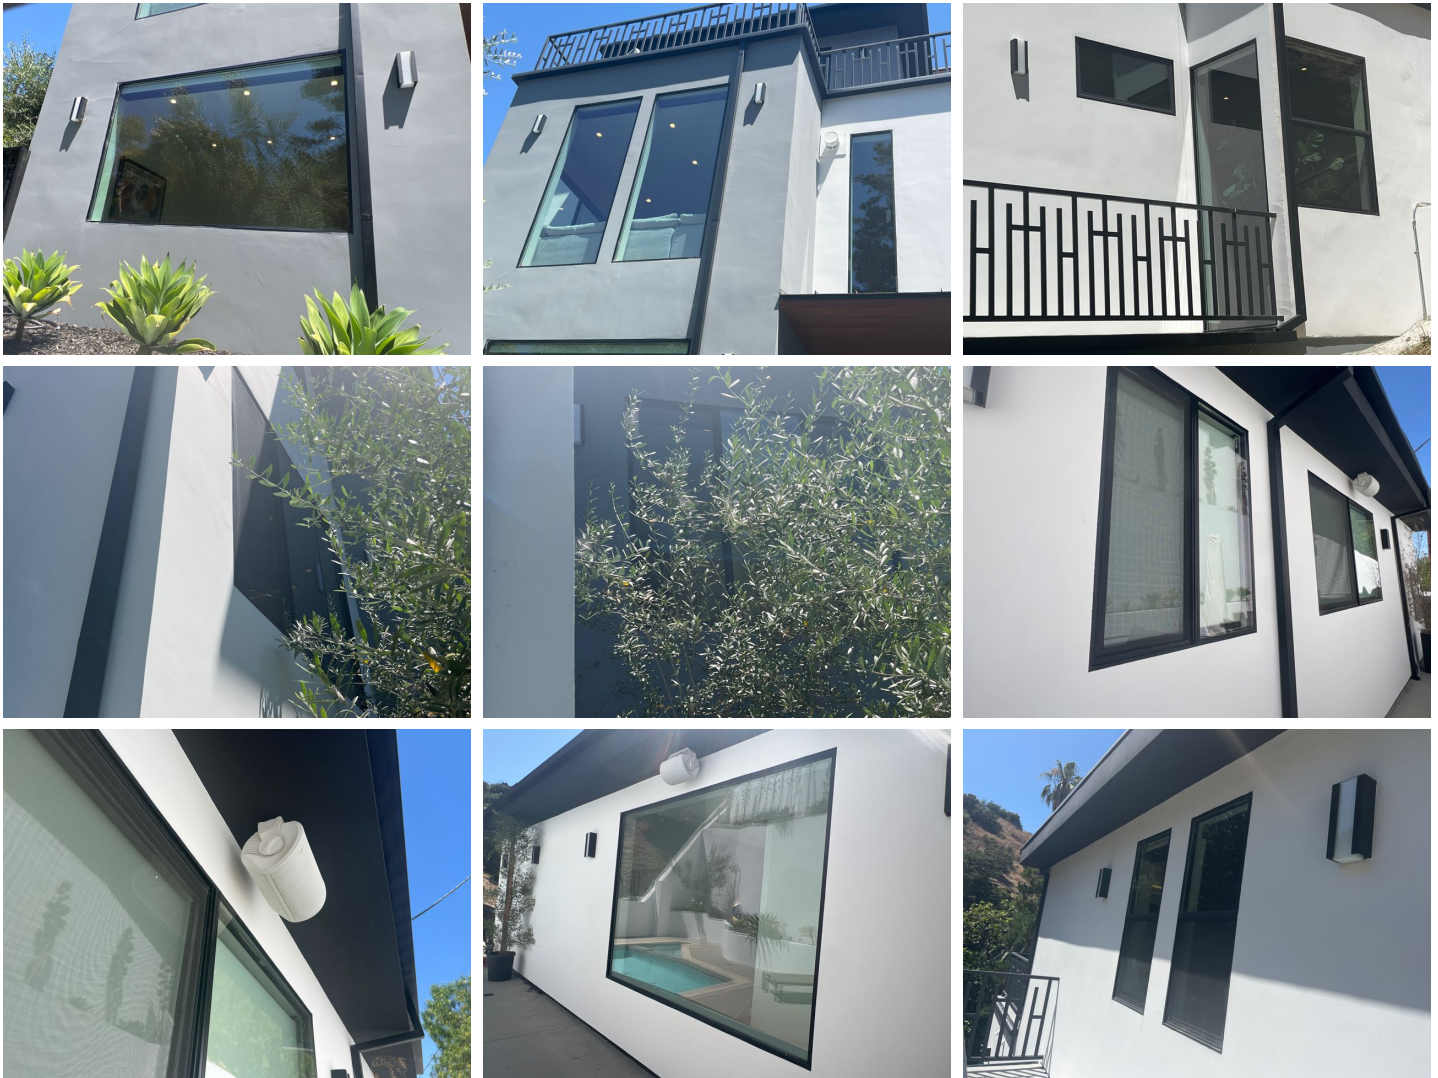
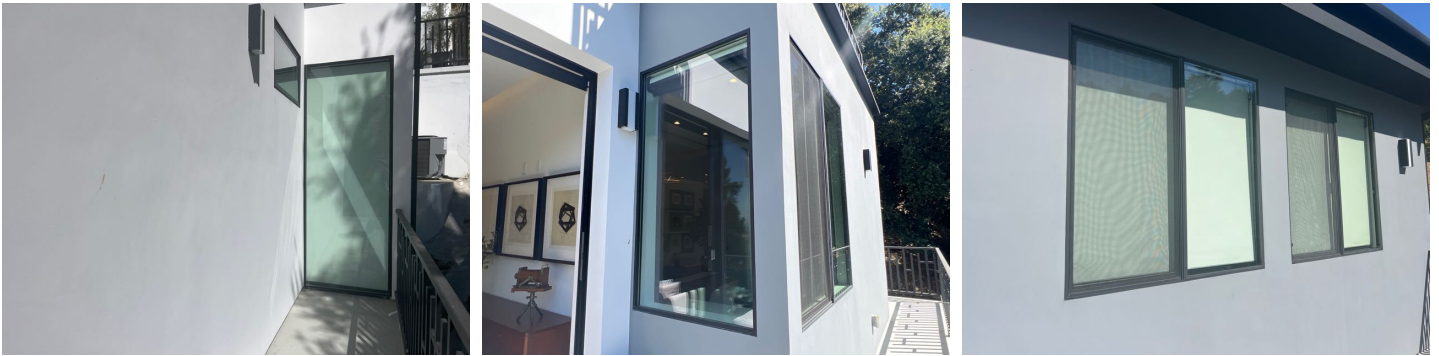
7.1. Window screen(s) missing and/or not installed at the time at dining area noted. Check with seller or have checked, any necessary correction made by qualified specialist.

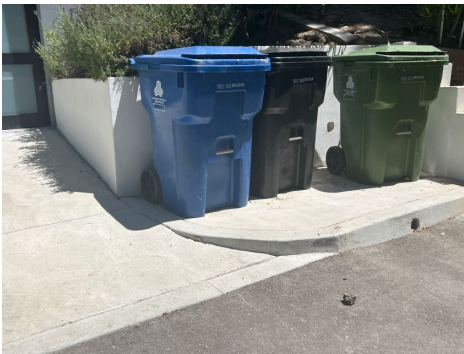
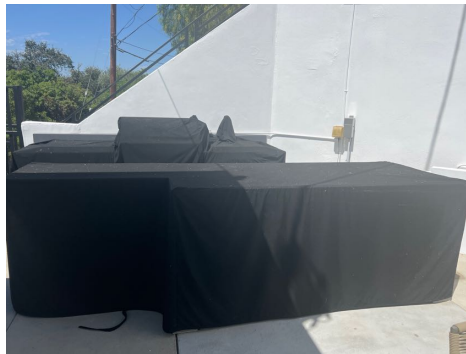
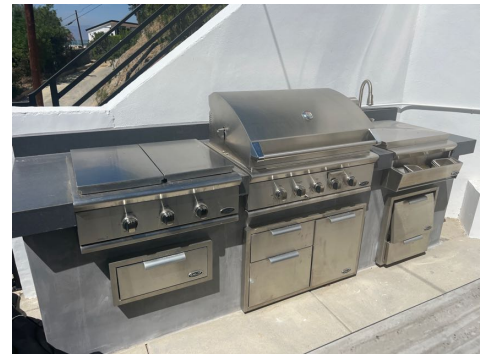
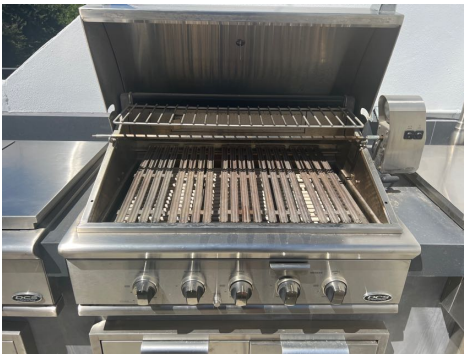
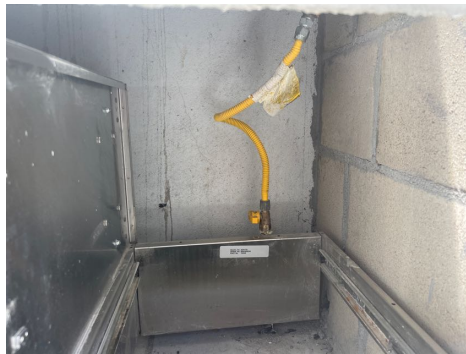
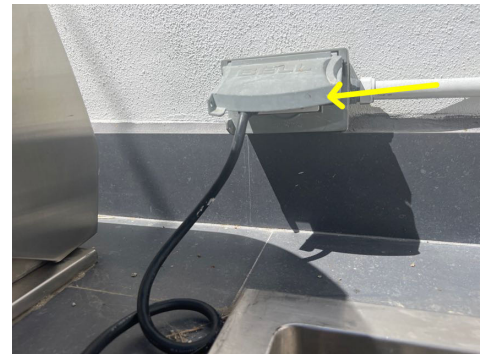
9.6. Rain tight covers are not present at unattended power cords. Missing cover plate at outlet at island. Risk of water intrusion and damage present. Recommend to correct by qualified specialist.

9.7. Cabinet drawers diffuse

To open and/or off track/loose at BBQ island. Have checked, fixed by qualified specialist.

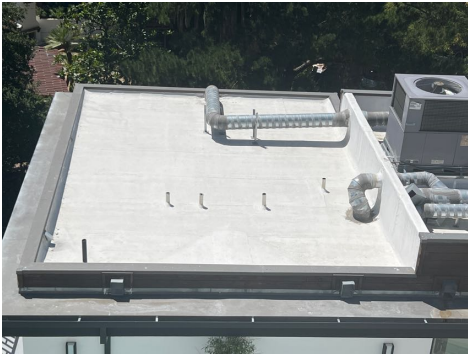
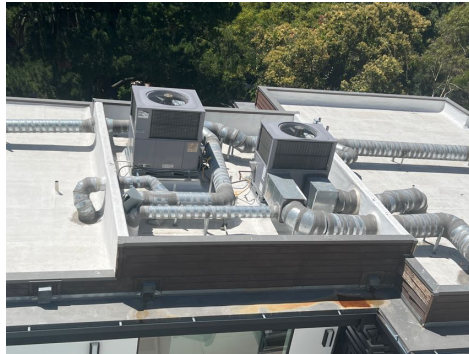
2.3. Water ponding and rust preset at sections at metal perimeter flat roof area noted- Recommend to have it evaluated, any necessary corrections made by a qualified Roofer.

Rust, ponding

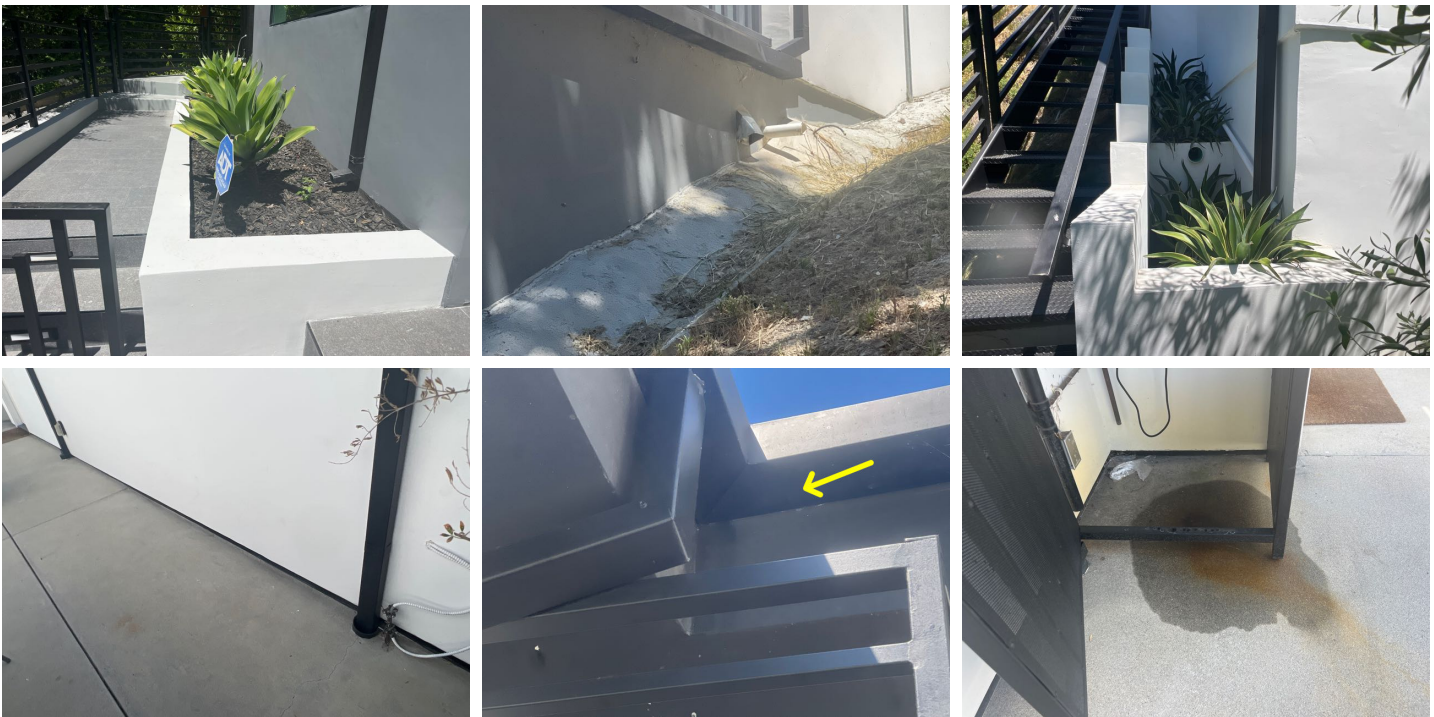
3.3. Leaking gutter noted at rear above water heater. Have checked, recommend to seal and correct by qualified specialist.

Gutter leaks- above water heater

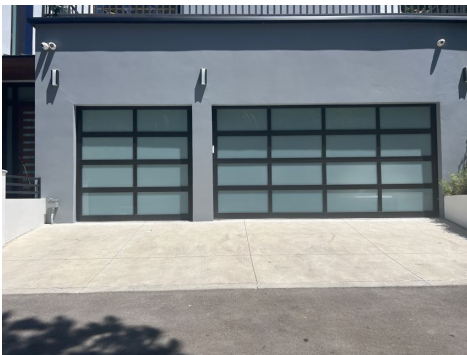
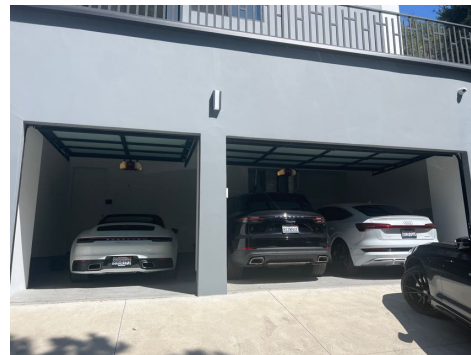
2.1. Sensors are in place and will reverse the door. (FYI)

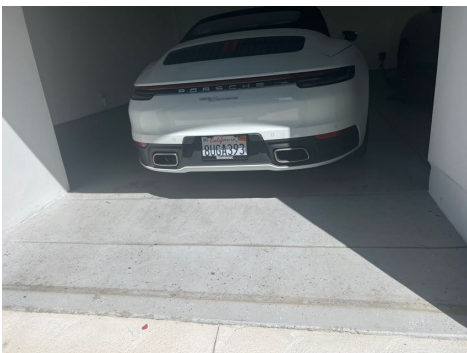
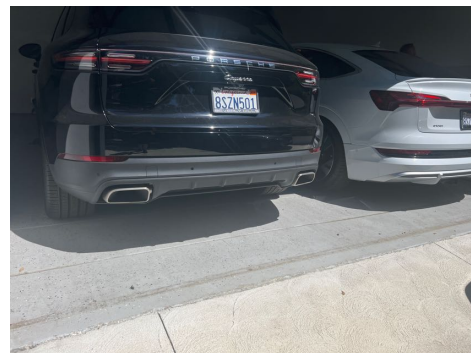
3.1. Flooring/walls of the garage was not fully visible at the time of inspection due to belongings or floor covering. Have it checked at Your final walk through.

3.2. Epoxy type coating noted at garage floor. Check records, with seller for any known defects, warranties.

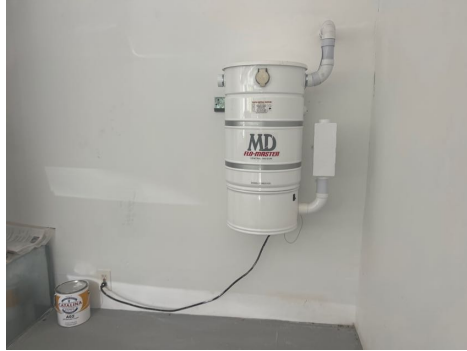
8.1. Central vacuum system noted - Not part of this inspection. Check records.

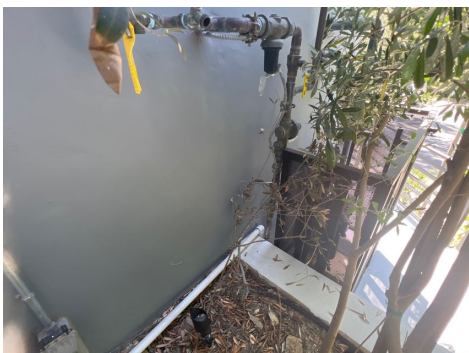
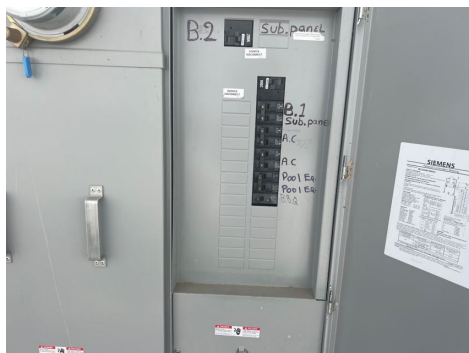
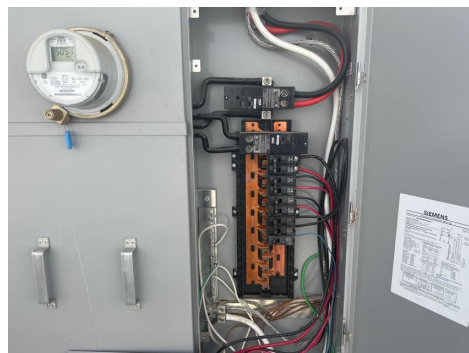
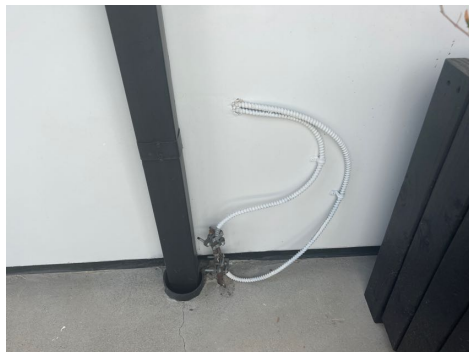
2.1. Gas pipes are not grounded/bonded. Recommend to install. Have it checked, corrections made by a qualified electrician.

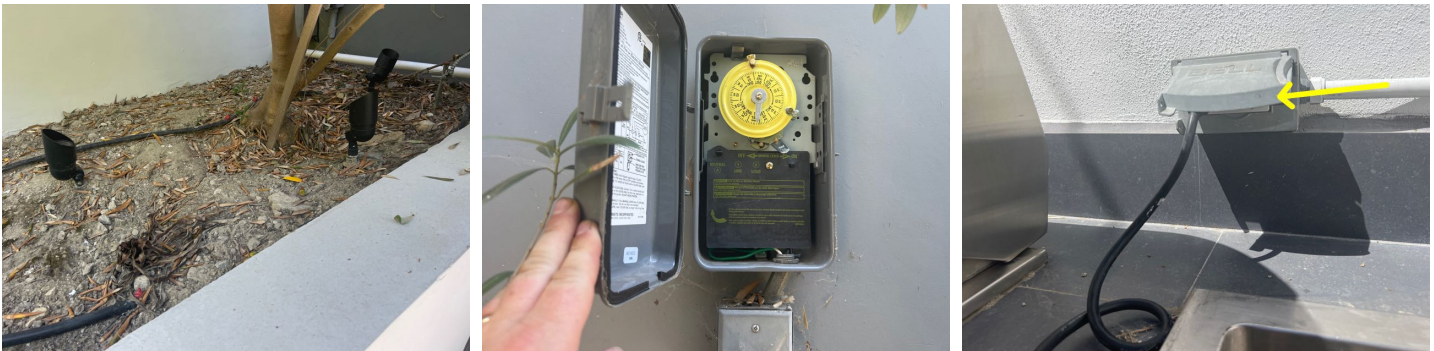
- 5.1. Rain tight covers are not present at unattended power cords. Risk of water intrusion and damage present. Recommend to correct by qualified specialist.
- 5.2. Garden lights, transformers, timers not part of this inspection. Check with the seller.
- 5.3. Outlet(s) with missing, damaged covers noted. Recommend to correct and install new exterior rated covers.
- 5.4. Rain tight covers are not present at unattended power cords. Risk of water intrusion and damage present. Recommend to correct by qualified specialist.

Bbq island

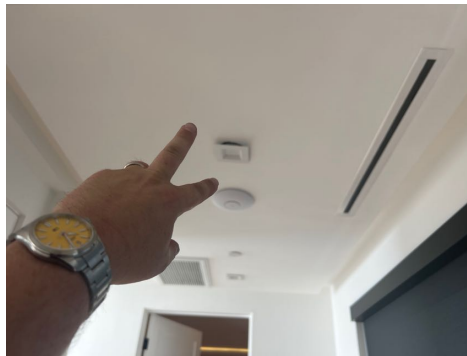
7.3. Ceiling light(s) loose at- Top floor hall in front of elevator. Have checked, fixed by a qualified specialist.

Loose light - upper level

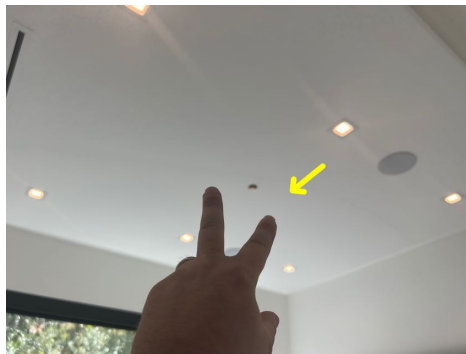
11.2. Loose and/or missing sprinkler cap present at lower bedroom ceiling. Have it checked, fixed by qualified specialist.

Missing cap

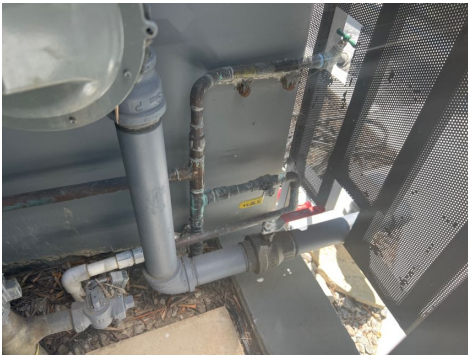
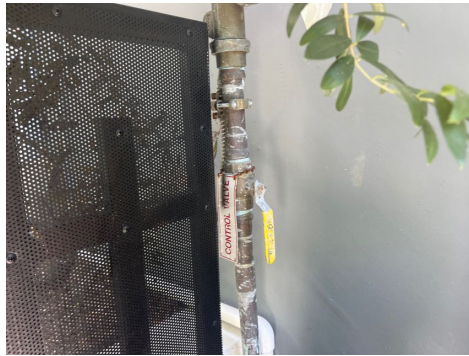
85 psi

2.3. Water pressure is too high, measured at - 85 PSI - recommend adjustment, repair, replacement of the regulator to below 80 PSI.

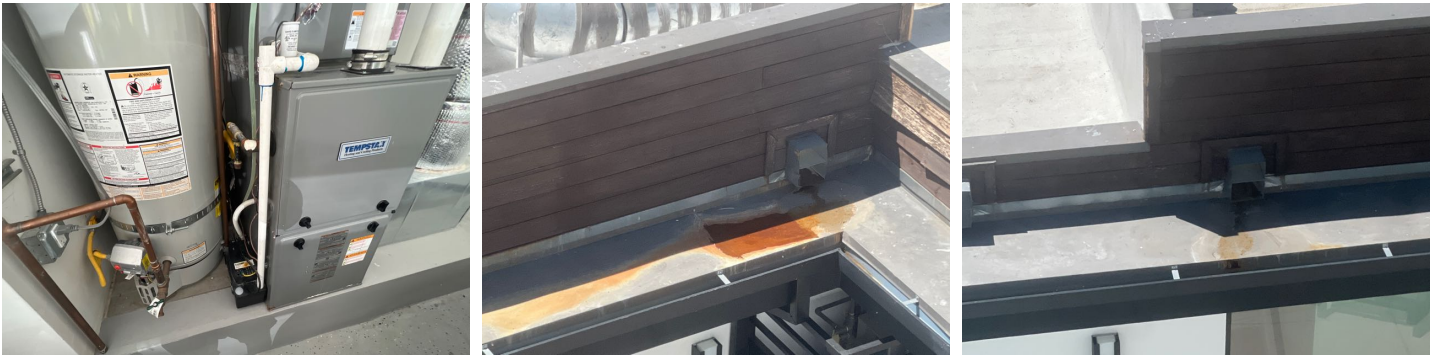
Rust, ponding

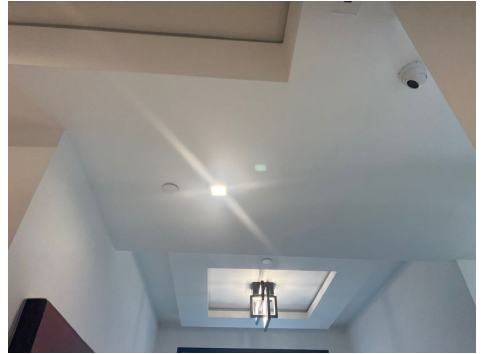
Missing cap

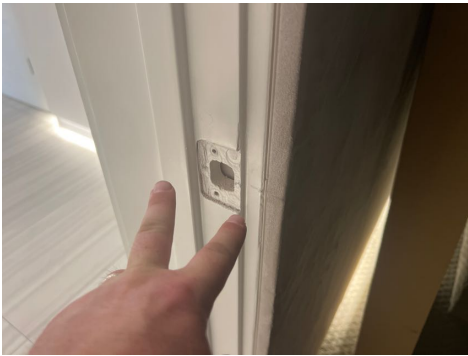
4.1. Missing strike plate hardware at movie room door. Have checked, recommend to correct.

Missing strike plate - movie room

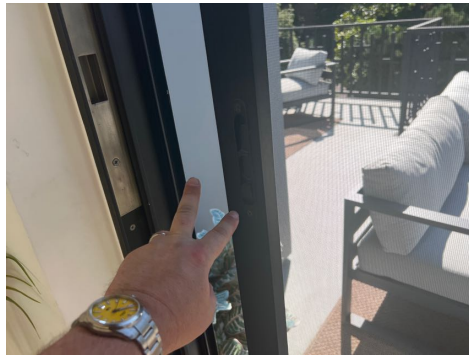
4.2. **Screen door hardware is not operational, locking mechanism is defective at sliders. Have it checked, repaired by a qualified specialist.**

Screen won't latch

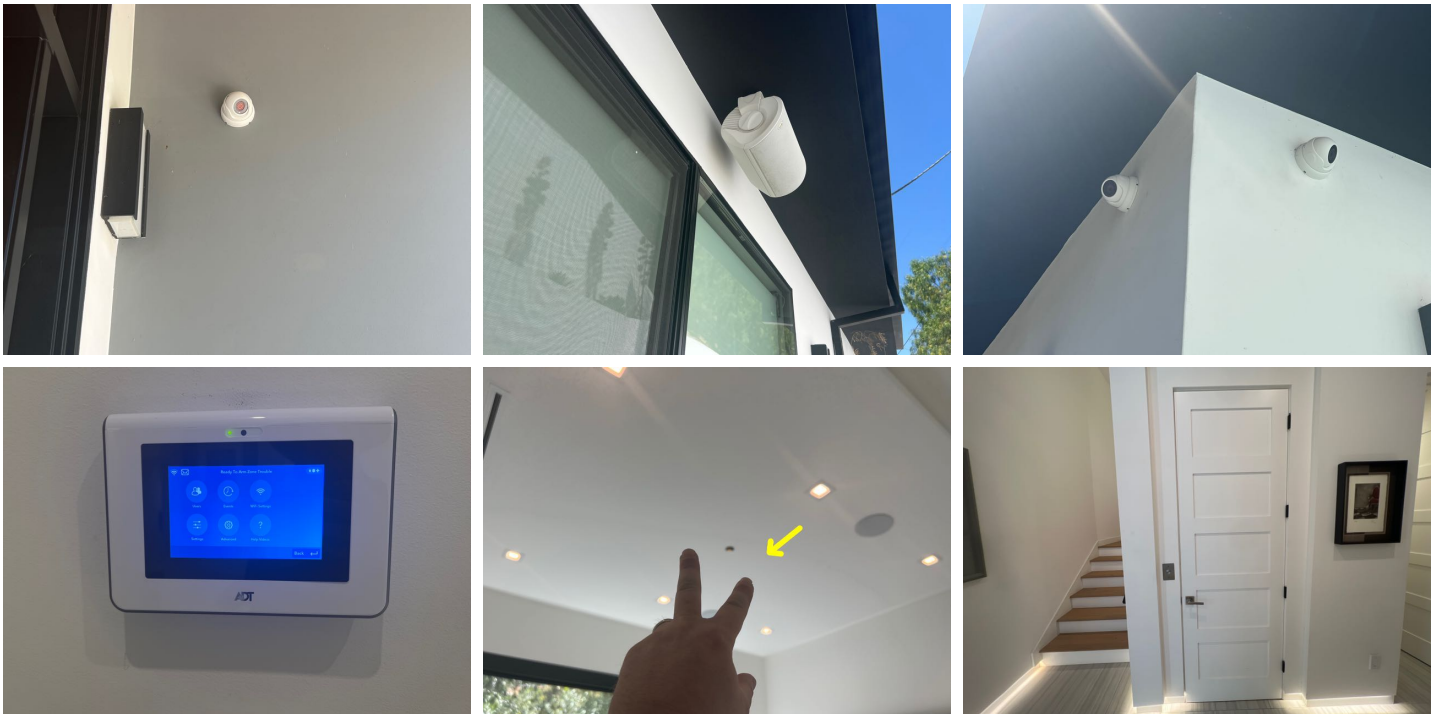
Missing cap

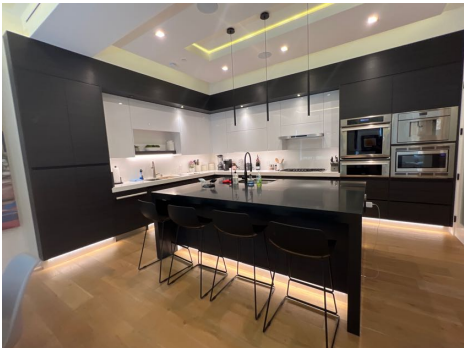
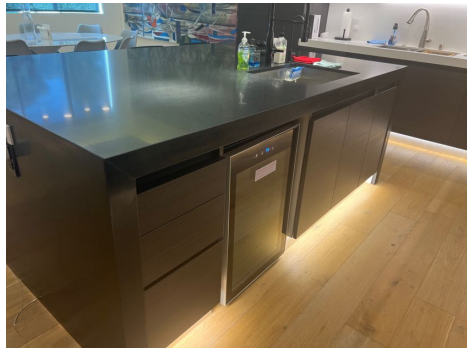
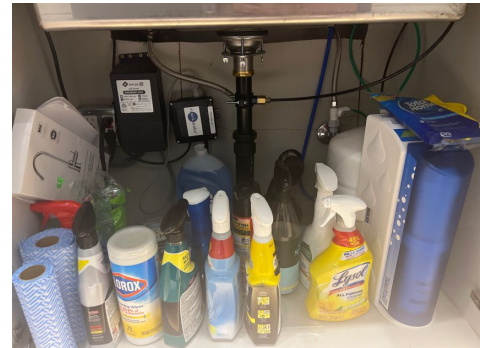
2.1. View under sink cabinets was restricted due to belongings.

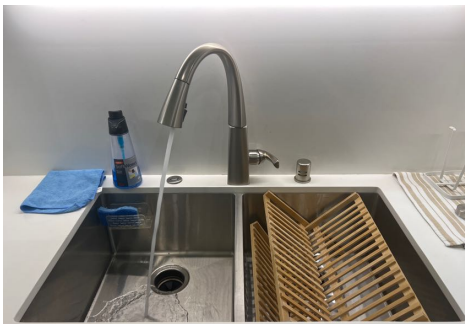
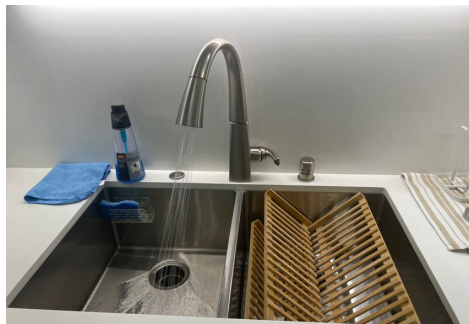
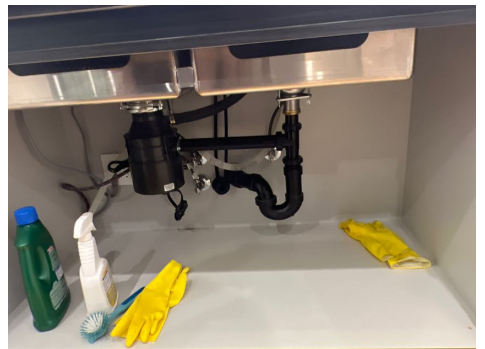
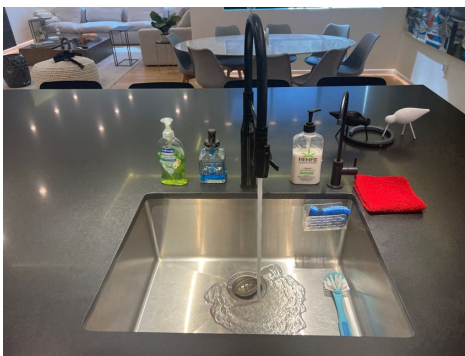
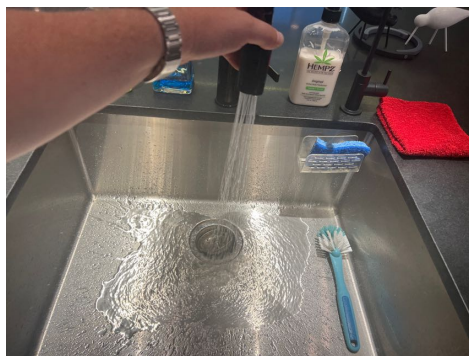
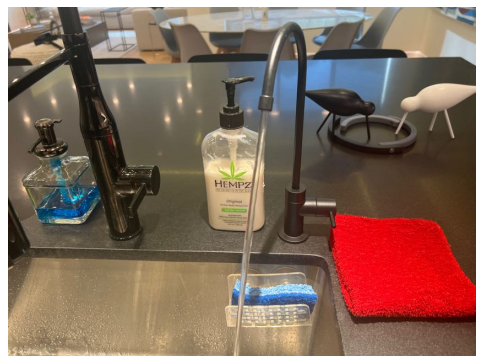
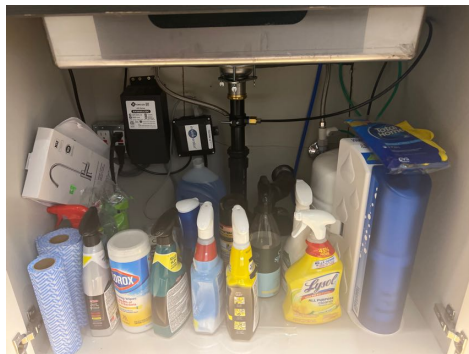
3.2. **View under sink cabinets was restricted due to belongings and not fully visible. FYI**

3.3. **Water filter/faucet noted - Was functional at the time (FYI). Water filter system and quality of water is not part of this inspection.**

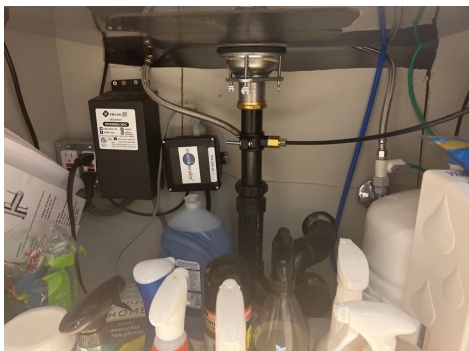
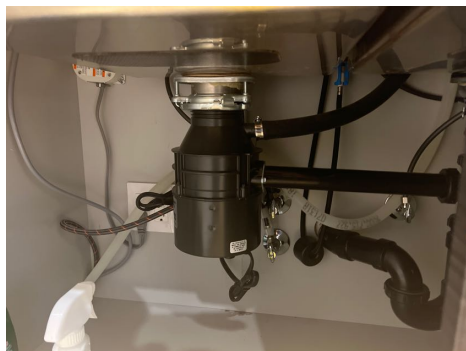
- 4.1. Unit(s) operated at the time. (FYI)
- 4.2. **No Disposer noted at- island sink. FYI**

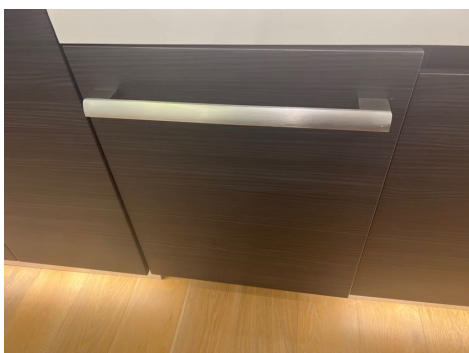
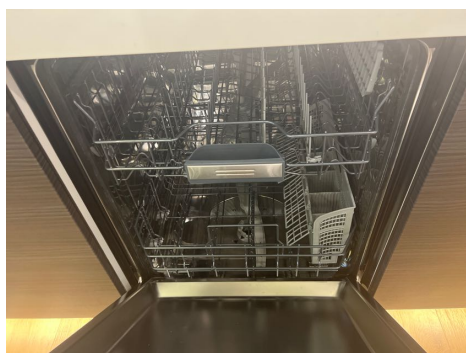
- 5.1. Dishwasher operated at the time. (Appliances are not removed at this type of inspection. There can be damage, defects not visible as a result). We recommend to check the records, with seller regarding any known defects or issues.
- 5.2. **Appliances are not removed at this type of inspection - There can be damage, defects not visible as a result. We recommend to check the records, with seller regarding any known defects or issues.**

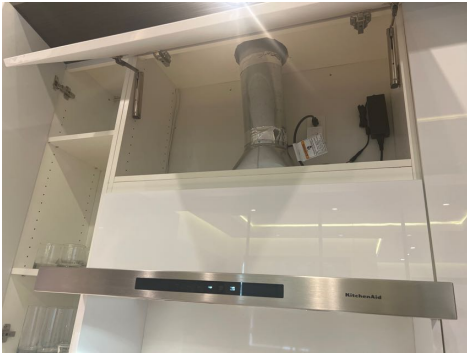
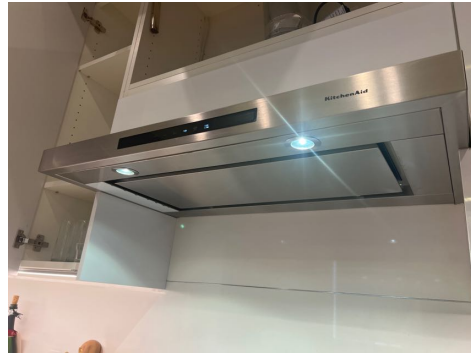
7.1. Operational at the time. (FYI)

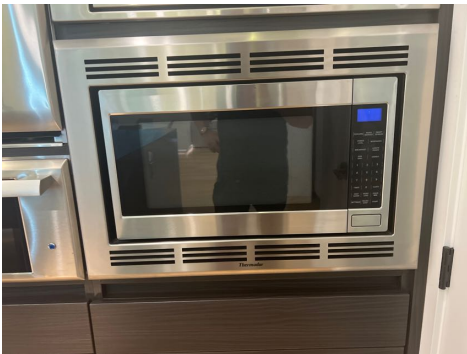
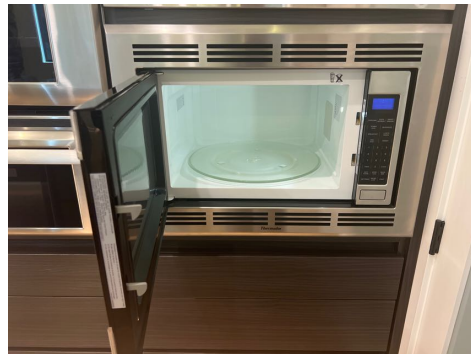
8.1. Microwave noted - Not part of this inspection. Check with the seller. Proper operation and/or microwave leak is not part of this inspection. We turn the unit on and off and check for visual damage.

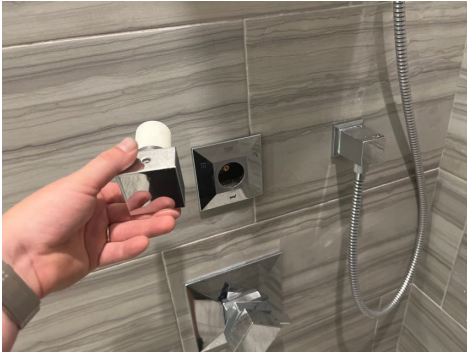
- 3.1. Recommend to have a qualified termite (structural pest) inspector to test the shower pan for possible leaks.
- 3.2. Shower valve(s) loose noted. In need of adjustment, correction. Have it checked by a qualified plumber.
- 3.3. Shower door opens inward only- improper. Should open outward for safety. Recommend to reverse weatherstripping and correct by qualified specialist.

Loose

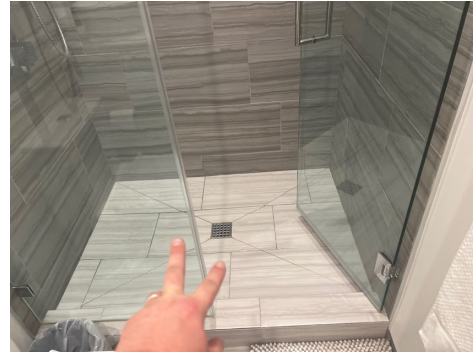
Opens inward only

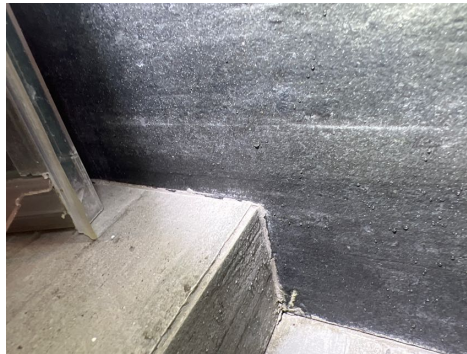
- 3.1. Recommend to have a qualified termite (structural pest) inspector to test the shower pan for possible leaks.
- 3.2. Cracked, dirty grout noted at shower enclosure noted. Recommend to re-grout or caulk, seal at shower tiles.

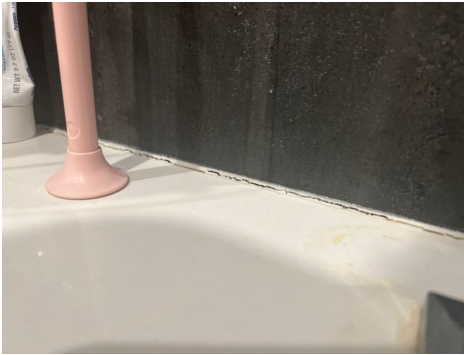
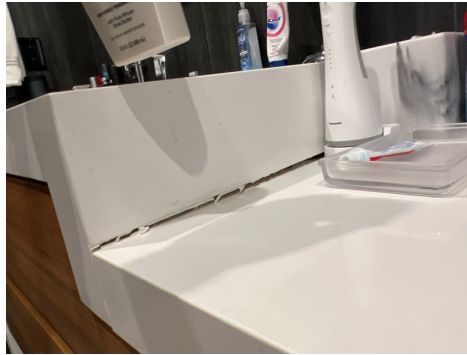
2.2. **Missing and/or damaged caulking noted at backsplash. Have it evaluated, corrected by a qualified specialist to prevent water seepage.**

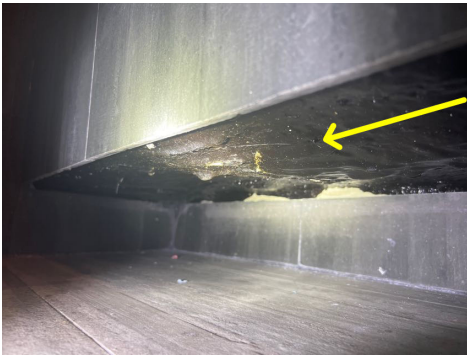
4.2. **Underside of ledge is not waterproofed properly, not tiled. Have checked, any necessary correction made by qualified specialist.**

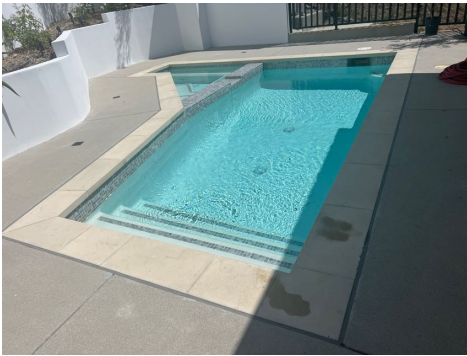
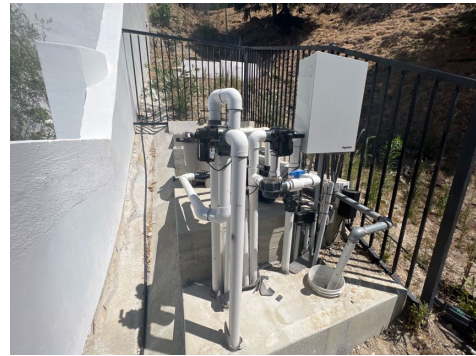
- 1.6. Missing enclosure, fence around the pool and/or spa equipment noted. Recommend to install. This is a safety concern. Have evaluated by a qualified specialist for correction.

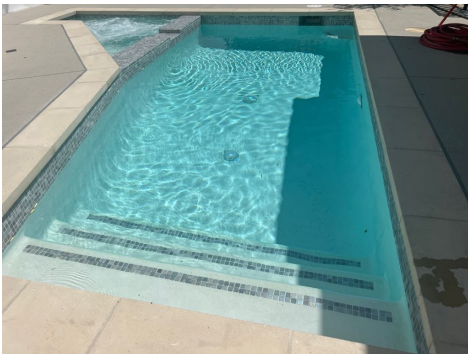
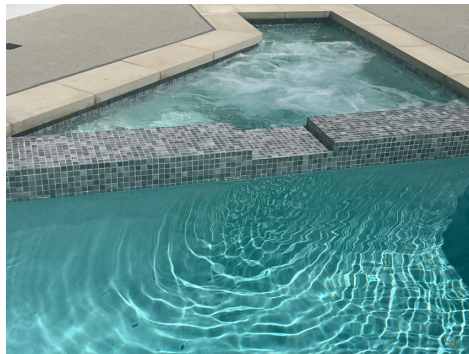
2.2. **Damaged tiles noted at pool, spa ledge. Have it evaluated by a qualified pool professional for necessary correction, repairs.**

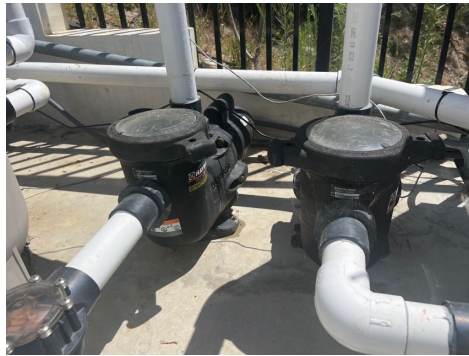
4. Pool Pump Systems

4.1. Pump(s) grounded (bonded) and operational at the time. Filter pressure was below 20 psi - FYI
