Property Inspection Report

14916 Round Valley Dr, Los Angeles, CA 91403
Inspection prepared for: Mike and Tammy Lang
Real Estate Agent: Gerardo Reyes - LA Group Realty

Date of Inspection: 7/25/2023 Time: 3:00 PM
Age of Home: 2019 Size: 4170 sq. Feet
Weather: Clear
Order ID: 1096

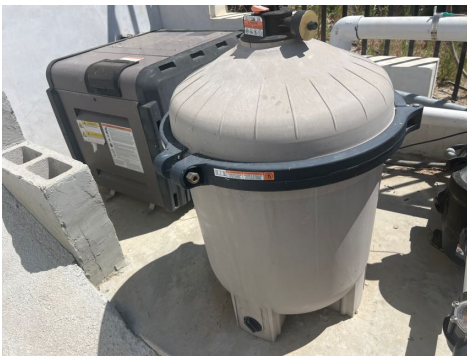
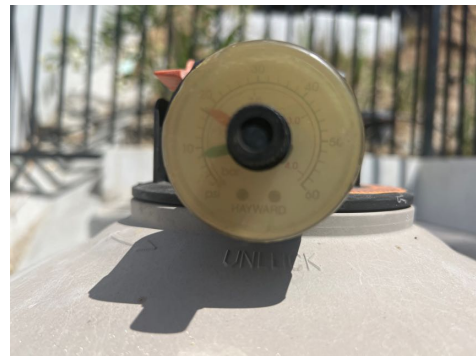
5. Pool Filter System

5.1. Pool Filter pressure was below 20 psi. (FYI)

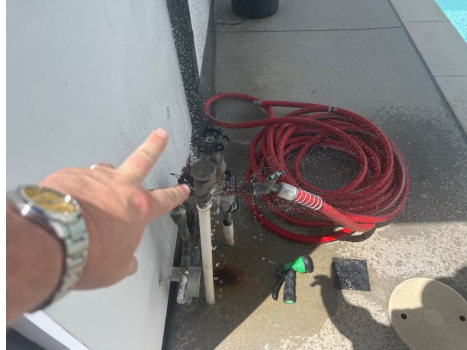
8. Other

8.1. Pool Fill valve was functional at the time. (FYI)

8.2. Pool fill Valve connections leaks. Have checked, fixed by qualified specialist.
