Key Property Inspection Group

Property Inspection Report

14850 Noblewood Cir, Lake Elsinore, CA 92530
Inspection prepared for: Christine Iniguez-Jackson
Real Estate Agent: Alyssa Barajas -

Date of Inspection: 11/23/2024 Time: 9:00 AM
Age of Home: 2004 Size: 2705
Weather: Clear
Order ID: 1515

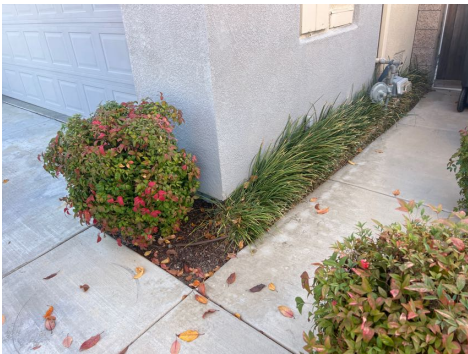
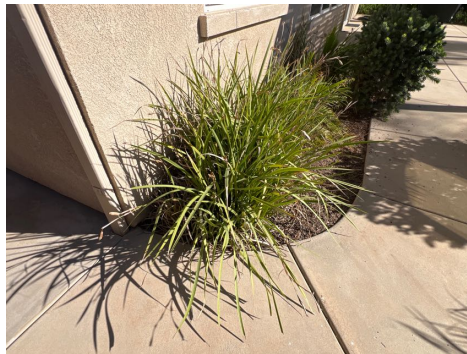
2.4. Planter(s) built at the foundation - not recommended. Recommend to remove to prevent water seepage into crawl space/foundation.

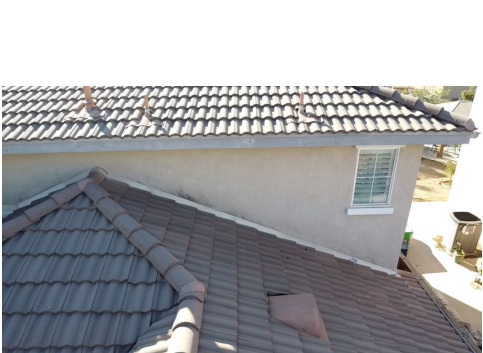
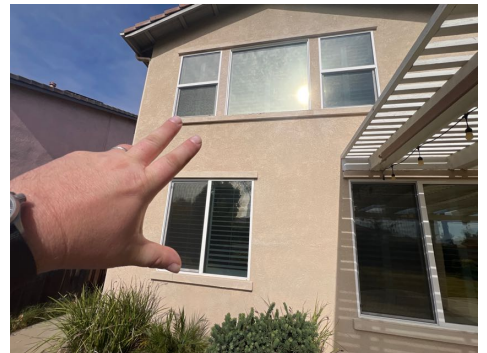
6.1. Moisture stains at base of stucco noted due to lack of gutters. Recommend to install to prevent damage and for proper drainage.

6.2. Damage noted at stucco molding at exterior window(s). Recommend to have checked, repairs made by qualified specialist.

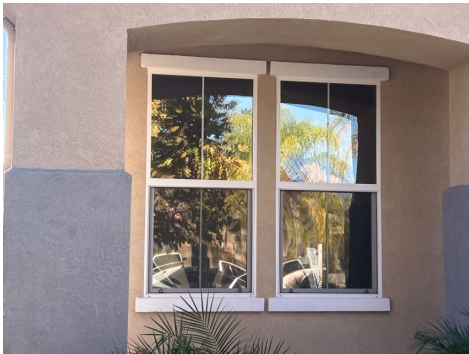
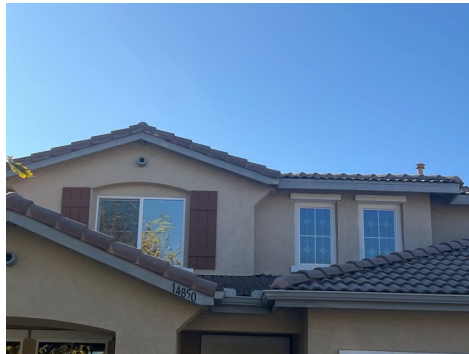
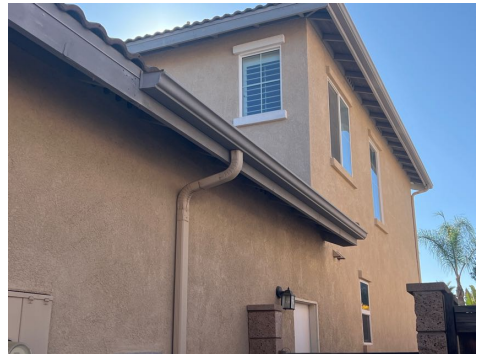
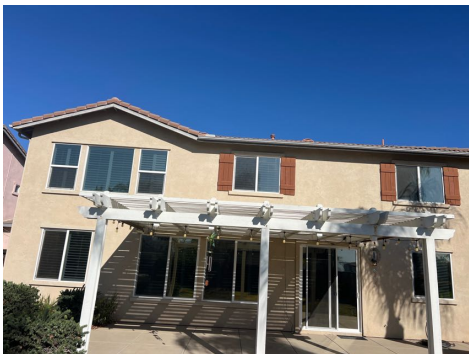
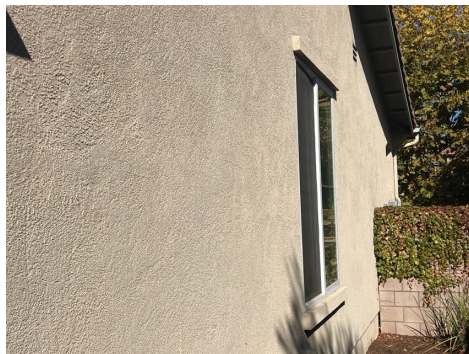
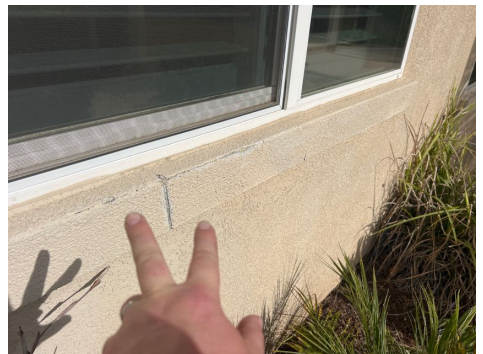
Damaged stucco molding - rear

7.2. Damage noted at stucco molding at exterior window(s). Recommend to have checked, repairs made by qualified specialist.

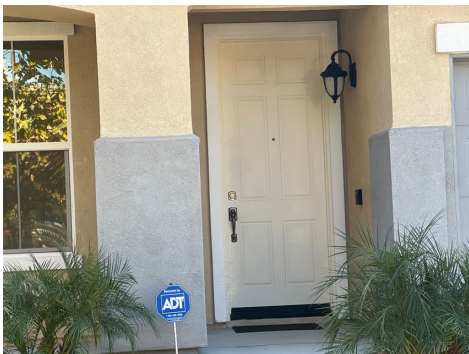
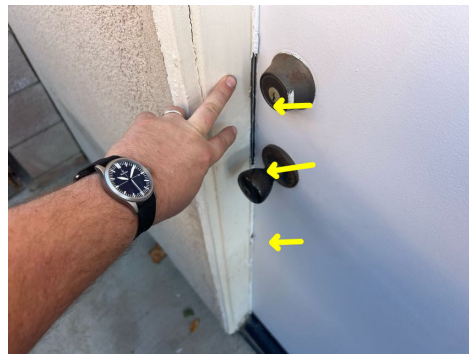
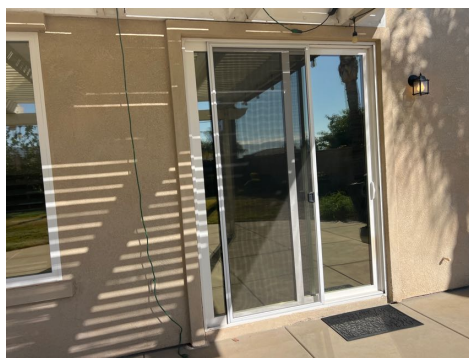
8.1. Damaged Weatherstripping at exterior doors noted. Recommend to correct and replace by qualified specialist.

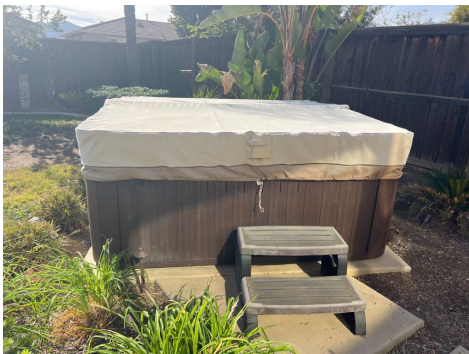
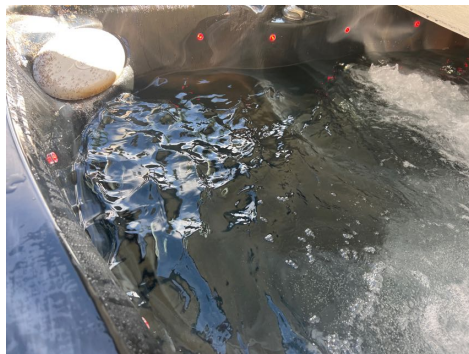
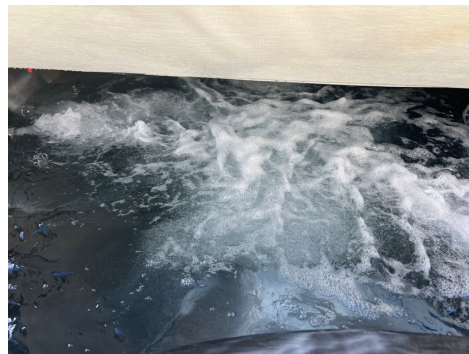
9.4. Some spa jets are not working properly - not responding to control panel. Check with seller for operation, any known defects, maintenance- Have checked for any necessary correction by a qualified specialist.

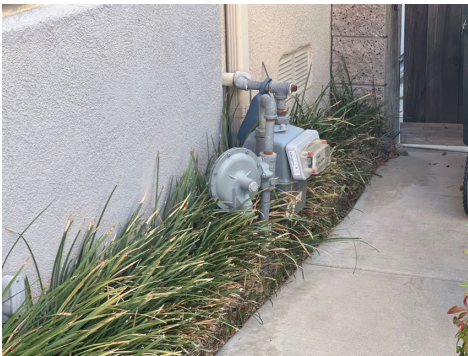
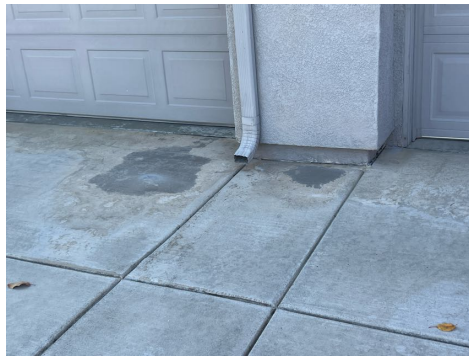
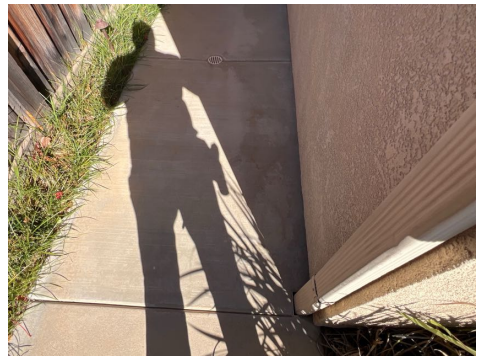
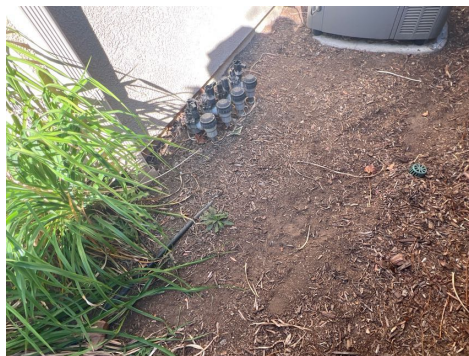
3.2. **Downspouts terminate at foundation- Poor location. Recommend to extend away and/or install flash block(s).**

3.3. **Some Below ground drain lines for downspout(s) noted - No tests done at this inspection- Unable to determine if drains will function properly. Check with the seller.**

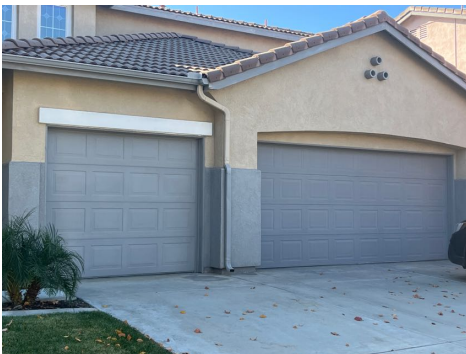
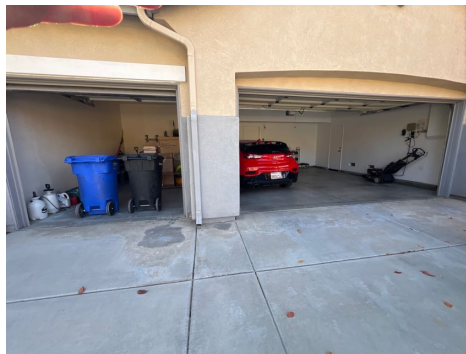
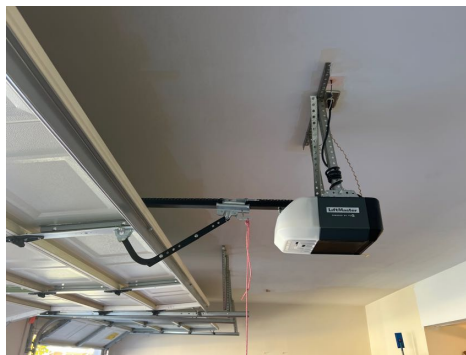
2.3. No automatic opener present at small door - Manual vehicle door type. (FYI)

2.4. Recommend to adjust the auto sensors within 6" of floor line for child/animal safety.

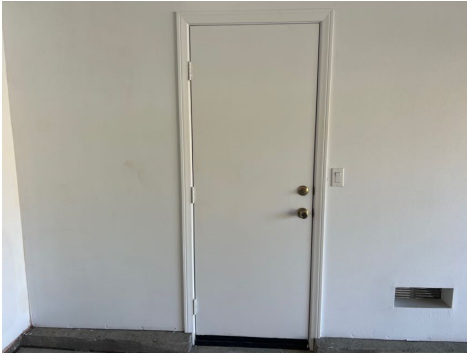
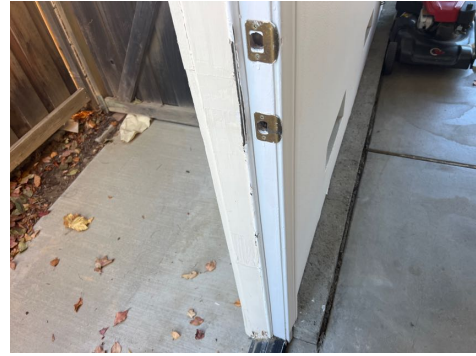
6.1. Damaged weatherstripping at garage exterior door - recommend to correct.

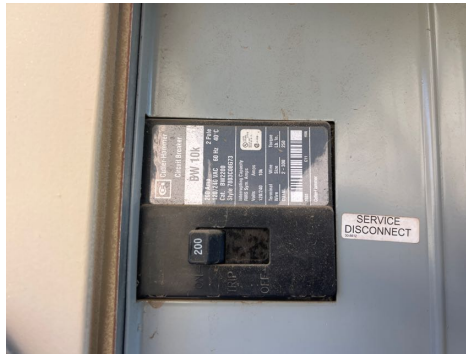
1.1. **Underground service was noted. In order to inspect the condition of the wires it requires removal of panel covers. Panel covers at pull box are not removed for safety reasons and are not part of this inspection (its beyond the scope of this inspection). Recommend to check the records for any known defects, repairs. Further evaluation by a qualified Electrical Contractor and or the local Utility Co. is recommended.**

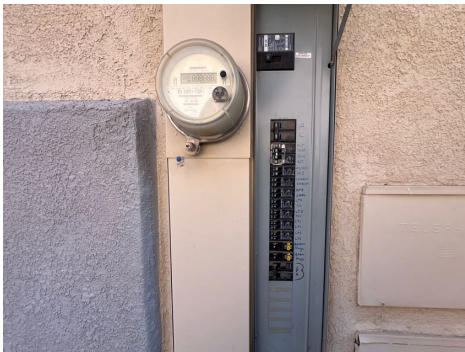
2.1. No major defects, damage found at Main panel and the visual part of wiring at the time(FYI). Check the records with the seller for any known issues and/or repairs regarding the electrical system of the building.

2.2. Ground rod and clamp not visible at the meter base. Possible ground rod/clamp was installed the wall (UFER ground) - was not accessible at the time. Check with the seller/building records and/or have it checked by a qualified electrician.

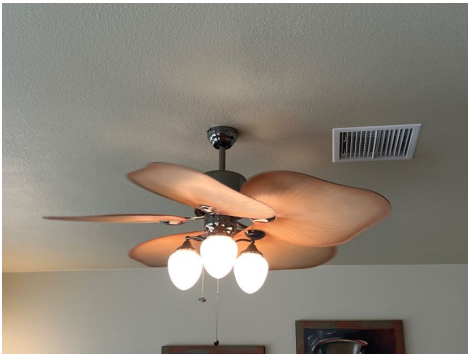
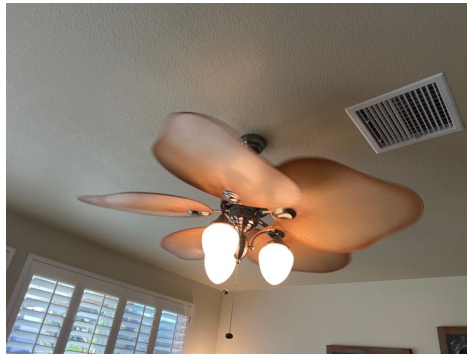
- 6.1. Electrical covers (switch, outlets, junction boxes, etc) not removed as part of this inspection - Inspection of the wiring is limited to Main panel. For a more in depth inspection recommend to hire a qualified Electrician.
- 6.2. Ceiling fans not tested for attachment/safety at this inspection. Recommend to check the records - Make sure it was installed and tested by a qualified specialist.
- 6.3. Light at Ceiling fan not working and/or not responding to switch at wall, unable to locate remote at primary bedroom. Have checked, necessary correction made by qualified specialist.
- 6.4. missing light cover(s) at interior noted at primary bedroom ceiling fan. Have checked, corrections made by qualified electrician.

Missing light cover, light not working - primary

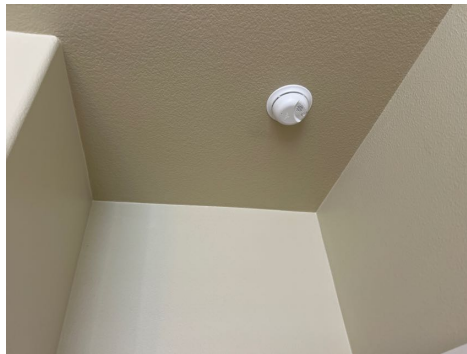
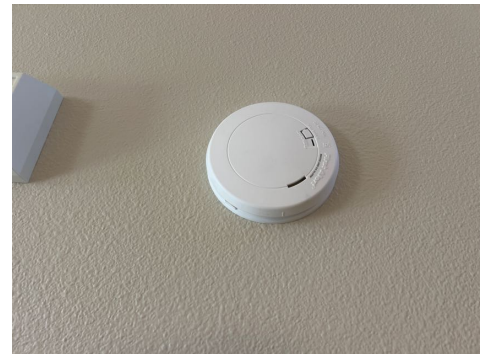
- 7.1. Smoke detectors in bedrooms and/or hallway noted - Recommend to test them periodically
- 7.2. Carbon monoxide detector noted- improper location noted- recommend to locate within 6 ft of bedrooms - Recommend to test it periodically.
- 7.3. **Smoke and Carbon Monoxide detectors, fire alarms/systems not inspected. Beyond the scope of this inspection. Recommend to install smoke and carbon monoxide detectors per City/Manufacturers requirements and test them periodically - Recommend to have checked by a qualified retrofitter. THIS IS A HEALTH/SAFETY CONCERN.**
- 7.4. CO2 detectors in wrong location- should be within 8FT outside each bedroom - FYI. Recommend to correct.

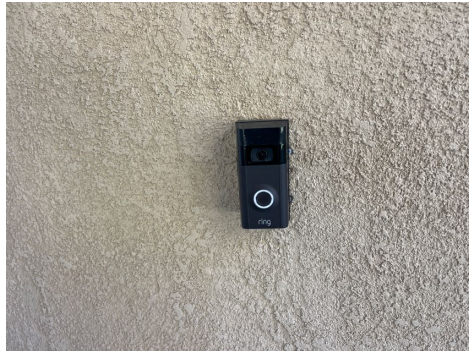
8. Door Bell

8.1. Door bell(s) functional at the time. (FYI)

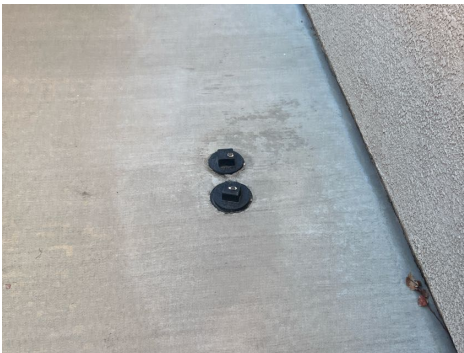
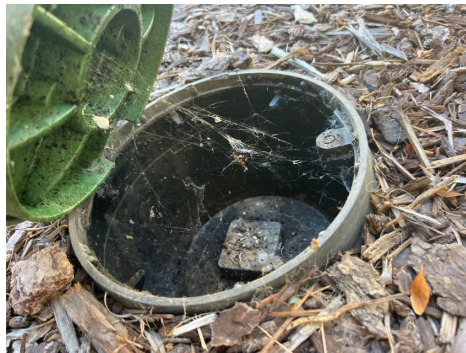
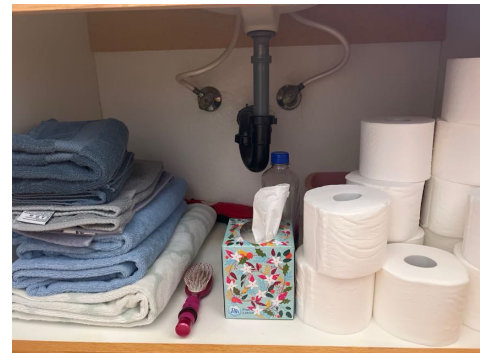
1.3. Sewer clean out at front and side yard noted - Recommend to check service records.

1.4. Most of the Sewer, Waste pipes are located underground not fully visible/accessible and not part of this inspection. A sewer video inspection must be completed prior to close of escrow by a qualified plumber in order to determine the true condition of the Sewer, Waste line.

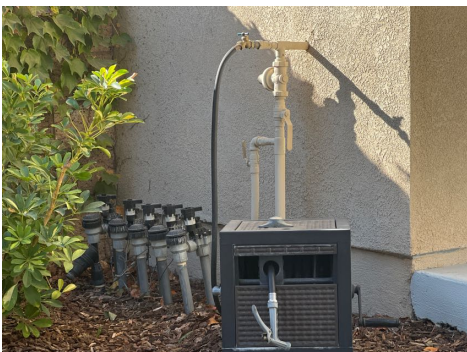
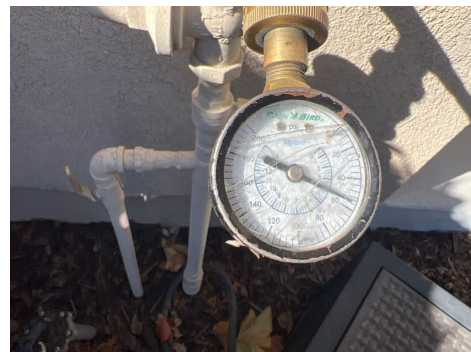
55 psi

2.1. Water main; Most of the water piping is located under ground - Not visible to comment. Check the records for any known defects, repairs. This is a limited visual inspection we do not perform leak tests on plumbing pipes. Recommend to check the records with the seller for any known issues, repairs with water pipes and or have it checked, tested by a qualified plumber.

2.2. Hose Bibs: Missing anti-siphon valve at hose bibs (A anti-siphon valve is a device that prevents liquid from returning to the line from which it came if a siphon action occurs). Recommend to have checked and installed by a qualified specialist.

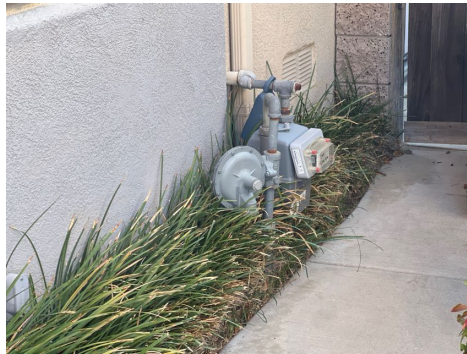
4.2. Gas meter - Seismic shut off was not present at the time of inspection, recommend to install - May not be required in the City of Location - Recommend to check the local regulations.

4.3. Underground gas pipe noted (type unknown). Have it checked for possible gas leak. Gas leaks or pipe testing not part of this inspection. Recommend to check the building records, permits for any known issues or repairs regarding gas pipes, fuel systems and/or have it tested by the Gas Co. and/or a qualified plumber.

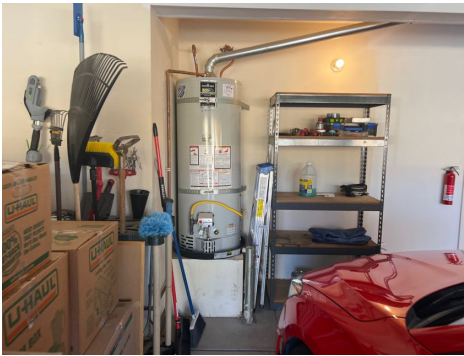
5.1. Water heater. No major defects found at the time.

5.5. Your water heater does not have a "Thermal **Expansion tank**" installed to prevent a possible leak at the T&P or "Pop-off" valve. Recent changes in code require one when a new water heater is installed. This change is not retroactive on older previously installed Gas/LP water heaters such as yours. There were no leaks or drips at the T&P valve during inspection. If your water heater does begin to drip or leak, then a Thermal Expansion tank may be needed.

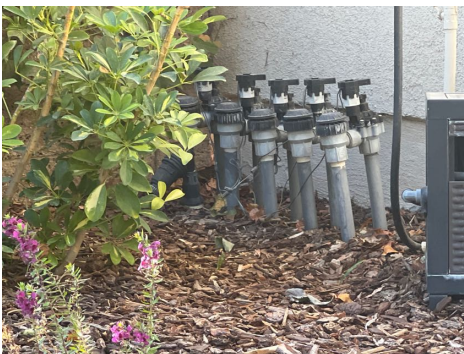
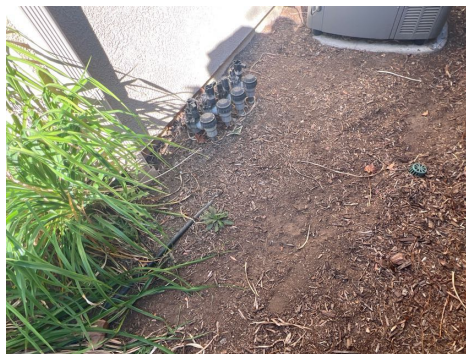
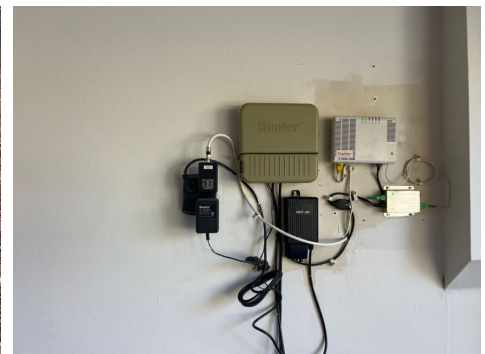
6.1. Yard Sprinkler systems/automatic timers are not tested and are not a part of this inspection (most of the pipes, spray heads installed underground). Check with the seller for any known defects, repairs of the system. We inspect type of pipes used for sprinkler system and report when old, galvanized pipes are present. We report location of the sprinkler heads and damage they cause to the structure.

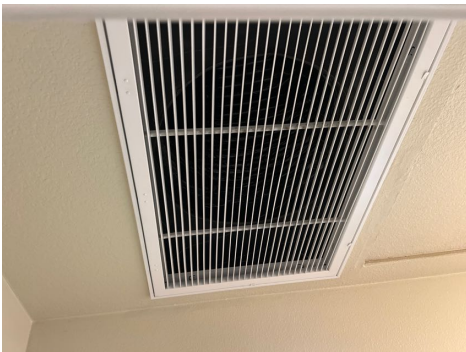
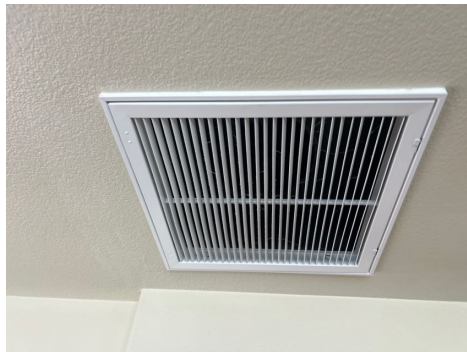
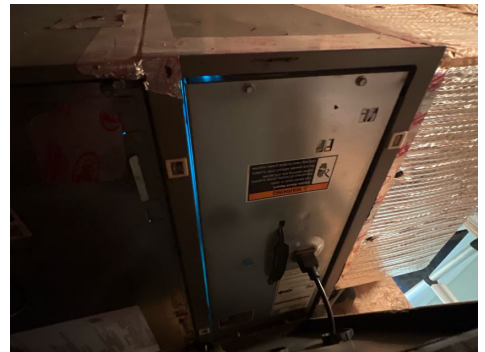
4.1. Air filters should be changed or cleaned regularly according to Manufacturer's instructions (seasonally and/or every 3-4 months recommended). Air flow, balance is not a part of this inspection. Recommend to check with the seller about air comfort and distribution.

4.2. Electronic air cleaner noted- Operated at the time. Periodic care, cleaning required. Check service, maintenance records and/or have checked and tested by qualified HVAC specialist.

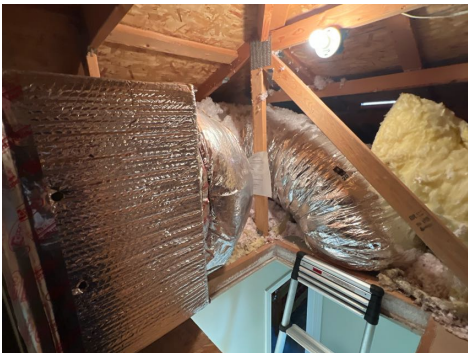
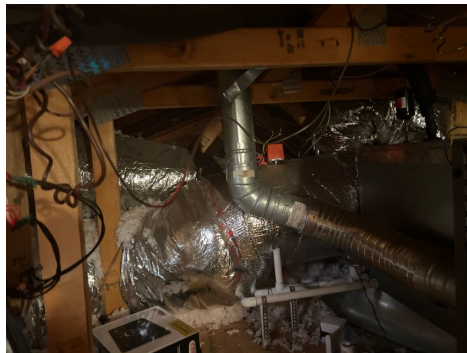
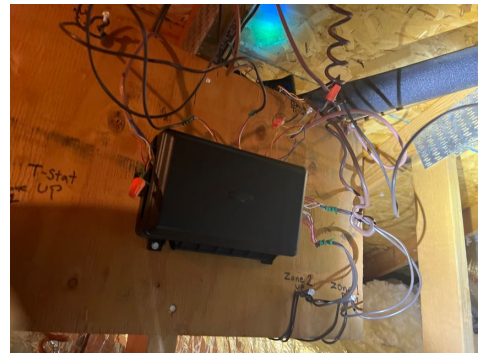
5.2. Ducting inside walls not fully visible, interior of ducts not visible at time of inspection. Check records, with seller for any known defects.

5.4. House with Zone system type control - Not part of this inspection (dampers are not tested at this inspection). Check with the seller about operation and service and/or have it tested by a qualified specialist.

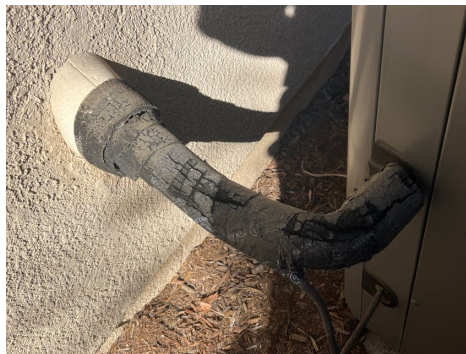
8.1. Worn insulation at refrigerant line noted at AC unit. Recommend to upgrade, correct.

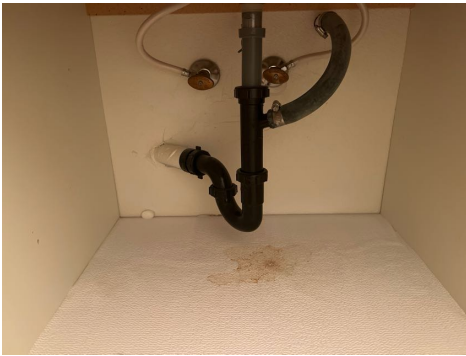
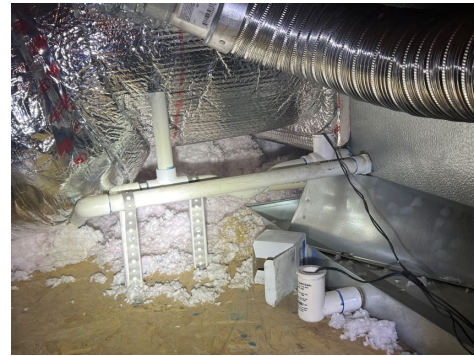
10.1. **A/C** condensation line drains at bathroom sink (FYI). Periodic cleaning, service required.

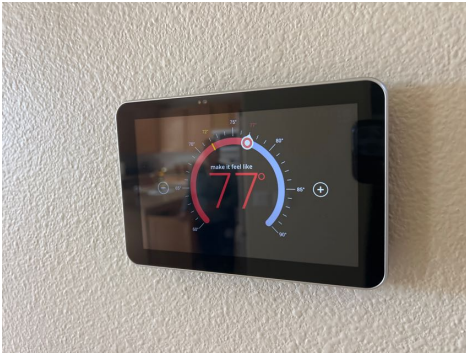
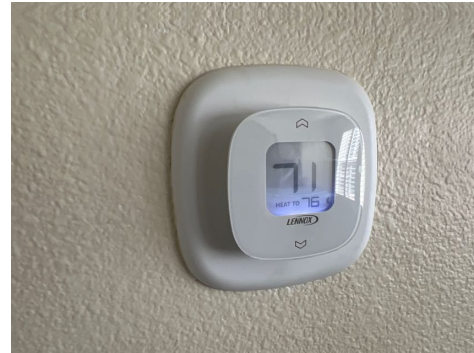
11.1. Thermostat(s) operational at the time of inspection. (FYI)

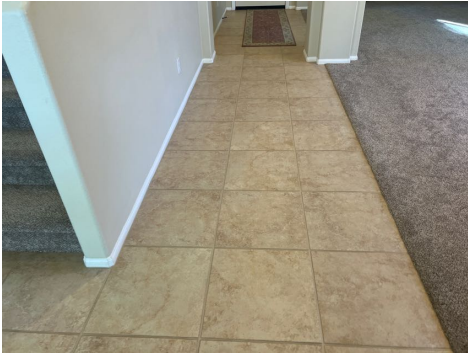
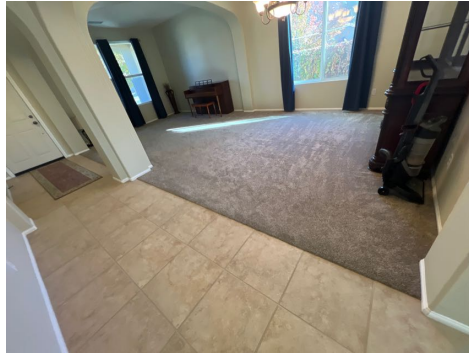
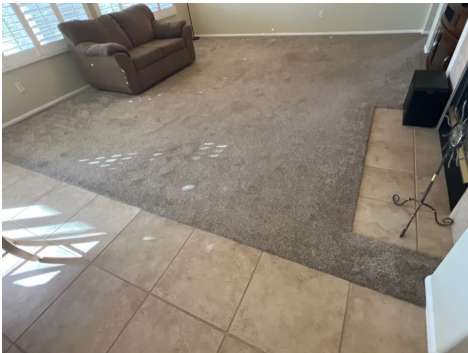
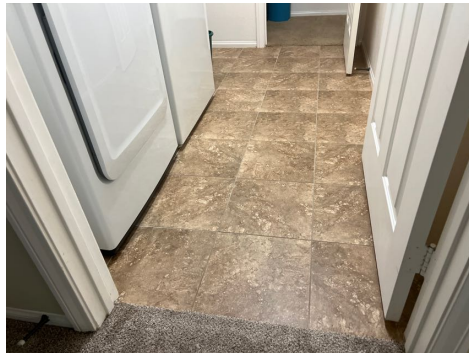
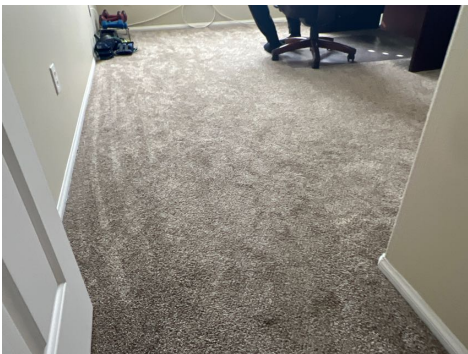
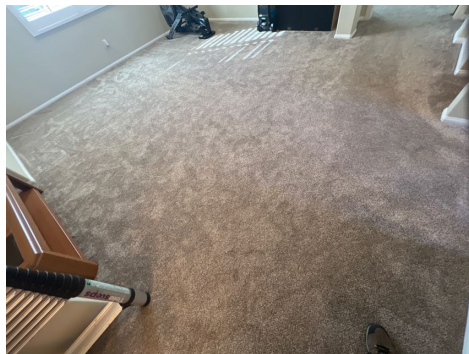
3.1. Cracked grout, Loose Tile(s) noted at interior at upper hall and primary bathrooms - Recommend further evaluation, any necessary correction made by qualified specialist(s).

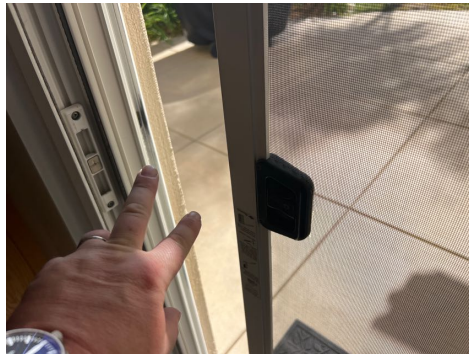
4.1. Screen door hardware is not operational, locking mechanism is defective. Have it checked, repaired by a qualified specialist.

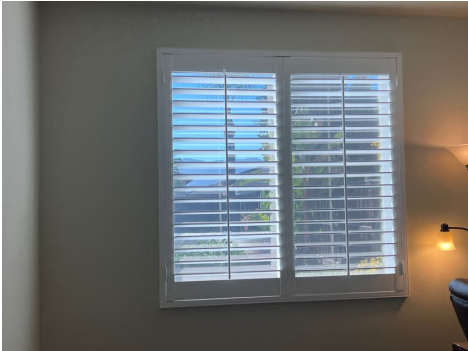
5.3. Damaged, broken spring(s) noted at window(s) noted at - lower guest bath and primary bedroom. Have checked, repairs made by a qualified specialist.

Lower guest bath - bad spring

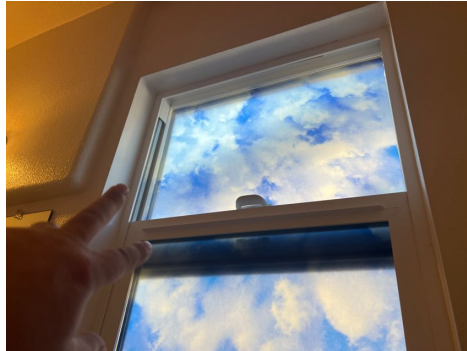
Bad spring - primary bedroom

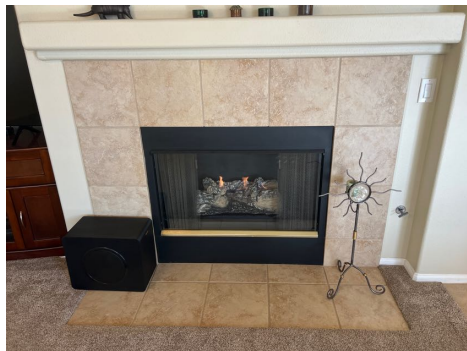
6.2. Gas was operational at the time. Flue was not fully visible at this inspection.

6.3. Recommend further and complete evaluation, video inspection of flue by qualified Chimney Inspector - This is a Safety and Fire concern.

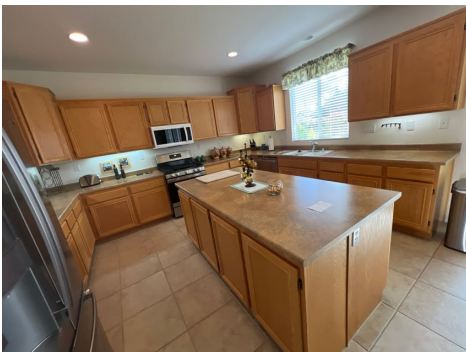
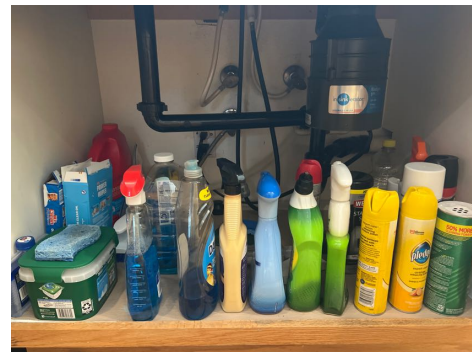
2.1. View under sink cabinets was restricted due to belongings.

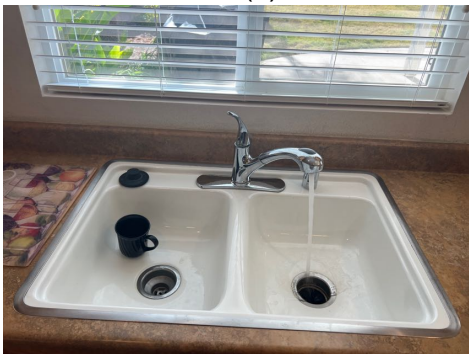
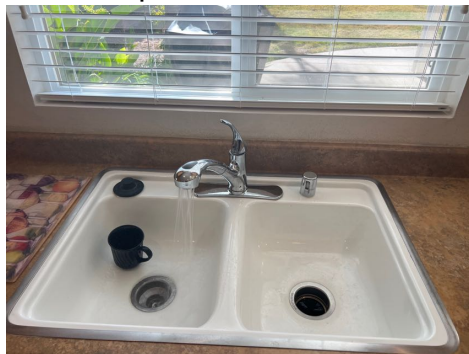
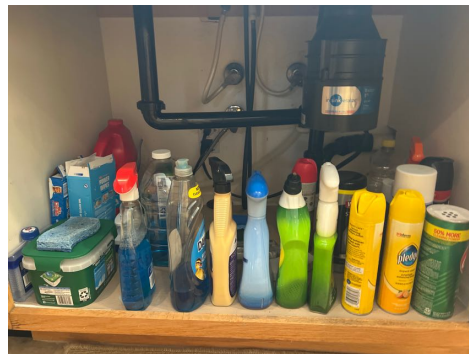
3.1. Sink faucet(s) functional at time of inspection.

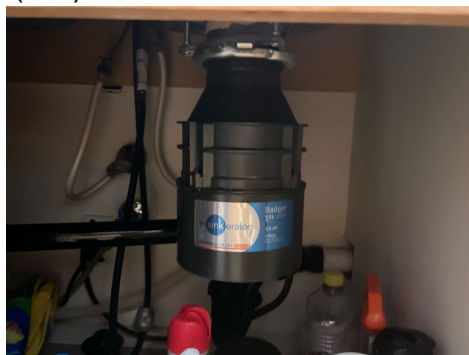
4.1. Unit(s) operated at the time. (FYI)

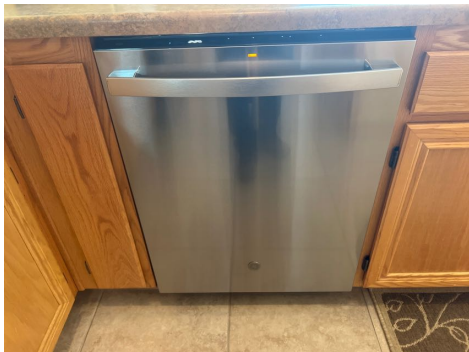
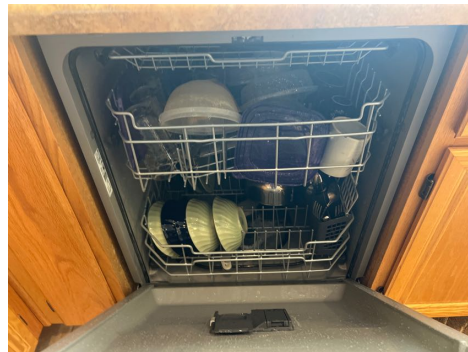
5.1. Dishwasher operated at the time. (Appliances are not removed at this type of inspection. There can be damage, defects not visible as a result). We recommend to check the records, with seller regarding any known defects or issues.

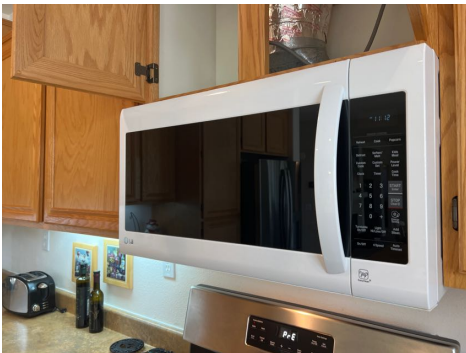
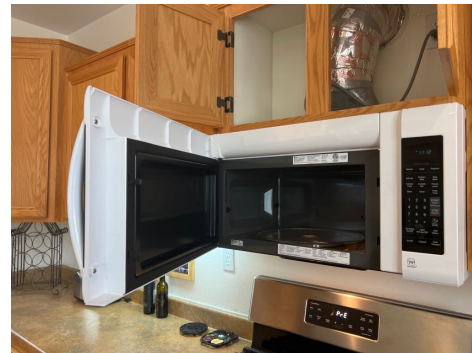
8. Microwave

8.1. Microwave noted - Not part of this inspection. Check with the seller. Proper operation and/or microwave leak is not part of this inspection. We turn the unit on and off and check for visual damage.

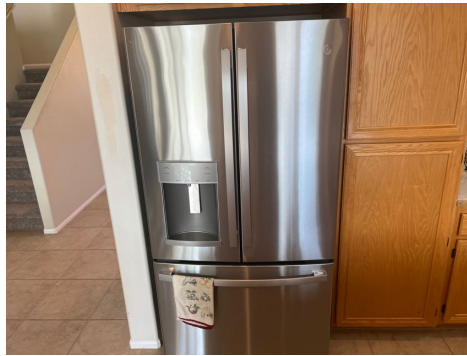
9. Kitchen Features

9.1. Refrigerators are not part of this inspection. Recommend to check the records with the seller for any known defects, repairs. Appliances are not removed at this type of inspection. There can be damage/defects not visible as a result. We recommend to check the records, with seller regarding any known defects/issues.

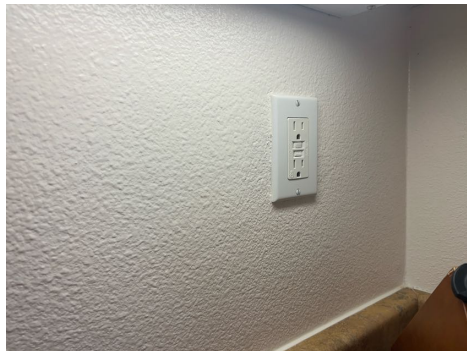
10. Other

10.1. GFCI type outlets at kitchen noted (FYI). Recommend to test them periodically.

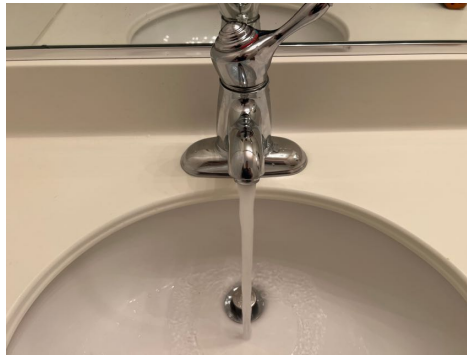
Hot cold reverse - left side sink

2.2. Hot and cold reversed noted at left side sink - have checked, recommend to correct

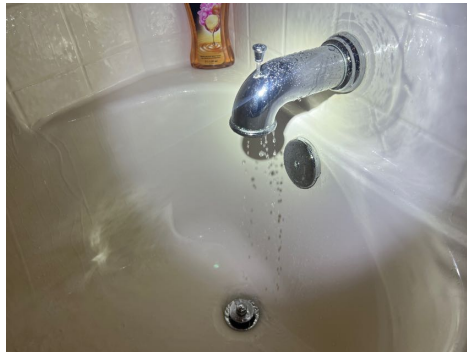
5.1. Leaking at downspout noted at shower mode due to defective shower diverter. Have it checked, evaluated, necessary correction or repair made by qualified specialist.

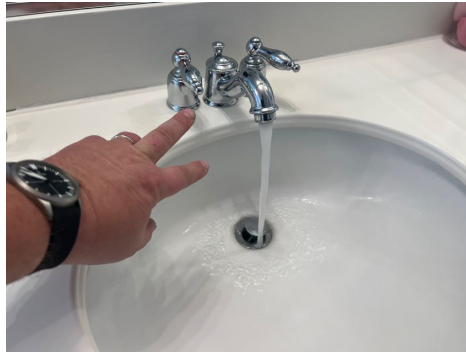
2. Sink(s), Faucets

- 2.1. Sink faucet(s) functional at time of inspection.
- 2.2. **Defective sink stopper noted. Have it checked, fixed by qualified specialist.**

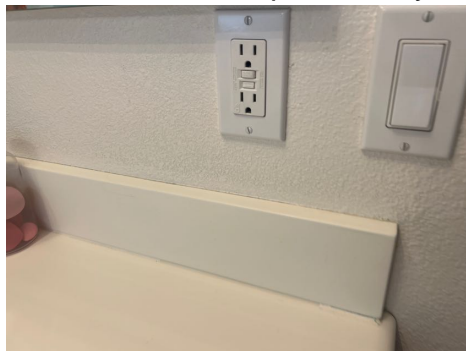
- 6.1. GFCI type outlet(s) noted. Recommend to test periodically.

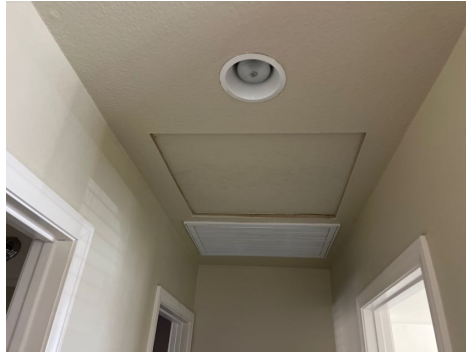
1. Attic Access Location

- 1.1. Attic access was located at hallway.

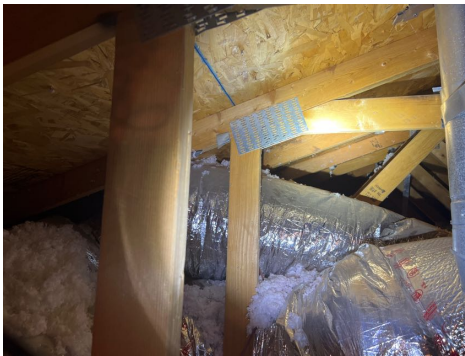
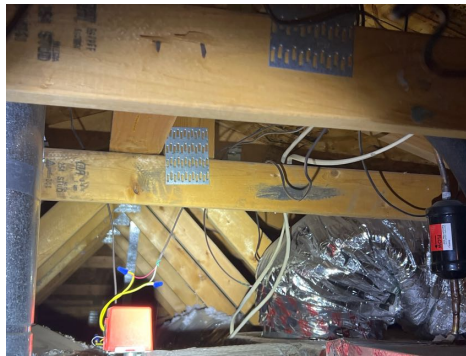
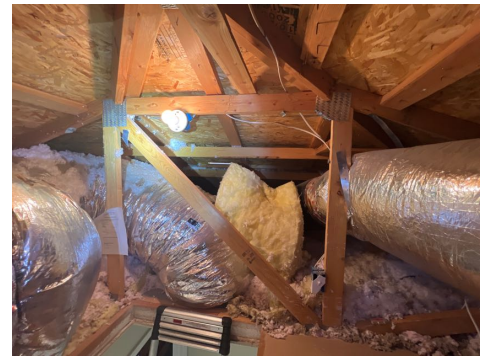
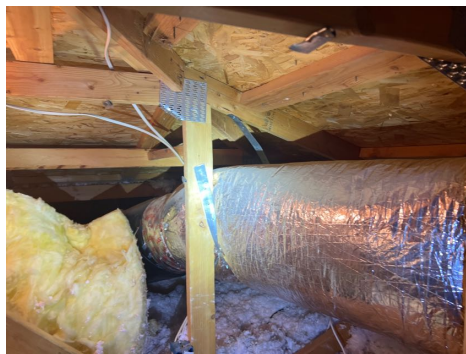
2. Roof Structure and Attic

- 2.1. Ceiling joists were not fully visible to comment due to insulation. Check the records for any known defects, repairs.
